**Re: Proposed Order No. R1-2016-0004 Waste Discharge Requirements for Nonpoint Source Discharges and Other Controllable Water Quality Factors Related to Timber Harvesting and Associated Activities Conducted by Humboldt Redwood Company, LLC in the Upper Elk River Watershed, Humboldt County**

Humboldt Redwood Company (HRC) appreciates the opportunity to comment on the Draft Waste Discharge Requirements (WDRs) proposed for HRC's forestry and watershed management operations in the Upper Elk River Watershed (Order No. R1-2016-0004; August 30, 2016).

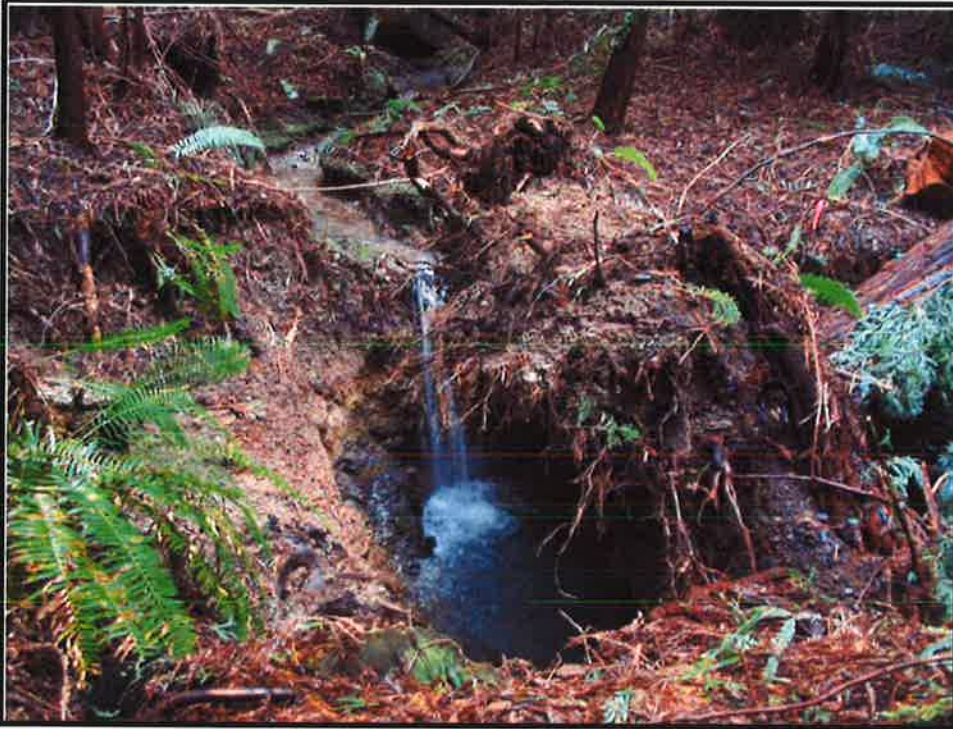
**Figure 1a.** Evidence of active erosion and incision in the YOC watershed, Caspar Creek, CA. Photo taken from Dewey (2007).

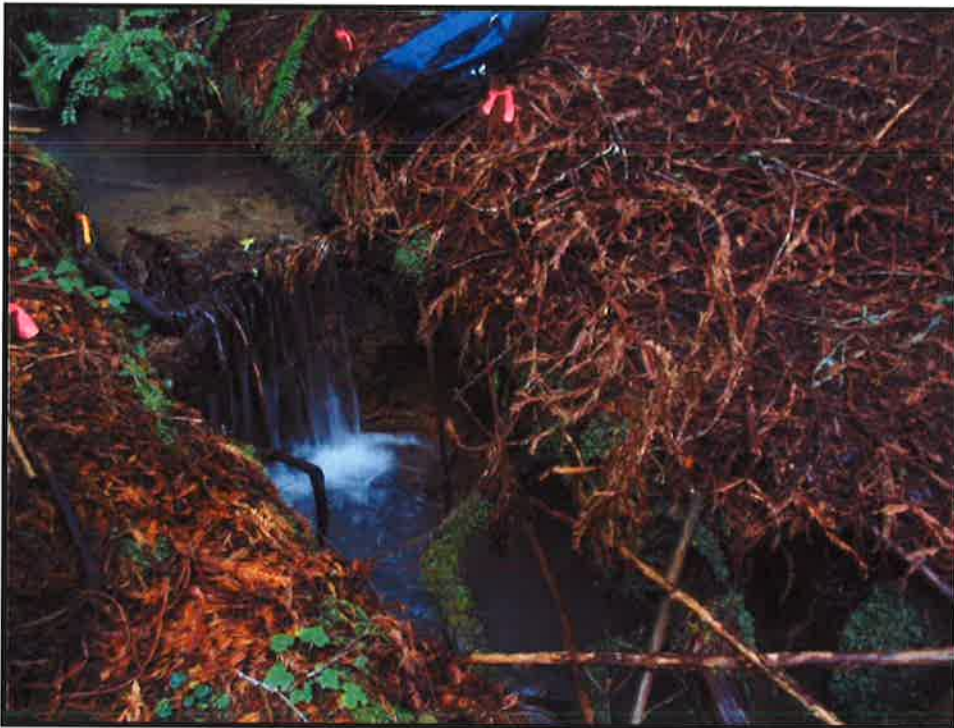
**Figure 1b.** Evidence of active erosion and incision in the MUN watershed, Caspar Creek, CA. Photo taken from Dewey (2007).

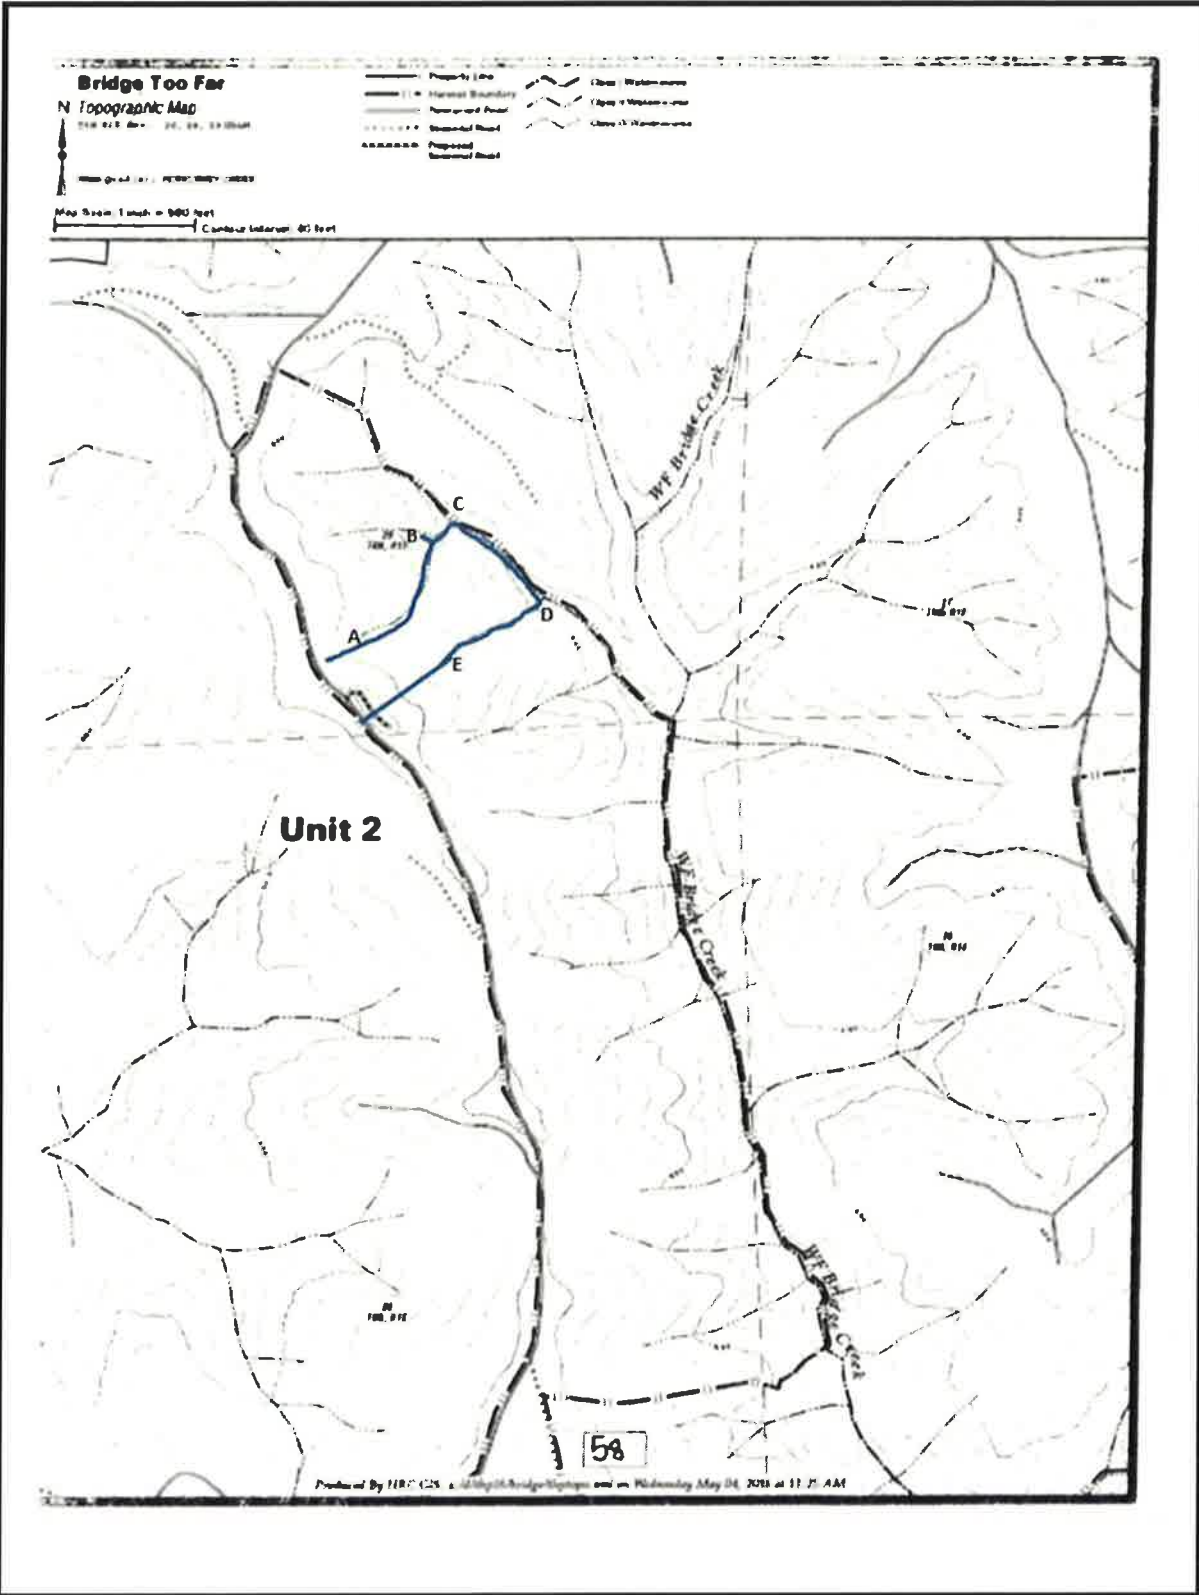
Figure 2. The route taken by the Review Team in Unit 2.

1-16-056 HUM - Unit 2: Unit 2 is a large selection harvest unit which is proposed to be cable logged. The field PHI Team (Team) walked down to the channel head of the first order (Strahler, 1957) Class III watercourse shown in Figure 2 (see point A). The location of the channel head appeared to be properly identified as no channelized flow was observed above where the channel head was flagged. The area where the channel head was located can be characterized as hydraulically rough due to the prevalence of live vegetation, thick layers of duff, and a relative abundance of large woody debris (Figure 4). Below the channel head, the watercourse was discontinuous, relatively entrenched, with generally subvertical and well vegetated banks. The channel exhibited a relatively steep and stepped profile with generally subvertical discontinuities (i.e., headcuts) present. Channelization was discontinuous, with subsurface channelization/piping occurring in conjunction with large woody debris (Figure 5) and thicker accumulations of colluvium and/or anthropogenically-induced valley infilling from first cycle logging.

The Team continued down to the confluence of two Class III watercourses (Figure 2; Point B), where the watercourse became a second order channel. Below the confluence the watercourse displayed slightly more consistent signs of channelization. However, valley gradient, the condition of the banks, and the roughness of the channel did not change significantly. The second order Class III watercourse combined with another second order Class III watercourse to form a third order Class III watercourse (Figure 2; Point C). This larger third order Class III watercourse was characterized by a much gentler valley gradient, a broader valley bottom (Figure 6), but largely remained a discontinuous channel. Watercourse banks were well vegetated and did not show signs of active erosion, although there was evidence of subsurface flow and/or erosion voids along the axis of the channel, particularly in areas with larger accumulations of large woody debris (Figure 7).

The third order Class III watercourse transitioned into a Class II watercourse shortly above point D on Figure 2. This transition appeared to be accurately identified by the RPF. At point D, the Team walked up a first order Class III watercourse. This watercourse displayed similar characteristics and conditions to that of the first watercourse walked between points A and B (Figure 2). The Team continued to walk the watercourse until the channel head was reached (Point E, Figure 2). The channel head at point E was very similar to the one discussed for point A (Figure 2).

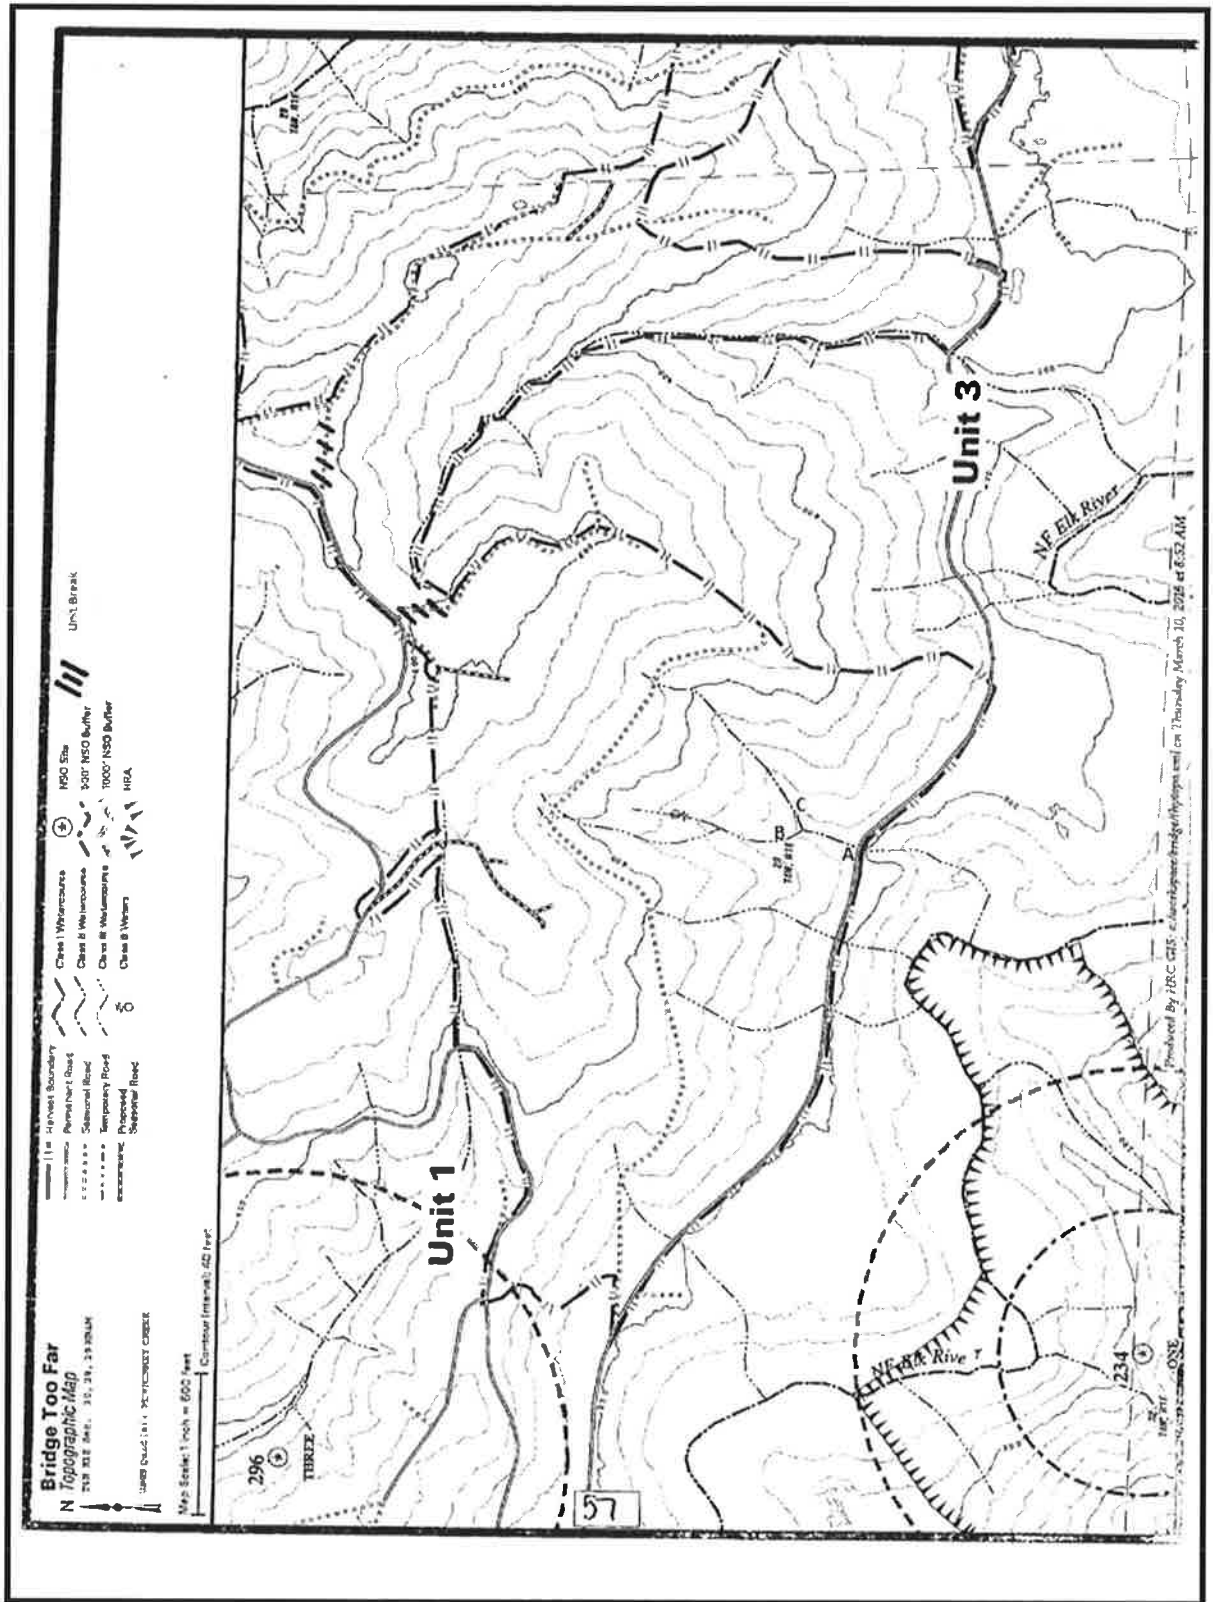
**Figure 3.** Points indicating the locations inspected in Unit 1.

1-16-056 HUM - Unit 1: The Team walked up the Class II watercourse shown in Figure 3 (Point A). The portion of the Class II watercourse directly above the road displayed active erosion and incision, and this was primarily attributed to base level lowering associated with watercourse crossing replacement. Above the influence of the watercourse crossing, the watercourse displayed no signs of recent erosion. The Team continued up to the confluence of a second order Class III watercourse (Figure 3; Point B) and a first order Class II watercourse (Figure 3; Point C). No recent in-channel erosion was observed in either watercourse, although evidence of an old skid trail fill failure was observed adjacent to Point C (Figure 3). The old failure is contained within the RMZ of the proposed THP.

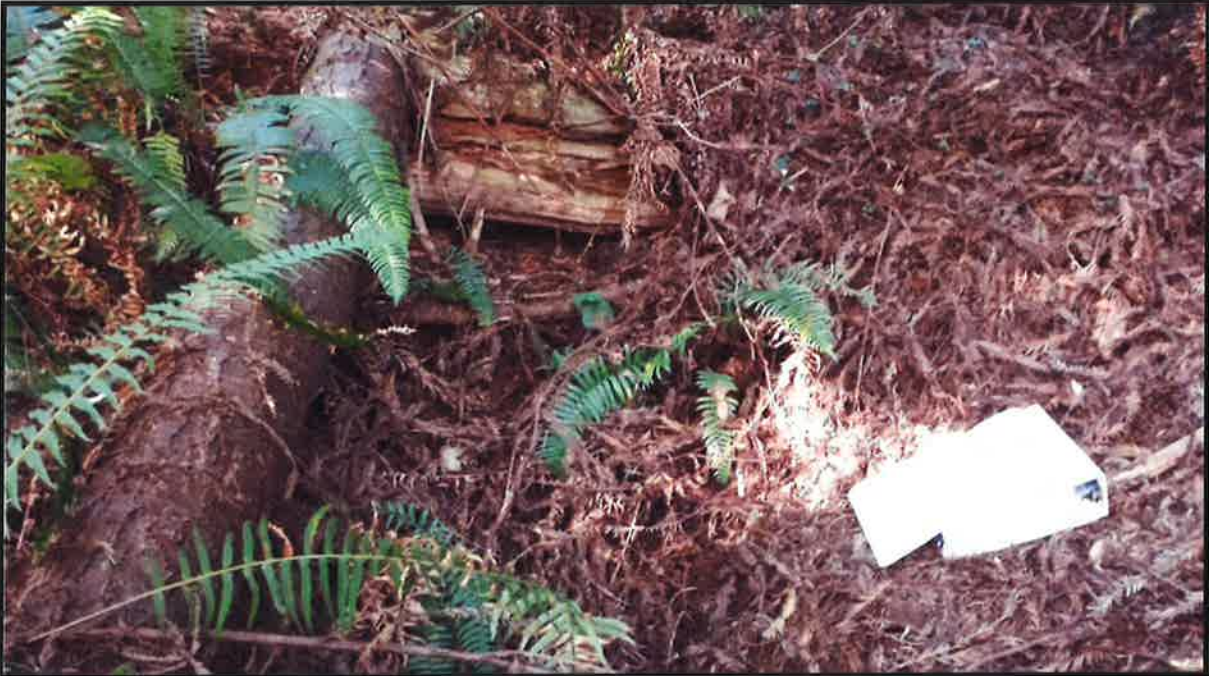
**Figure 4.** The channel head of the Class III watercourse. Note the dense vegetative cover and relative abundance of large woody debris.

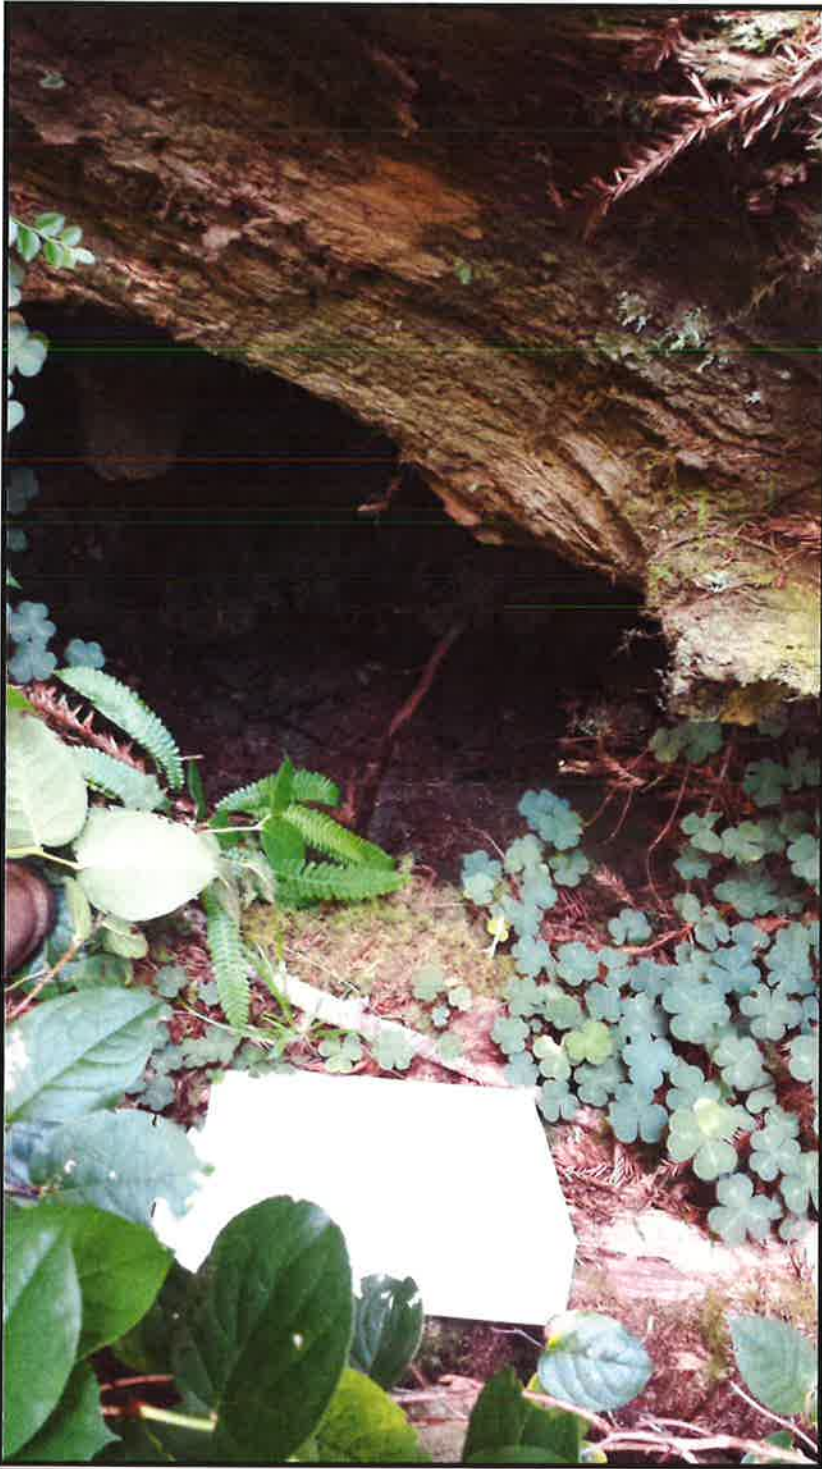
**Figure 5.** The Class III watercourse several hundred feet below the channel head. The watercourse went subsurface in response to large woody debris. Binder used for scale.

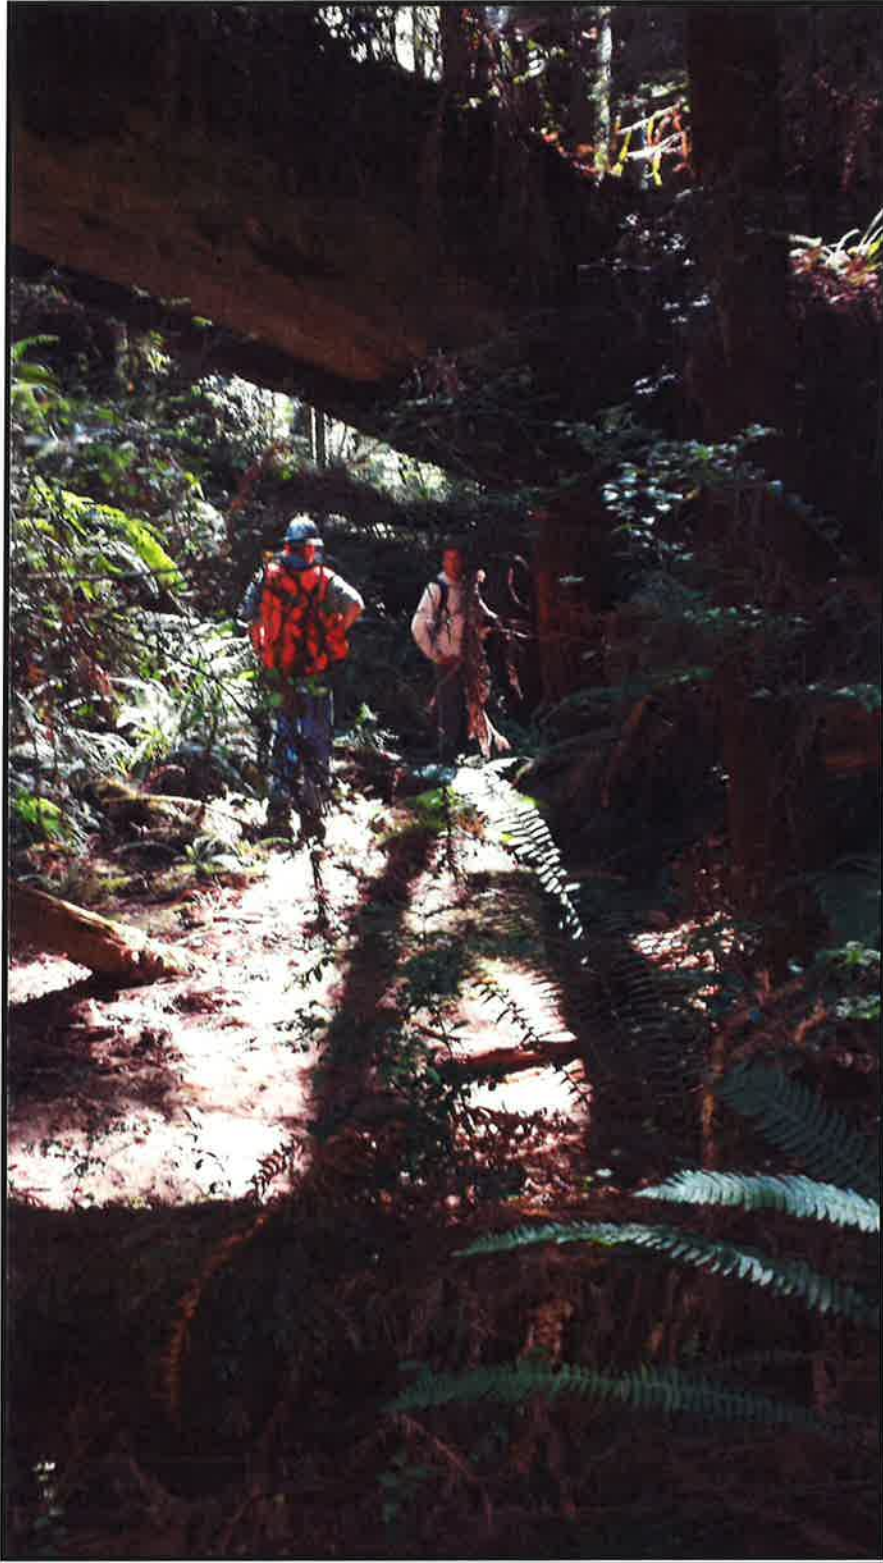
**Figure 6.** The third order Class III watercourse. Note the lack of channelization and relatively unconfined valley bottom.

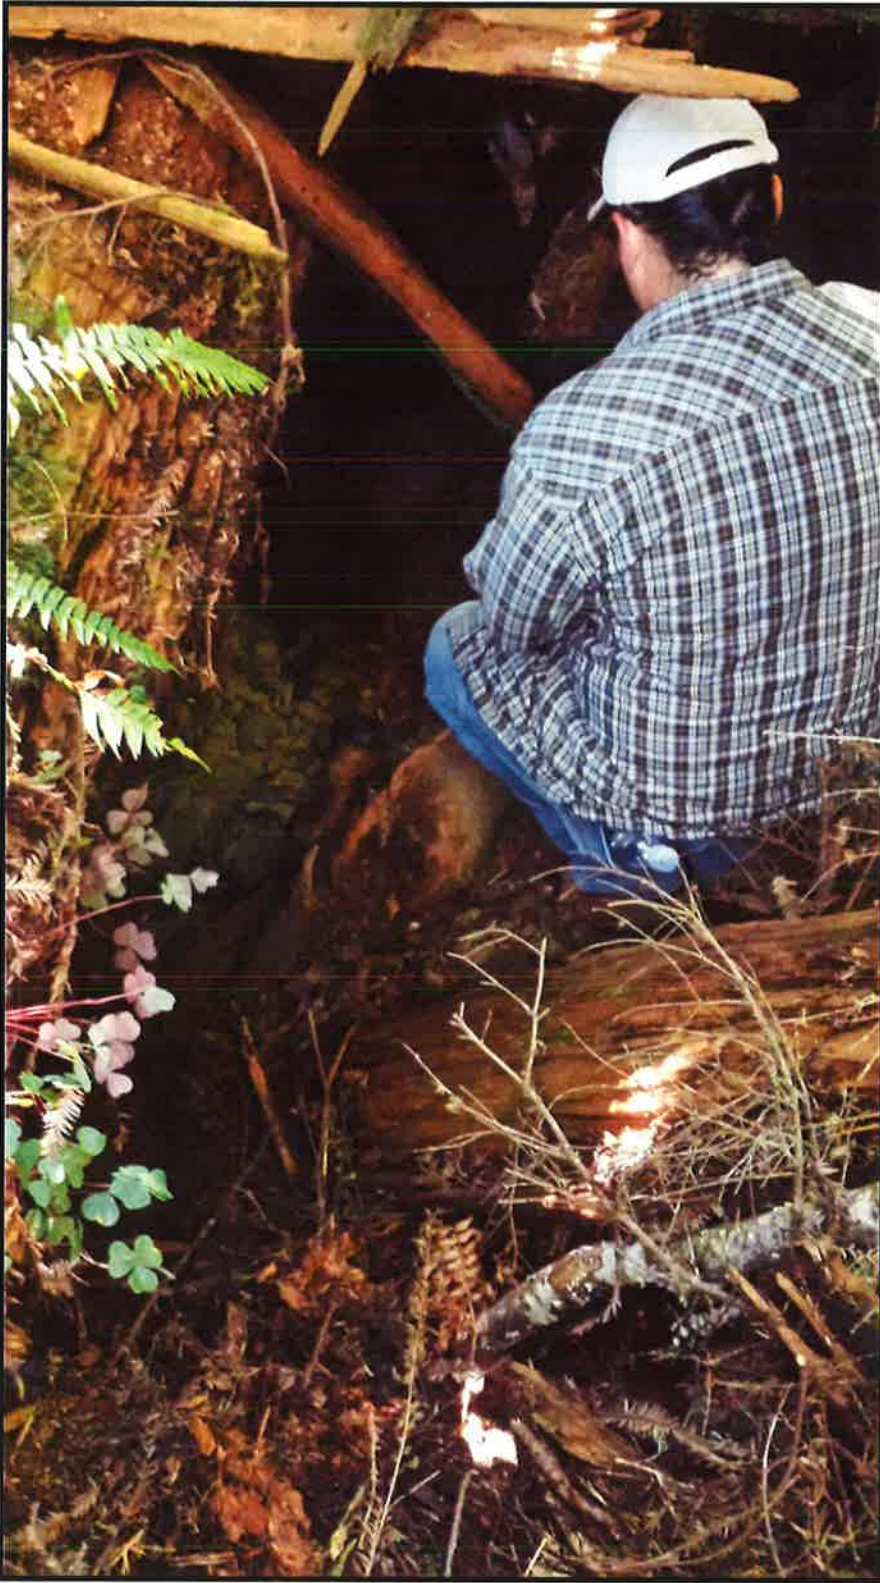
**Figure 7.** Subsurface erosion along the third order Class III watercourse.

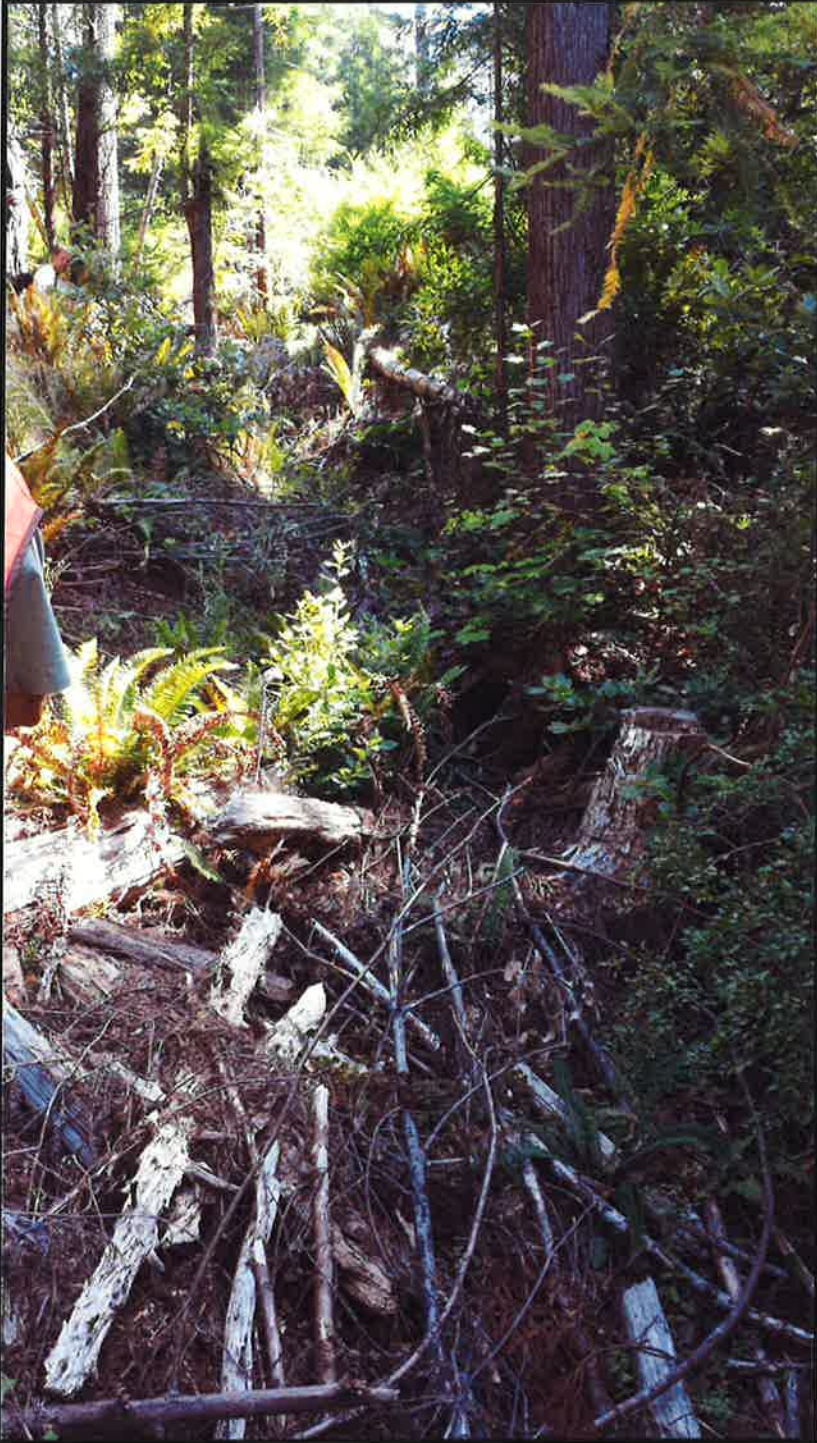
**Figure 8.** Looking up at the Class III watercourse in the Three Forks THP (1-13-005 HUM).

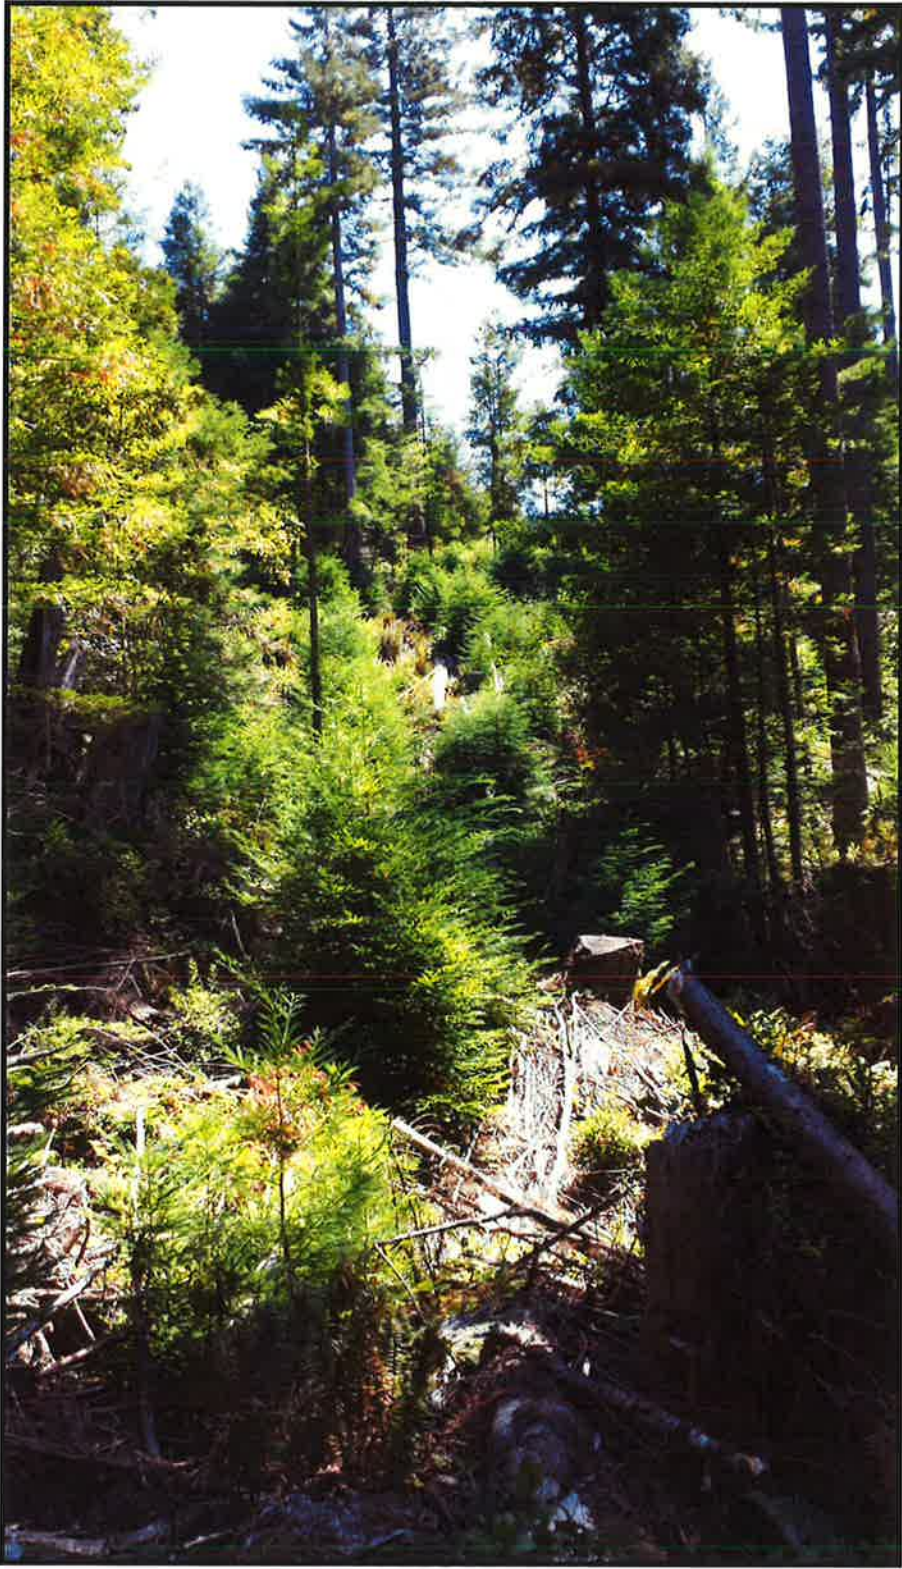
**Figure 9.** Canopy retention above the Class III watercourse in a unit of the Three Forks THP (1-13-005 HUM).

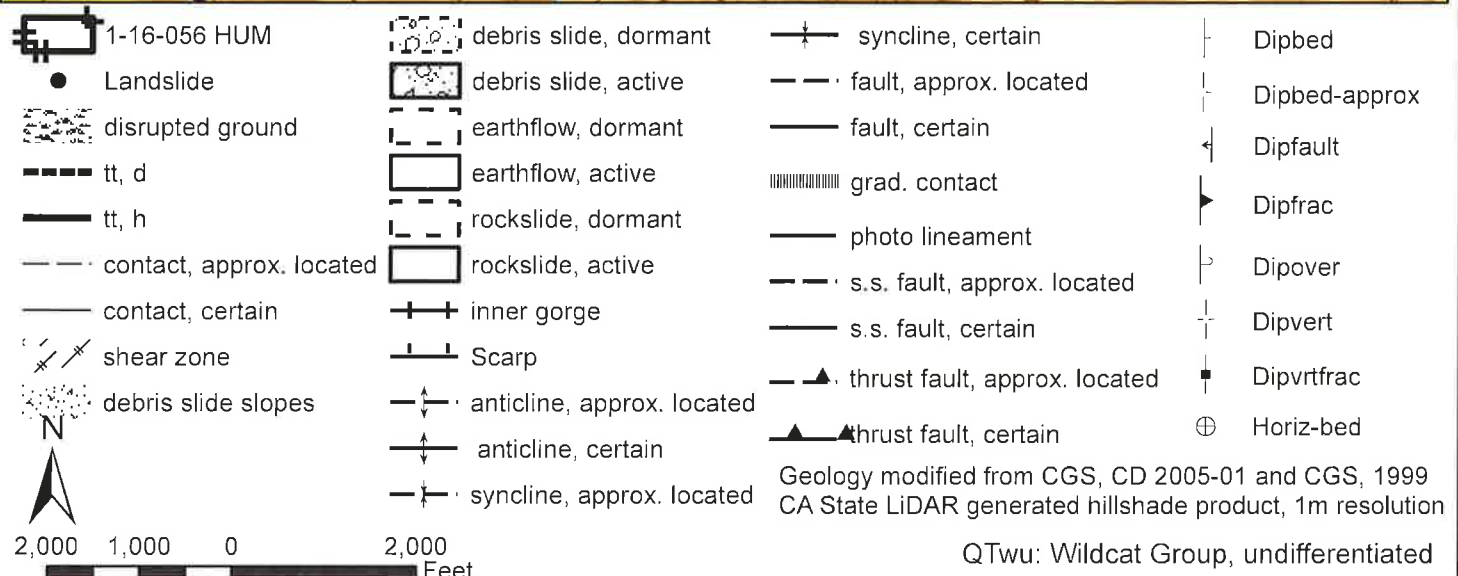
Date: 7/20/16	<b>Regional Geologic and Geomorphic Map          To Accompany          2nd Field Evaluation          THP 1-16-056-HUM</b>	<b>Figure:          1</b>
Scale: 1:24,000		
Approved by: jao

Within the plan area, we observed light brown to gray, poorly consolidated, fine sandy siltstone exposed in road cuts and natural exposures throughout the plan area. The bedrock composition is consistent with descriptions of the undifferentiated Wildcat Group (Ogle, 1953). Within the Class III channel visited in proposed Unit 1, we observed terrace deposits cut into the on top of fine sandy siltstone. The terrace deposits contained a coarse cobble to boulder sized lag deposit on top of the strath terrace cut into the undifferentiated Wildcat Group bedrock. The coarse lag deposit was capped with fine grained silt and sand with few gravels.
