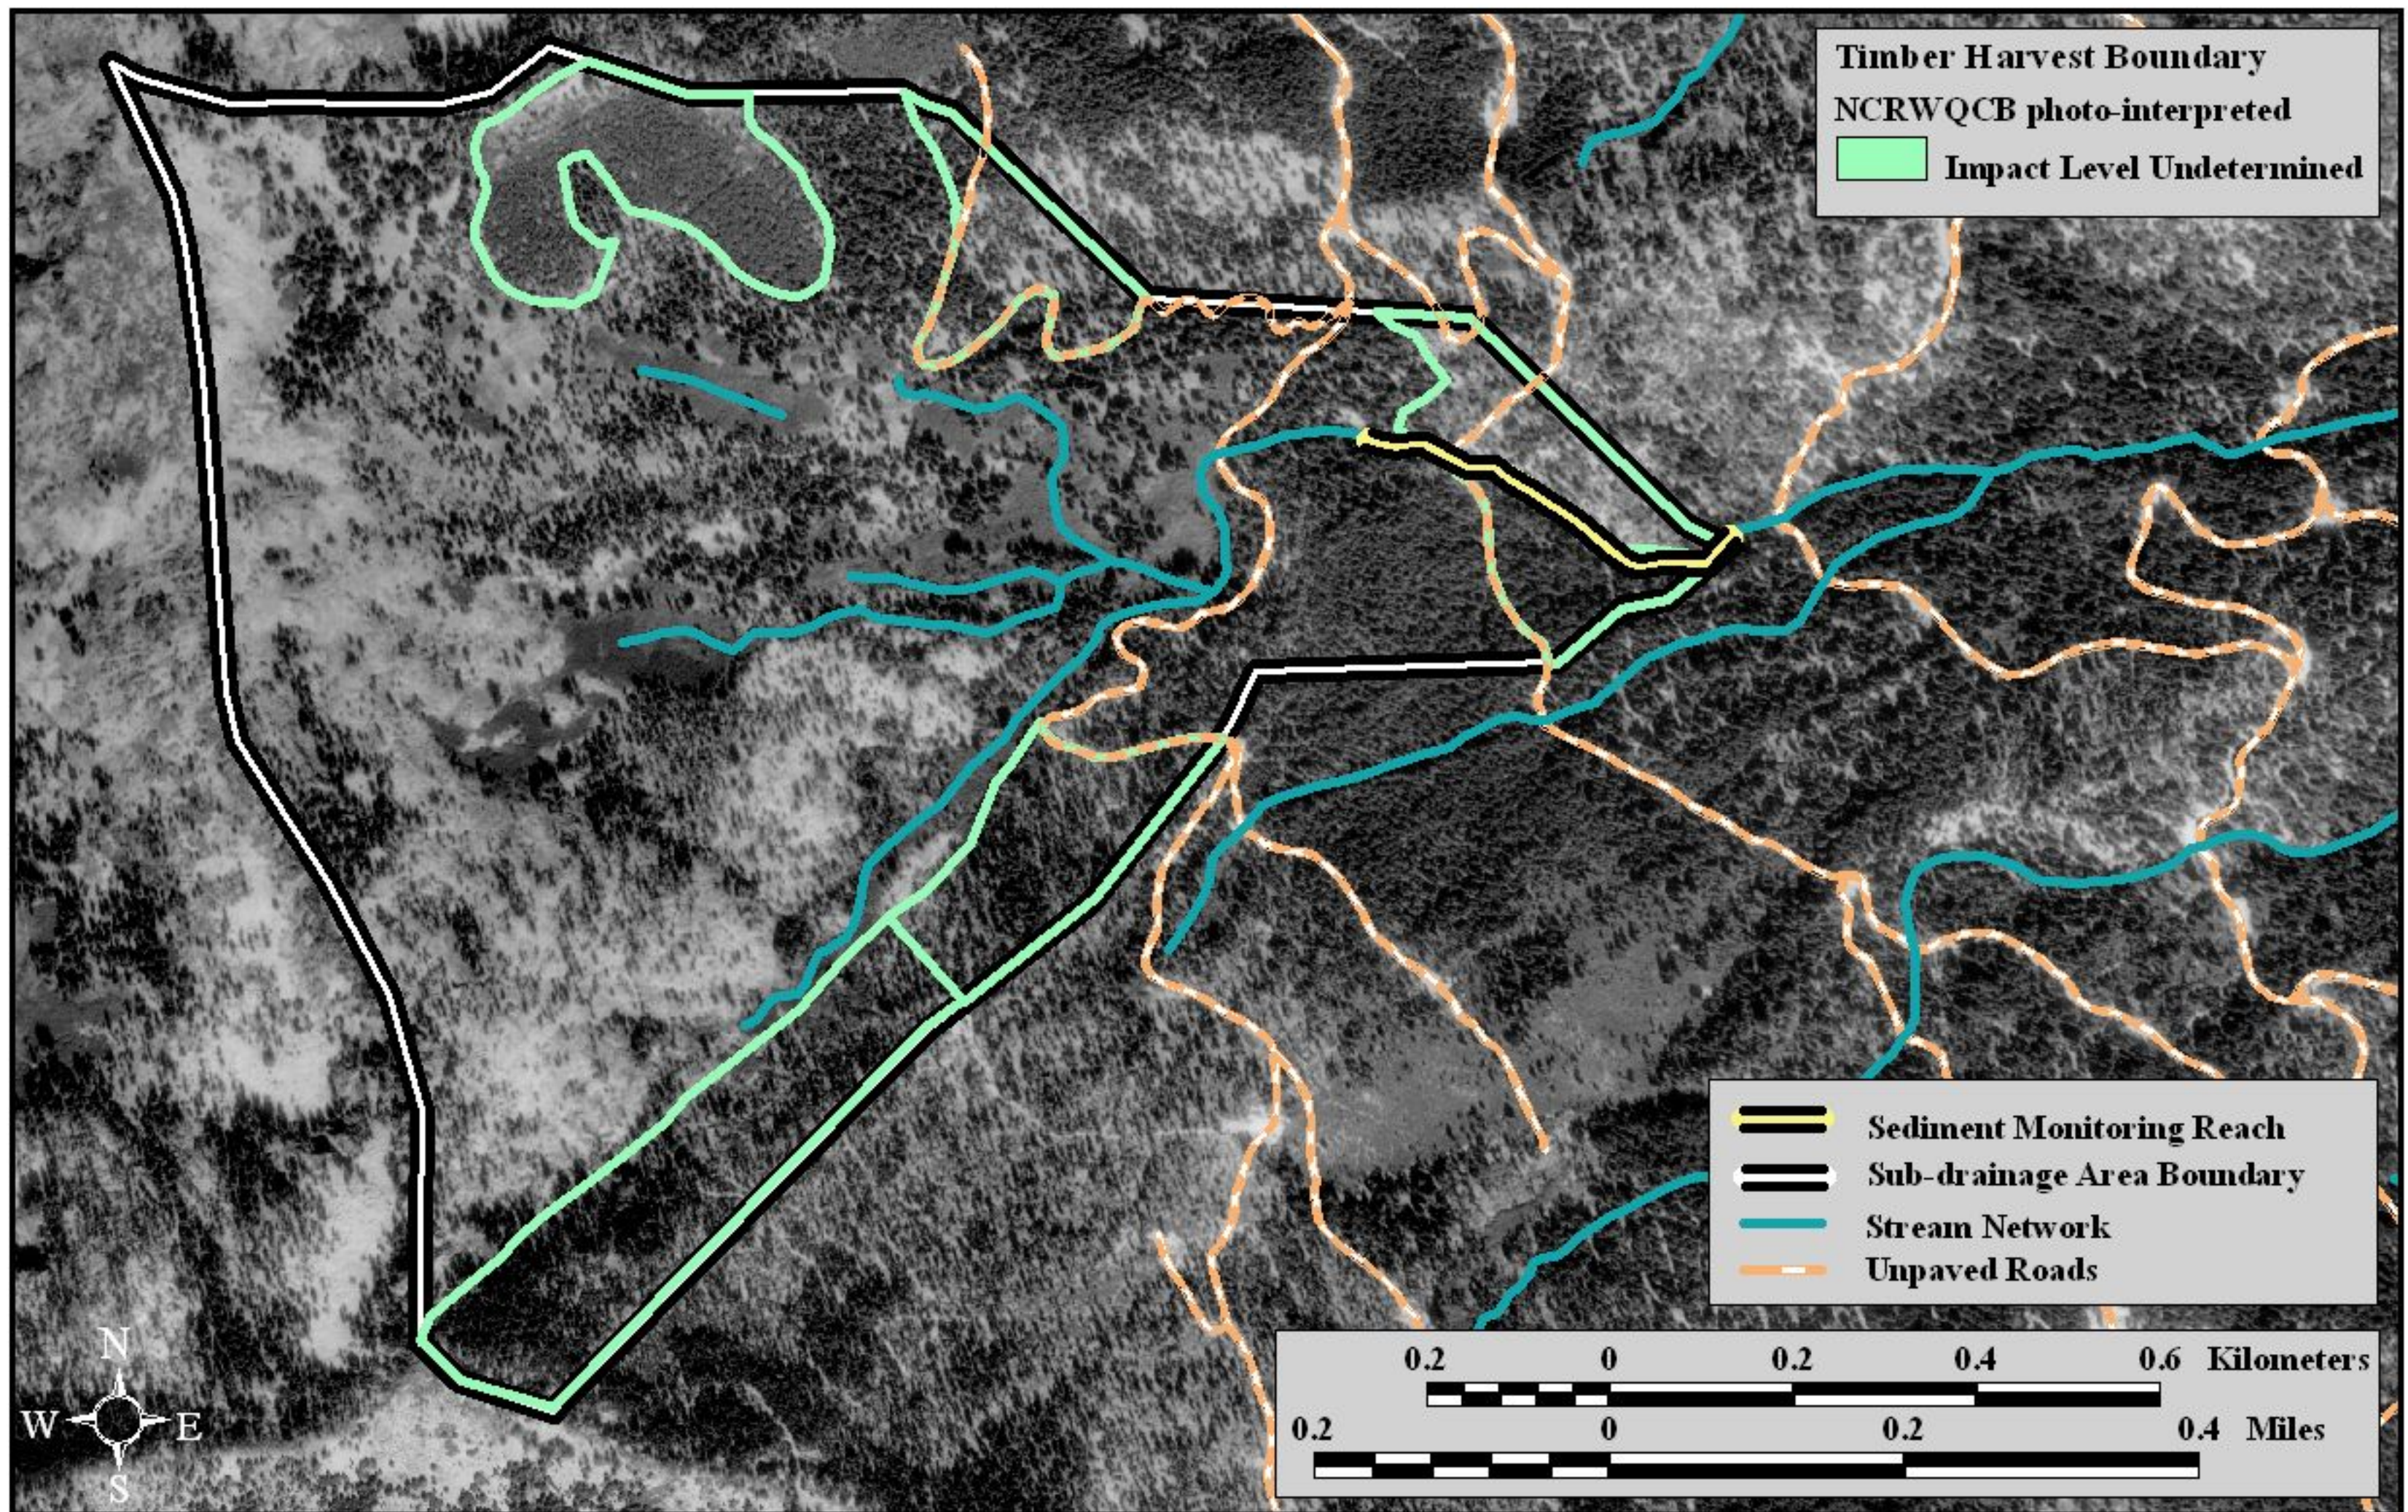
Figure 3.11. Orthophoto with GIS and photointerpretation coverage showing disturbance history in an area where human-caused sediment delivery is interpreted to be in the 50 percent category. North Fork French Creek.
