The East San Joaquin Water Quality Coalition (Coalition) is submitting a request to update its Monitoring and Reporting Program Plan (MRPP) submitted on August 25, 2008 to move the sampling location Mootz Drain @ Langworth Rd (535XMDALR) from its current location to a downstream location approximately 250 feet to the west of Langworth Rd. The Coalition has monitored the current location from October 2008 to August 2009 and would move to the new location starting September 22, 2009. The current monitoring location on the Mootz Drain water body pools water from upstream and acts as an agricultural holding pond for agricultural discharge upstream of this point. The Coalition requests to continue collecting samples on Mootz Drain downstream of the pond where the pooled water exits and continues west to the Modesto Irrigation District Main Canal. The closest downstream access point to Mootz Drain is a good site for sampling, and is proposed to be the alternate site for Mootz Drain @ Langworth Rd. The access point furthest downstream along Mootz Drain prior to discharge into the MID Main Canal is adjacent to a dairy and it would be difficult to distinguish between agricultural and dairy

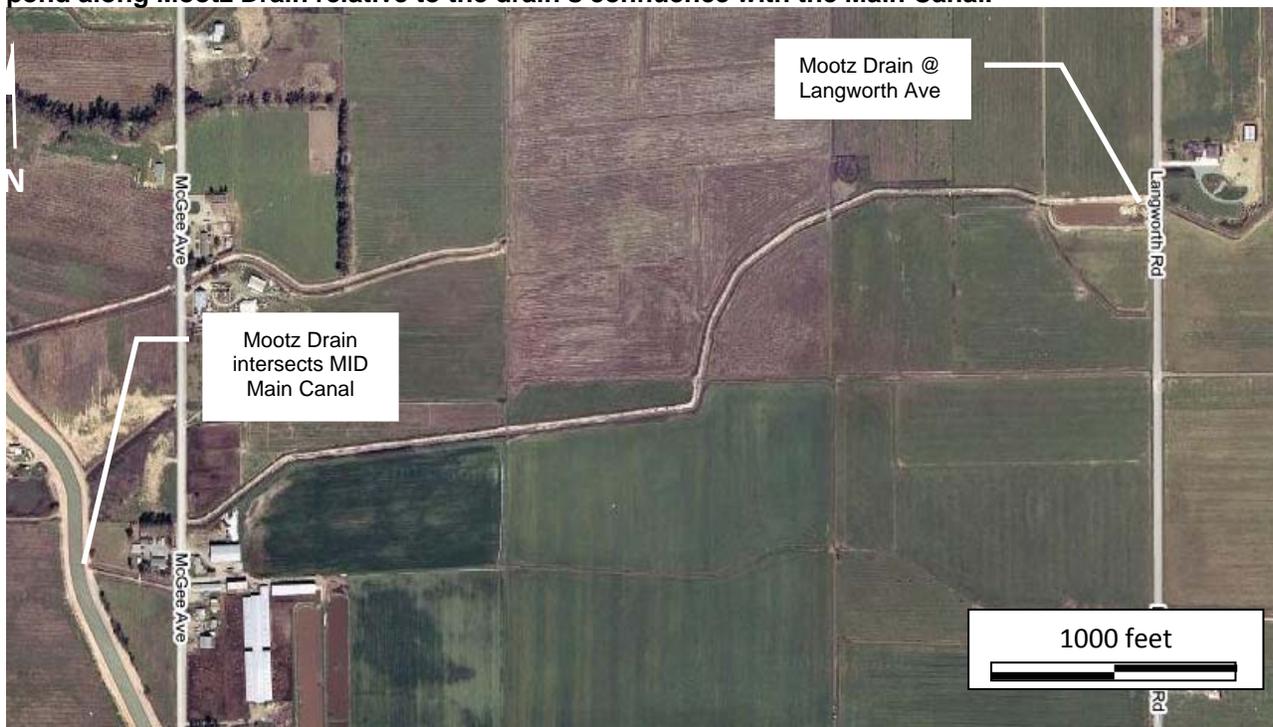
Figure 1. Aerial photograph (from Google maps) depicting current monitoring site at the settling pond along Mootz Drain relative to the drain's confluence with the Main Canal.

Mootz Drain @ Langworth Rd is a small site subwatershed containing a little over 1000 acres of agricultural land. Mootz Drain originates approximately three miles east of the sample site (at Langworth Rd) flowing west a total of about four miles where it spills into the MID Main Canal. The current sampling site is located at a settling pond along Mootz Drain about one mile from the MID Main canal.

The Coalition originally selected Mootz Drain @ Langworth Rd as a monitoring location based on ARC GIS land use maps and aerial photography (N 37.70582, W -120.89303). Samplers located the site using latitude/longitude coordinates and indicated it was suitable for sampling. During winter sampling, Mootz Drain did not contain water except for in this pond. In addition, samplers noted that this location acted as a “holding pond” and investigated other possible locations to sample. Holding water is a known management practice that can be used to capture sediment and other particulates as well as allow time for chemicals to biodegrade prior

to discharging. As a result, samples collected from the Mootz Drain holding pond do not accurately characterize discharge from Mootz Drain to the Main Canal. Samplers were unable to collect samples to the east of Langworth Avenue due to a barbed wire fence. The other alternative is to move the collection point downstream of the Langworth pond.

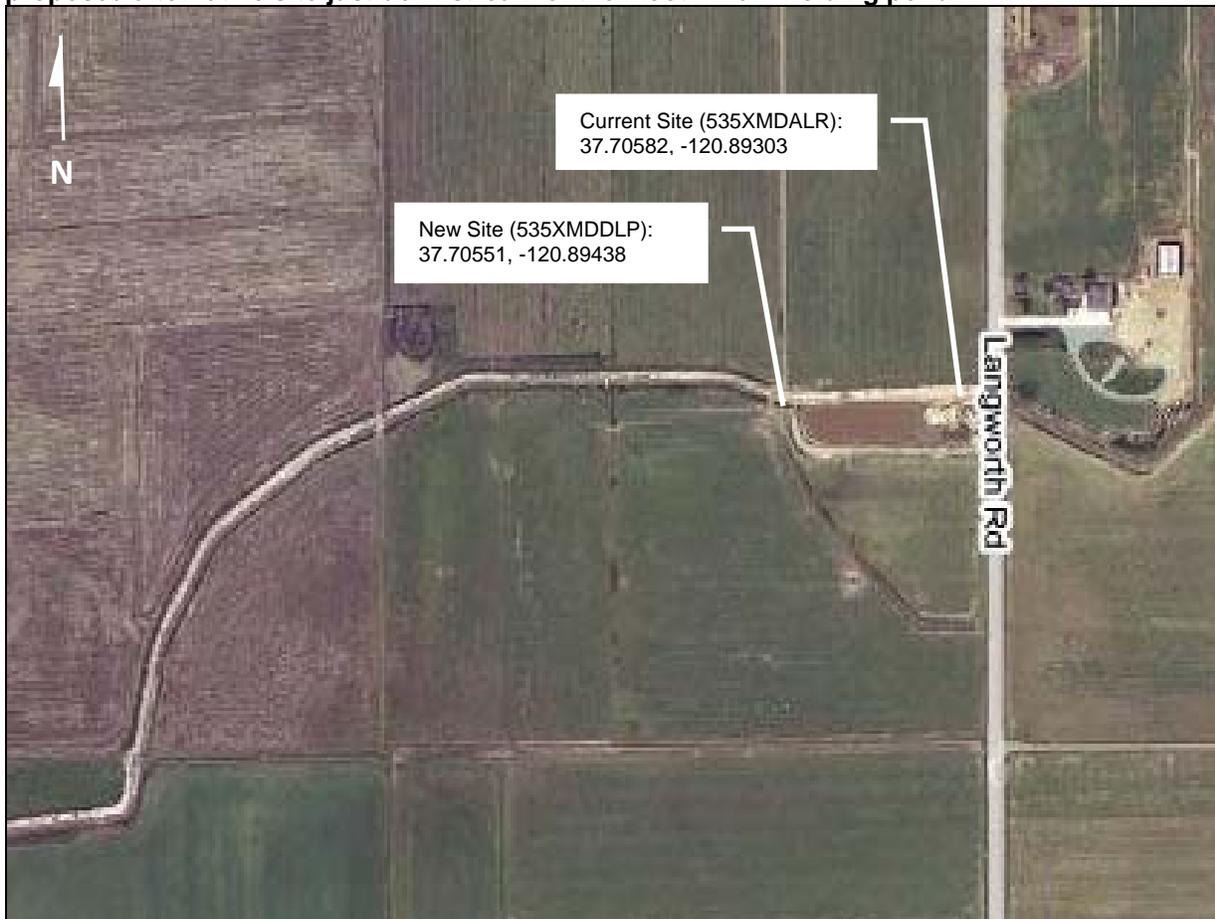
Figure 2. Aerial photograph (from Google maps) depicting current monitoring site and the proposed alternative site just downstream of the Mootz Drain holding pond.

The Coalition proposes to move its current sampling location approximately 50 yards downstream of the holding pond where Mootz Drain narrows into a small canal. This location (Mootz Drain Downstream of Langworth Pond) is close to the endpoint of agricultural discharge from the Mootz Drain site subwatershed, prior to its confluence with the Main Canal.

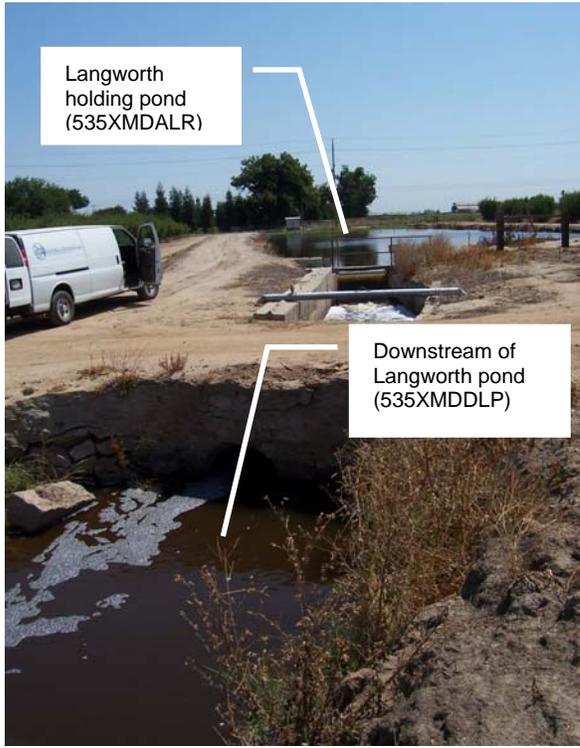
Figure 3. Photographs taken in the field at proposed alternate site location, facing east (A) and facing west (B).
