**Subject: Water Quality Petition – Cleanup and Abatement Order R5-2014-0700**

**CLEANUP AND ABATEMENT ORDER R5-2014-0700, JESS RANCH AND MARCIEL RANCH BIOSOLIDS APPLICATION SITES, ALAMEDA COUNTY**

CLEANUP AND ABATEMENT ORDER R5-2014-0700  
FOR

BIOSOLIDS RECYCLING, INC.  
JOSEPH AND CONNIE JESS  
PAUL AND SALLY MARCIEL  
JESS RANCH AND MARCIEL RANCH BIOSOLIDS APPLICATION SITES  
ALAMEDA COUNTY

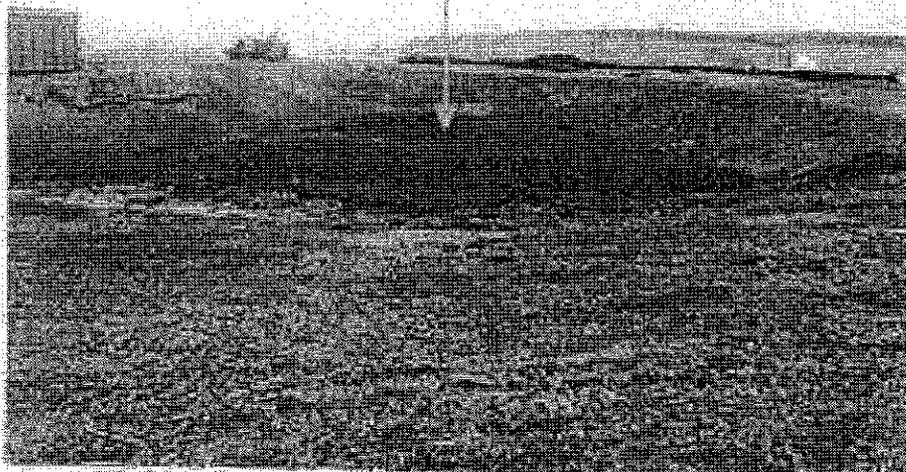
Figure 1  
Looking south at 400 tons of biosolids (red arrow) that remain in a pit within the Site's western containment basin.

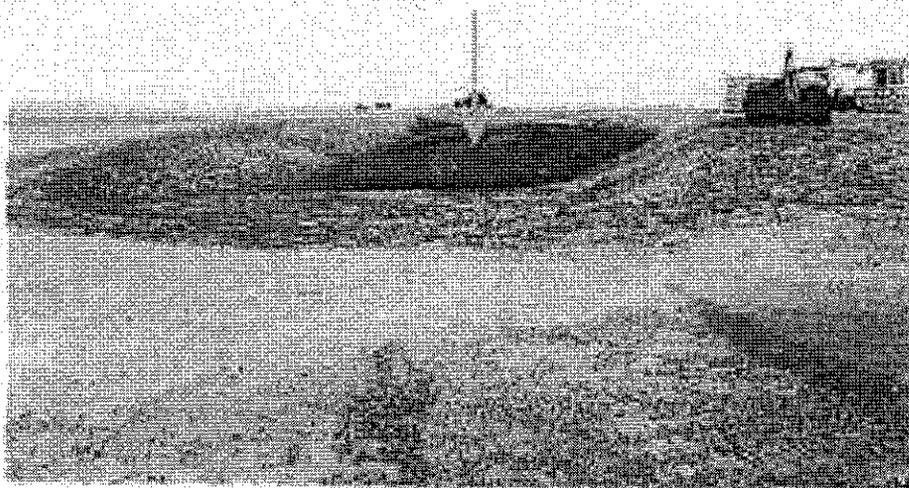
Figure 2  
Looking north at the 400 tons of biosolids (red arrow) that remain in a pit within the Site's western containment basin.

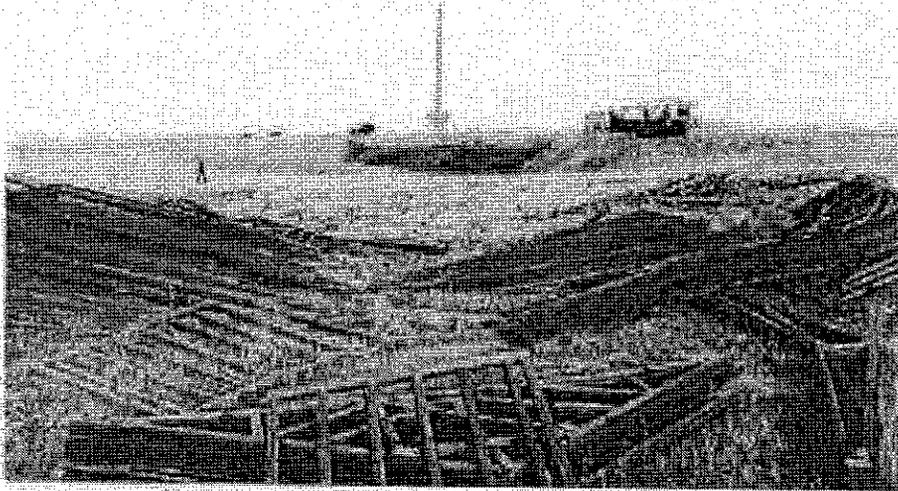
Figure 3

Standing near the southeastern end of the western containment basin looking north at the remaining biosolids stockpile, red arrow.

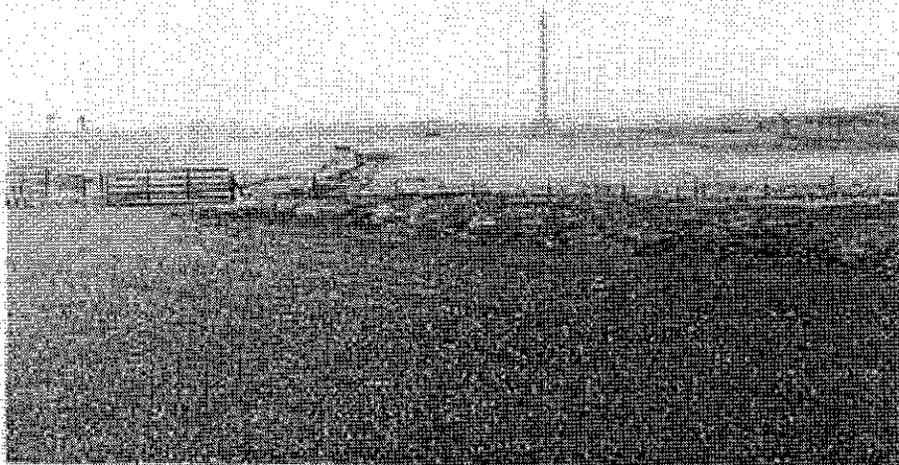
Figure 4

Standing just north of the remaining biosolids stockpile, looking north at section J-7 on the attached map. The red arrow points to the area where Biosolids Recycling, Inc. would like to land apply the remaining biosolids stockpile.

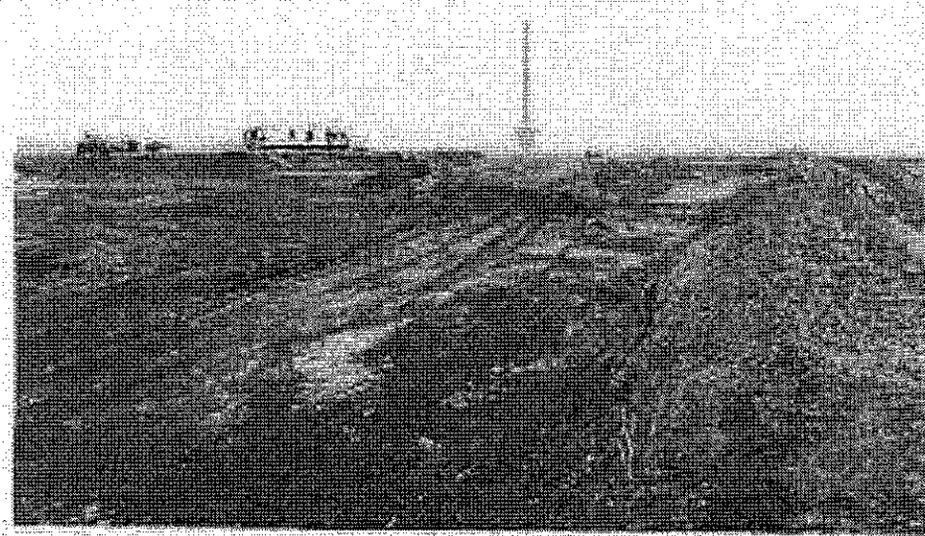
Figures 5, 6, and 7 show section of the eastern basin, where the car wash waste water was discharged. A large stockpile of soil is present in the eastern basin. Additionally, as seen in Figure 8, a soil stockpile was also observed just south of the eastern basin. According to

Figure 6  
Standing at the southern end of the eastern containment basin looking north. The red arrow points to the same soil stockpile seen in Figure 5.

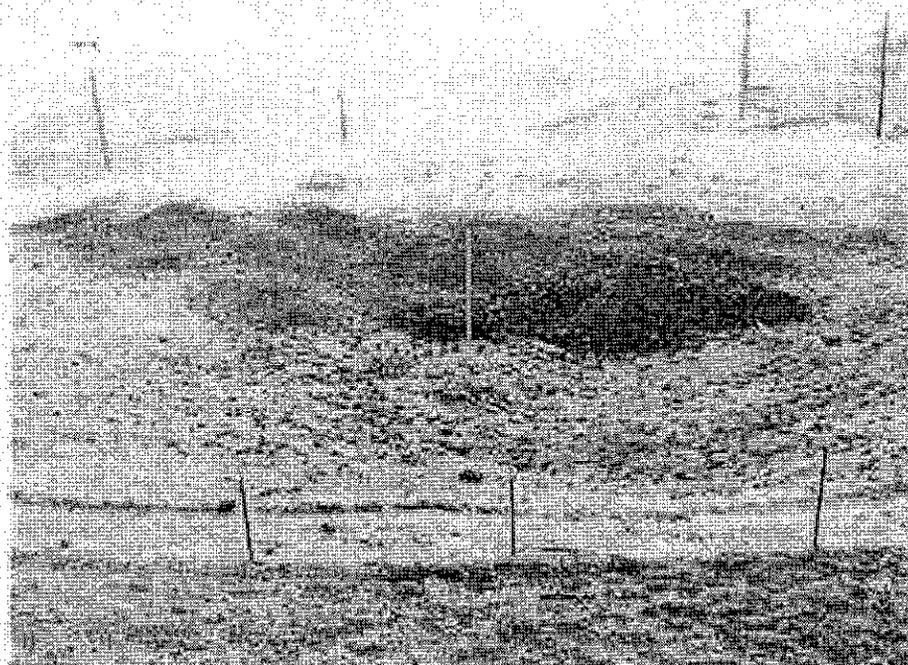
Figure 8

Looking south from atop the eastern containment basin, where the car wash waste water was discharged. According to Michael Harding, the soil piles seen in this photo are waste from the Site's former horse stables. The red arrow points to the carcass of a dead cow.

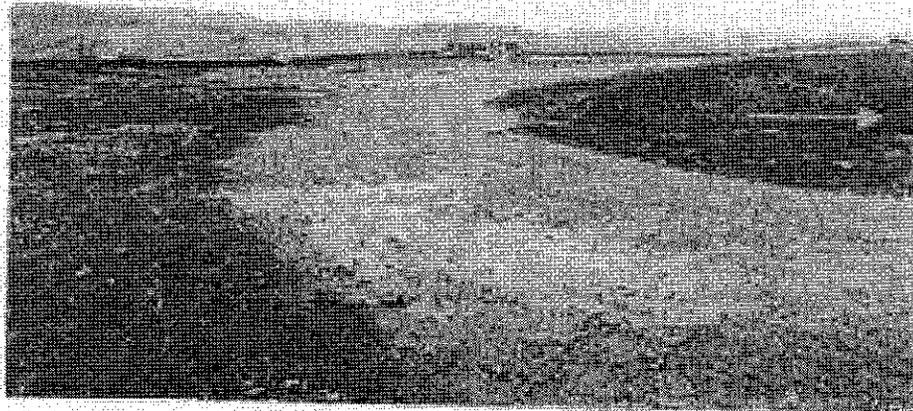
Figure 9  
Standing just south of the remaining biosolids stockpile, red arrow, looking east across a section of the western containment basin.

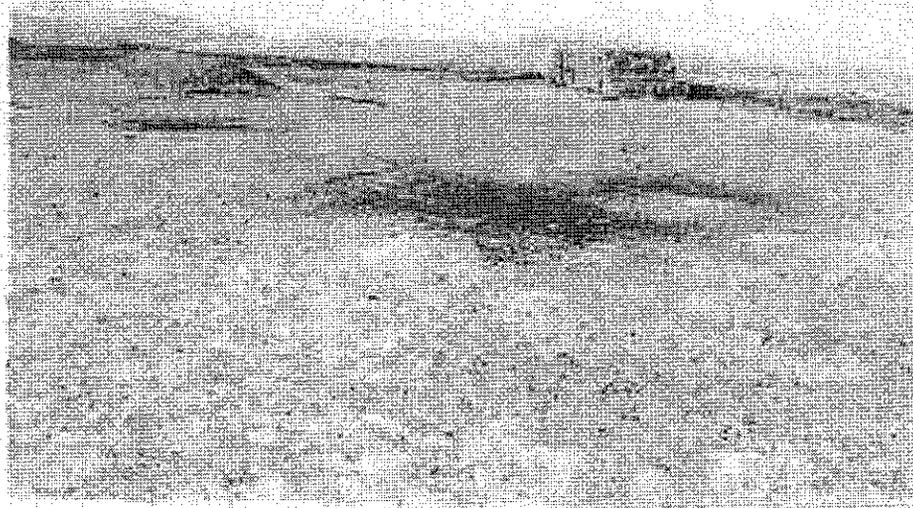
Figure 10  
Looking south across a section of the western containment basin.

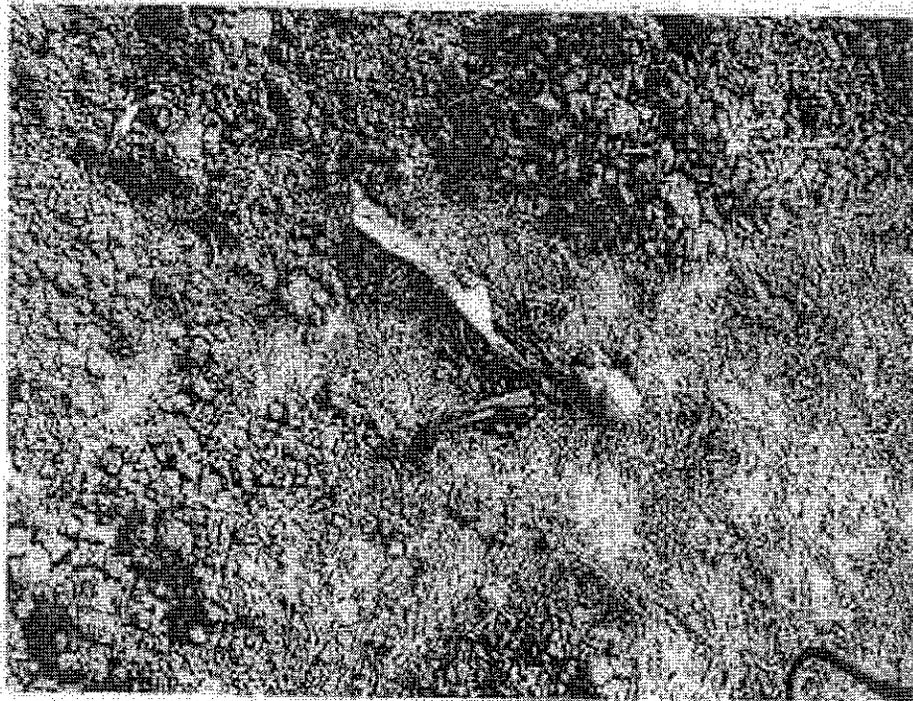
Figure 14

- c. The disposal of undocumented and uncharacterized soil containing visible trash, including plastic and fiberglass, (M-7 Waste Soil) across section M-7 of the Marciel Ranch. The location of the M-7 Waste Soil is shown on Attachment C.

A close-up of some of the trash seen in the soil recently applied to the Marciel Ranch property.

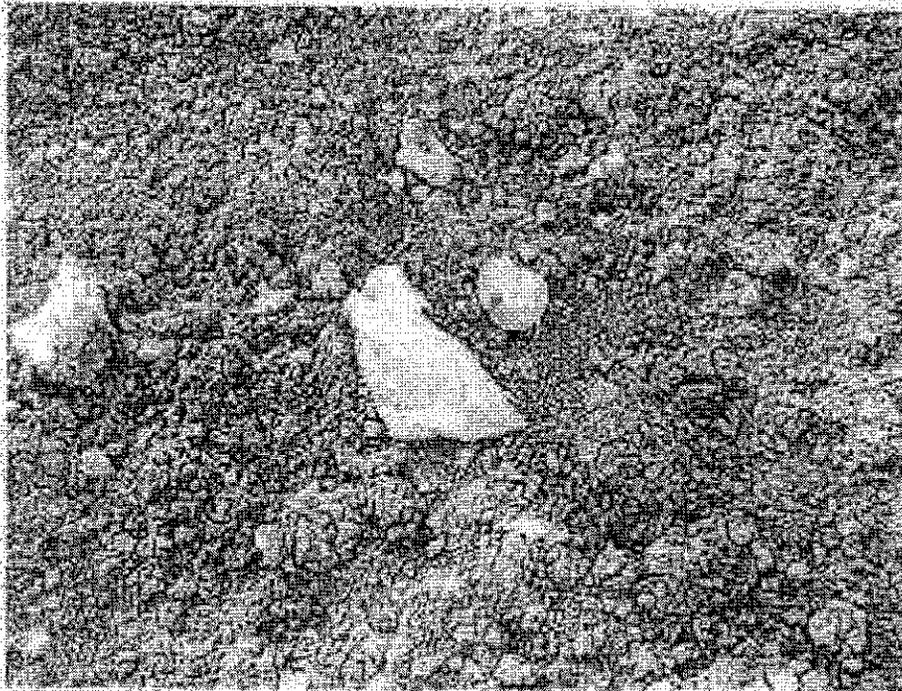
Figure 16

A close-up of some of the trash seen in the soil recently applied to the Marciel Ranch property. This piece of trash was originally imbedded in the soil, and was removed in an effort to identify its origin.

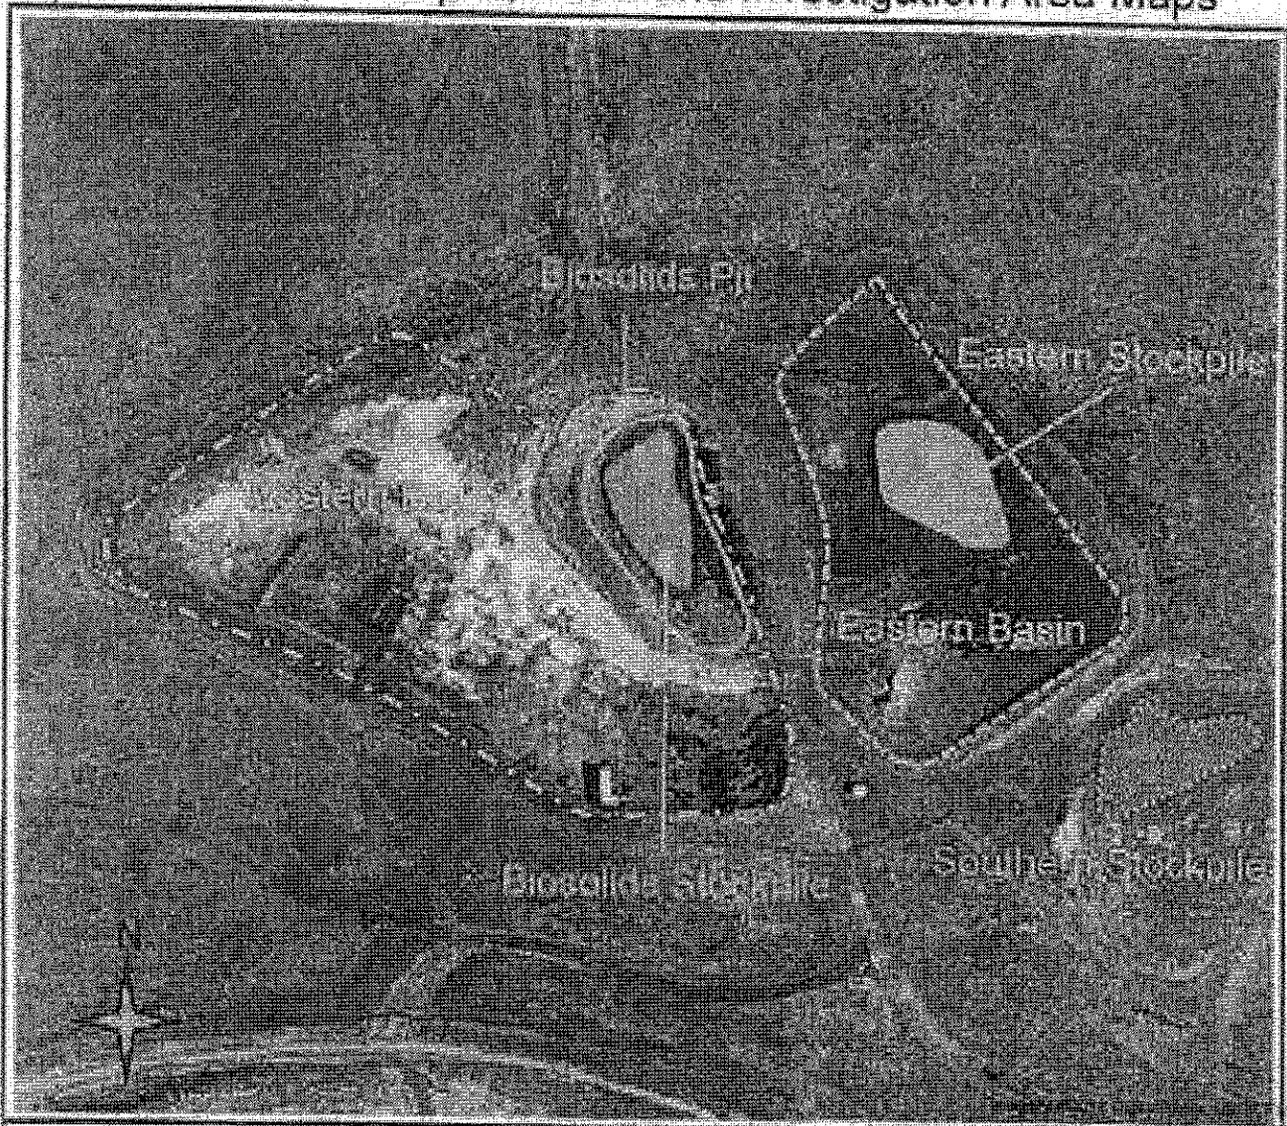
Attachment C  
Jess Ranch Stockpile, Basin and Investigation Area Maps

- a. The discharge of 36,000 gallons of liquid waste with a pH less than or equal to 2, which constitutes a hazardous waste. The discharge is a violation of Prohibition A.9 of the WDRs. This material was discharged into the Biosolids Pit, as shown on Attachment C to this CAO.

- b. The discharge of 36,000 gallons of liquid hazardous waste and 26,800 gallons of liquid car wash cleanout waste, which is a considerably different type of waste than the discharge of biosolids permitted under the WDRs. The discharge of this non-permitted waste is a violation of Section A.4 of the WDR's Standard Provisions, and of Water Code section 13260. According to the Dischargers, the liquid hazardous waste was discharged into the Biosolids Pit as shown in Attachment C, and the liquid car wash cleanout waste was discharged into the Eastern Basin as shown in Attachment C.

- c. The storage of 400 tons of uncovered biosolids (hereafter referred to as the Biosolids Stockpile) atop native soil for almost two years, in violation of Sections D.1 and D.2 of the WDRs. The location of the Biosolids Stockpile is shown in Attachment C.

- a. The placement of an undocumented and uncharacterized stockpile (Eastern Stockpile) in the Eastern Basin. The locations of the Eastern Basin and the Eastern Stockpile are shown on Attachment C.

- b. The placement of an undocumented and uncharacterized stockpile from the site's former horse stables (Southern Stockpile), just southeast of the Eastern Basin. The location of the Southern Stockpile is shown on Attachment C.

⇒ M-7 Waste Soil

4. By 1 April 2014, the Dischargers shall submit an *Unauthorized Disposal Characterization Workplan* adequate to determine the nature of the Biosolids Stockpile, the Eastern Stockpile, the Southern Stockpile, and the M-7 Waste Soil. The workplan must also contain a proposal to assess the nature of the native soil beneath the Biosolids Stockpile, the Eastern Stockpile, the Southern Stockpile, and beneath the hazardous waste and liquid car wash waste discharge areas. At a minimum, this *Workplan* shall contain:
