Historical Ecology of Lower San Francisquito Creek

Phase 1

Technical memorandum
accompanying project GIS data

Prepared for the San Francisquito Creek Joint Powers Authority

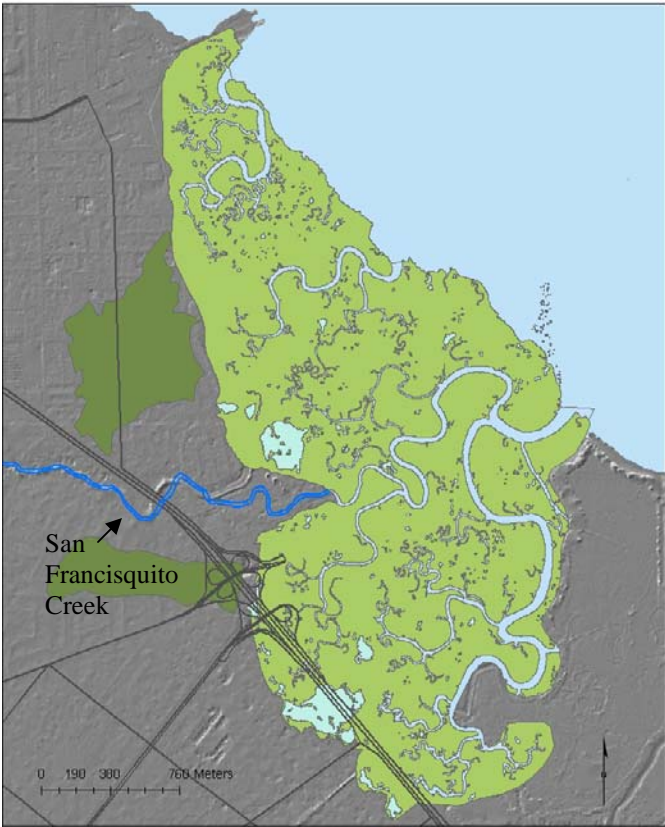
A: 1857

In 1857, the US Coast Survey (USCS), a federal mapping agency renowned for its accuracy, surveyed the lower stream reaches and surrounding baylands (Figure 1A). At this time, tidal marsh habitat covered 1142 acres. The tidal marshes were dotted with small pannes and larger, salt-producing salinas. Also surveyed on this T-sheet are two large (63 and 118 acres) willow groves adjacent to the tidal marsh associated with high groundwater tables and seasonal flooding. San Francisquito Creek maintained a sinuous stream course with several major meanders in the reach between current day Highway 101 and the backshore extent of historical tidal marsh. The depiction of the shoreline on the 1857 T-sheet indicates that tidal marsh is accreting, developing a chain of small marsh patches out into the Estuary.

1857 and 1897

These years were mapped based on the T-sheets. Variations in detail exist between the two years. It appears that the earlier T-sheet shows pannes in the tidal marshes with much greater detail and accuracy. The 1897 T-sheet shows very few pannes despite few other major changes. It is possible, but unlikely that such a large number of pannes disappeared in that time period. For this reason, it is important to note that the number of pannes in the 1897 view is likely to be greater than that depicted.

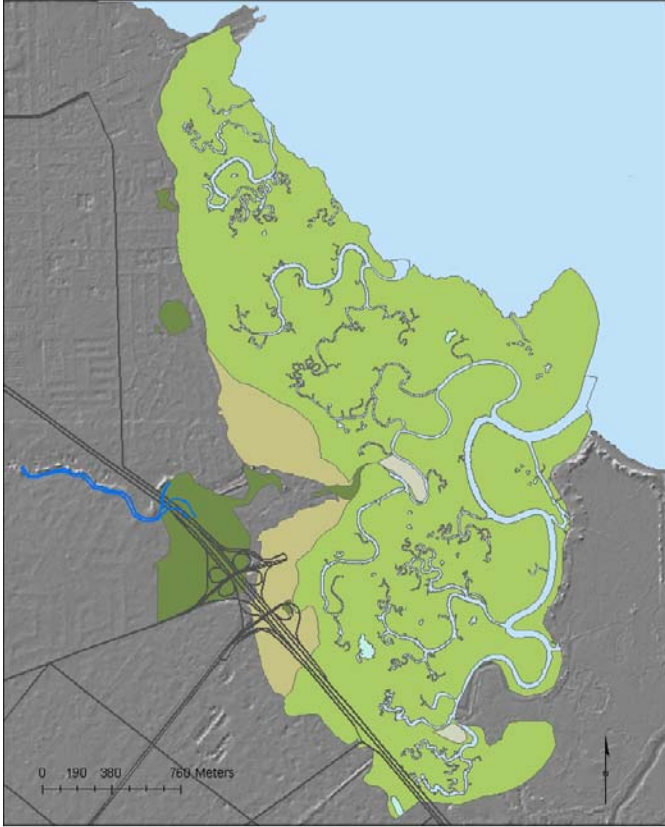
B: 1897

By the 1897 resurvey of the area around San Francisquito Creek (carried out by same agency, now called the US Coast and Geodetic Survey), the creek mouth was mapped much further inland, at the present day Highway 101 crossing (Figure 1B). High sediment load apparently caused the creek to fill its channel, creating a distributary system about a half mile from the former tidal mouth. Since 1857, the willow groves have changed size, shape and position due to changes in land use and characteristics of San Francisquito Creek. In 1897, there have been only limited modifications to the broad tidal marsh area. While some levees are visible, they were generally not successful (Westdahl 1897). Wilson's Landing and Clarke's Landing are clearly visible by 1897, apparently creating small areas of landfill. However, tidal marsh habitat acreage remains roughly the same as in 1857 at 1109 acres (1142 acres in 1857). Interestingly, loss of tidal marsh can be seen along the backshore boundary as San Francisquito Creek appears to have deposited significant amounts of sediment over the marsh surface. We referred to this process as "alluvial fill." Over the same period -- presumably due to large sediment supply -- the shoreline continued to build out north of the San Francisquito tidal slough, offsetting the loss in the upland transition.

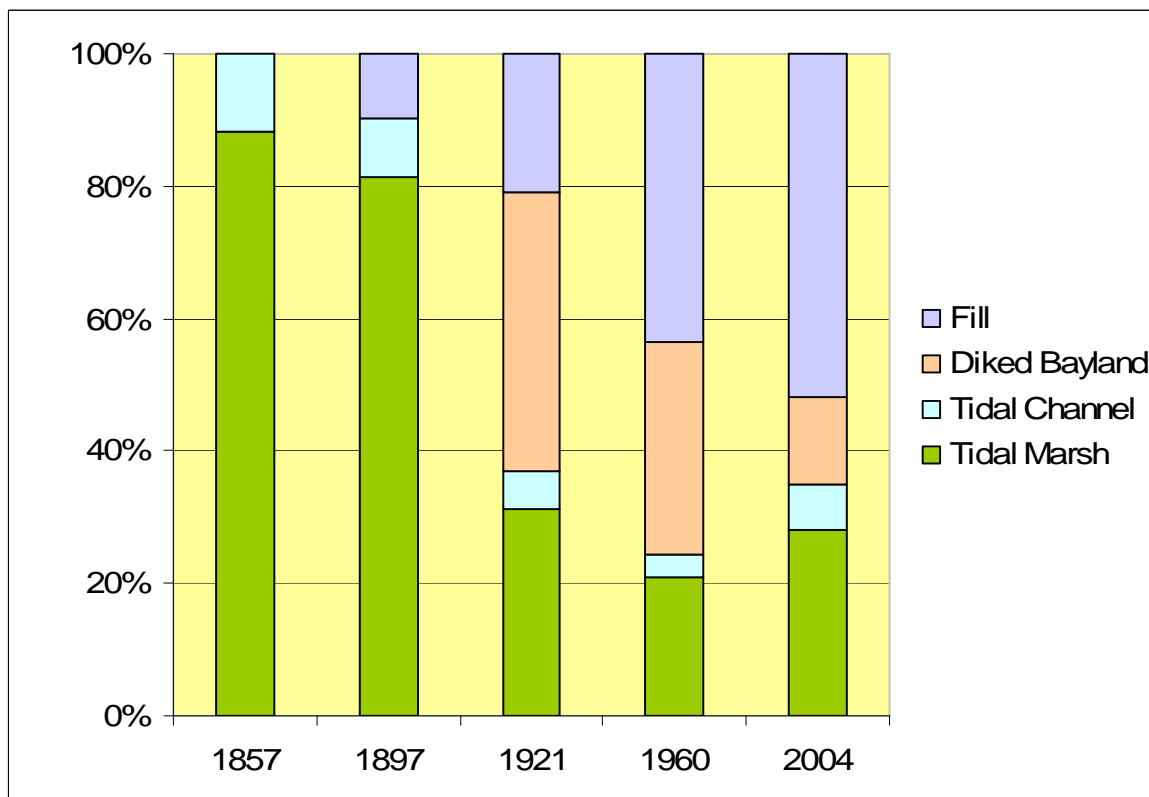
Figure 2: Shifts in landscape functions in lower San Francisco Creek. Total area approximately 1300 acres.

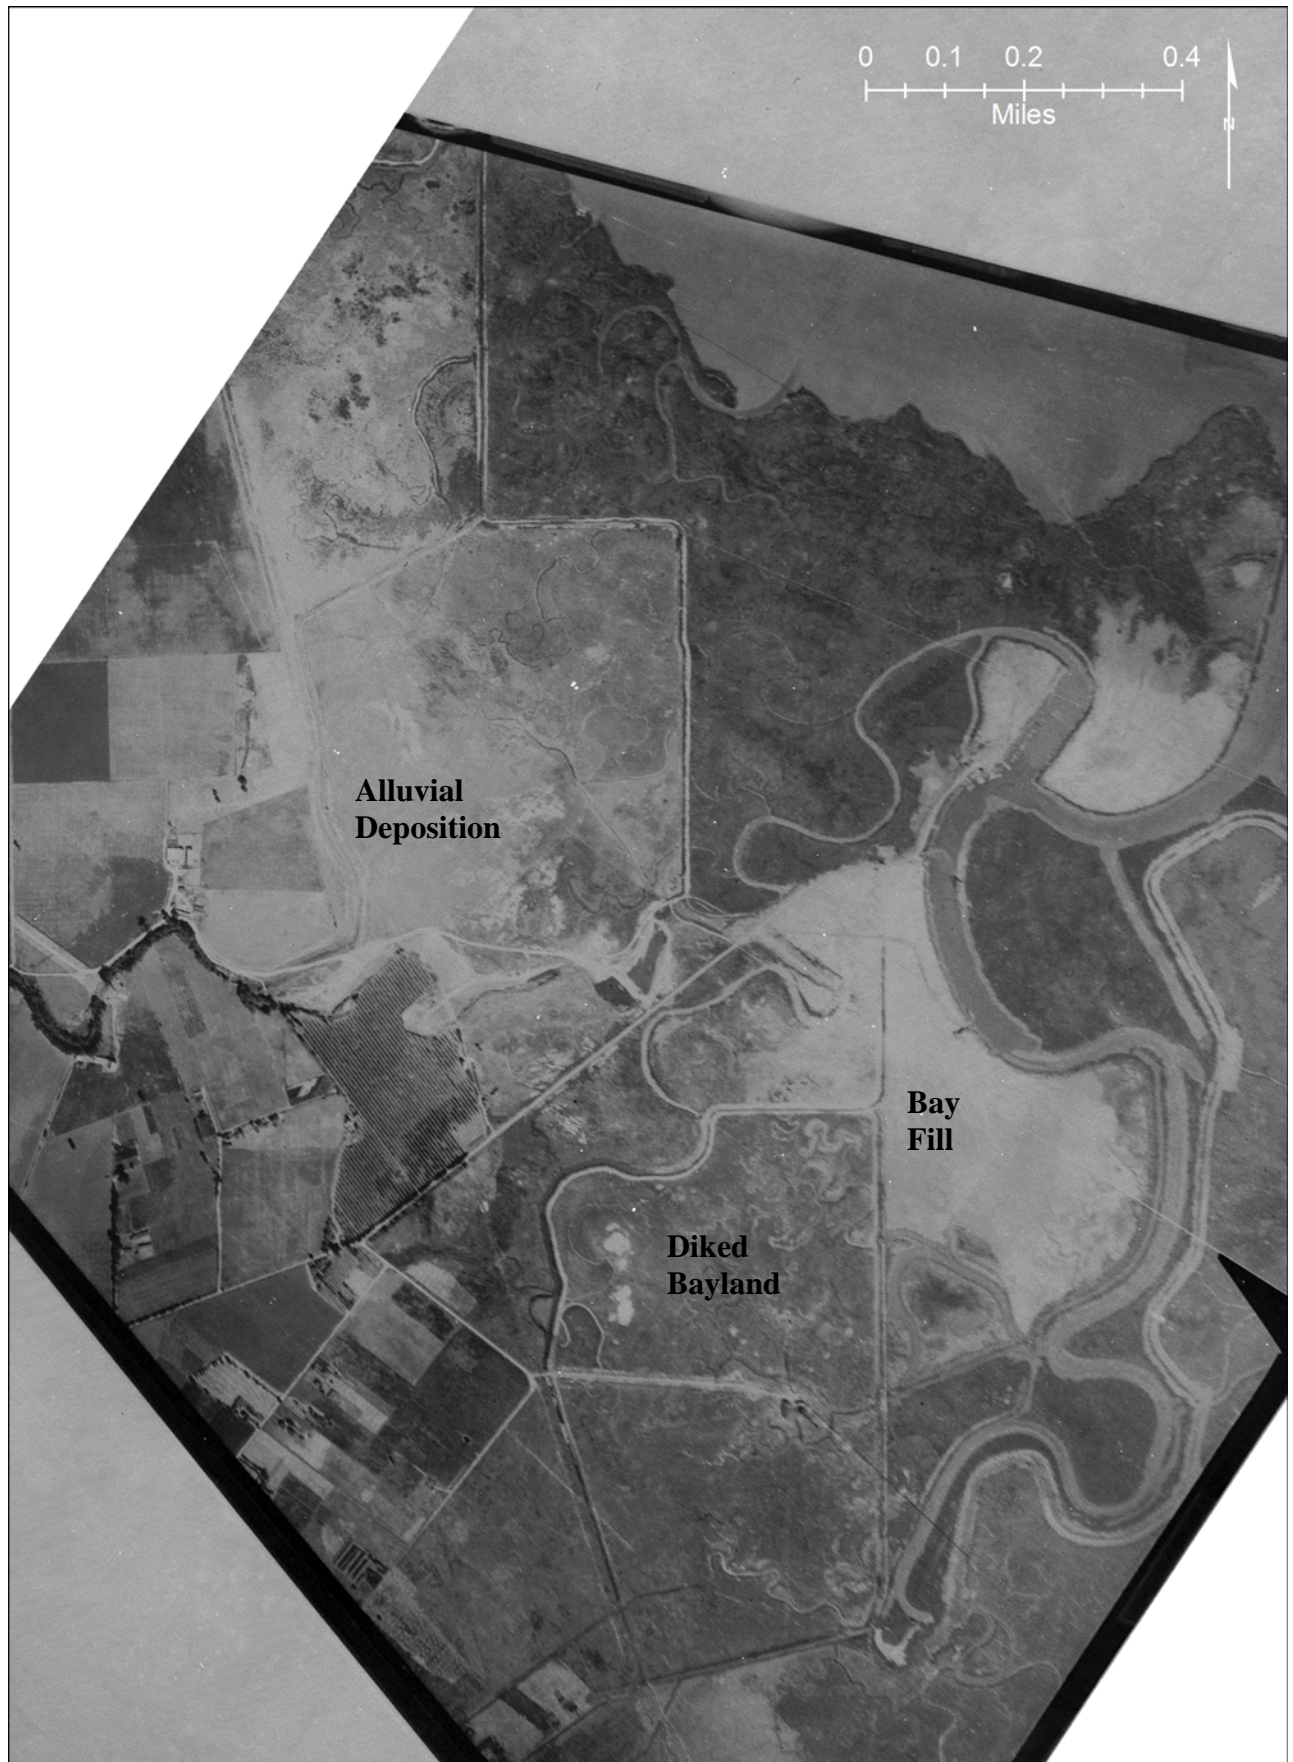
Figure 6: National Ocean Survey Photograph, 1921 (courtesy Alan K. Brown)

The map of 1921 habitats was produced based on unusually early aerial imagery obtained by Alan K. Brown from the National Ocean Survey, and provided to SFEI. This imagery contains a gap in the far northern portion of the study area. This lack of information occurs in an area of tidal marsh that has remained undisturbed throughout our analysis. For this reason, we have retained tidal channels from the previous era and assumed no significant change when surrounding areas also showed no significant change. Pannes and salinas were not mapped due to difficulties in distinguishing these features from aerial imagery, but these features likely existed on the ground.

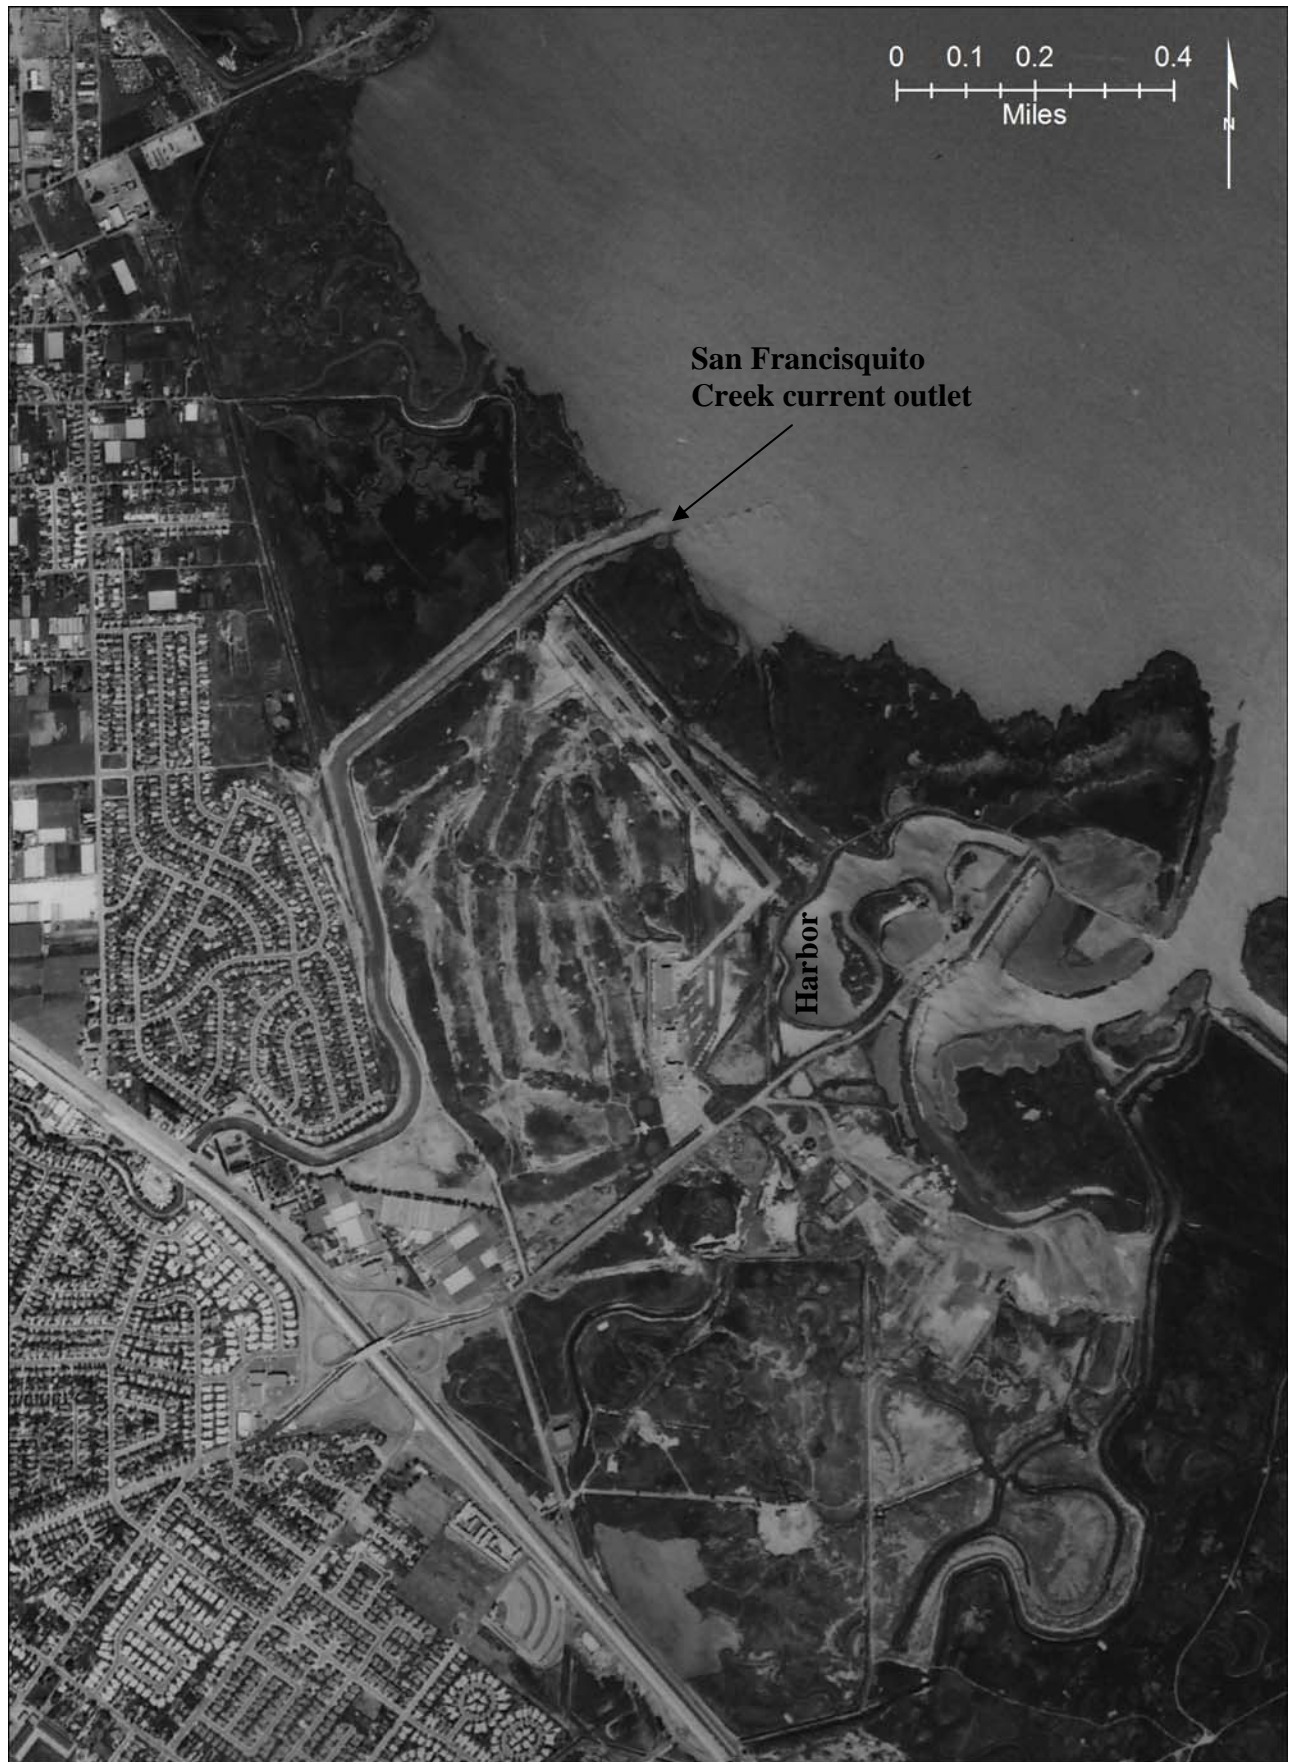
Figure 7: US Air Force Photograph, 1960 (courtesy UC Berkeley Earth Sciences and Map Library)

Data and maps were generated based on aerial imagery of this year, flown by the US Air Force and obtained from UC Berkeley. A single image covered the extent of the study area and presented few difficulties for mapping. Like 1921, pannes and salinas were not mapped from the aerial imagery. This habitat is excluded in the mapping, but believed to exist on the ground.

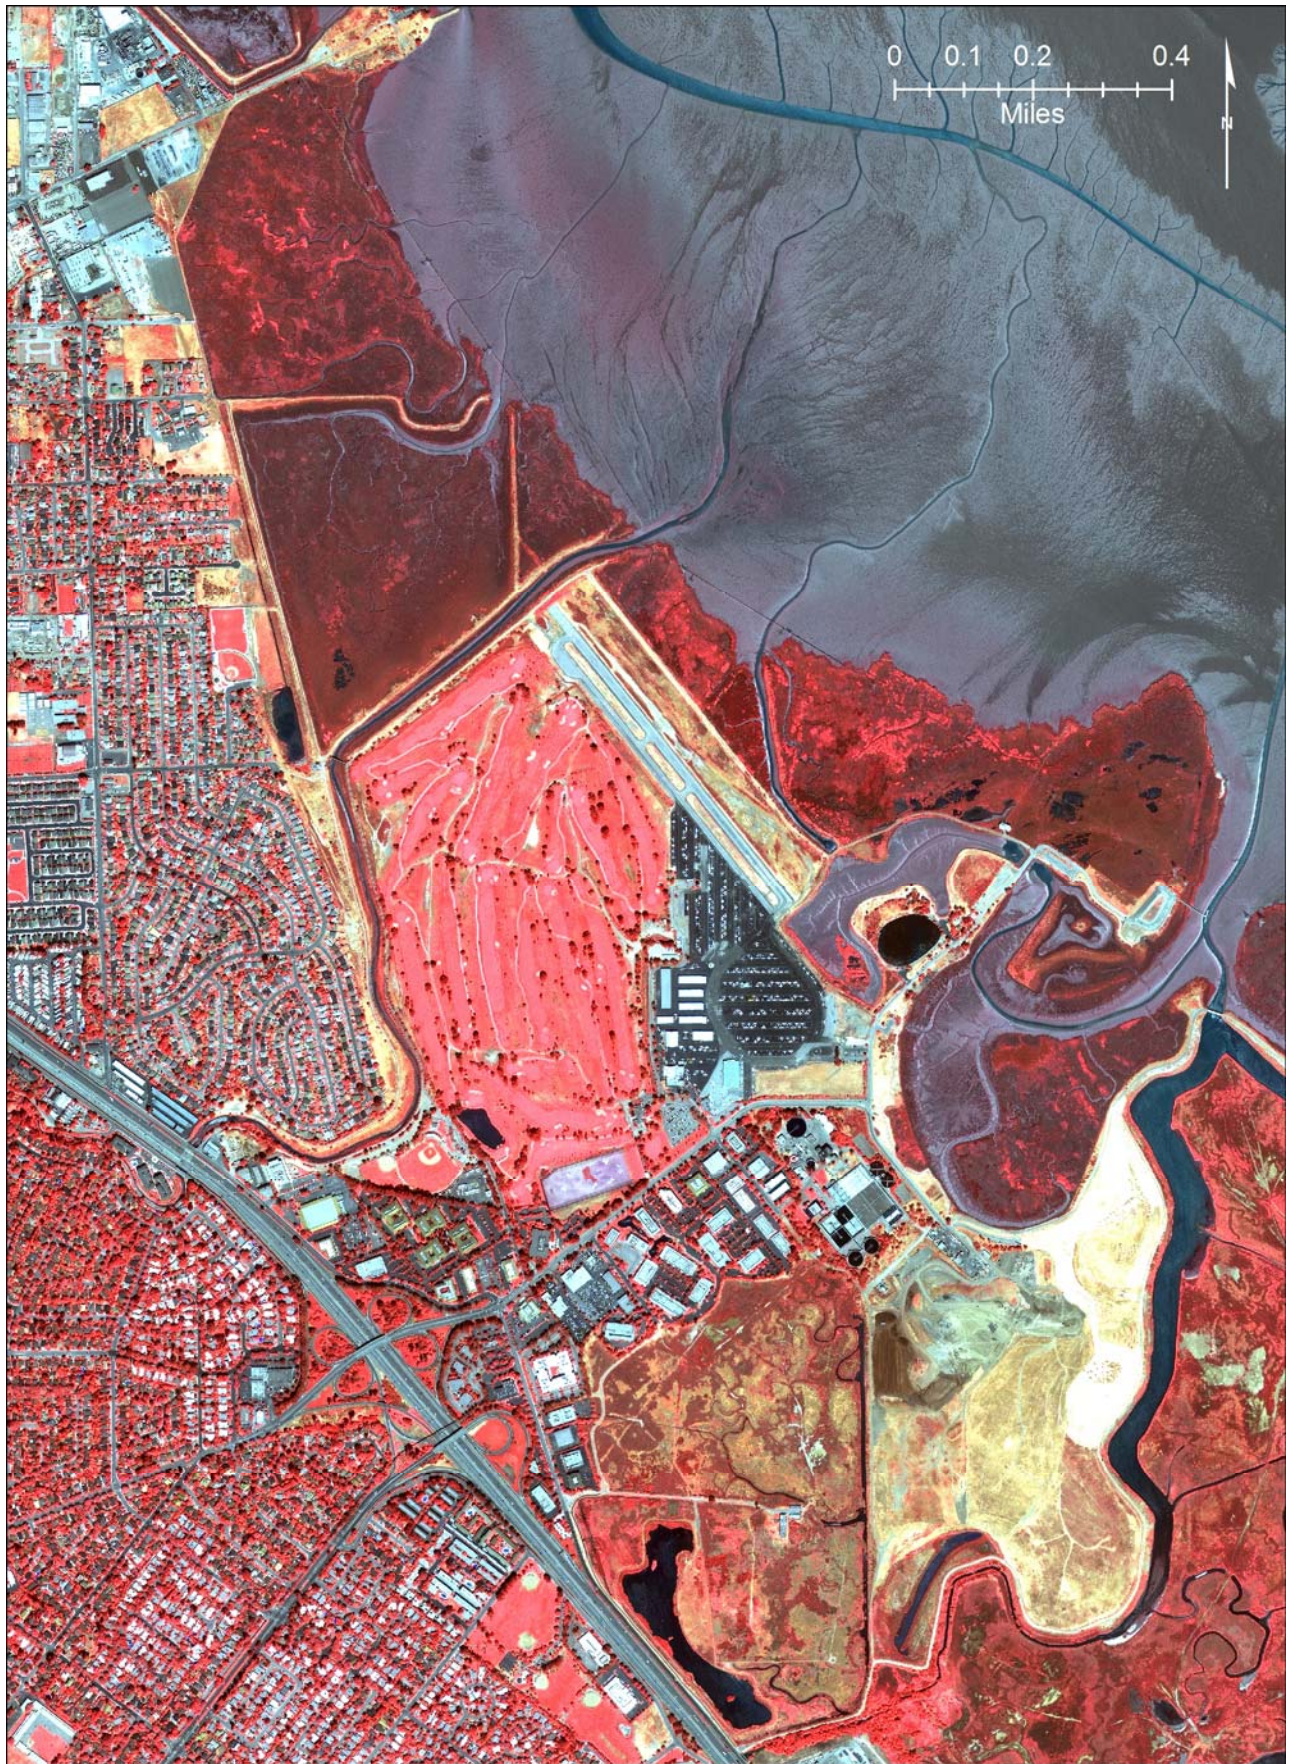
Figure 8: Color Infrared IKONOS Satellite Imagery, 2004 (courtesy City of San Jose)

IKONOS color infrared satellite imagery was used for this year. A greater level of detail was mapped for the tidal marshes so that levees are distinct as areas of fill. Pannes were included in this view as they were readily apparent, visible in the imagery, and indicate a recent configuration for tidal wetlands.
