State of California – The Resources Agency
DEPARTMENT OF PARKS AND RECREATION
PRIMARY RECORD

*Resource Name or # (Assigned by recorder) Peyton Slough Shed

c. Address About 2 miles east of downtown Martinez City Martinez Zip 94553

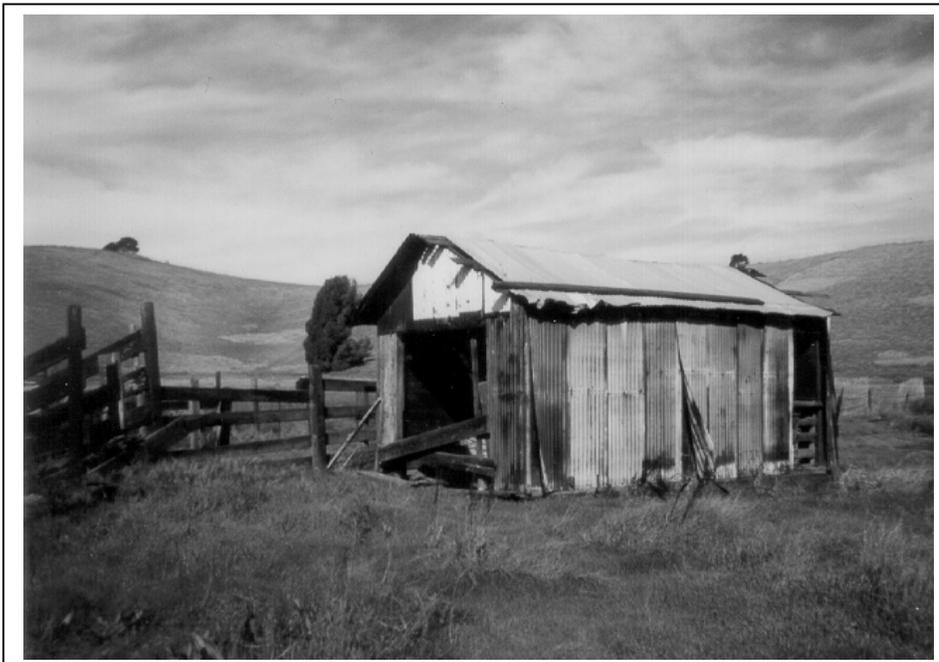
P5b. Description of Photo: (View, date, accession #) Photo #1, January 9, 2002, camera facing north

The shed sits on the northern side of both the former Southern Pacific Railroad tracks and the parallel Waterfront Road, and to the east of Peyton Slough. The area around the shed is open marshland encircled by various industrial complexes. The shed is a small rectangular building of wood frame construction. It is a simple front gable building sheathed with corrugated metal panels at the roof and walls. In several places the metal panels have deteriorated substantially, or as is the case at the southeast corner, the metal panel is missing altogether. The original opening is at the west gable end and has no door. There are no openings on the other elevations. A timber post and plank corral and a loading chute are located to the north and northwest of the shed. This fencing includes many types of replacement and repair fencing such as bailing wire, chain link, and chicken wire.

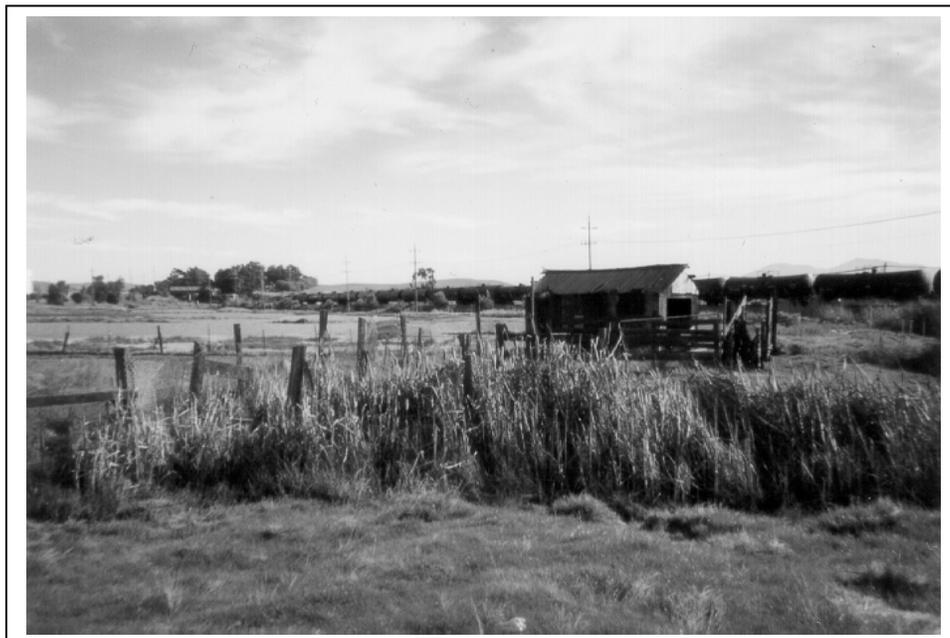
Photograph 2. Shed and corral, camera facing southeast.
