RE: City of Menlo Park
Municipal Regional Stormwater National Pollution Discharge Elimination System
Permit (NPDES)
FY 2014/15 Annual Report

**CITY OF MENLO PARK
FY 2014/15 ANNUAL REPORT**

STRATEGIC PLAN TO IMPROVE PUBLIC AREA TRASH AND RECYCLING CONTAINER MANAGEMENT

Prepared by: Cascadia Consulting Group, Inc. | EOA, Inc.
Prepared for: City of Menlo Park

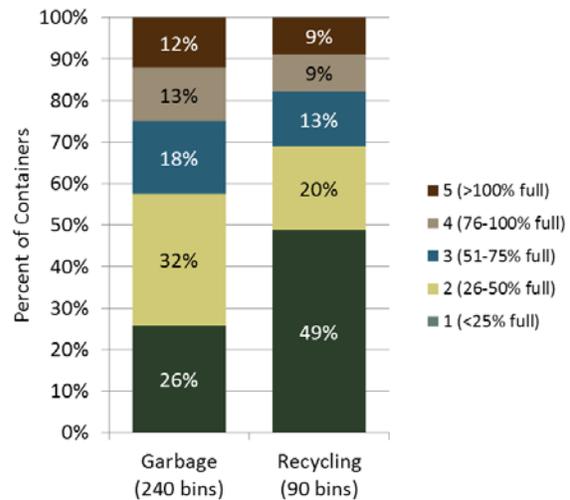
Figure 1. Container Fullness Ratings

- A total of 29 garbage containers (12%) and 8 recycling containers (9%) received the poorest rating for fullness, meaning they were found to be overflowing (see Figure 1 and Table 1). Another 31 garbage containers (13%) and 8 recycling containers (9%) were found to be more than three-quarters full, increasing the likelihood of overflow and litter generation before collection.
- In contrast, 58% of garbage containers and 69% of recycling containers were found to be less than half full (a fullness rating of 1 or 2).

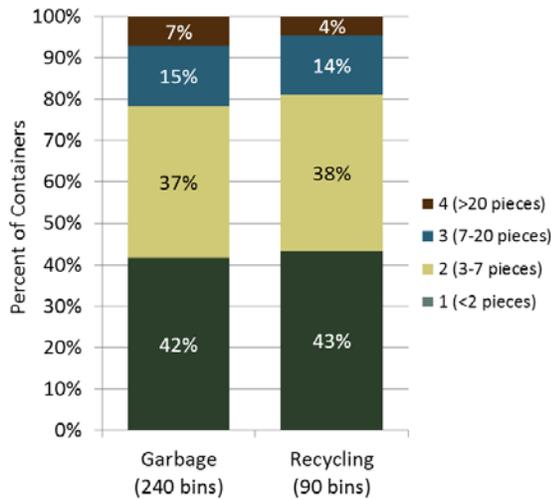
Figure 2. Nearby Litter Ratings

- Overall 17 garbage containers (7%) and 4 recycling containers (4%) were found to have more than 20 pieces of nearby litter—and therefore received the worst litter rating of 4 (see Figure 2 and Table 2). Another 35 garbage containers (15%) and 13 recycling containers (14%) had between 7 and 20 nearby pieces of litter. Common causes included container overflow or damage, such as a missing lid.
- In contrast, more than two fifths of containers—42% of garbage and 43% of recycling bins—had no litter in the surrounding area.

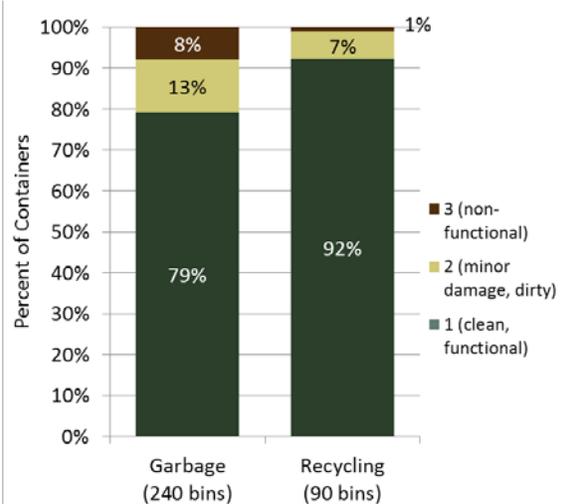
Figure 3. Container Condition Ratings

- Most containers were found to be in good condition (see Figure 3 and Table 3). Approximately 79% of garbage containers and 92% of recycling containers received the best rating for being clean and functional.
- However, 19 garbage containers (8%) and one recycling container (1%) received the poorest rating for container condition, indicating reduced functionality that can result in litter issues.

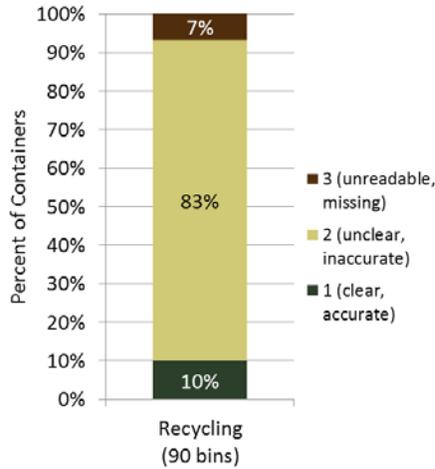
Figure 4. Recycling Signage Condition Rating

- The majority of recycling containers (83%) received the middle signage rating because their signs were readable but incomplete (see Figure 4 and Table 4). These signs often read “Recycle” or did not list all the materials accepted by the hauler.
- Only six recycling containers (7%) received the poorest rating for signage condition, indicating a missing or illegible sign, which can lead to recycling contamination.

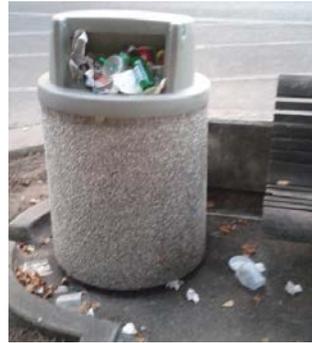
Whether because of overflow or direct littering by the public, 58% of public containers surveyed had three or more pieces of litter present within a fifteen foot radius of the container, such as containers pictured in Figure 5 and Figure 6. Field researchers observed that the most commonly littered items appeared to be cigarette ends and single-serve foodware, such as paper beverage and food cups.

Figure 5. Garbage Container Overflow in Downtown Area

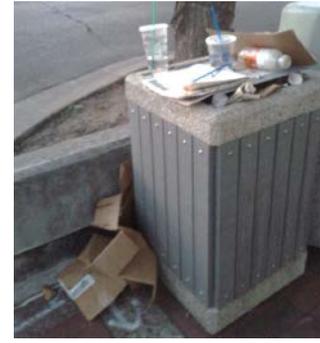
Figure 6. Recycling Container Overflow in Downtown Area

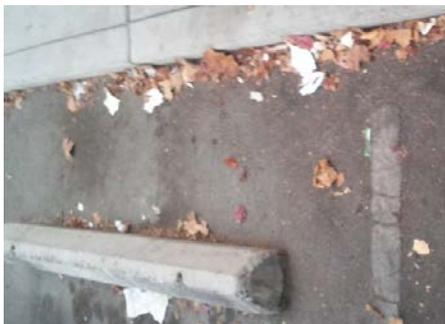
Field researchers noticed that the parking lots and alleys of many private businesses often have high litter levels. Additionally, train stations and bus stops were also noted as having high litter levels, even when public containers were available, supporting the findings of previous research that shows transit sites tend to have high litter levels.⁵ Caltrain parking stalls on the Alma Street side, in particular, were noted as having high litter levels. Field researchers observed litter in parking lots occurring as a result of individuals deliberately littering (e.g., cigarette ends), accidental littering from vehicles and pedestrians, and overflowing waste from public containers and private business dumpsters (see Figure 7 and Figure 8). Despite current street sweeping and cleanup efforts, field researchers noticed that the majority of the City’s storm drains contained litter.

Figure 7. Litter in Parking Stalls

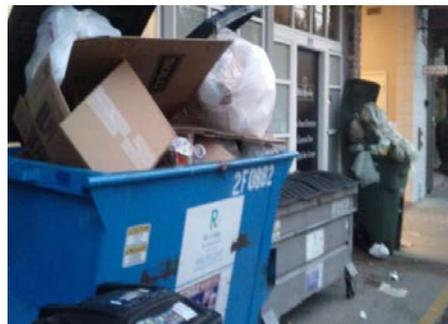
Figure 8. Litter from Overflowing Dumpsters

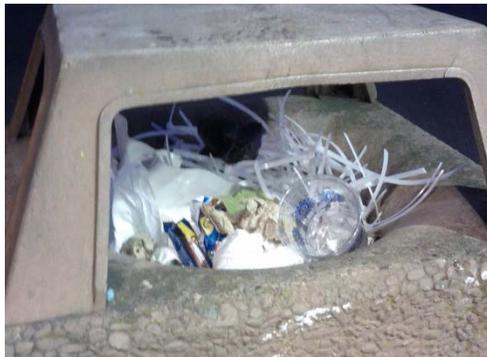
The current hauler Franchise Agreement requires the hauler to pick up abandoned waste or illegal dumping, but does not include the cleanup of litter or implementation of other litter abatement activities.⁶ In addition, collection activities may actually contribute to litter. For example, trash observed in a container prior to the day of collection (see Figure 9) was found as litter following collection (see Figure 10).

Figure 9. Trash Observed in Container Prior to Collection

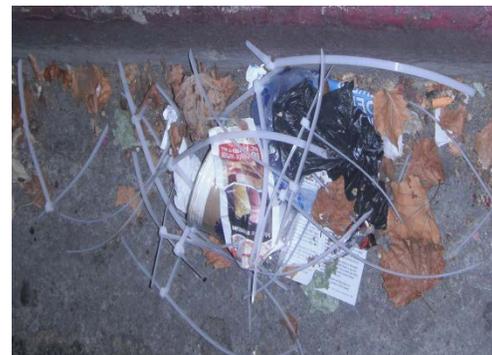
Figure 10. Trash from Container Observed as Litter Following Collection by Hauler

Cleaning up litter from streets, parking lots, alleys, sidewalks, vegetation, and other open areas before it reaches the storm drain is an effective way to reduce the trash loads to the MS4. The City is recommended to undertake the following actions to improve litter cleanup:

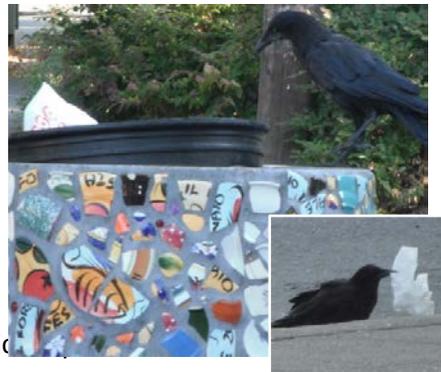
Damaged containers can contribute to litter in several ways. Missing or broken doors that prevent locking the bins securely inside the containers aid scavenging by pedestrians or wildlife. Missing lids can create windblown litter and expose trash to scavenging wildlife—especially birds—that will remove trash from open bins. This issue was witnessed at several locations with missing lids during the field survey (see Figure 11).

Figure 11. Scavenging Wildlife Creating Litter at a Container Missing its Lid

Replacing or installing the 24 missing lids is expected to have the greatest litter reduction effect among the recommended container improvements because missing lids lead to windblown and scavenger-created litter. The TMAs with containers that are missing lids that are already not in a low, or green, generation area, will likely move to a lower (green) generation rate, in the area surrounding the container with the addition of a lid. The TMAs with containers areas that may be improved with the addition of a new or repaired lid include 1B, 2A, 2C, 3A, 3B, 3D, and 4A. Improvements to container signage will likely affect TMAs city-wide as signage is added to new and existing containers throughout the city to reduce litter generation and improve material collection.

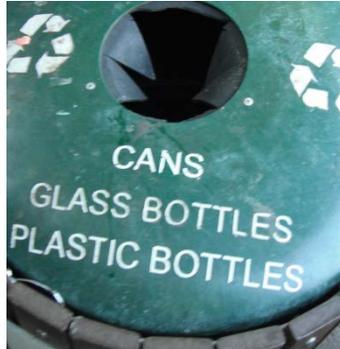
In Menlo Park, 83% of surveyed recycling containers were labeled in the form of lids with stickers or engraving saying “Recycling” or “Cans, Glass Bottles, Plastic Bottles” (see Figure 12 and Figure 13). A small percentage of recycling containers had no written labels and were simply color-coded blue. Only carts provided by Recology had signage for single-stream recycling that listed all the materials the hauler currently accepts. Field researchers noticed that recyclable paper products such as newspapers and shopping bags

Figure 12. Recycling Container Signage Accepting Limited Recyclables

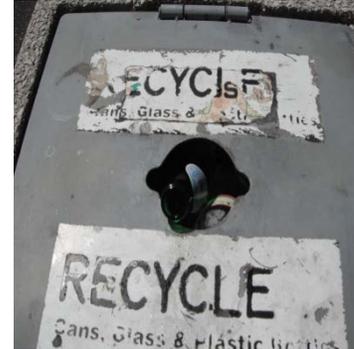
Figure 13. Impaired Recycling Container Signage Accepting Limited Recyclables

Improved signage should be consistent throughout the entire City, meaning the same signage should be adopted throughout the City to avoid confusion at different container types. Signage should be standardized and contain symbols for recycling and garbage—and organics, if adopted in the future. Vermont has introduced state-wide signage symbols for garbage, recycling, and food scraps (shown in Figure 14) to support its Universal Recycling Law (Act 148,) which bans all recyclables from landfill by 2015 and all food scraps by 2022.⁹ These symbols are to be used by businesses, solid waste management entities including haulers, schools, and anywhere else where materials are source separated. Vermont modeled its universal signage after programs in San Francisco and Seattle that use similar symbols.

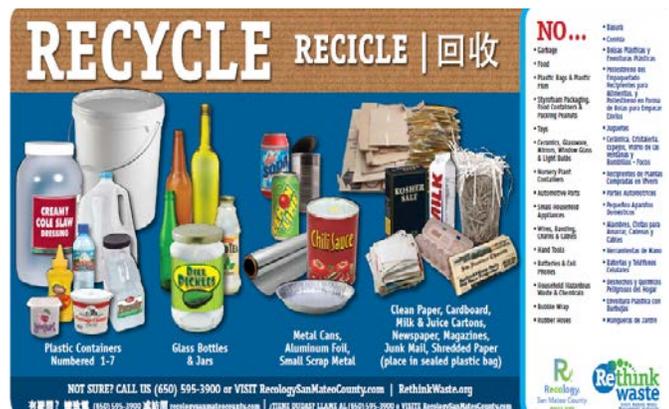
Figure 15. Recology Recycling Label

In addition, to symbols for garbage, recycling, or organics, photo images or other symbols to show accepted materials are helpful to avoid contamination between containers. The existing signage available for carts from Recology for garbage and recycling containers provides some images that may help users identify recyclable items as shown in Figure 15. The City should examine opportunities to use and develop new signage with Recology to ensure consistency among container labels.

The City of San Francisco provides a Signmaker tool for businesses, schools, and residents that allows for stock photos of the most commonly generated items to be added to a sign for free printing by the City. Signs have minimal text, with a focus on the sample photos, as shown in Figure 16. The City should provide signage with photos or symbols of the most commonly littered items in the area where containers are located. For example, single-use cups and cigarette end images should be used in the downtown area and pizza box and single-use foodware images should be used on containers located near park picnic tables. Keep America Beautiful also recommends that container labels clearly list or picture prohibited items that commonly contaminate recycling containers (such as polystyrene cups and pet waste in parks), as shown in the Recology label in Figure 15 and Figure 17.¹⁰

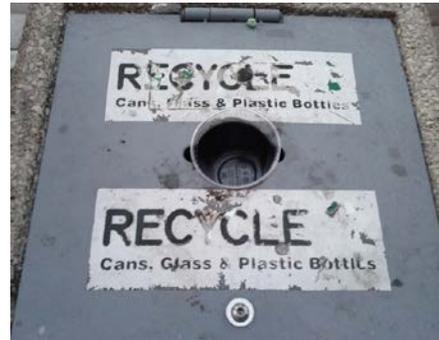
Currently, the downtown area of Menlo Park uses estimated 20-gallon recycling containers, (container Type B shown in Appendix G) with narrow openings that are too small for some of the materials generated in the downtown area, such as wide-rim cups. Although limited overflow was observed from recycling containers, field researchers noticed materials such as wide-rim cups often blocking the opening (see Figure 18), which could result in materials being stacked on the container or contributing to litter elsewhere by preventing disposal of materials.

Figure 18. Cup Blocking Container Opening

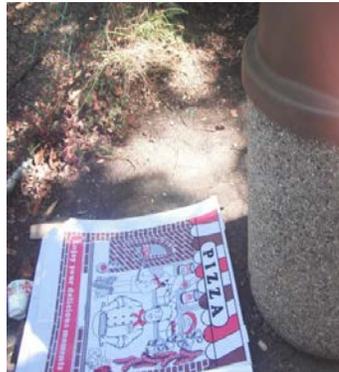
Surveying indicated that additional containers are needed at public parks and facilities, particularly the City’s Civic Center and Willow Road Park, where large volumes of litter and large-sized trash such as pizza and beverage boxes are generated (see Figure 19 and Figure 20). Field researchers observed that additional Recology carts were sometimes placed adjacent to the smaller public containers at the Civic Center picnic area on weekends, but even more containers were needed to prevent overflow and litter.

Figure 19. Littered Pizza Box too Large for Existing Container

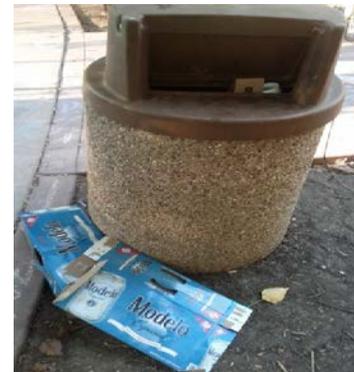
Figure 20. Littered Beverage Boxes too Large for Existing Container

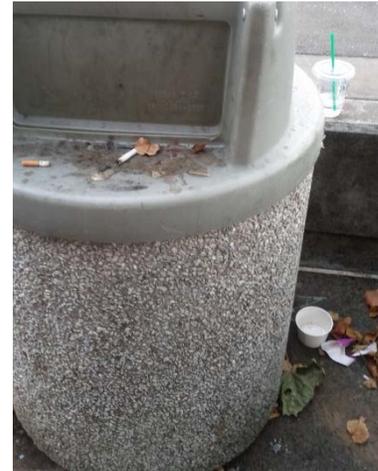
Figure 21. Cigarette Ends on a Garbage Bin

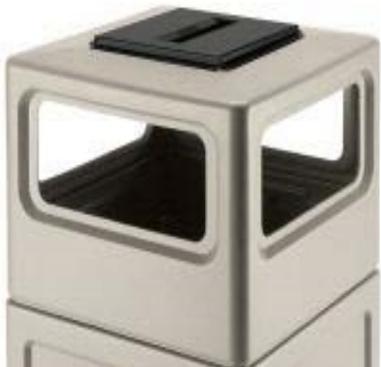
Figure 22. Receptacle with Limited Opening to Prevent Litter

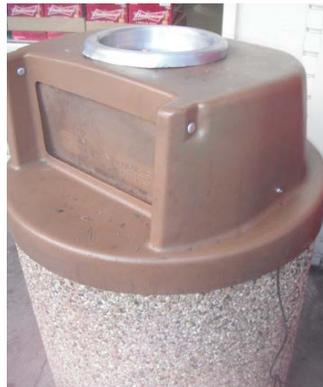
Figure 23. Open Receptacle that Can Contribute to Litter

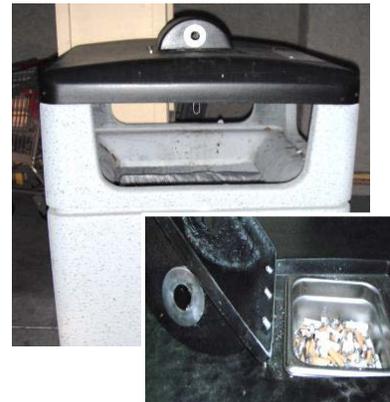
Figure 24. Example Cigarette Receptacle in Menlo Park

- **Consider using garbage containers with enclosed cigarette receptacles** in the lid to save space compared to using dedicated cigarette receptacles. While many of the existing garbage containers (see Type C shown in Appendix G) can be retrofitted with lids that have cigarette receptacles built in; these receptacles are not recommended because they are the open type that can create windblown litter. A good example of the recommended type of enclosed

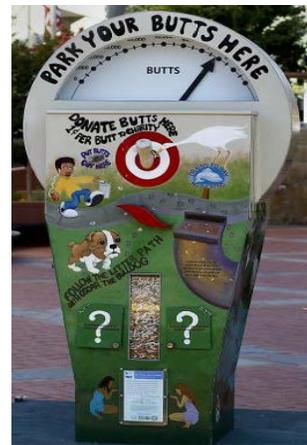
Figure 25. Cigarette Eater Meter

In 2013 San Rafael Clean (SRC), a coalition of local agencies and volunteers, installed a “Cigarette Eater Meter” in the City plaza to encourage the collection of cigarette ends and prevent them from being littered. As pictured in Figure 25, the display showed the pathway cigarette ends take when deposited as litter to the waterways. For every cigarette end collected via the meter, an anonymous donor donated \$0.02 to charity. After about a three month campaign, approximately 100,000 cigarette ends were collected and a \$2,000 check was presented to St. Vincent de Paul Society in San Rafael. The meter display was paired with an opening ceremony and with website and flyer outreach to residents and businesses to promote the campaign. Collected cigarettes were sent to TerraCycle to be recycled into new products such as pallets and cigarette receptacles. The “Cigarette Meter Eater” is available for campaigns in other Bay Area cities through the City of San Rafael.

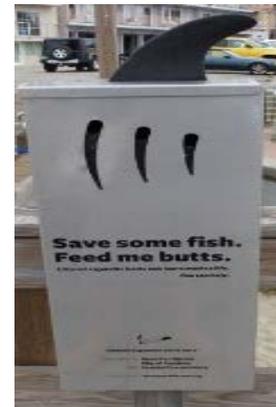
Figure 27. The Bait Tank Cigarette Receptacle

The City of Santa Cruz, with Save Our Shores, offers a \$200 to \$250 rebate program to help businesses buy, install, and maintain a Bait Tank on their property. Both the cities of Santa Cruz and Capitola have ordinances to ban smoking in public places, including beaches and parks.

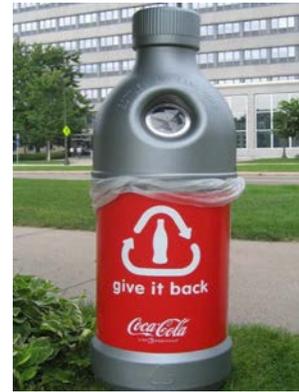
Figure 28. Keep America Beautiful/Coca-Cola CRV Container

One example of a specialty bin is the Keep America Beautiful and Coca-Cola Recycling Bin Grant Program that provides grant recipients with indoor or outdoor containers, including containers shaped like large bottles, as shown in Figure 28. Clearly identifiable containers that are labeled and designed to collect CRV may be an effective way to ensure the recovery of CRV containers. Grant recipients range from non-profit organizations, government agencies, schools, and religious organizations. The grant program also offers recycling bins with lids to capture single stream recyclables, not just CRV containers. Since 2007, the Coca-Cola Public Space Bin Grant program has placed more than 29,000 recycling bins in 380 communities in 48 states and the District of Columbia and the US Virgin Islands.

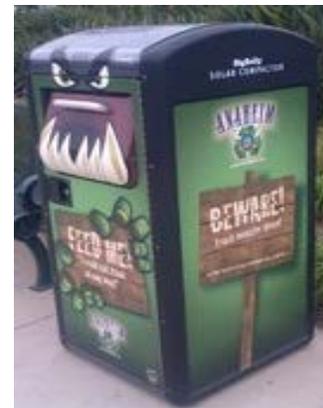
Figure 29. City of Anaheim Solar Compactor Public Outreach

Other cities using solar contractors have paired the installation of containers with a public outreach campaign. The City of Anaheim, California has installed 25 solar compactors for garbage and recycling in high pedestrian, using over \$235,000 in state grant funding. Compactors installed in areas frequented by children were decorated with cartoon-like monsters and slogans such as “Feed Me, I can eat trash all day long!” (see Figure 29). Additional bins were decorated with photos of people wearing t-shirts with phrases such as, “I ♻️ for Anaheim!” Decorated bins are designed to attract children and adults to use the containers.
