Addressing DO impairments to restore cold freshwater habitat in Chorro Creek.

Chorro Creek is a tributary to Morro Bay (Figure 1). Chorro Creek watershed drains into the Morro Bay Estuary ([an estuary of national significance](#)) and is located in northern San Luis Obispo County, north-west of the City of San Luis Obispo (Assembly District 33 and Senate District 15).

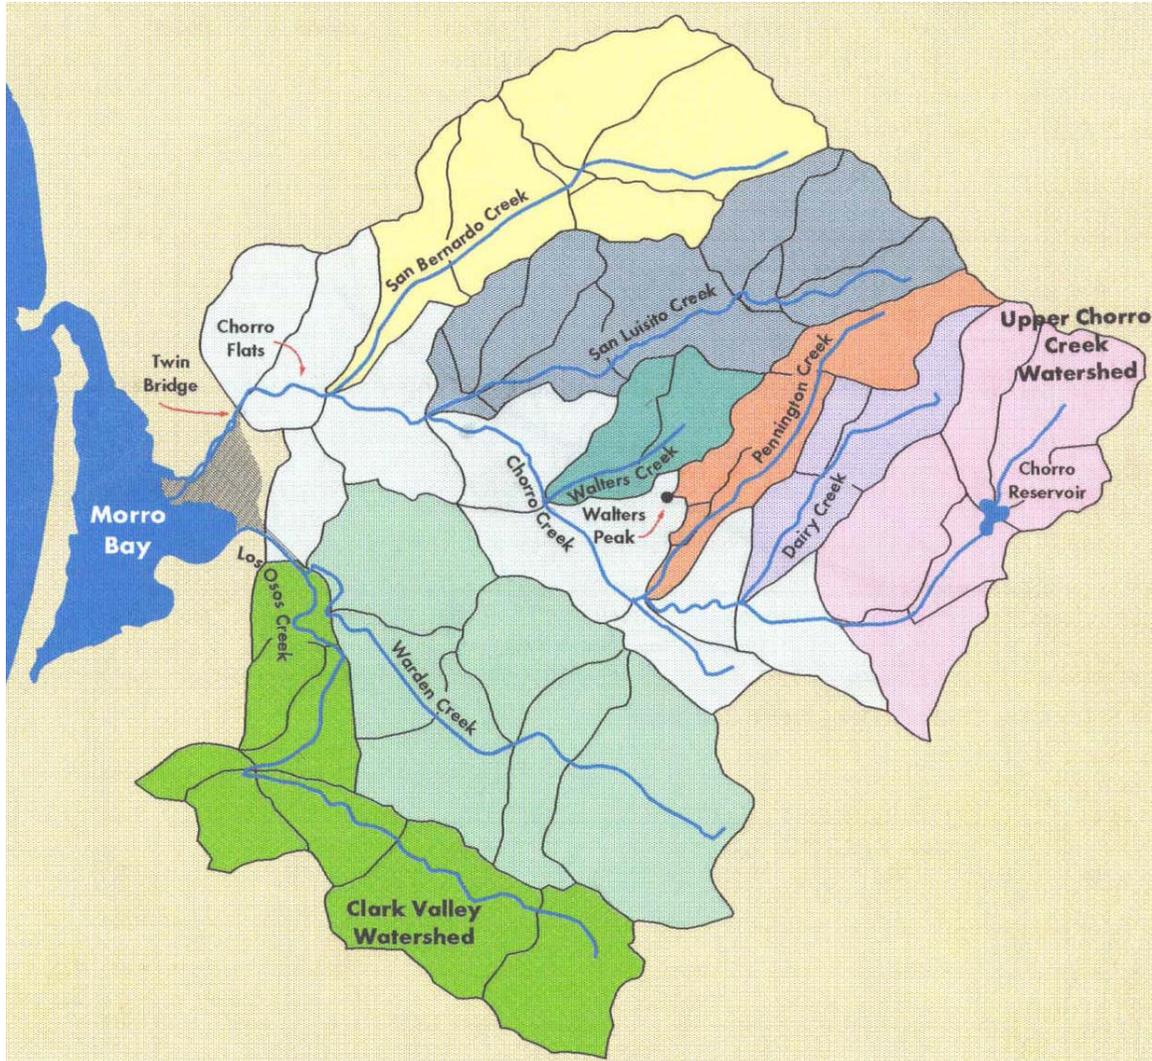
Figure 2. Subwatersheds of Morro Bay (TetraTech, 1998)

Chorro Creek watershed is approximately 27,670 acres (Figure 2). The majority of the lower watershed is comprised of valley grassland, coastal scrub, and oak savanna. The upper elevations of the watershed are comprised of mixed conifer forest, oak woodlands, and agriculture, with some low-density residential and commercial areas.

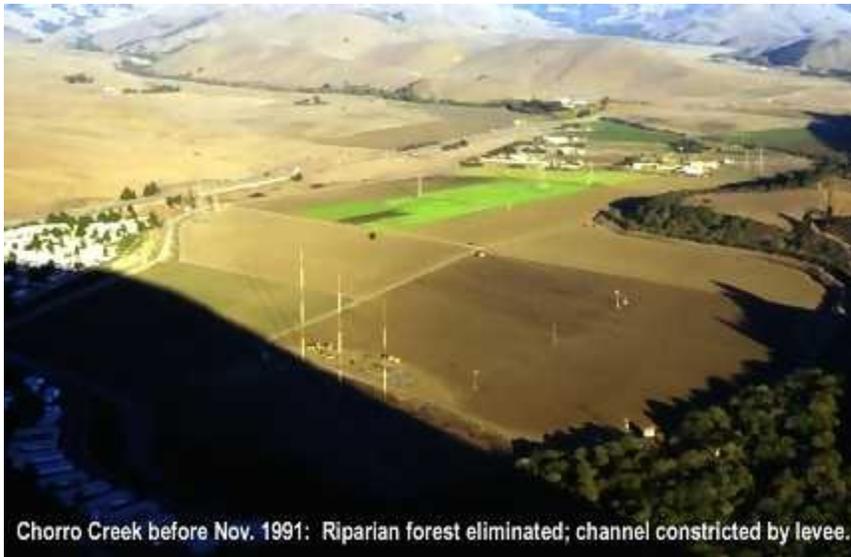
Photo 1. Pre-Project

Photos from the Chorro Flats floodplain and riparian corridor restoration project, courtesy of Phillip Williams & Associates, LTD, see the project website at http://www.pwa-ltd.com/projects/pr_res_chorro_flats.html.

- The Coastal San Luis Resource Conservation District worked with property owners, and local and state agencies to provide technical assistance and oversee the restoration of Chorro Flats floodplain. The Chorro Flats floodplain restoration project was designed to re-establish riparian habitat and trap sediment upstream of Morro Bay. Approximately 100-acres of agricultural land were converted to a floodplain by realigning Chorro Creek channel (i.e. removing levees and planting appropriate native riparian vegetation to trap sediments). Approximately 67 acres of riparian and wetland habitat were restored.

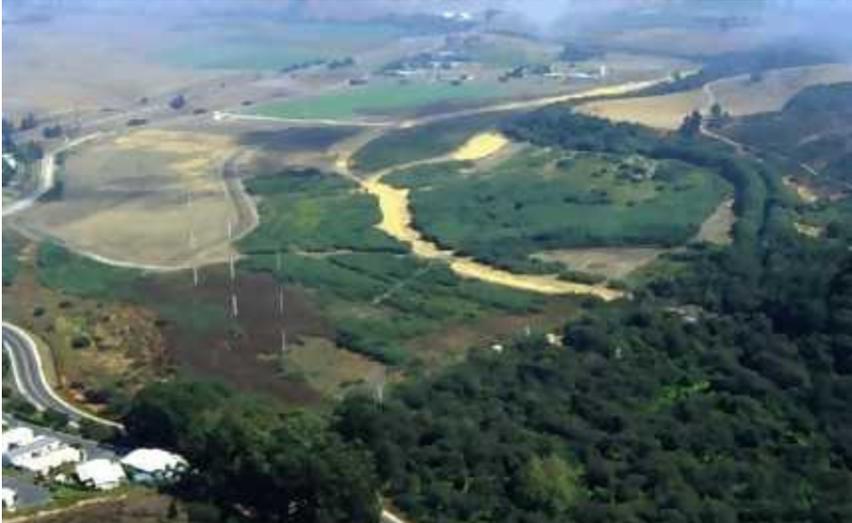
Chorro Creek, Nov. 1991 following implementation: Channel restored to original location
Photo 2. After project implementation.

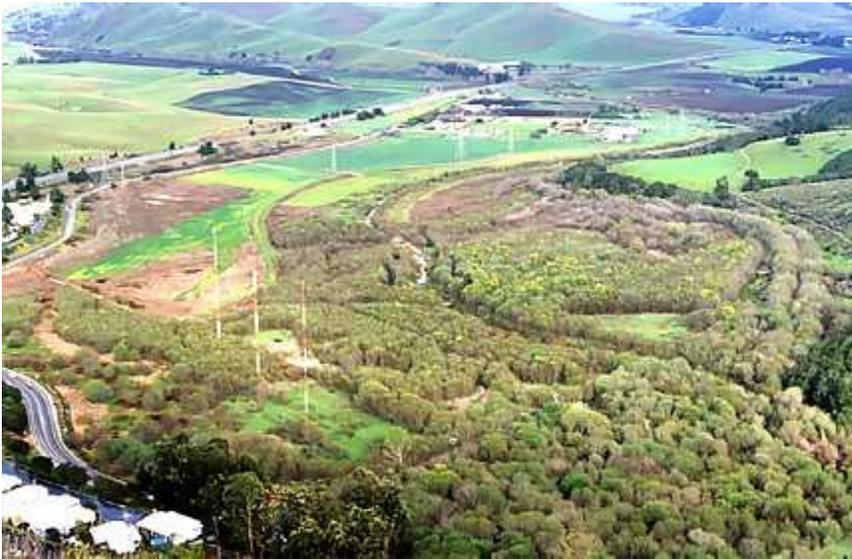
Photo 3. Riparian vegetation has been re-established.

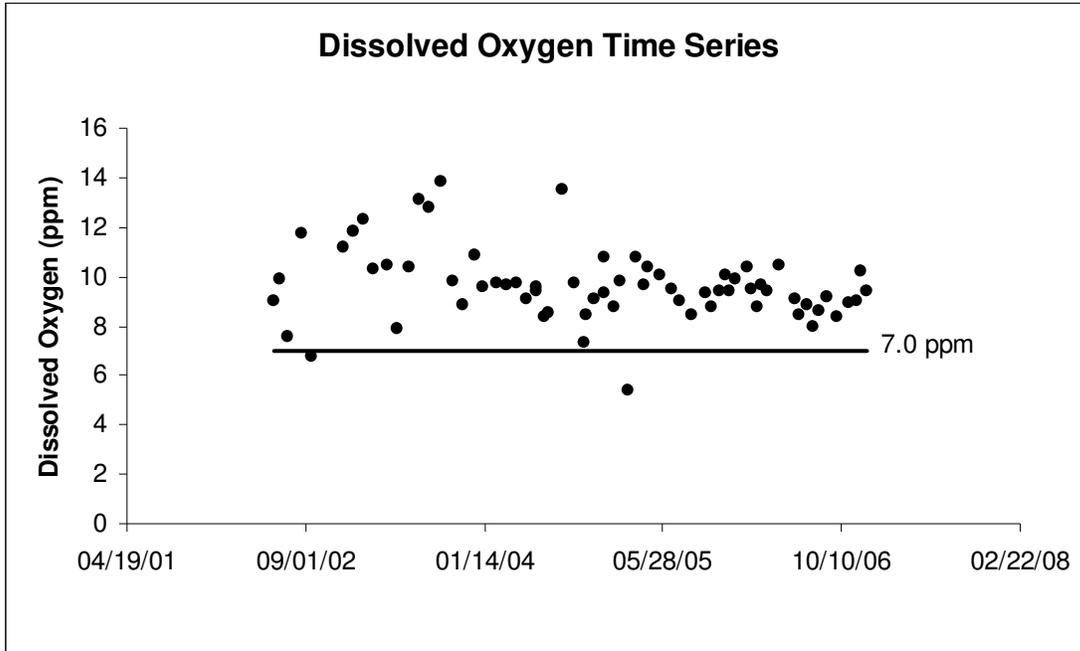
Figure 3. Dissolved Oxygen Time Series, samples collected and analyzed by Morro Bay National Estuary Program

The basis of the original dissolved oxygen listing, was that five (5) out of ten (10) samples were below the water quality objective of 7.0 ppm dissolved oxygen. Since the original listing, more than one hundred additional samples have been collected and analyzed by the [Central Coast Ambient Monitoring Program](#) (CCAMP). These data conclude that nine (9) of the 111 samples did not meet the dissolved oxygen water quality objective for the COLD beneficial use (i.e. were below 7.0 ppm). Independent of the CCAMP effort, MBNEP has collected and analyzed 67 different samples (Figure 3). Similar to the CCAMP data, MBNEP data shows that since 2002, only two (2) of 67 samples did not meet the dissolved oxygen water quality objective for the COLD beneficial use. In conclusion, these data meet the COLD beneficial use water quality objective and are sufficient justification to remove the dissolved oxygen CWA section 303(d) listing for Chorro Creek. However, Chorro Creek is still impaired by nutrients, and therefore is only partially restored.
