Re: THP 1-03-042 SCR Redtree Properties, L.P.

Timber Harvest Information Form with Fact Sheet

**REDTREE PROPERTIES, L.P.
MEYLEY UNIT THP OPERATIONS MAP**
(Keyed to Timber Operations Plan pages 26-28)
Page 1 of 2

Summarized Redtree Properties, L.P. Meyley Unit THP1-03-042 SCR

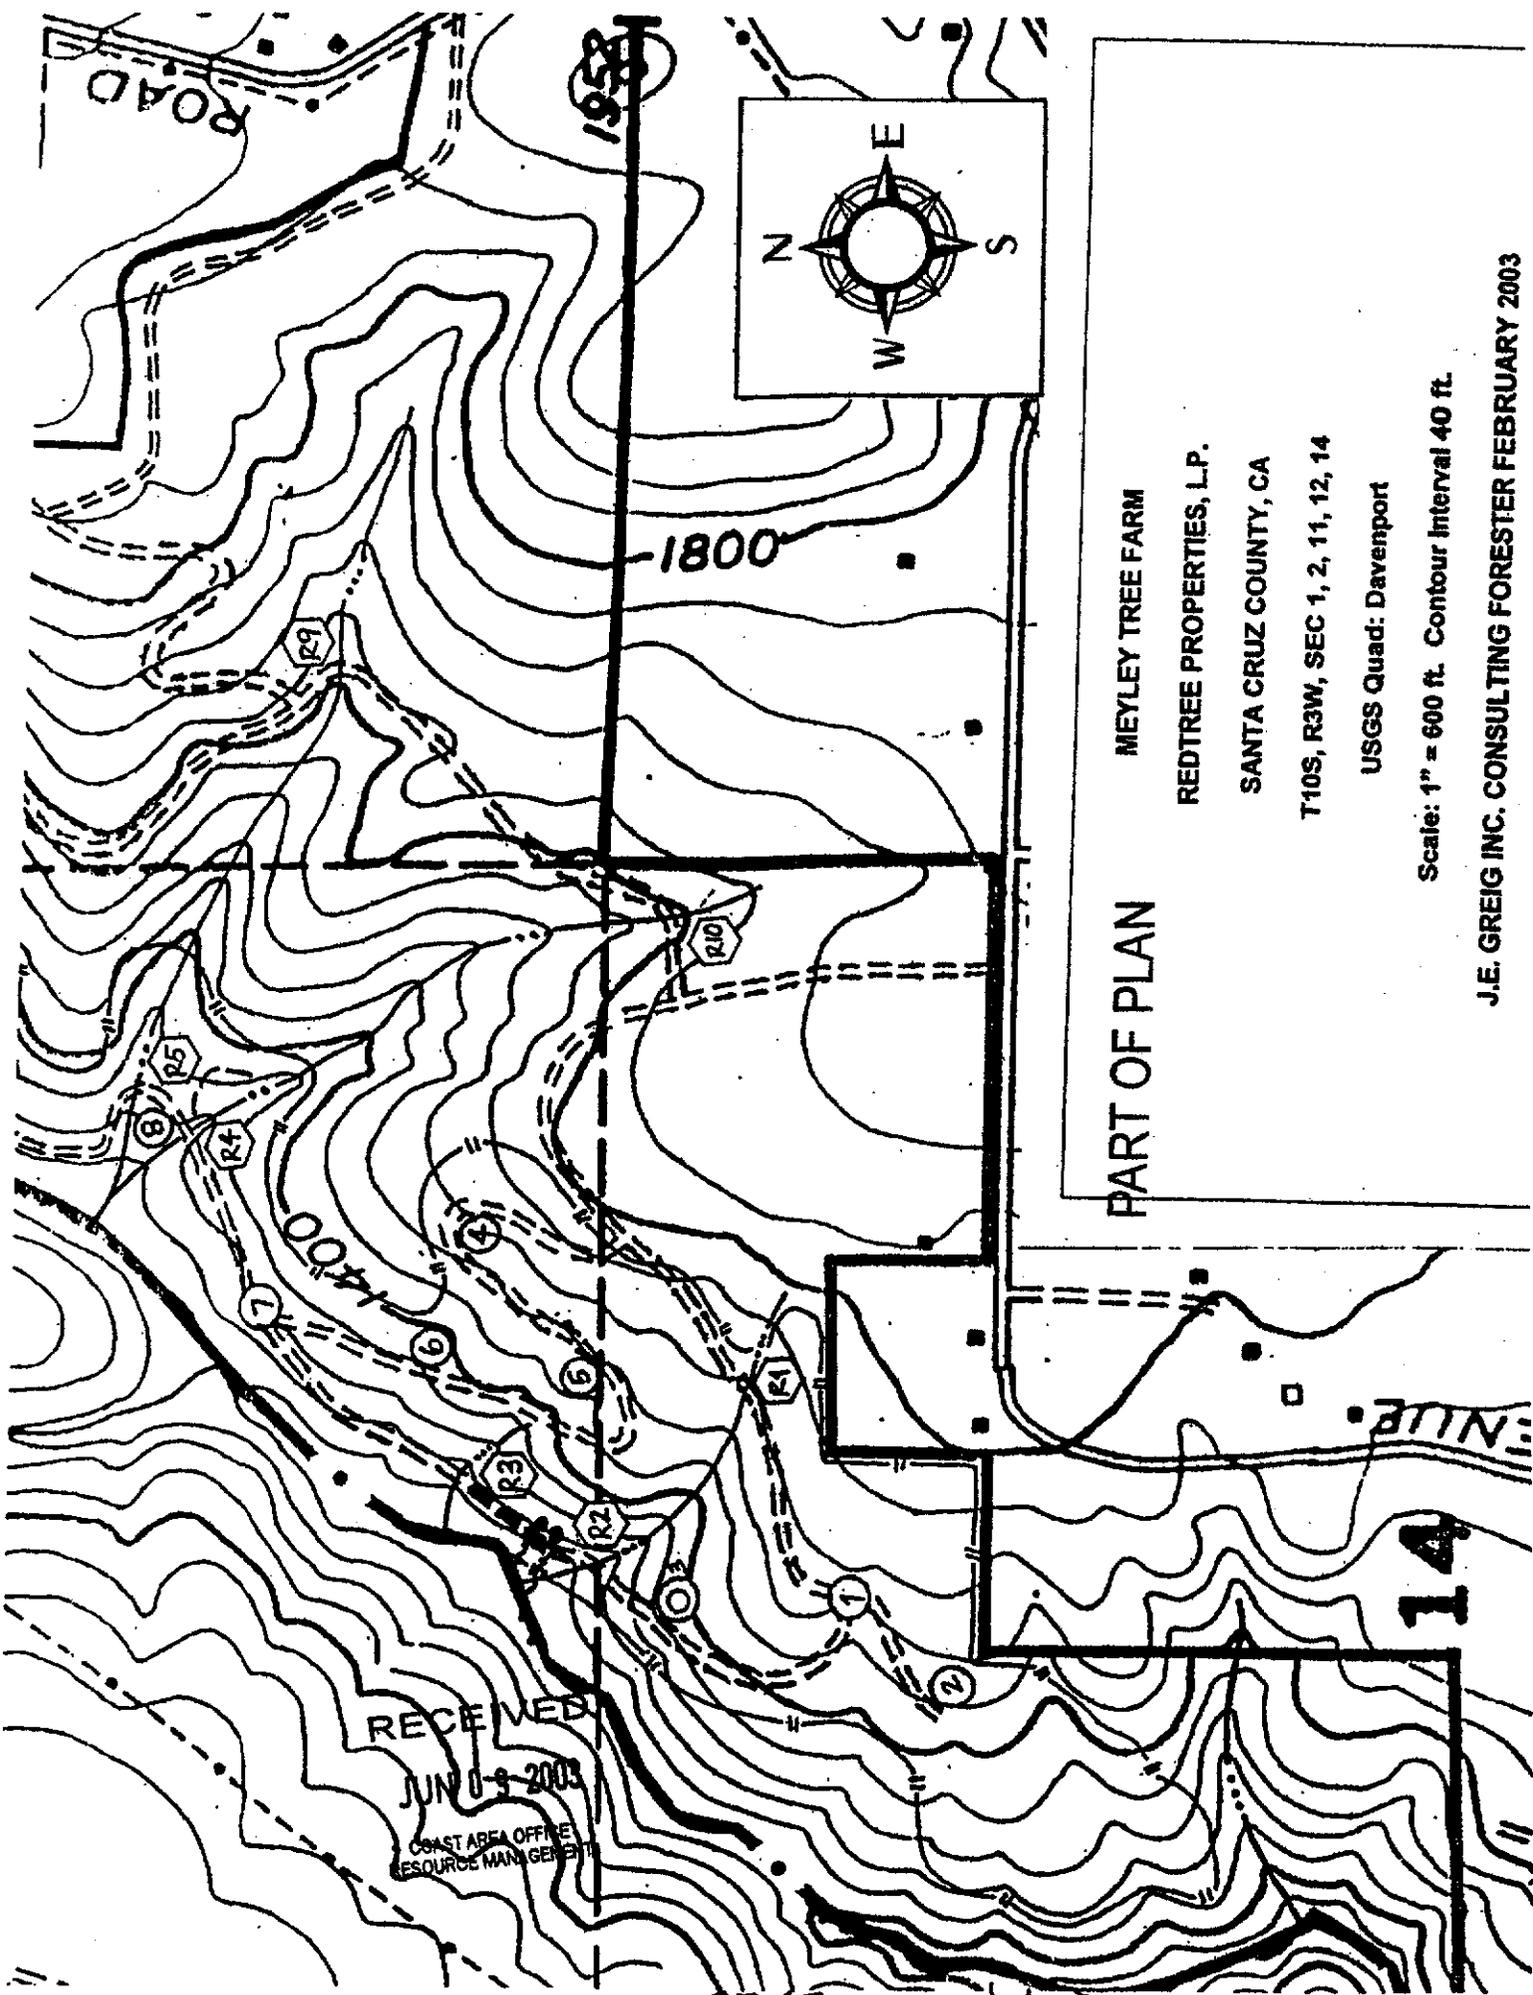
Area of probable low deflection.
See Item 20.

Cable Yarding Area:

Tractor Area: Rest of THP

MEYLEY TREE FARM
REDTREE PROPERTIES, L.P.
SANTA CRUZ COUNTY, CA
T10S, R3W, SEC 1, 2, 11, 12, 14
USGS Quad: Davenport

Scale: 1" = 600 ft. Contour Interval 40 ft.

R1 The existing road crosses a moderately sized, steep gradient class 3 watercourse. Drainage is conveyed through a 18" diameter culvert 60ft. in length. Road dips and is outsloped thru the crossing and although rolling dips are placed closely to crossing sheet flow has concentrated in a point on fill face and caused minor rilling of fill slope at low point. Mitigation- Establish rolling dips at each approach to the crossing. Inslope the road between these dips and ditch to the head of the culvert. Maintain a slight critical dip for stream continuity. Rock road surface 25' each direction.

R2 The existing seasonal road crosses the same class 3 discussed above in R1 downstream approximately 600 ft. Runoff is conveyed under the road in a 24" CMP 40 ft. in length. Road dips slightly and is outsloped at crossing to prevent diversion of watercourse in the event the culvert becomes plugged. Inlet of pipe has 3 t-post trash rack. Outlet of pipe is shotgunned 6ft. above channel but due to rocky channel no accelerated erosion has resulted.

R4 The existing seasonal road crosses a small class 2 watercourse. The original crossing, a 30" CMP, has become plugged with 4-6" granite rocks most likely in the 1998 storms. The crossing functioned relatively well in that the stream has remained in the channel and is currently flowing across the road in a ford.

S1 Existing skid trail crossing of a class 3 watercourse. Use as is, dip out at completion of operations and tractor pack both sides of crossing with slash for 25 ft. prior to October 15th.
