**AERIAL PHOTOGRAPHIC ANALYSIS OF THE BURIAL TRENCH AREA,
P/S LANDFILL BARRIER, AND PRE-SITE DRAINAGES
CASMALIA DISPOSAL SITE
CASMALIA, CALIFORNIA**

May, 2003

Prepared By: ERI

**Prepared for:
CH2MHILL
325 East Hillcrest Drive
Suite 125
Thousand Oaks, CA 91360**

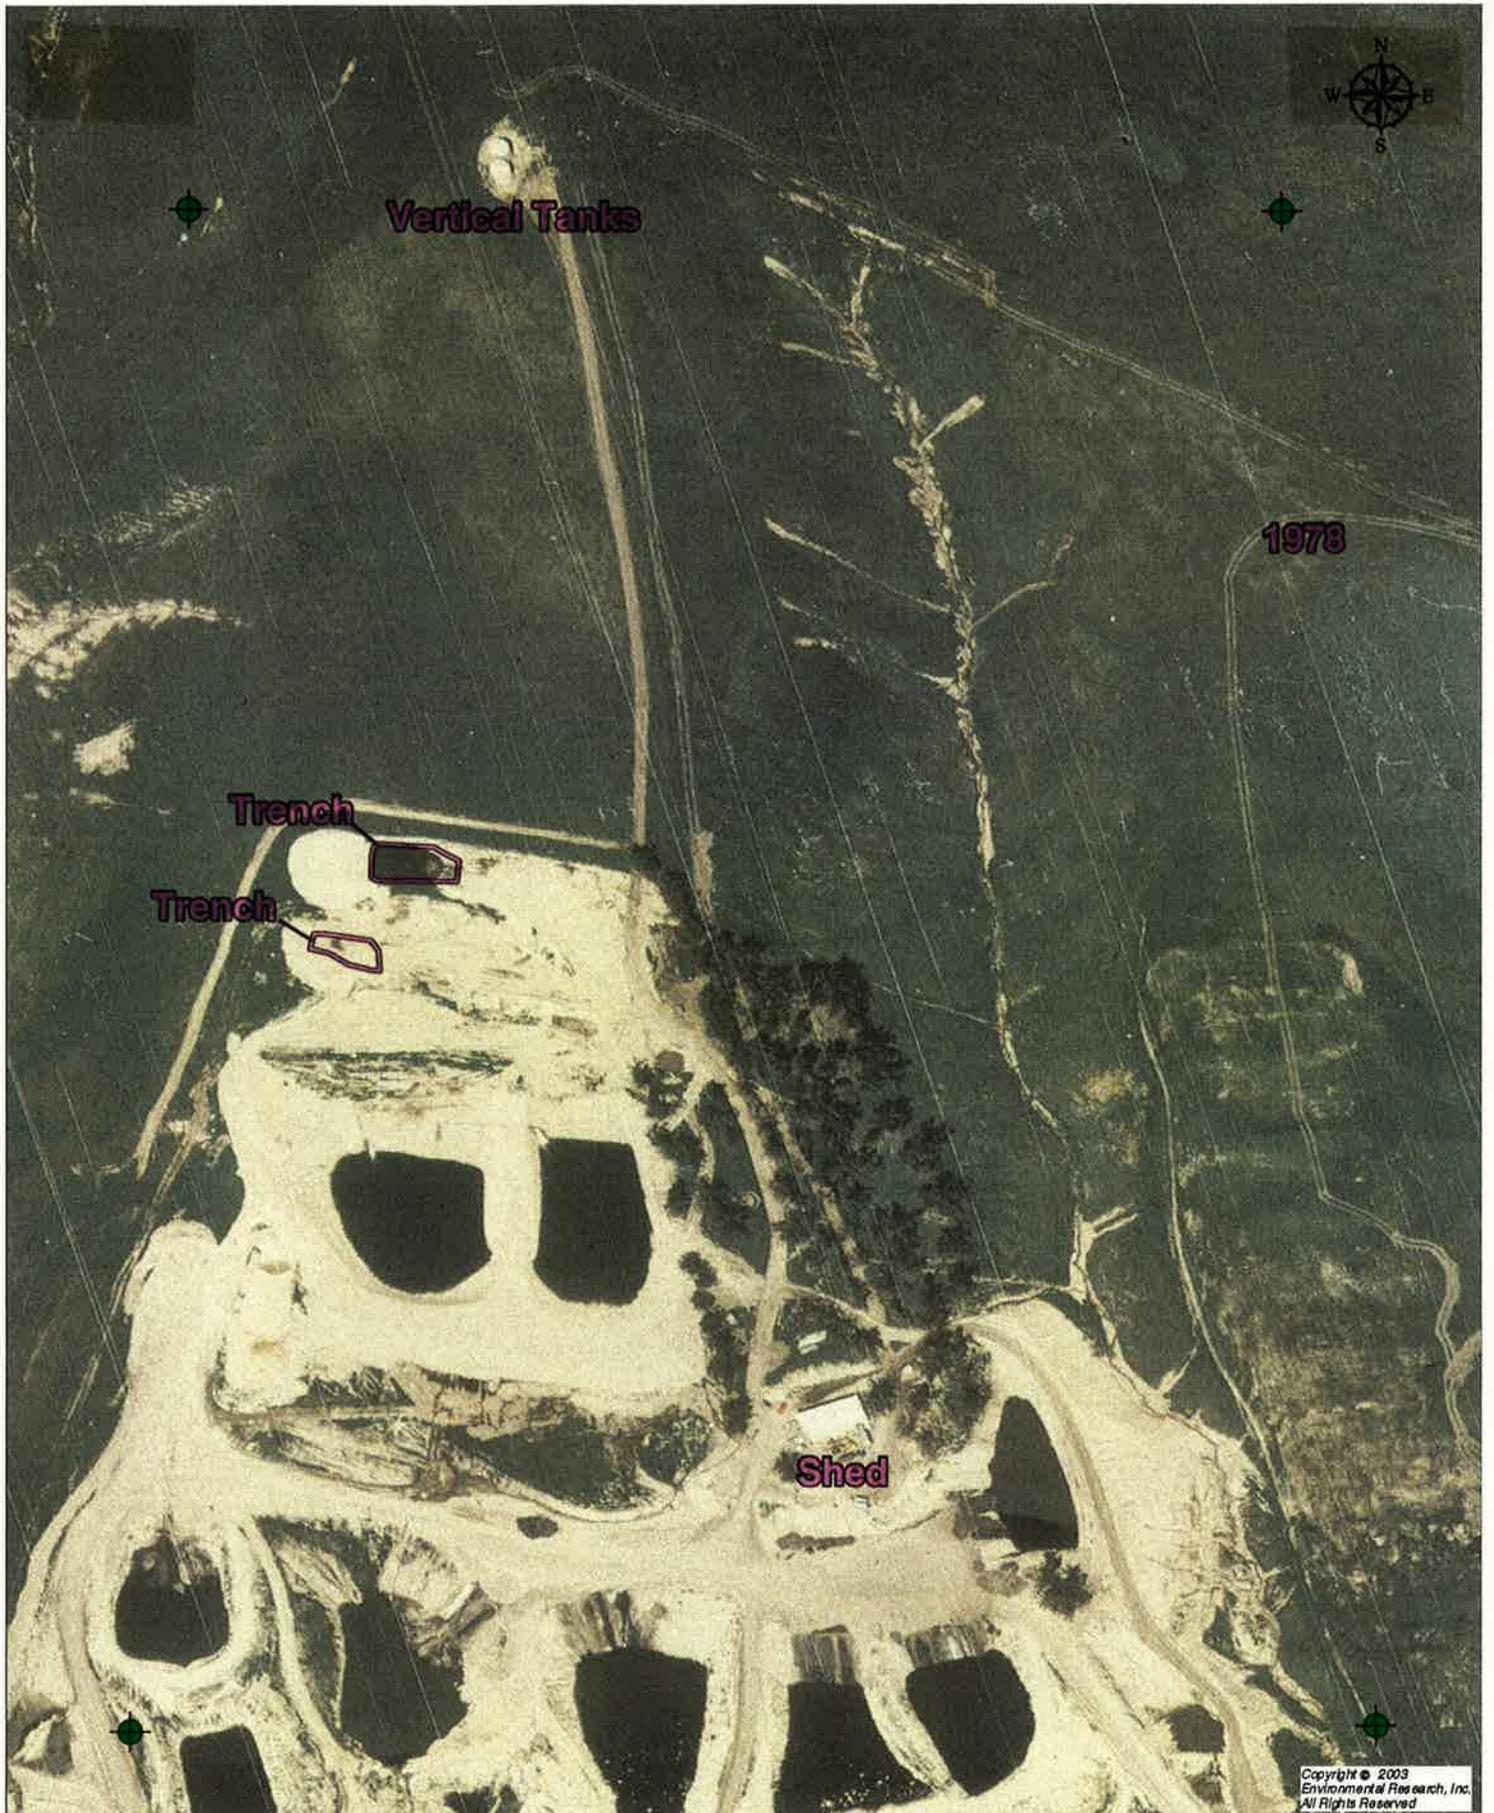
Date: March 14, 1978

Registration is the process of making an image conform to another image. This process was used to align the specific areas of interest of the photographs for the Burial Trench Area and the P/S Landfill Barrier. Features common to the separate images are selected as control points to be used to register the images to one another. Accuracies associated with this process vary depending on such things as photographic parallax, scale, and resolution, as well as the degree of change from one date to the next. Accuracies specific to this analysis are estimated to be in the 6-12 foot range. One exception being the 1978 photograph, with accuracies estimated to be in the 12-20 foot range.

Trenches were noted on all dates except December 16, 1981. Wellheads within the burial trench area were visible from July 18, 1979 to December 16, 1981.

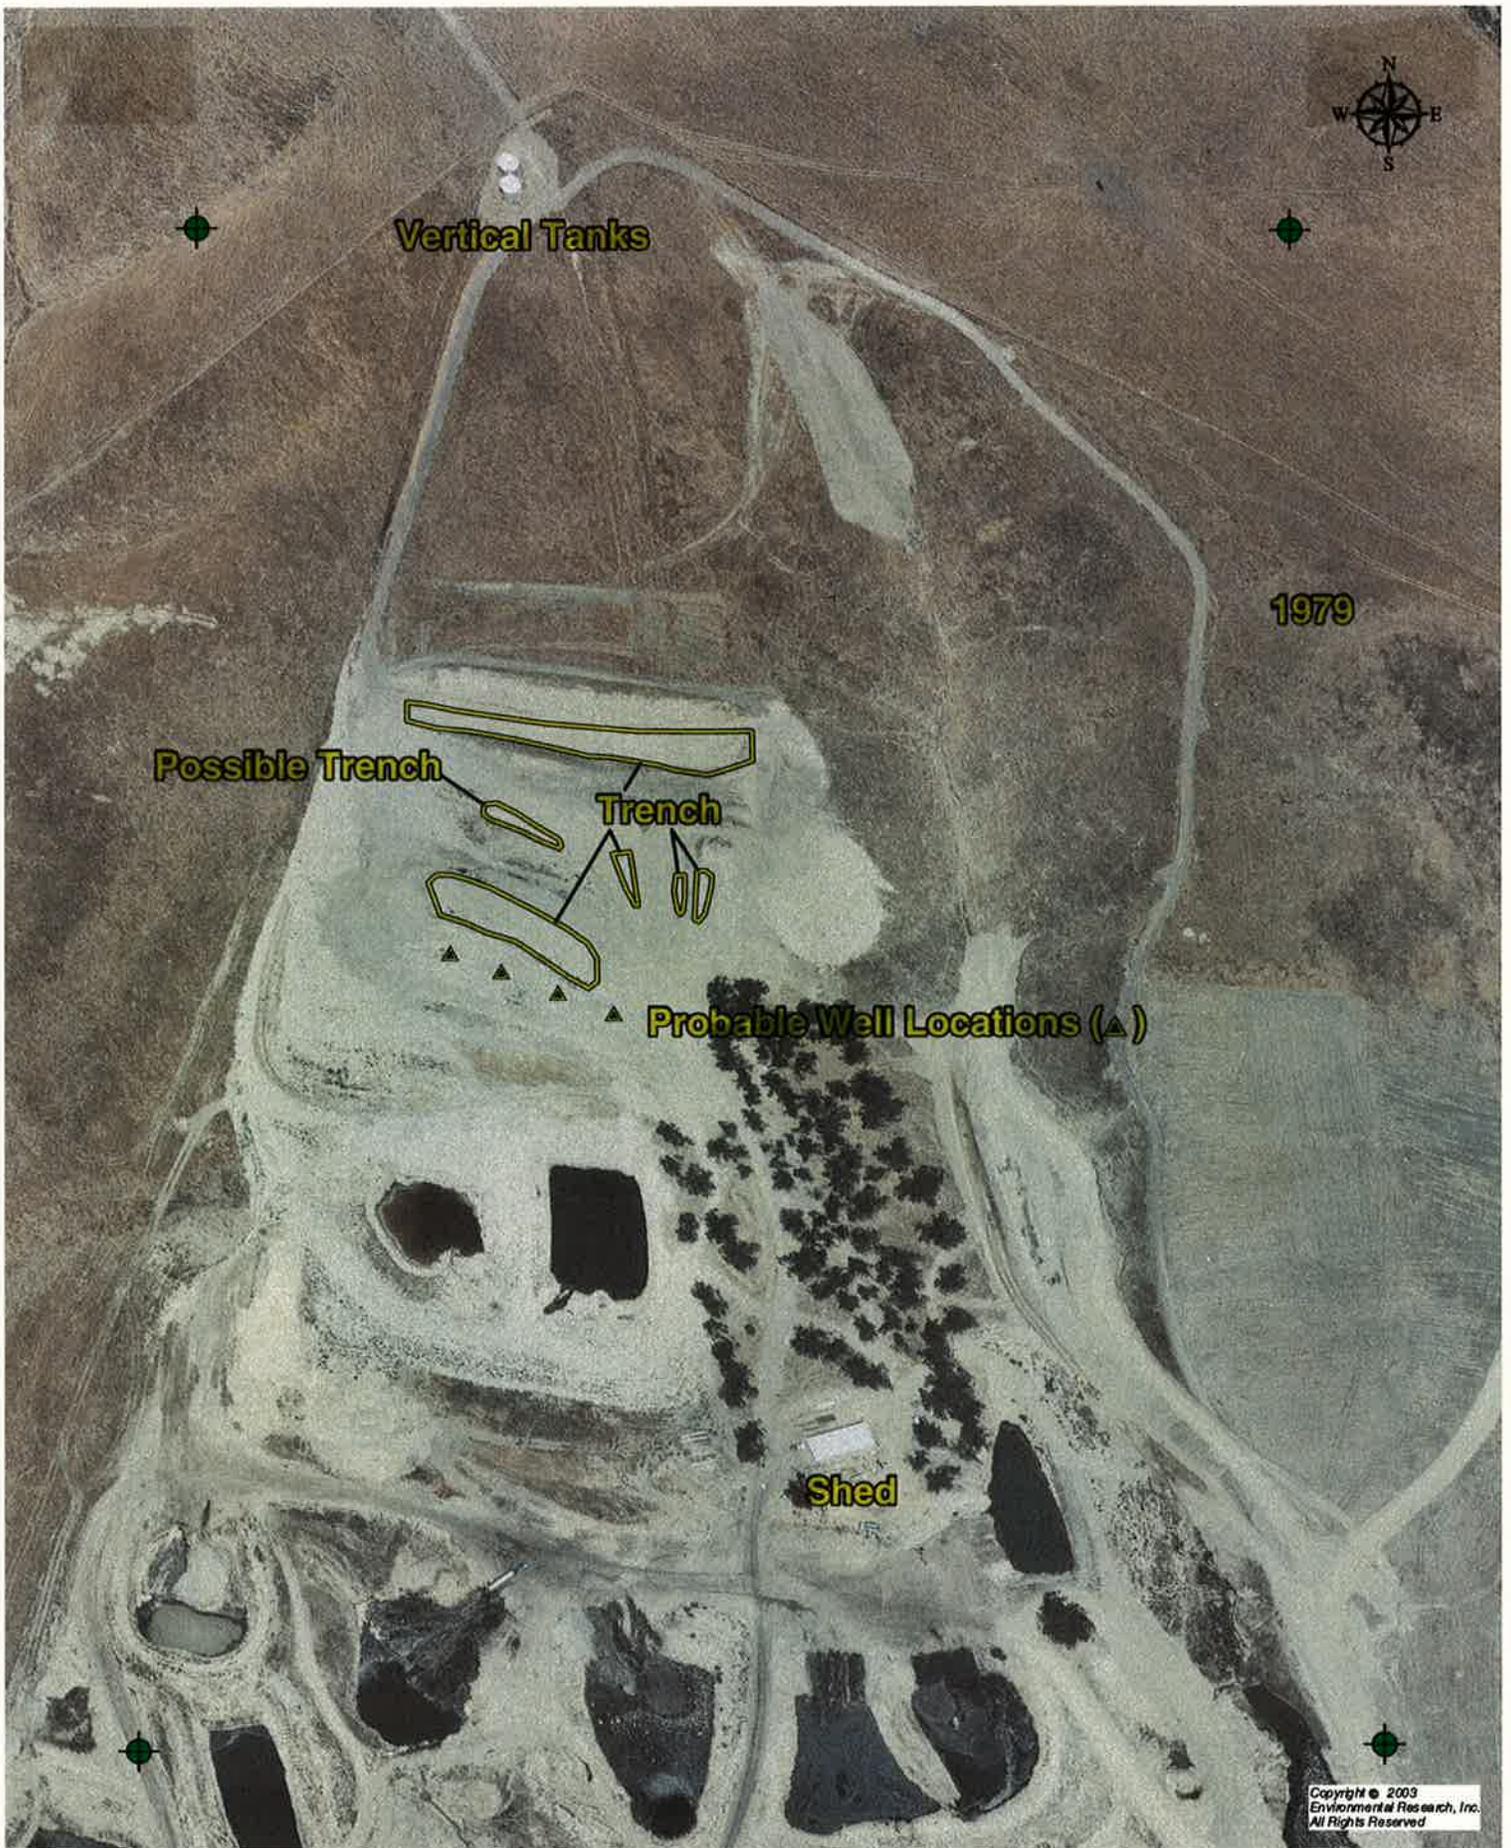
Date: July 18, 1979

Vertical Tanks

Possible Trench

Trench

Probable Well Locations (▲)

Shed

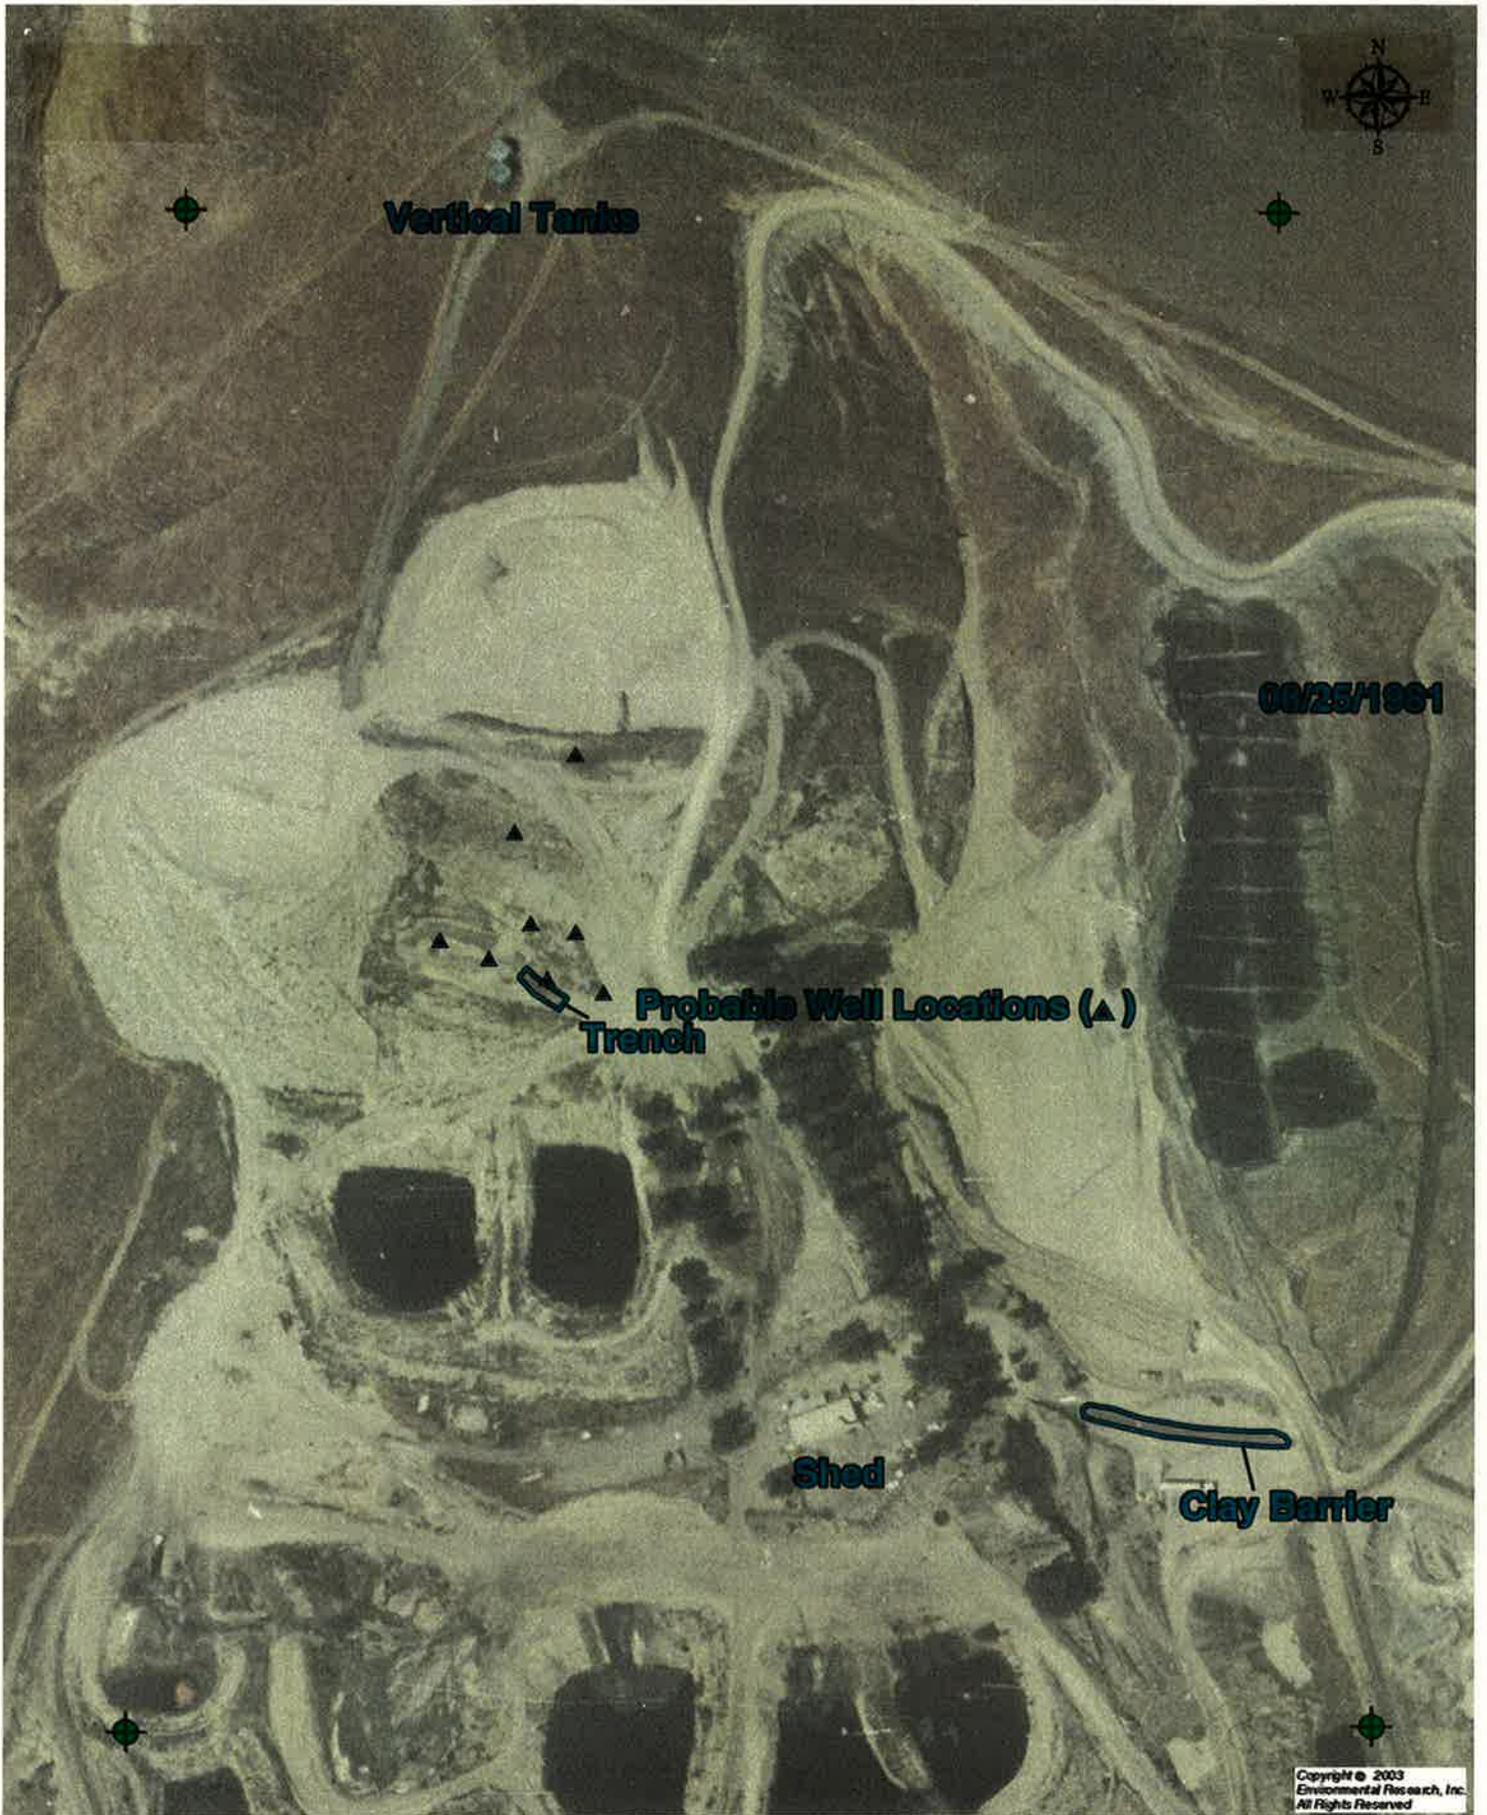
Date: August 25, 1981

The clay barrier is visible on August 25, 1981 and December 16, 1981 aerial photographs only.

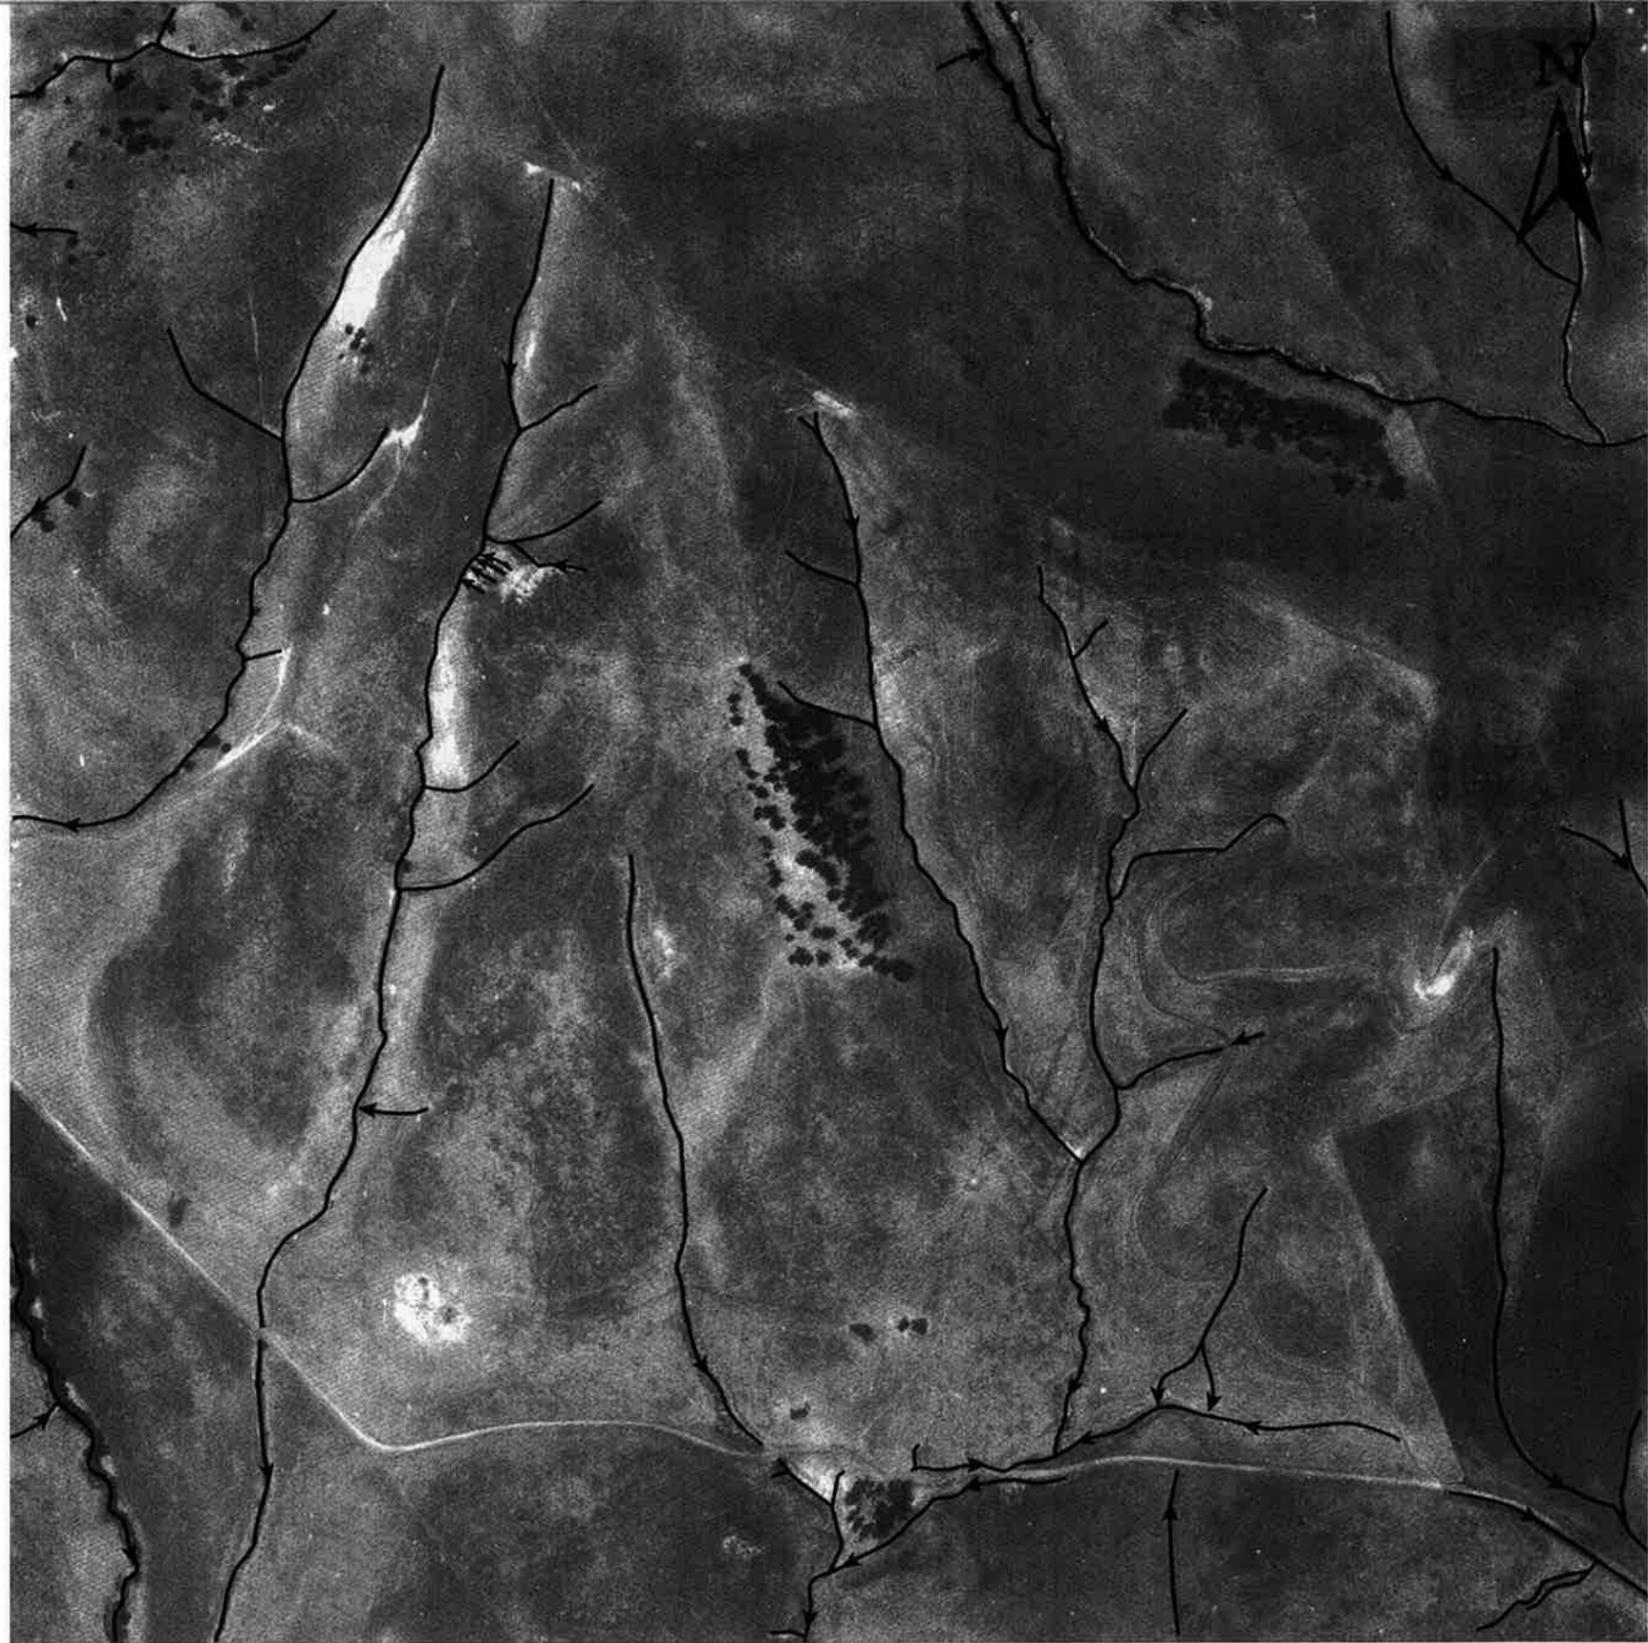
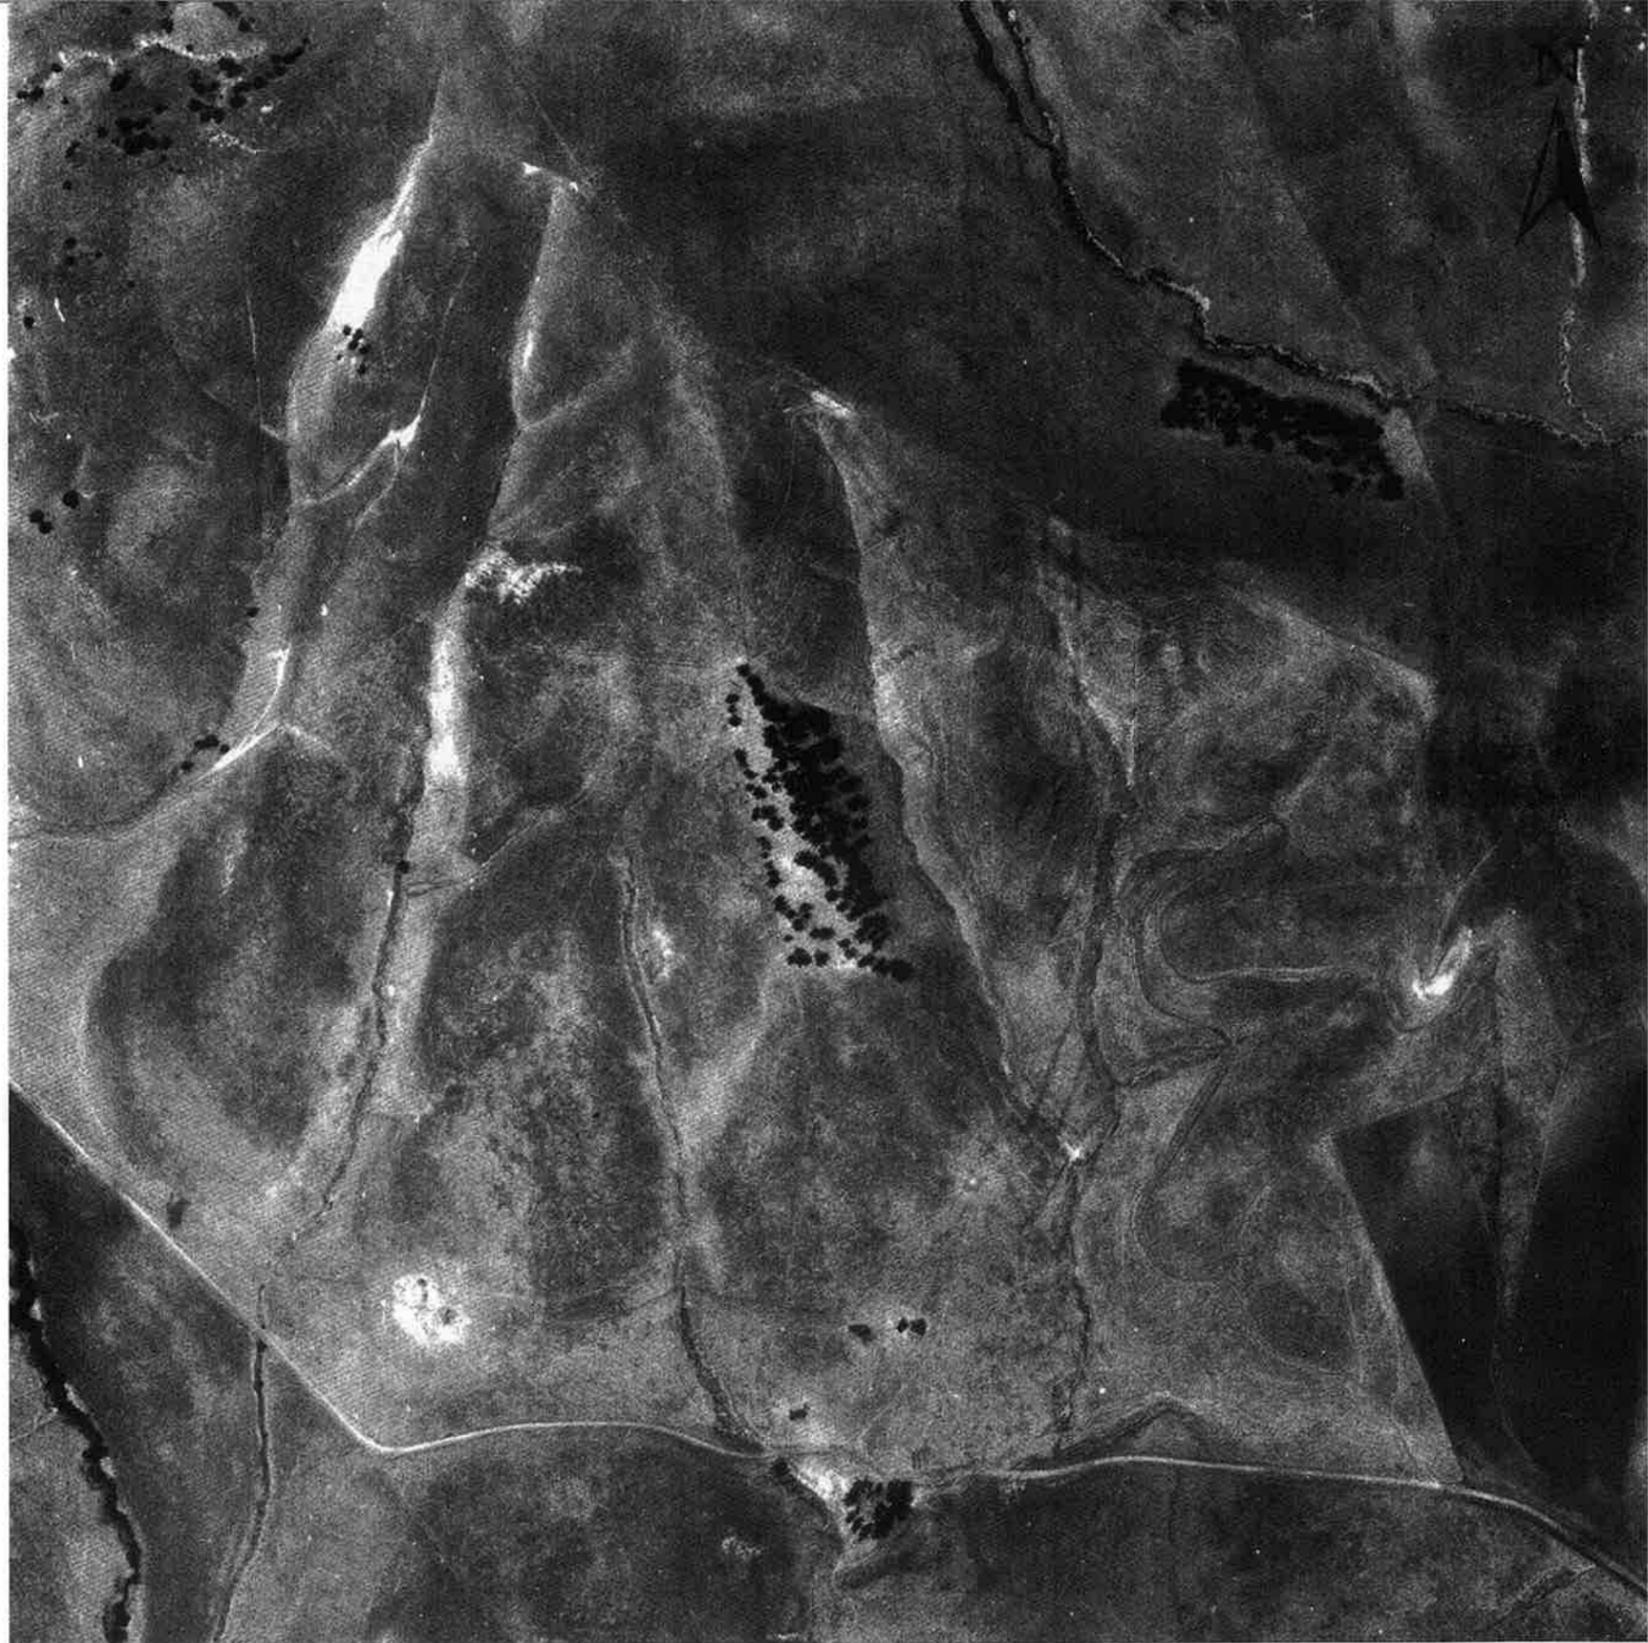
JUNE 10, 1970 FRAME: 136
DRAINAGE ANALYSIS

A surface drainage analysis was performed and is illustrated on the June 18, 1970 aerial photographs to document the pre-site drainage patterns. This information, extracted from the 1970 aerial photographs, is also depicted on the Figure 4-1 map. Due to the large area analyzed for the drainage pathways and the lack of common control points in the location of the Casmalia Disposal site between the 1970 aerial photographs and the base map, no accuracy statement is possible.
