CENTRAL VALLEY REGIONAL WATER QUALITY CONTROL BOARD

INSPECTION REPORT

FACILITY: Brooks & Arlene Rushing
Stanislaus County APNs 088-009-014, 088-009-024, 088-009-029
(38 acres)

LOCATION: Fulkerth Rd & W. Tuolumne Rd at N Washington Rd, Turlock CA

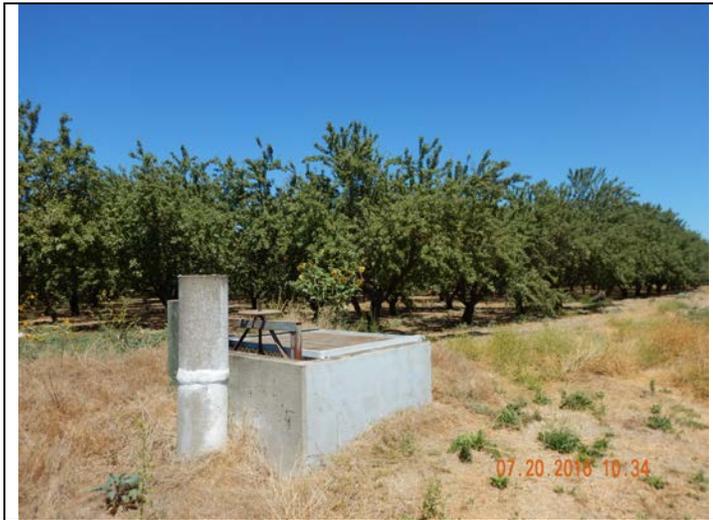
<p>Photo 1 (photo 0833.JPG): Photo taken facing Northwest from southeast corner of APN 088-009-024. Parcel is an almond orchard, and is lower than adjacent road. Soils are sandy and parcel is flood irrigated.</p>	<p>Photo 2 (photo 0834.JPG): Photo taken facing Southeast from northwest corner of APN 088-009-014. Parcel is an almond orchard, and is lower than adjacent road. Soils are sandy and parcel is flood irrigated.</p>

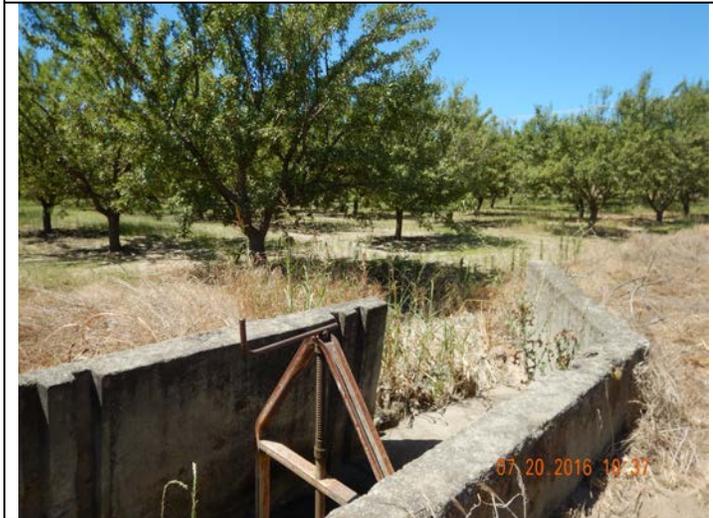
<p>Photo 3 (photo 0835.JPG): Photo taken facing West from northeast corner of parcel 088-009-014. Shows another view of orchard along with flood irrigation value. There are no roadside drainage ditches in this area of the County.</p>	<p>Photo 4 (photo 0836.JPG): Photo taken facing South from north center of parcel 088-009-029. Parcel is not irrigated agriculture, although has flood irrigation value onsite. ** Google Earth review of this parcel shows possible AG onsite on 3/23/14.</p>
