CENTRAL VALLEY REGIONAL WATER QUALITY CONTROL BOARD

INSPECTION REPORT

LOCATION & COUNTY: Reeve Road Heifer Ranch
21070 Reeve Road, Tracy
San Joaquin County

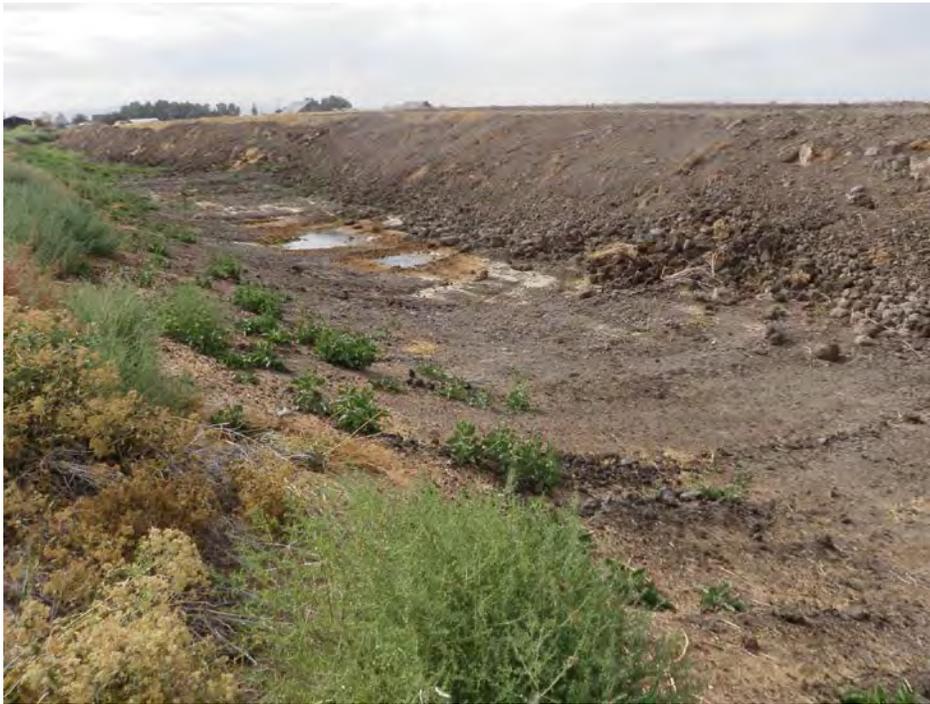
No manure has been removed from the property. The manure from the wastewater storage lagoon has been placed on top of the manure / bones south of the wastewater lagoon (Photos 1-3). Staff walked along the top of manure that was removed from the lagoon lightly sifting through the top layer; several bones were observed and shown to Mr. Tosta (Photos 4-5). Mr. Tosta responded by saying coyotes likely carried the bones onto the property; then Mr. Tosta asked again if he could land-apply the manure. Staff clearly stated that Mr. Tosta cannot land-apply the manure. Staff asked Mr. Tosta about a plan regarding the clean up / manure removal from the site; Mr. Tosta stated his environmental consultant Jim Avila told him he would submit a plan that day. As of 10 September 2012 no clean-up plan for the Reeve Road Heifer Ranch has been received.

Photo 1: This manure was removed from the Reeve Road Heifer Ranch wastewater storage lagoon. The pictured manure is stacked on top of manure that contains bones and cannot be land-applied.

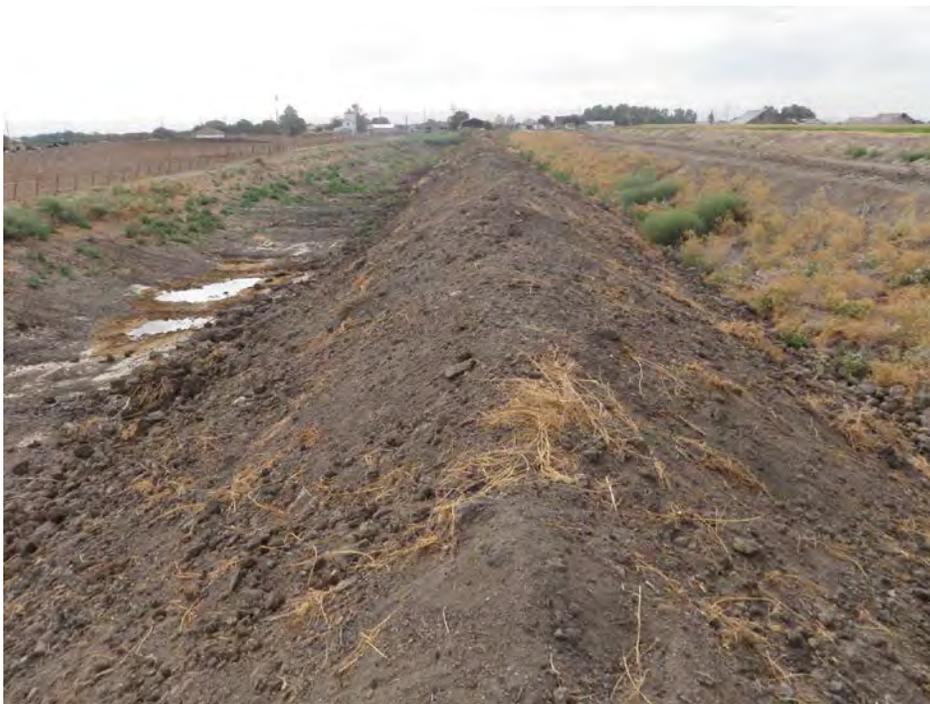
Photo 2: Staff walked the entire length of this pile lightly sifting through the manure looking for bones. Please see 4-5.

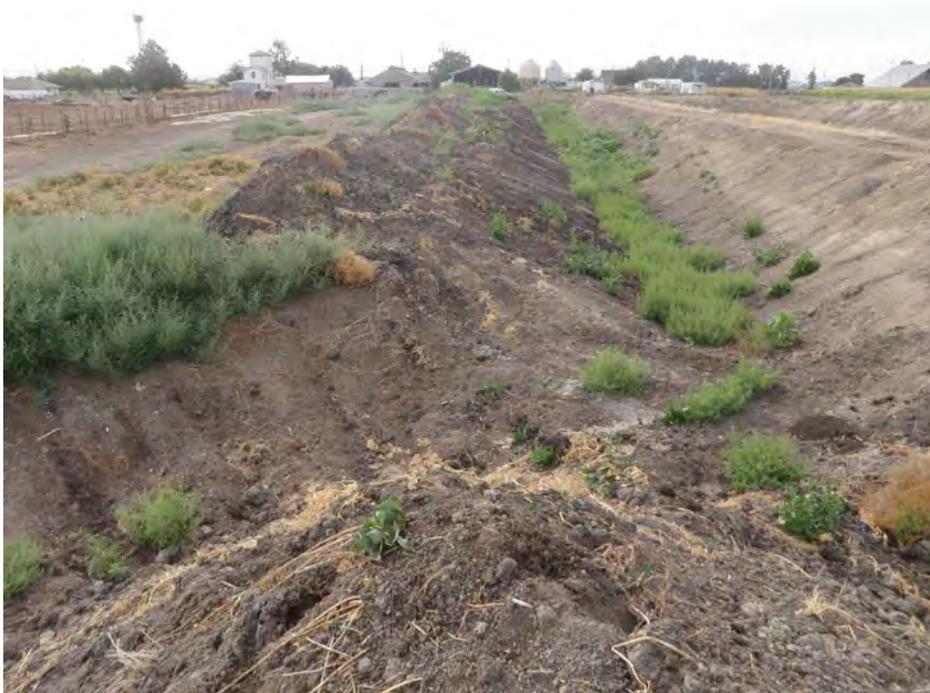
Photo 3: Staff walked the entire length of this pile lightly sifting through the manure looking for bones. Please see 4-5.

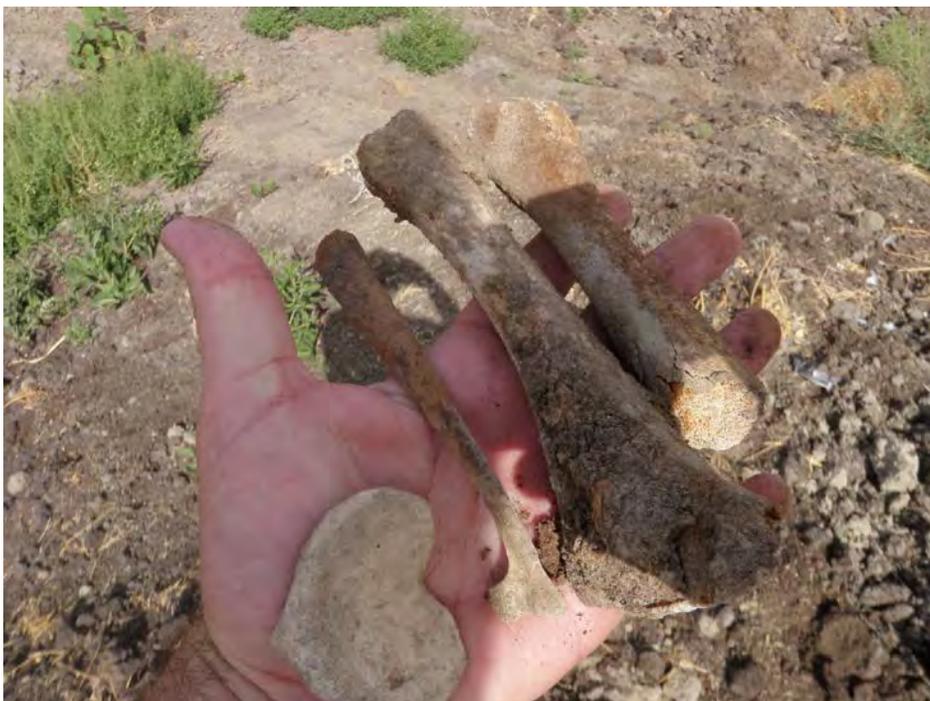
Photo 4: Staff found these bones in the manure pile located south of the lagoon. Many more bones were observed, staff picked these out as examples to show Mr. Tosta.

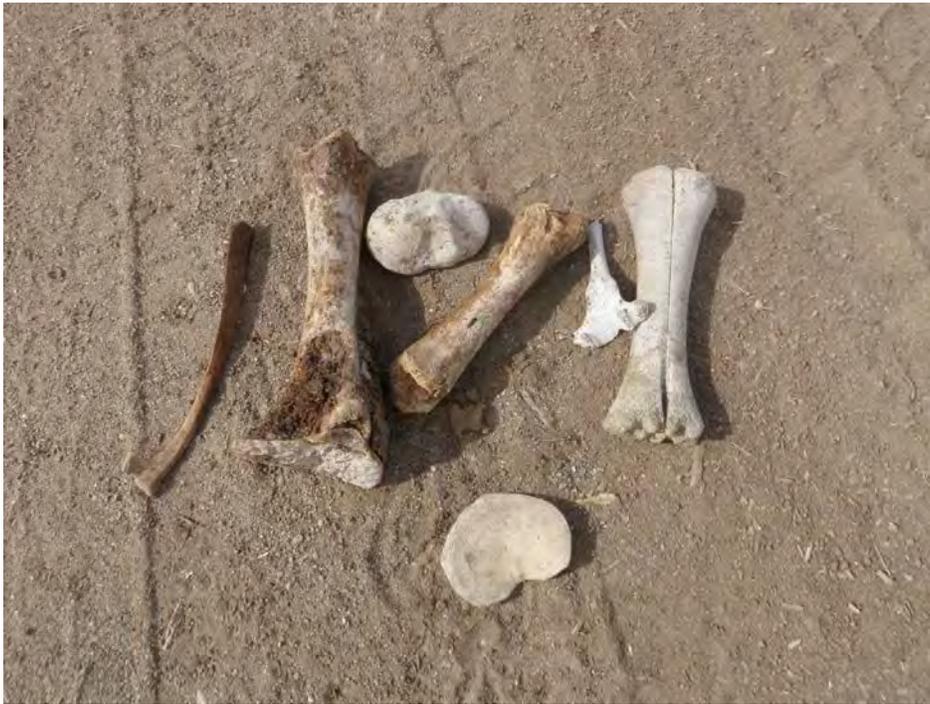
Photo 5: The pile of bones shown to Mr. Tosta.

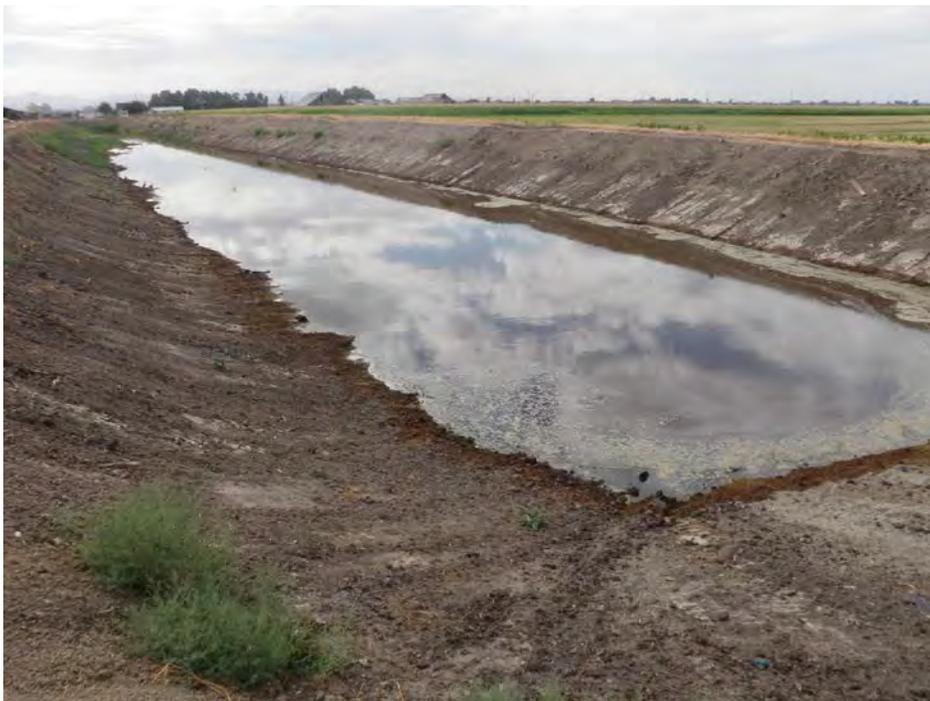
Photo 6: Reeve Road Heifer Ranch wastewater storage lagoon contains clean irrigation water.
