**CalRecycle - SWIS Inspection Summary Report**

## Closed Disposal Site Inspection Report (188)

Enforcement Agency:		County of Placer			
SWIS Facility File Number (99-xx-9999)		Inspection Date		Program Code	
31-AA-0120		3/25/2015		LEA Periodic	
Time In		Time Out		Inspection Time	
Facility Name			Received By		
Berry Street Mall - Fingers Landfill			Daniel Sheehan- A Greener Globe		
Facility Location			Owner Name		
N of Berry Street W. of Harding Blvd., Roseville 95678			Daniel Sheehan- A Greener Globe		
Inspector			Also Present (Name)		
Paul Holloway

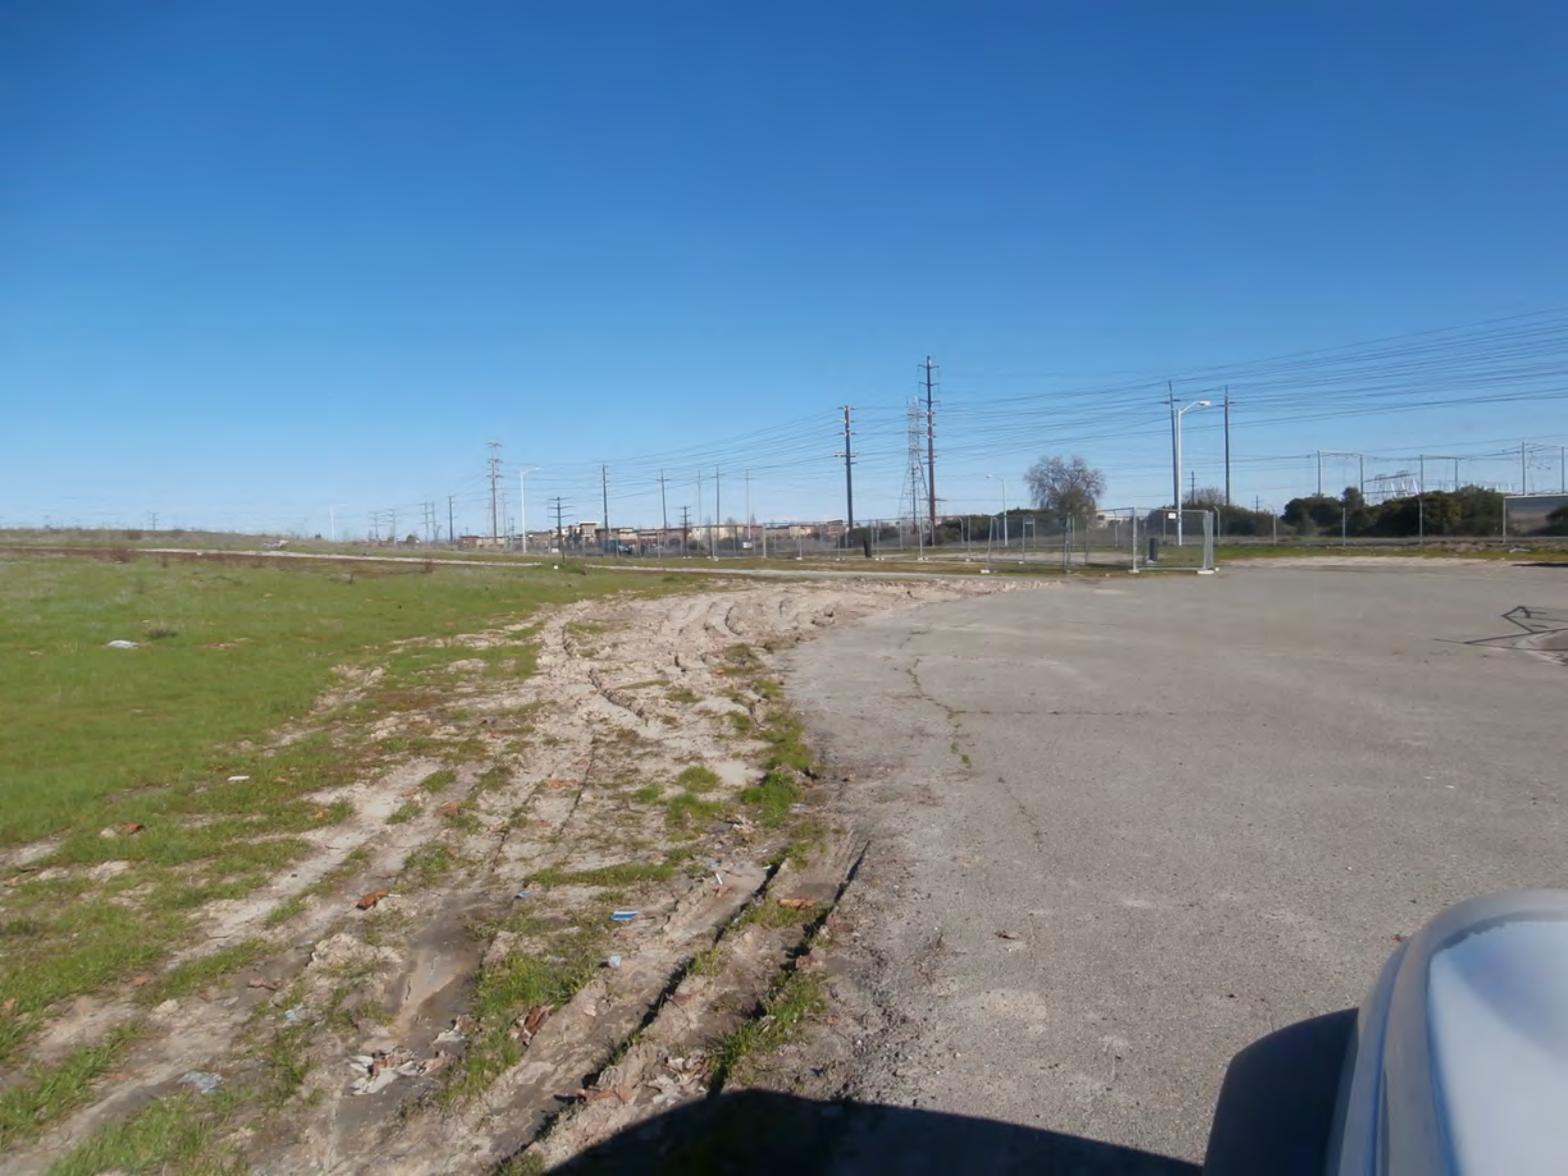
LEA Periodic 12/30/2014 Berry Street Mall - Fingers Landfill 31-AA-0120 Rutting NE corner Attachment	JPG

REGULATION	AREAS OF CONCERN (A)/VIOLATIONS(V)	COMMENTS
20750	A	Tire ruts were observed just inside of the access road at the SE, E, NE, NW, and SW portions of the landfill. It appears that during wet weather, a large vehicle (possibly a large truck) had driven around the site which likely had difficulty maneuvering around the corners of the access road. Damage appears to only have affected the top vegetative layer. These ruts should be repaired and corrected immediately and access to the site should be restricted. An area of subsidence was observed at the top of the landfill just within the access road at the top of the landfill. This area measures approximately 15ft x 20ft in size. This area should be evaluated, stabilized, and repaired immediately by qualified personnel.
20530	A	The gate was unlocked and two cars were parked on the asphalt area inside of the Landfill Mass Area as defined in the Closure/Postclosure Maintenance Plan. The inner temporary fencing was open allowing access to park on the landfill, if desired. Per the approved closure and postclosure maintenance plan, this area is to remain locked and secured at all times except for ingress and egress. There is no approved parking in the landfill mass area. See comments under Site Maintenance.
