NOTICE OF VIOLATION AND REPORT OF 20 AUGUST 2015 INSPECTION, THE MORNING STAR PACKING COMPANY, L.P., COLUSA COUNTY

The Morning Star Tomato Packing Plant which is owned and operated by Morning Star Packing Company, L.P. (Discharger) is regulated by the Central Valley Regional Water Board under Waste Discharge Requirements (WDRs) Order R5-2013-0144.

INSPECTION REPORT

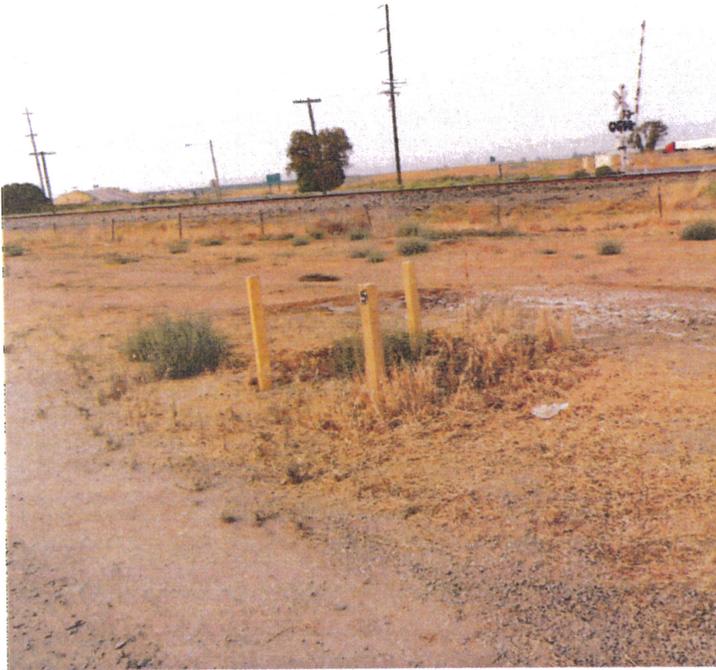
- At 0802 am on the morning of 20 August 2015, Board staff noted slight odors at the corner of Husted and Abel Roads, which is northwest of the facility and adjacent to Monitoring Well 5 (Figure 1).

Figure No. 1: Groundwater monitoring well located at the corner of Husted and Abel Roads. Staff detected slight odors at this location

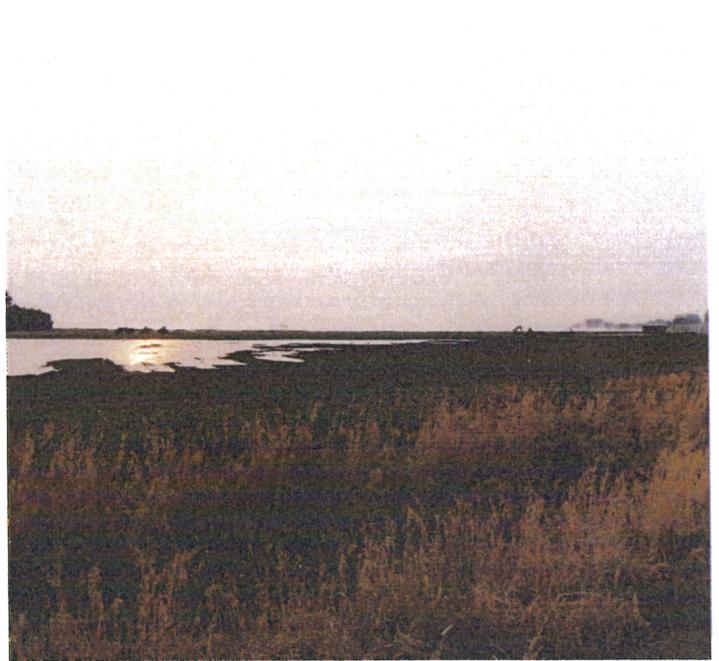
- Standing water was observed on property located northeast of the cooling pond. Mr. Raj indicated later that this was groundwater. In addition, construction equipment was also observed on property located northeast of the cooling pond (Figure 2). Mr. Raj also informed staff that the Discharger was constructing a new warehouse building.

Figure No. 2: Looking southeast at standing water located on property northeast of the cooling pond. The source of the ponded water is unknown. A new warehouse building will be located in the area of the construction equipment.

- Board staff observed construction equipment on an area just north of the cooling pond. It is our understanding that this is the future site of a new warehouse building. Be advised that discharges of storm water associated with construction that results in the disturbance of one acre or more of land must **forthwith** apply for coverage under the State Water Resources Control Board General Storm Water Permit 2009-0009-DWQ.
- Our records show that the Discharger does not have coverage under the State Water Resources Control Board's General Permit 2014-0057-DWQ for storm water discharges associated with industrial activities.

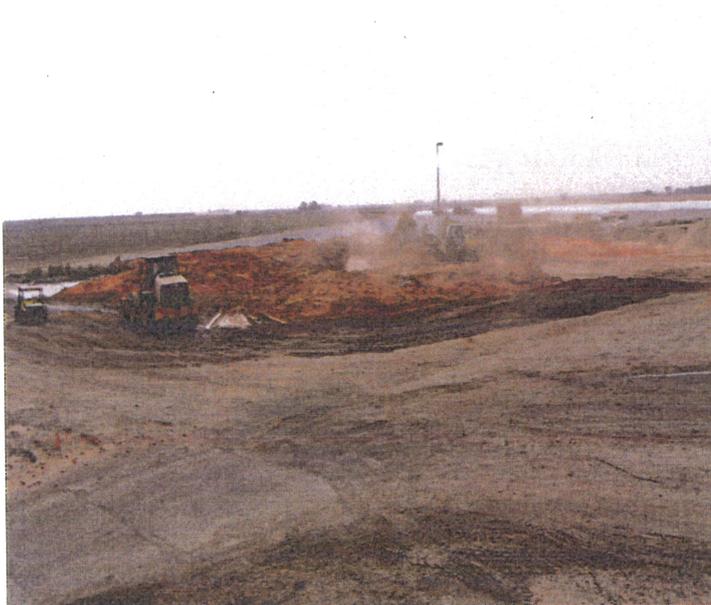
- The inspection began in the southern area of the facility. Board staff observed water and tomato solids in ditches located next to the tomato solids staging and storage areas located southeast of the wastewater settling pond (Figures 3, 4, and 5). Board staff was not clear why these ditches contained standing water and solids. Odors were noted in these areas of the facility.

Figure No. 3: Tomato solids staging/storage area located southeast of the settling pond.

- It appears that waste was also being discharged in areas not allowed in the WDRs. Board staff observed water and solids in ditches located next to the tomato solids staging and storage area located southeast of the wastewater settling pond. Based on this observation, the Discharger is in violation of the WDRs. Discharge Specification D.15, states: "*Storage of residual solids, including cull tomatoes, vines, pomace (seeds and skins) on areas not equipped with means to prevent storm water infiltration, or paved leachate collection system is prohibited.*"

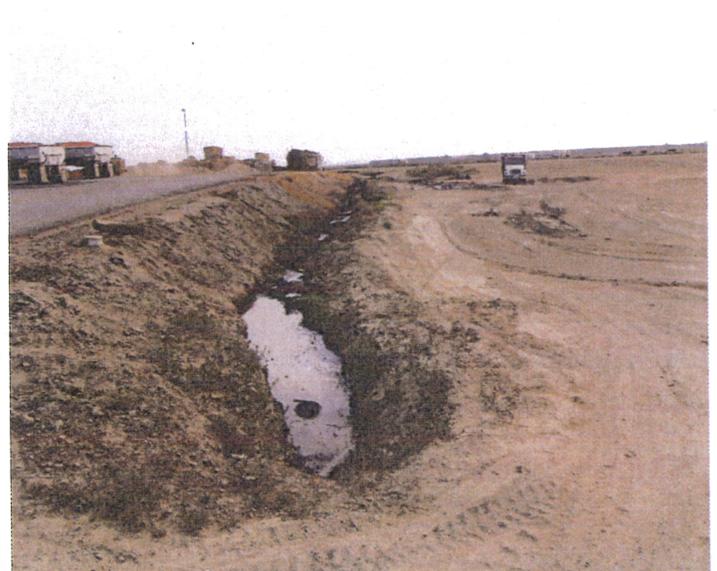
Figure No. 4: One of the ditches located near the tomato solids staging/storage areas. Some tomato solids were observed in the ditch.

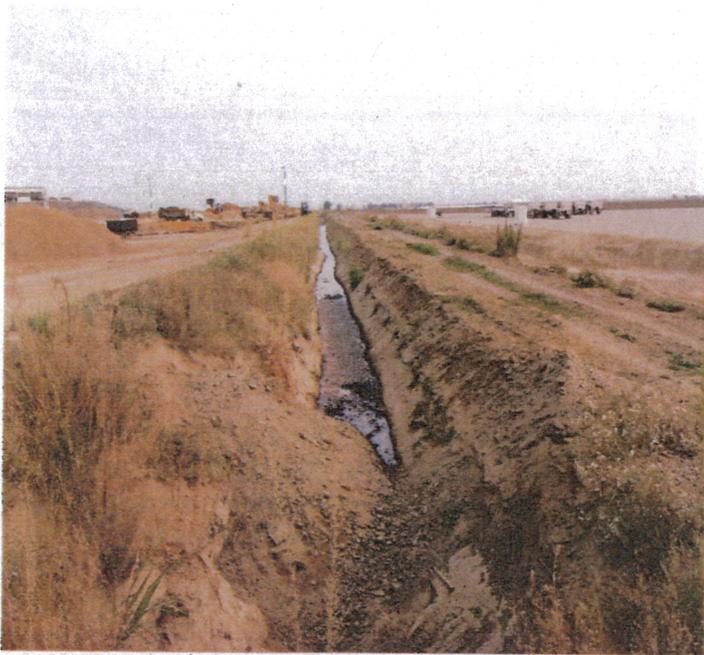
Figure No. 5: Looking north at the main ditch. Some solids were observed in the ditch. The tomato unloading area is located west of the ditch.

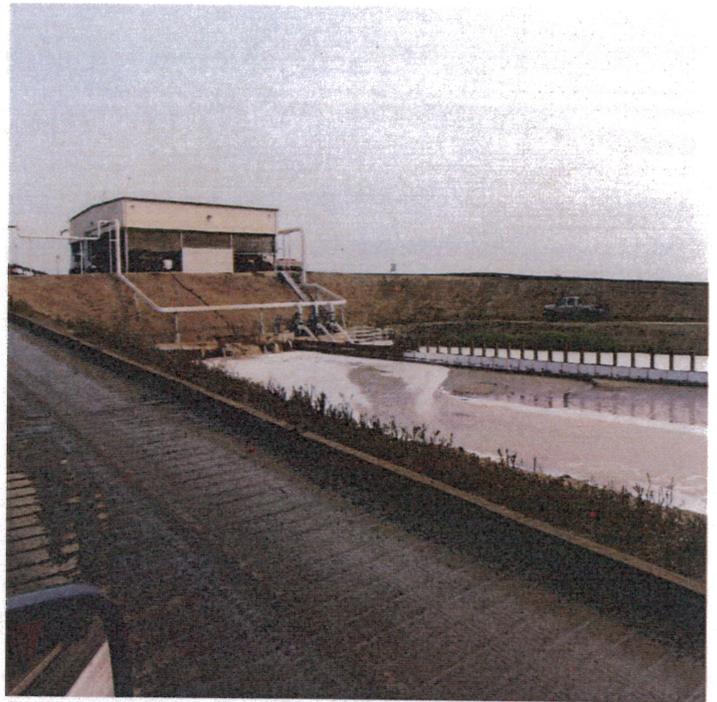
- Some odors were noted at the tomato unloading area (Figure 6 and 7), and adjacent to the wastewater settling pond (Figures 6 through 10).
- Board requested an opportunity to observe the Discharger's technician collect Dissolved Oxygen (DO) measurements from the settling pond using a hand held instrument (Figures 10 through 12). Both grab samples and direct readings from one foot below the surface of the water were taken. DO readings were taken from the north end of the pond at the location of the three intake pumps, the effluent flow structure located along the northeast side of the pond, and from the south end of the pond. Grab samples were collected using a glass bottle attached to a pole which was submerged one foot below the surface. The sample was then poured into a plastic bottle and the DO measurement taken. The DO measurements taken from the bottle sample ranged from 1.12 to 3.38 mg/L. While the DO measurements taken using directly from the pond were all less than 1.0 mg/L Discharge Specification D.8 of the WDRs states that the DO in the wastewater pond shall not be less than 1.0 for three consecutive sampling events.

Figure No. 6: Looking north at the tomato unloading area and the settling pond.

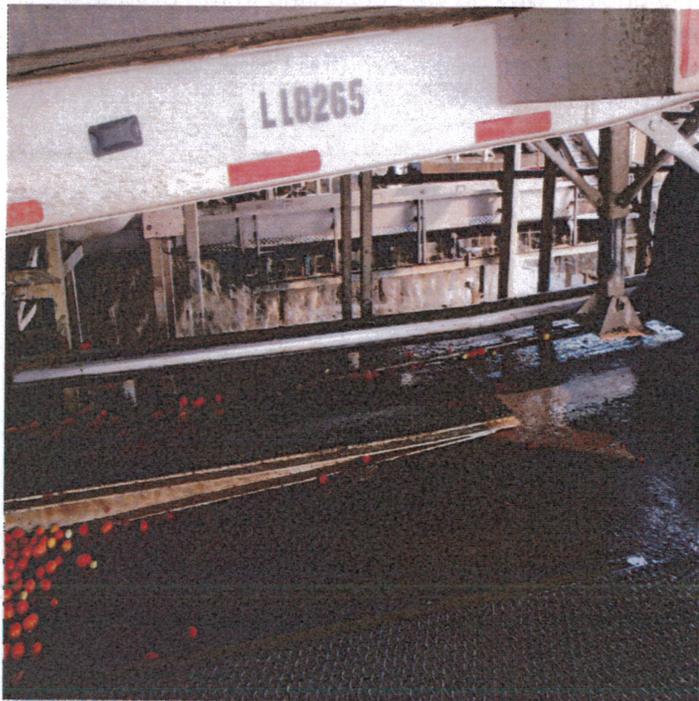
Figure No. 7: Operations within the tomato unloading area.

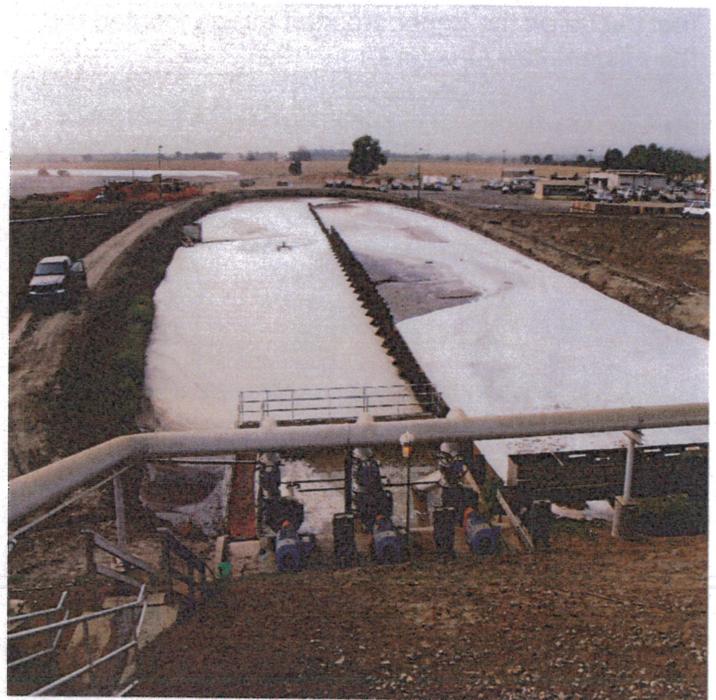
- One mechanical aerator was observed in the wastewater settling pond (Figures 6, 8, 9 and 10). Mr. Raj indicated that the aerator operates 24 hours per day and seven days per week. Board staff suggested that additional aeration was needed to increase the dissolved oxygen levels in the pond.

Figure No. 8: Looking south from the tomato unloading area at the settling pond. Note, there is only one aerator in this pond.

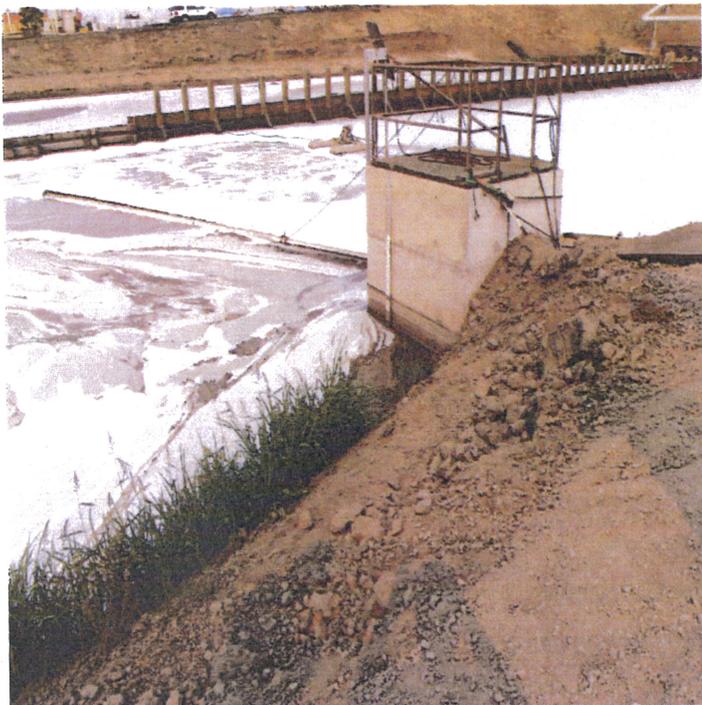
- The freeboard in the wastewater settling pond was observed at 3.3 feet based on a freeboard staff gauge (Figure 9). A scum layer was observed on the surface of the pond (Figures 6, 8, 9 and 10). Discharge Specification D.9 of the WDR requires that the operating freeboard in any pond shall never be less than two feet.

Figure No.9: Effluent flow structure in settling pond. The one aerator within the pond was operating at the time of the inspection. Freeboard in the pond was 3.3 feet based on the freeboard staff gauge located on the effluent flow structure.

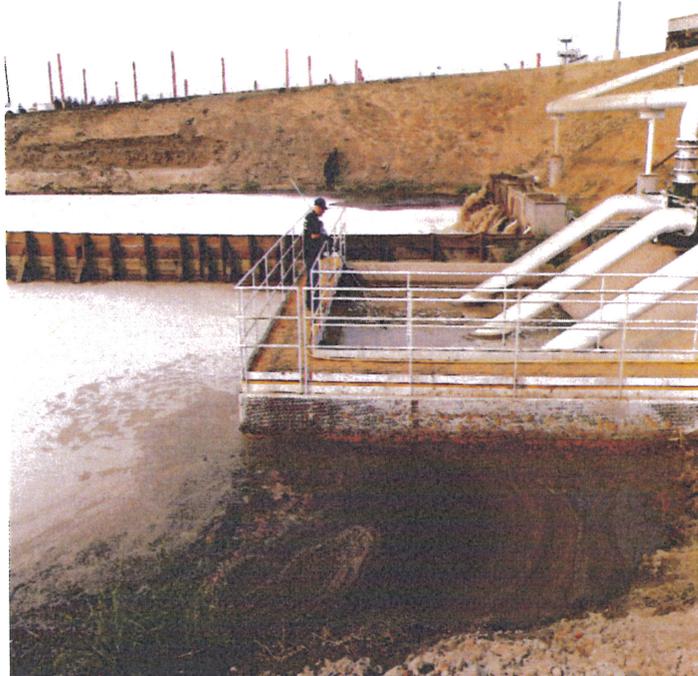
Figure No. 10: Morning Star employee collecting dissolved oxygen measurement from the settling pond. It is unclear why he was collecting in the oxygenated waters of the pump intake, rather than just in front of where the photo was taken (the brown water)

7. Standard Operating Procedures for collecting representative DO samples from the settling and cooling ponds are required by the WDRs. This is necessary because during the inspection, Board staff observed DO measurements in the settling pond of less than 1.0 mg/L using a direct probe sampling technique, and DO measurements of greater than 1.0 mg/L using a grab sampling technique.

- Because of the significant difference in DO measurements, Board staff informed the Discharger to continue taking DO measurements on a daily basis using both sampling methods, and continue submitting the information in the Daily Assessment Reports. In addition, Board staff indicated that a Standard Operating Procedure for collecting and analyzing DO samples needed to be developed to ensure that the samples being collected and analyzed were representative.

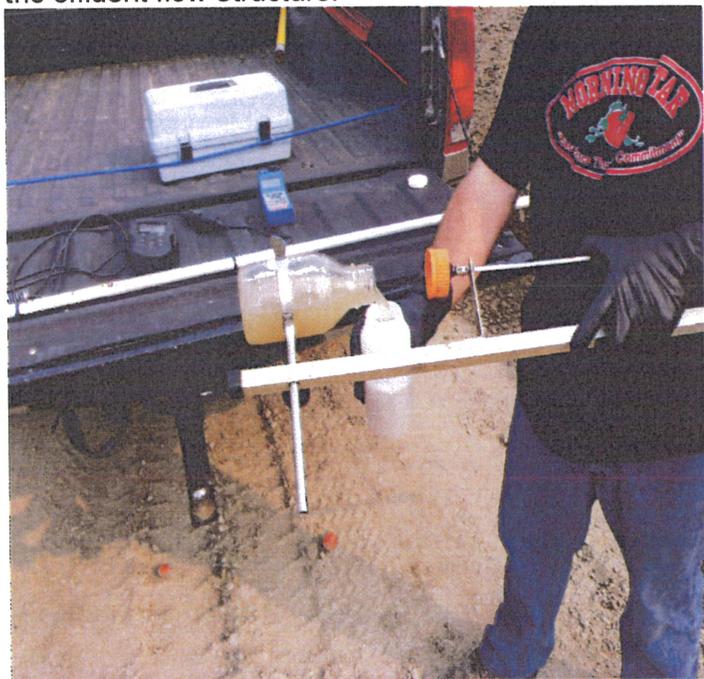
Figure No. 11: Sample of wastewater that was collected from the settling pond being poured into a sample bottle. Pouring the water into the sample jar would aerate the sample. Dissolved oxygen measurements were taken from the sample bottle using a Hatch HQ30d meter.

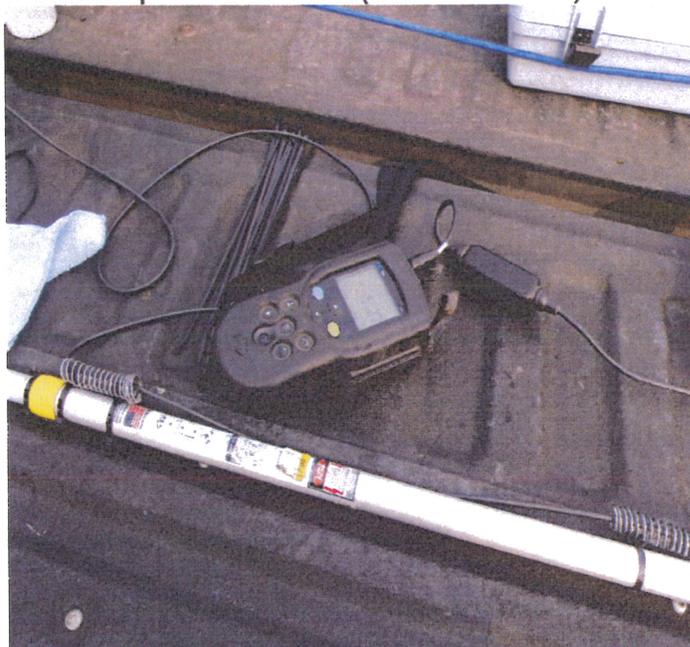
Figure No. 12: Hatch HQ30d dissolved oxygen meter

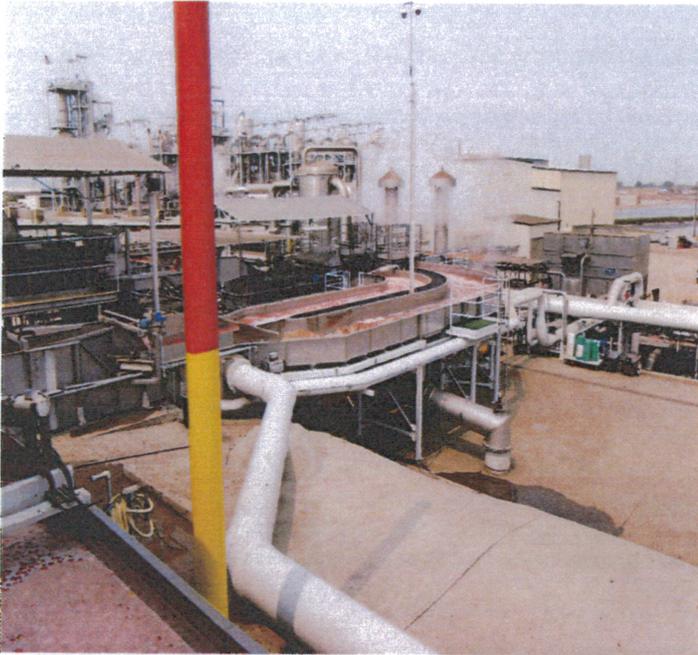
Figure No. 13: Looking northwest at the tomato processing operations. Steam is from the evaporators.

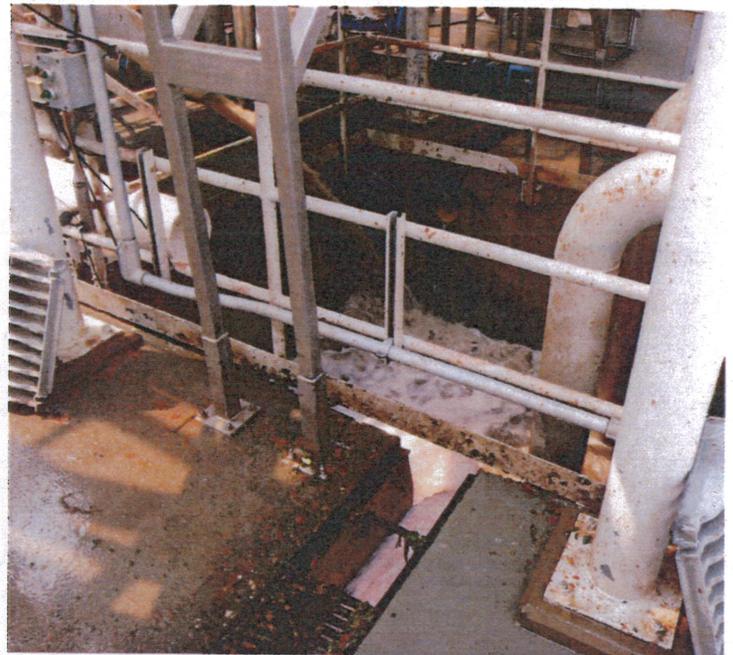
Figure No. 14: One of the discharge sumps located within the processing facility.

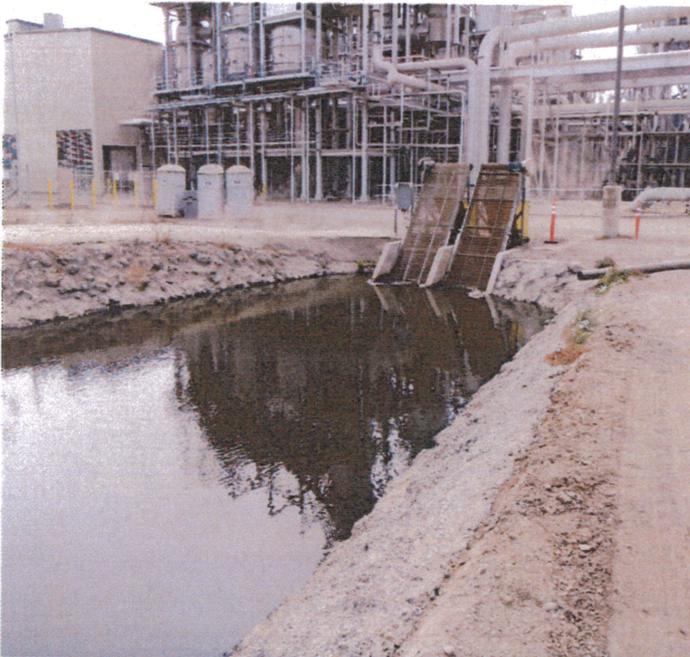
- Board staff observed the Discharger's technician collecting DO measurements from the cooling pond. A DO measurement from the south end of the pond was 0.20 mg/L using the direct probe measurement technique, and 1.87 mg/L from a grab sample which was poured into a bottle and measured.

Figure No. 15: Looking south at the evaporative cooling pond. This is the location water intake to the the plant. In addition, this is the location where dissolved oxygen meter readings are taken.

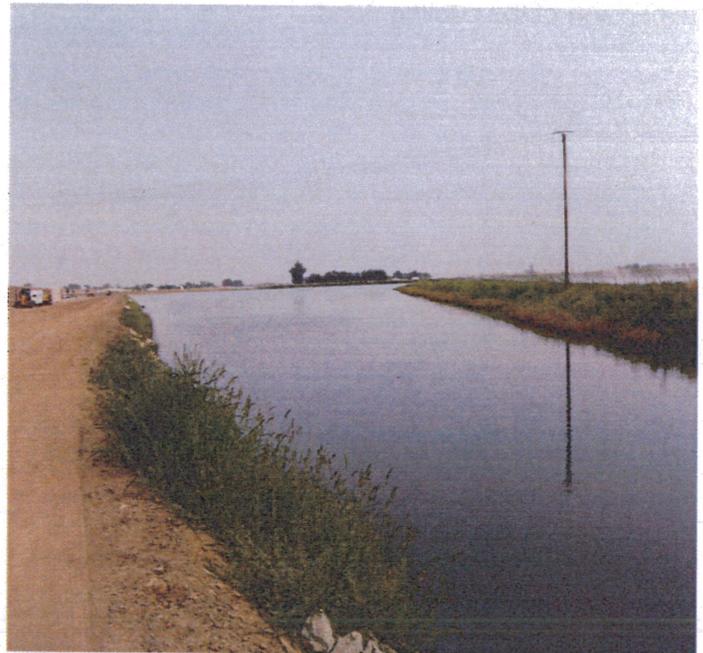
- The freeboard in the cooling pond (Figure 18) was observed at three feet based on a staff gauge. Minor vegetation was observed along the edges of the pond (Figures 16, 18, and 19). Mr. Raj indicated that a 60 acre expansion to the cooling pond was completed in June 2015, increasing the size of the pond to approximately 100 acres. No aerators were observed in the cooling pond.

Figure No. 16: Looking north the evaporative cooling pond.

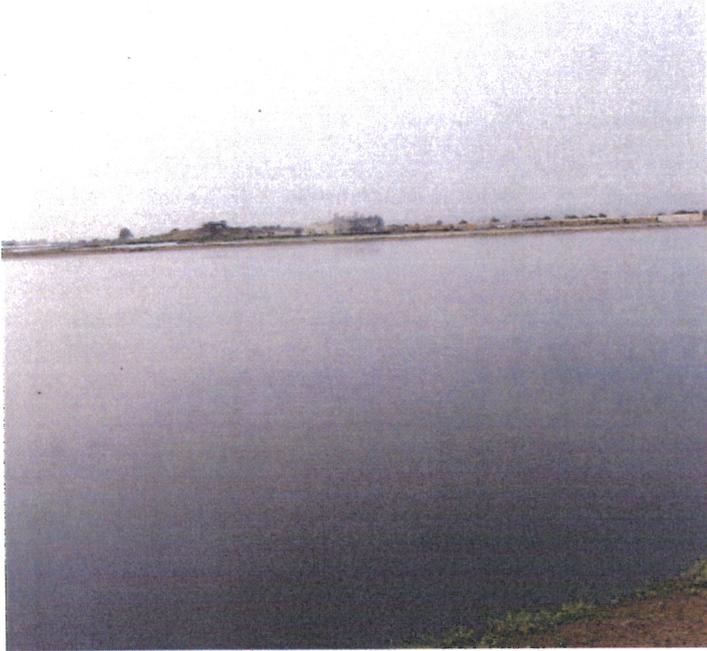
- Board staff observed that the cooling pond had been expanded and Land Application Area MS 20A, 20B, and 21 removed. The Discharger indicated that the pond had been expanded from 60 acres to approximately 100 acres in size. Because the cooling pond was expanded, and Land Application Areas (MS 20A, 20B, and 21) were removed as part of the expansion, the Discharger is in violation of the WDRs. Provision H.11 states: *“As described in the Standard Provisions, the Discharger shall report promptly to the Central Valley Water Board any material change or proposed change in the character, location or volume of the discharge.”* The volume and character of your waste stream has increased, meanwhile the area used for land application diminished, both situations are considered violations of the WDRs

Figure No. 17: Looking north at the evaporative cooling pond. This is where Land application area MS 20A and 20B were. This was an unapproved expansion of the cooling pond.

2. A plan for replacing Land Application Area MS 20A, 20B, and 21 that were removed as a result of the expansion of the cooling pond.
3. A proposed location and depth for additional groundwater monitoring wells for the entire cooling pond.

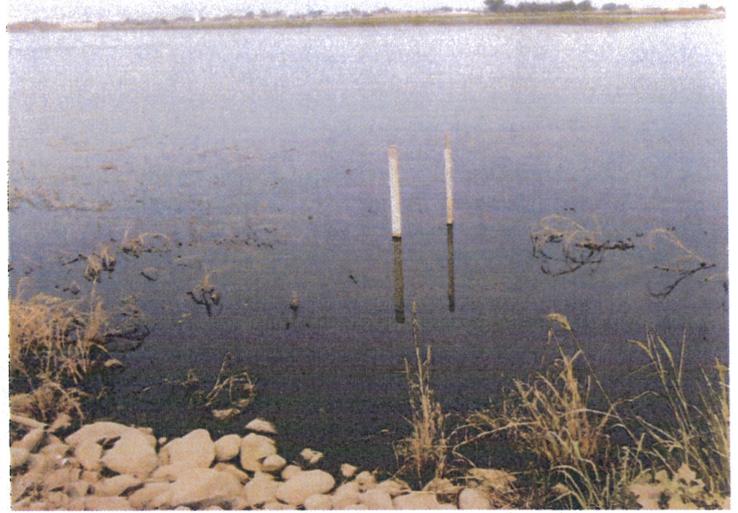
Figure No. 18: Looking northeast at the evaporative cooling pond. The freeboard in the pond was three feet based on the staff gauge.

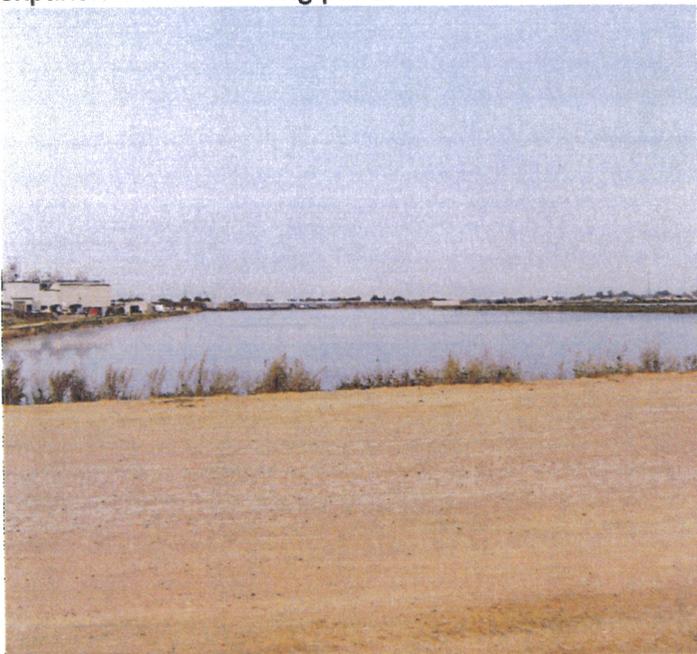
Figure No. 19: Looking west at the evaporative cooling pond. Some vegetation looking around the edges of the pond.

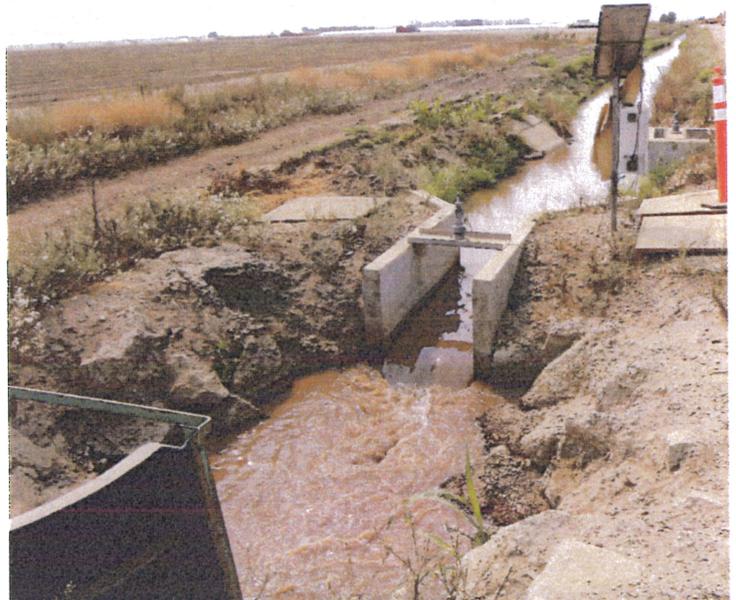
- Mr. Raj indicated there are ultrasonic flow meters at the three metering structures to the main ditch (Figure 20). The meters are calibrated on an annual basis.

Figure No. 20: Looking southeast at the main ditch used to convey wastewater from the settling pond and the evaporative cooling pond. The flow metering structure is for evaporative cooling pond and for combined flows.

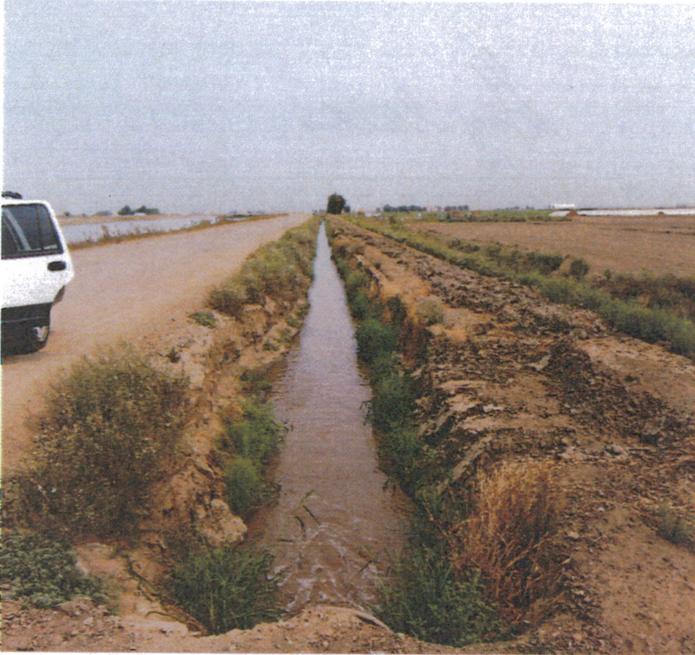
Figure No. 21: Looking north at the main ditch used to convey wastewater to the irrigation fields.

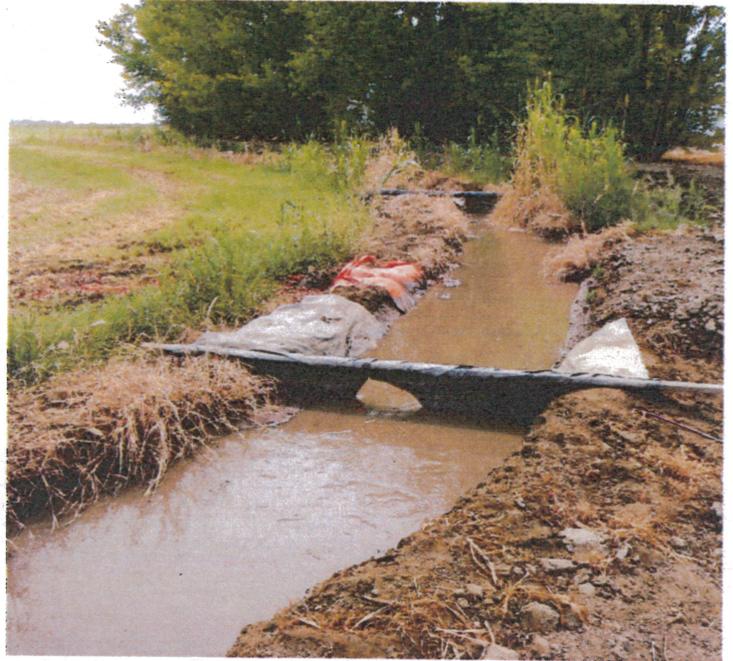
Figure No. 22: Irrigation ditches and check systems. The level in the ditches is controlled by the use of the plastic sheets and tarps. Some tomato solids noted in the irrigation field.

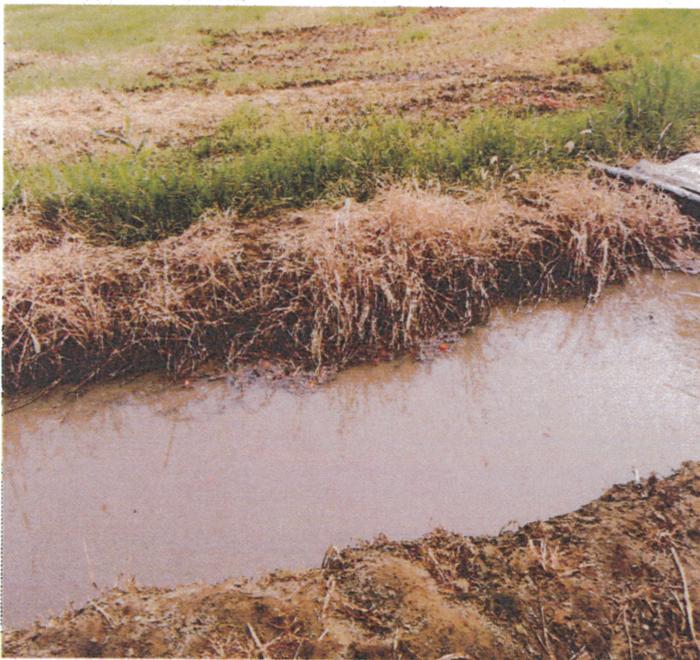
- Board staff observed facility staff removing tomato solids from the main ditch area and using a portable pump to the recirculate water in the ditch. Mr. Raj indicated that there had been a recent upset with the settling pond where the pumps had plugged up and some tomato solids were released to the main ditch. He also indicated that they were planning to install a rotary screen in the main ditch. In addition, Board staff observed some tomato solids along the edges of the irrigation ditches and the checks (Figures 23 and 24).

Figure No. 23: Some tomato solids noted in the irrigation ditches. This suggests that the screens are not functioning properly.

the Discharger, the tomato solids were discharged to the ditch due to a plugged settling pond pump. Disposal Specifications G.2 of the WDRs states: "...sludge, solid waste, or residual solids shall be removed from screens, sumps, and ponds as needed to ensure optimal operation and adequate storage capacity." Failure to maintain the equipment necessary to prevent solids from entering the ditches is a violation of the WDRs.

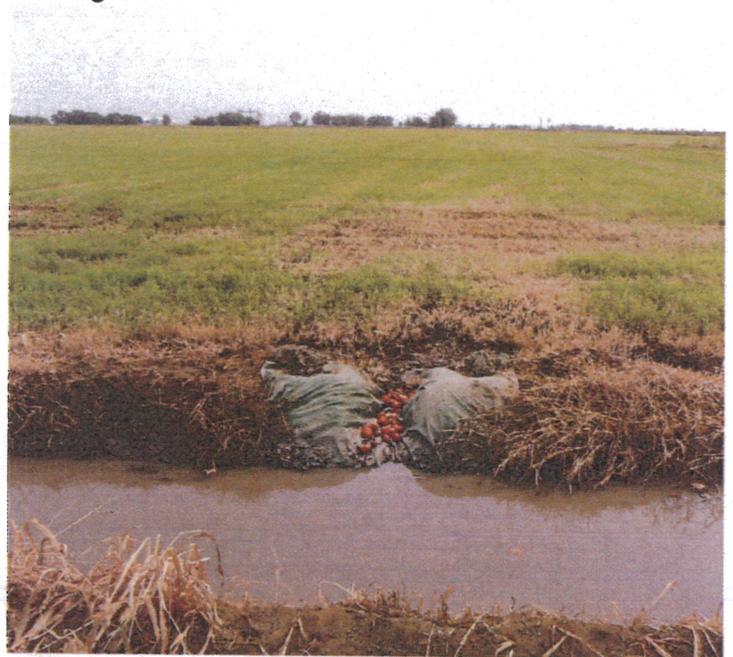
Figure No. 24: Again, Tomato solids noted in one of the checks. The field is planted in sudan grass.
