**Map Grid Index**

### Groundwater Cr(VI) Concentrations in Monitoring Wells:

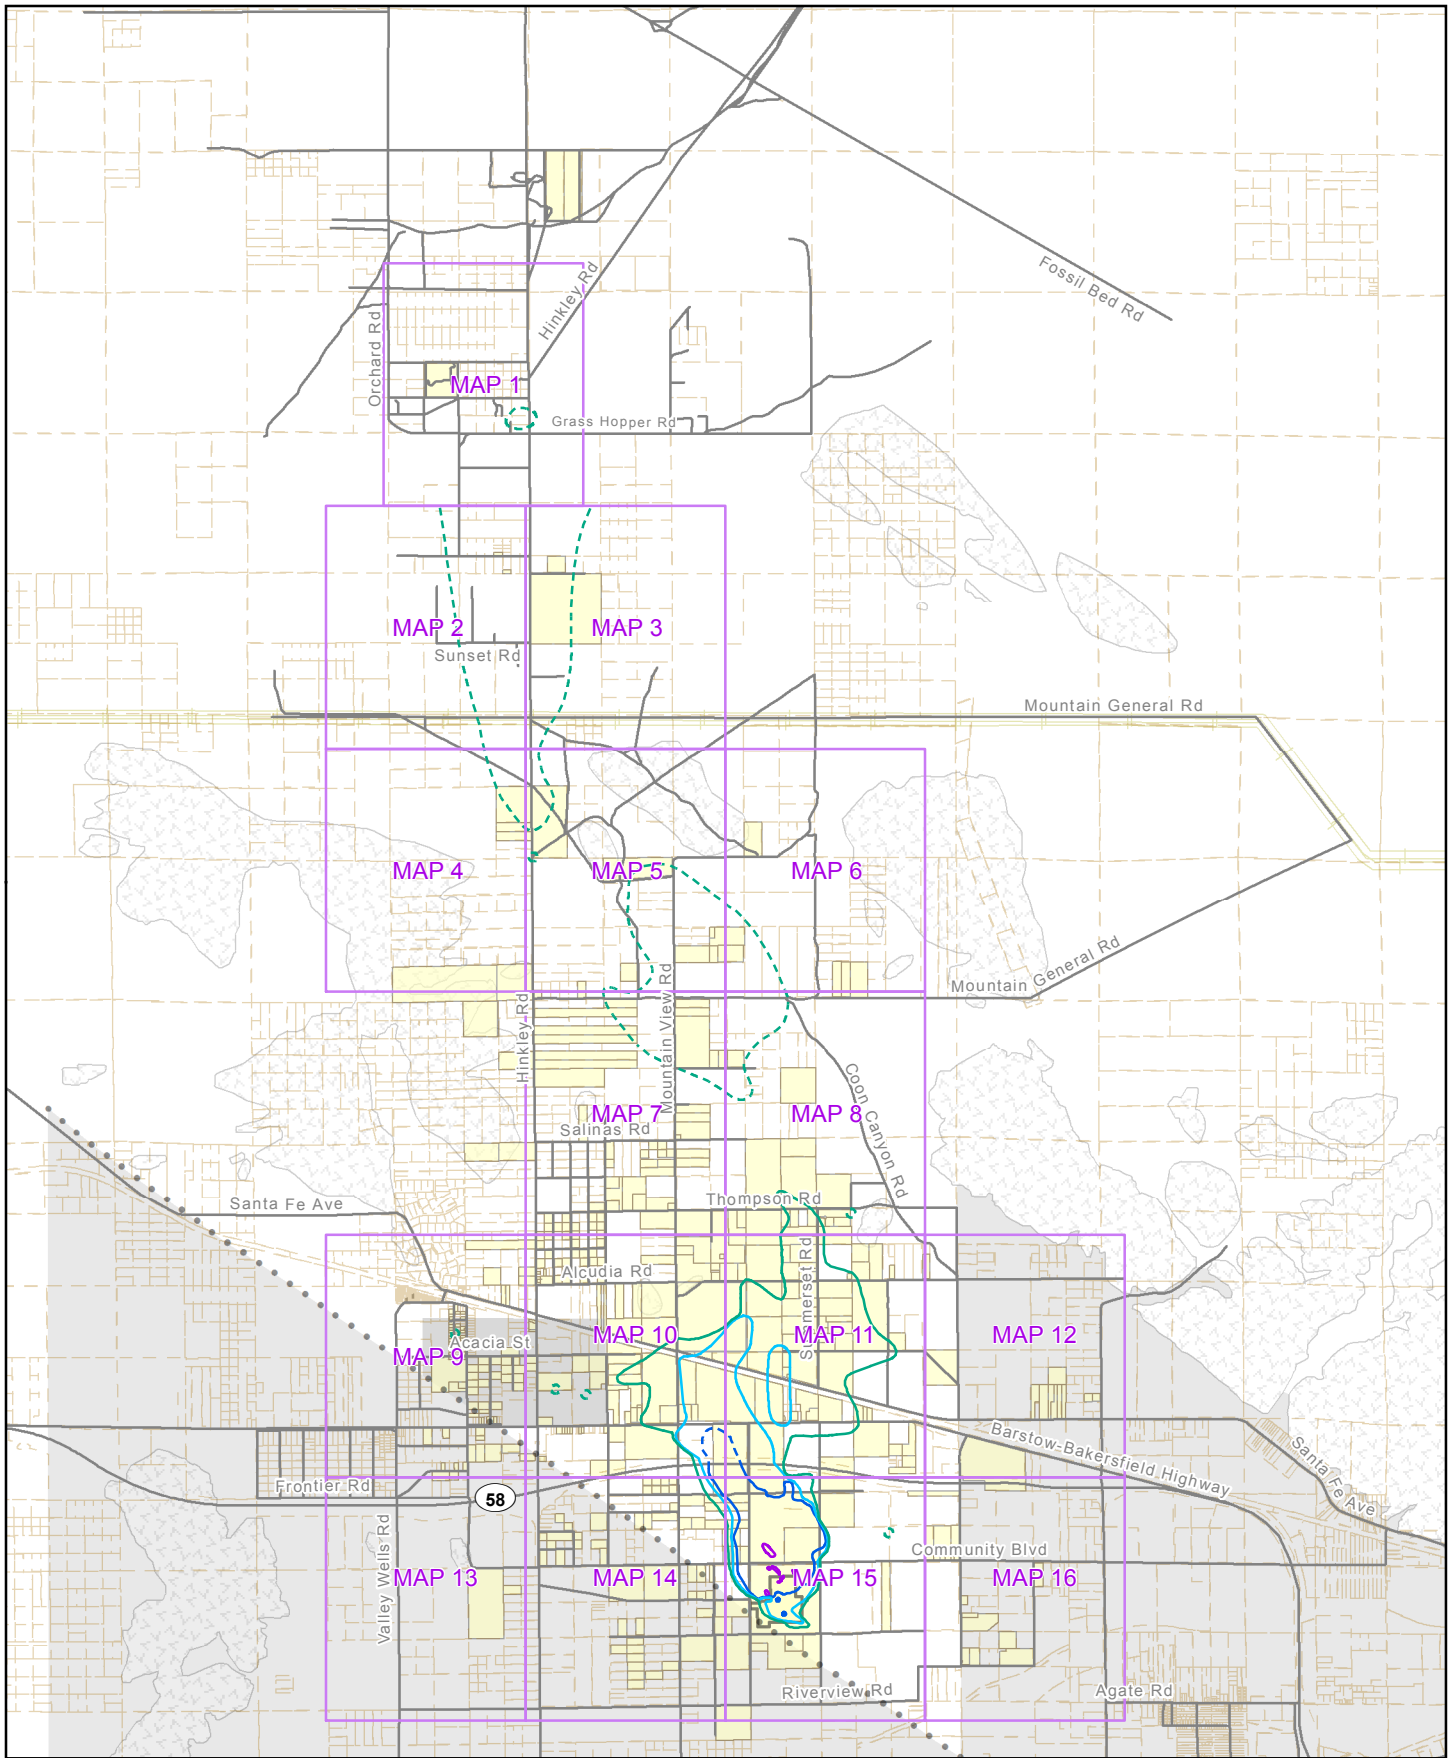
1.5/1.7 Cr(VI)/Cr(T) concentrations in µg/L; maximum of primary and duplicate samples during Second Quarter 2017 sampling.  
(0.73/1.2) Data in parentheses are from previous reporting period.  
See Table E-1 for sample dates.

- Chromium results are shown for Site-wide Groundwater Monitoring Program and domestic wells sampled in the Second Quarter (April through June) 2017 monitoring period. For wells sampled multiple times during the reporting period, the most recent results are shown.

- The concentration contours are based on Second Quarter 2017 chromium results for the groundwater monitoring and extraction wells that are completed in the shallow zone and deep zone of the Upper Aquifer as noted on Figures 5-1 and 5-2. Results for domestic wells (brown-colored labels) were not used for chromium plume contouring, except for those in the northern disputed plume areas, pursuant to the Lahontan Regional Water Quality Control Board's Cleanup and Abatement Order dated November 4, 2015 (Water Board 2015).
