REVISED ORDER TO SUBMIT A WORK PLAN AND CONDUCT A SOIL AND GROUNDWATER INVESTIGATION IN THE VICINITY OF LAUREL AVENUE AND LOWELL STREET, CITY OF RIALTO, SAN BERNARDINO COUNTY, CALIFORNIA

**REVISED FOCUSED SUMMARY REPORT OF
INVESTIGATION OF WCLC USE AREAS
160-ACRE SITE
RIALTO, CALIFORNIA**

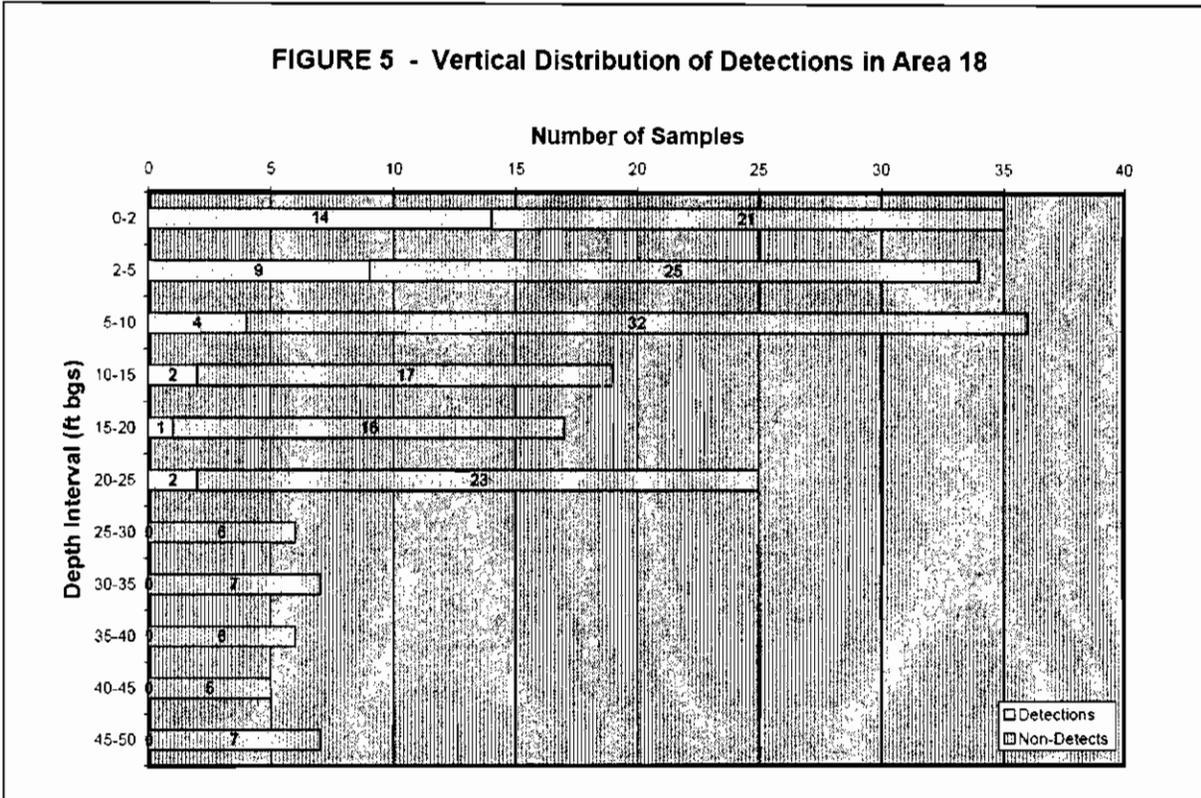
Perchlorate was detected in 32 of the 197 soil samples collected in Area 18. Figure 5, which follows, provides a graphical summary of the number of samples collected and the number of detections and non-detections at the various depth intervals sampled in Area 18. The number of samples containing detectable perchlorate decreased rapidly with depth.

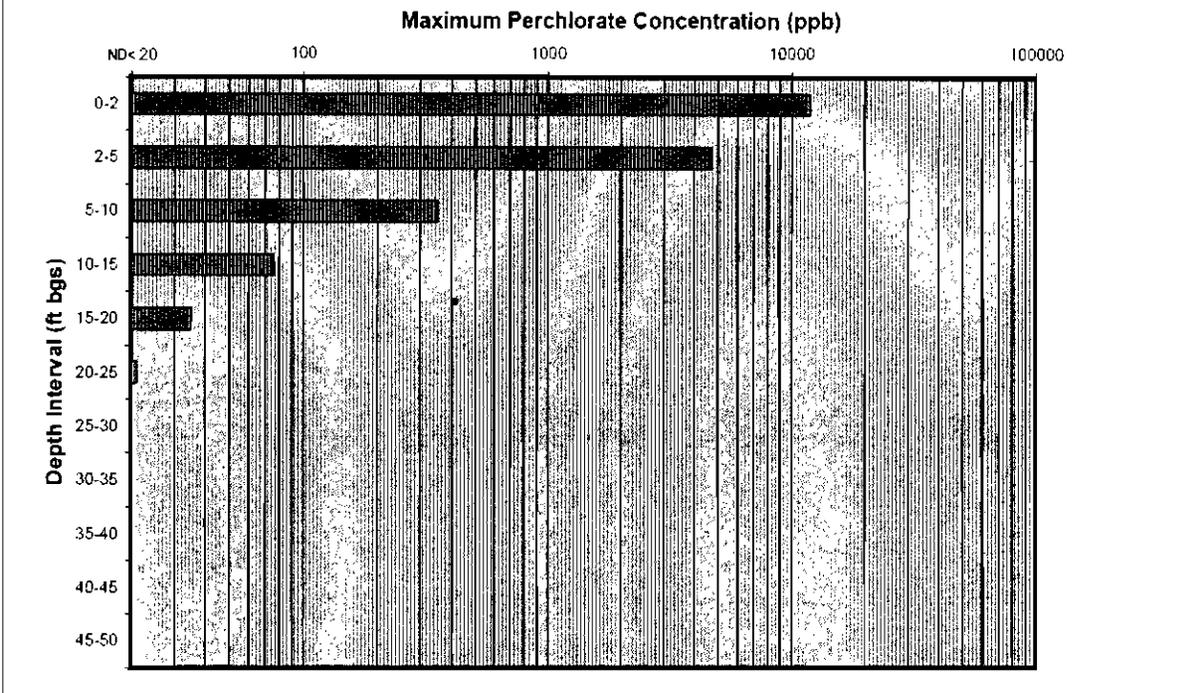
FIGURE 6 - Soil Profile of Maximum Perchlorate Concentrations in Area 18

Perchlorate detections in Area 18 ranged from 12,000 ppb to 20 ppb with the highest detections in the shallowest samples (2 ft) and rapidly decreasing concentrations with depth. Deeper soil borings, which extended to 50 ft below the surface, showed no detectable concentrations of perchlorate at depths greater than 25 ft at any location. Figure 6 (see page 9), which follows, is a representation of the data presented in Table 5, showing the profile of maximum concentrations of perchlorate with depth. The data shows that there are fewer detections with depth (Figure 5, above), and that perchlorate concentrations rapidly decrease with depth (Figure 6, page 9).

Based on all the data collected from Area 18 and presented here, the presence of perchlorate in the soil has been bounded laterally and vertically (see Figure 4, page 15).

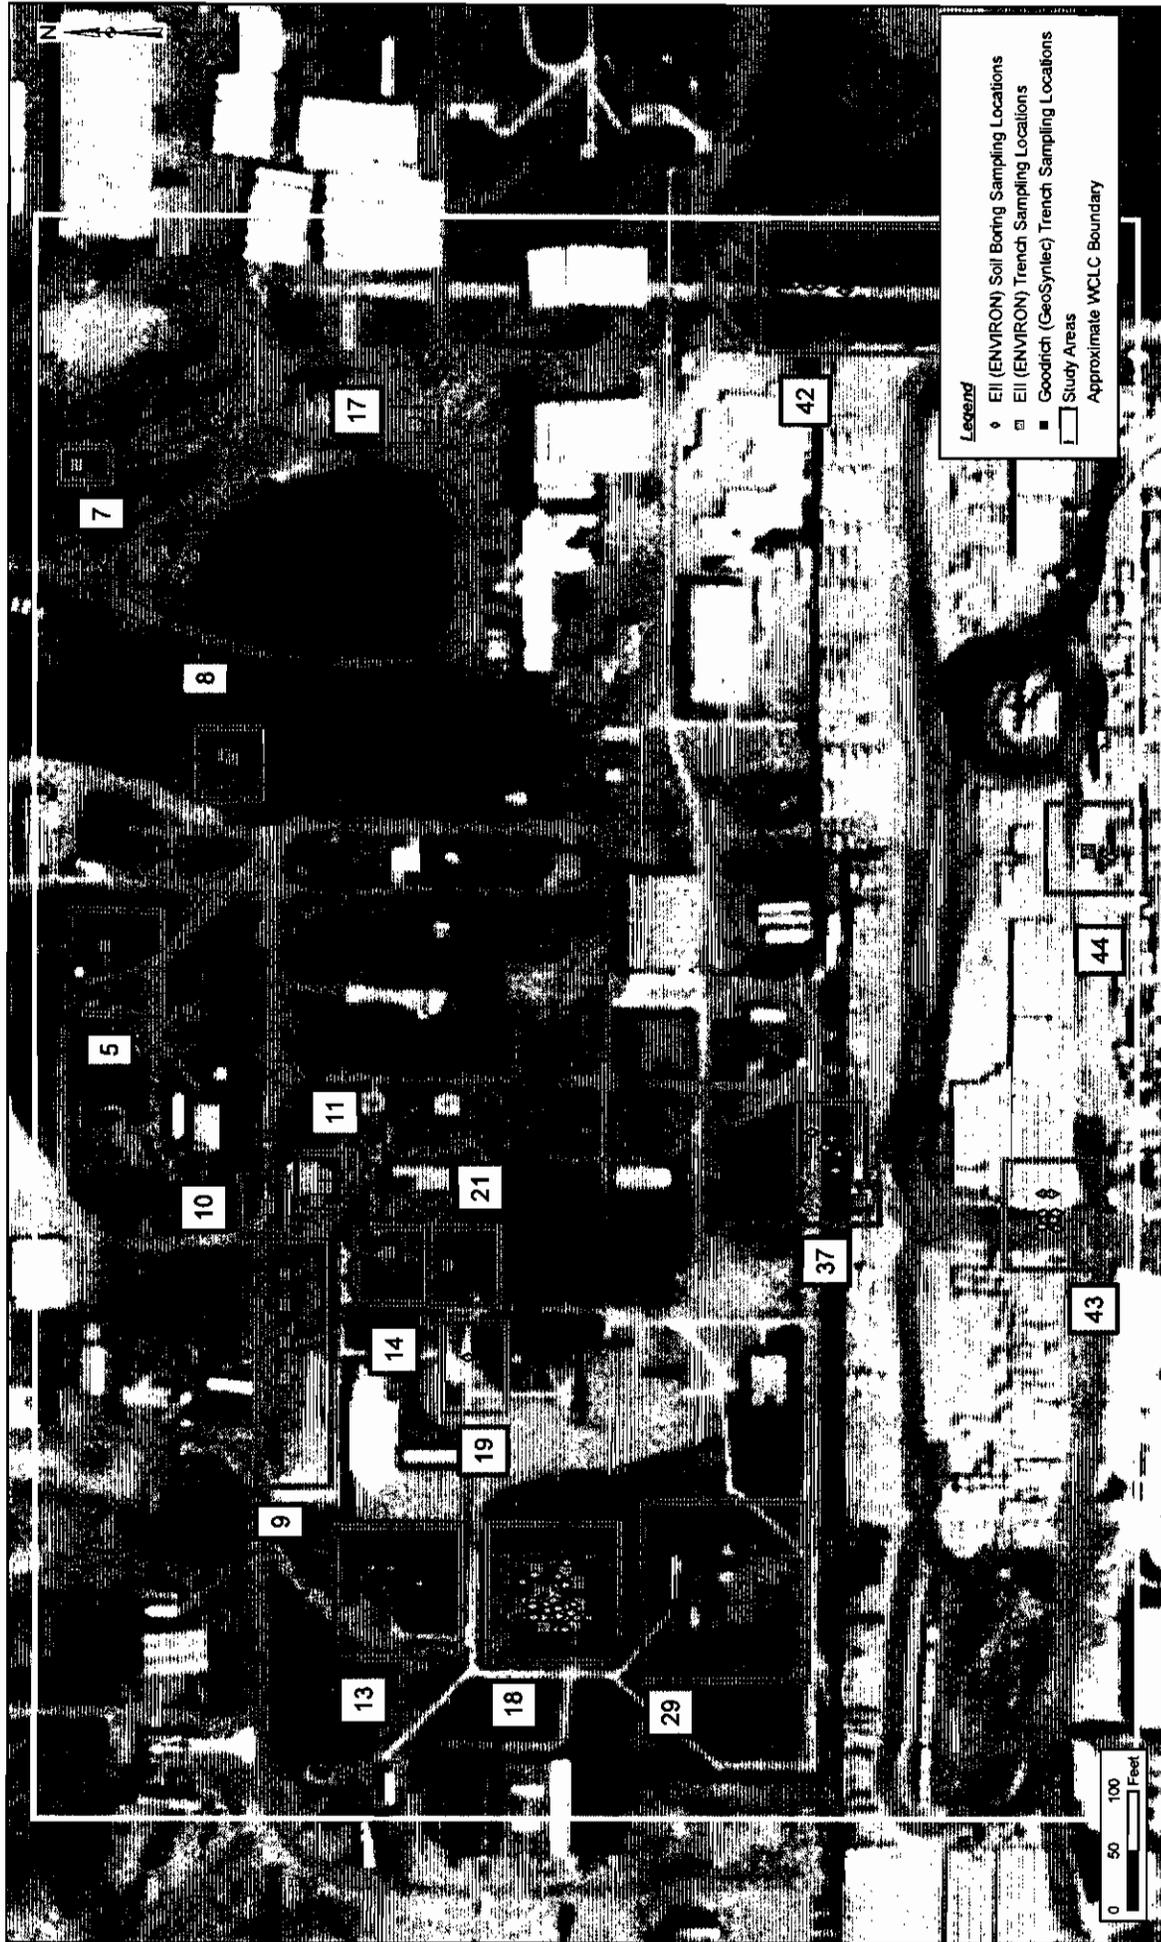
PERCHLORATE SOIL SAMPLING LOCATIONS IN FORMER WCLC USE AREAS

160-ACRE SITE (2003 AERIAL)

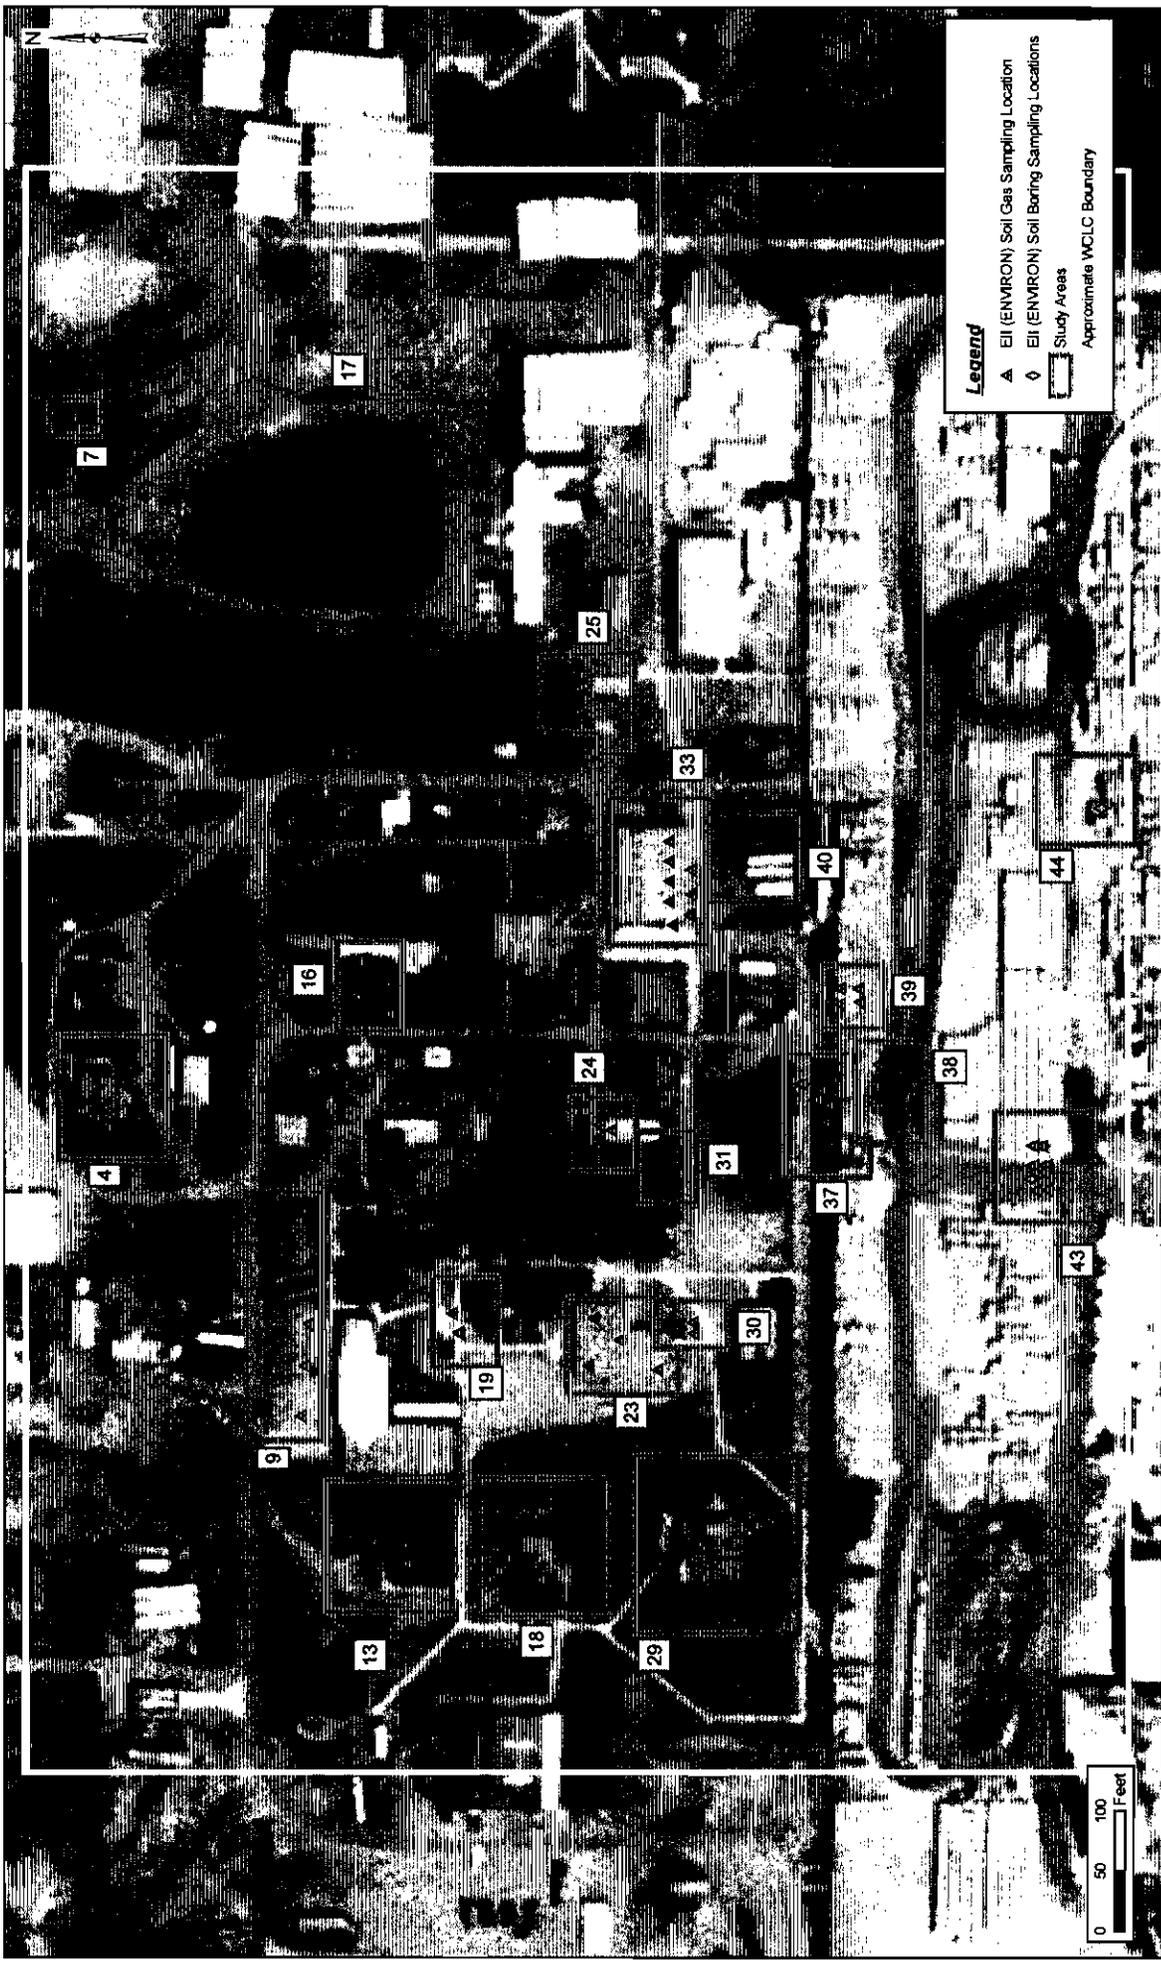
Legend

- A EII (ENVIRON) Soil Gas Sampling Location
- ∅ EII (ENVIRON) Soil Boring Sampling Locations
- Study Areas
- Approximate WCLC Boundary

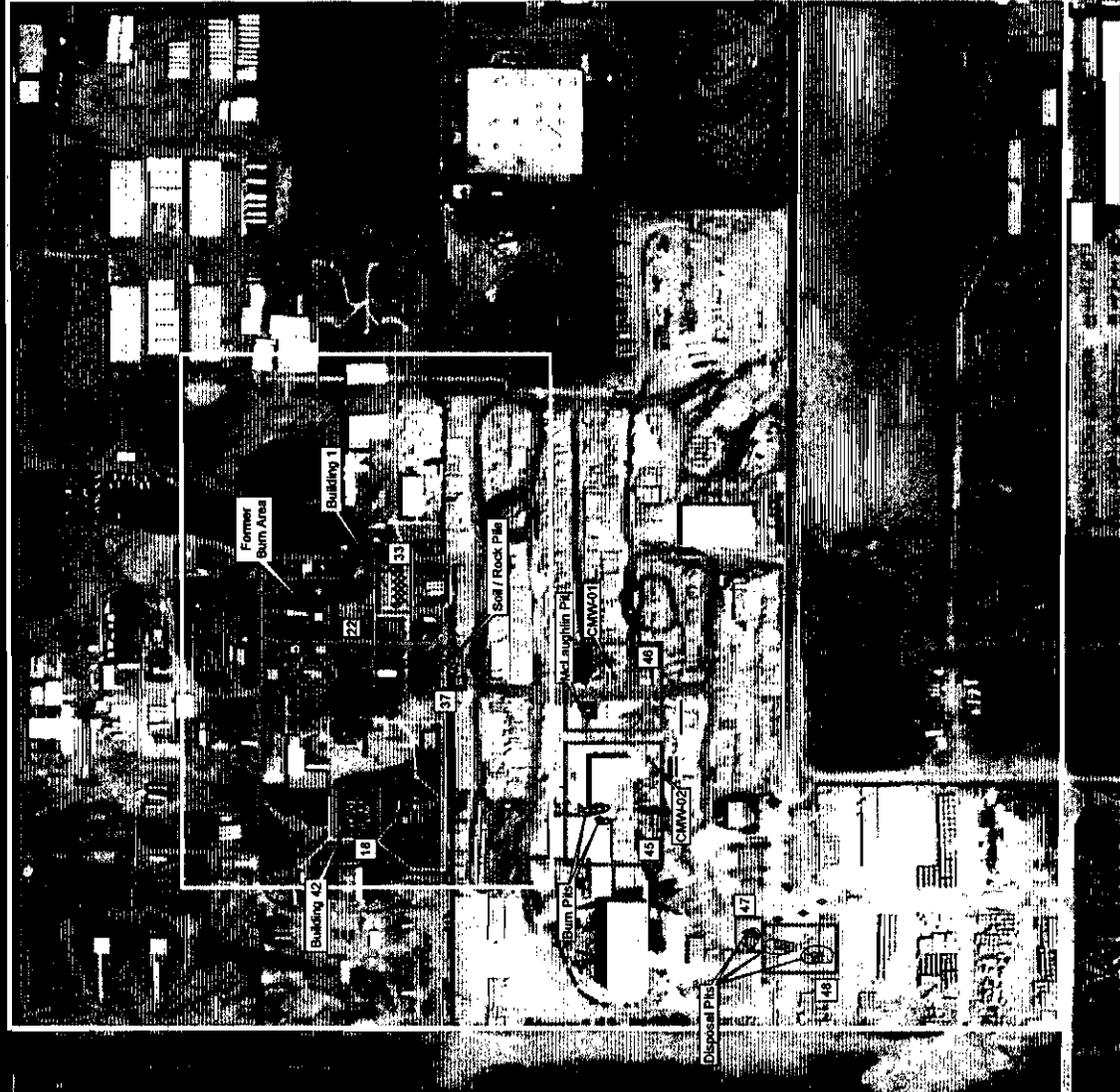
AREAS WITH PERCHLORATE DETECTIONS IN SOIL >100 PPB
 160-ACRE SITE (2003 AERIAL)
 Rialto, CA

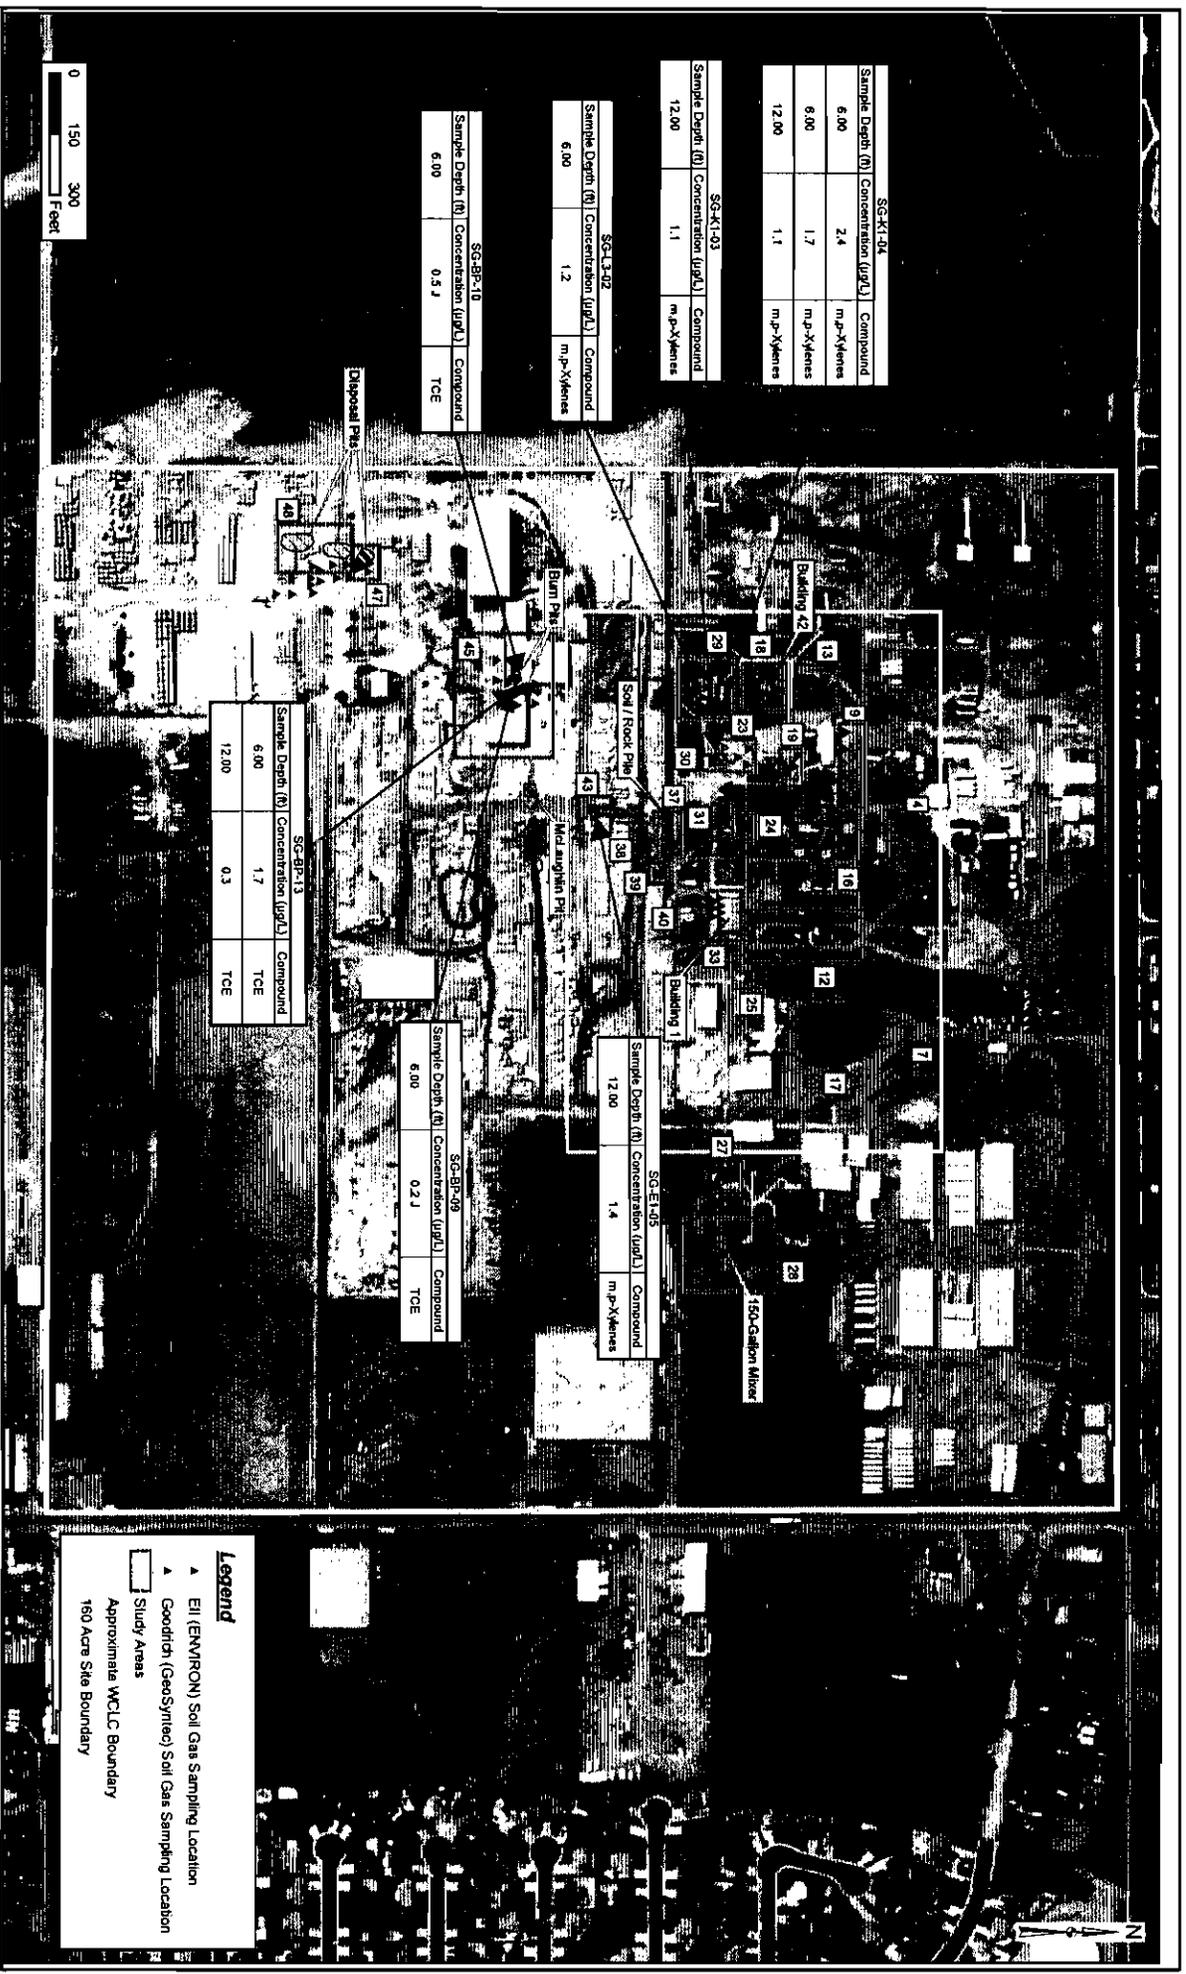
Sample Depth (ft)	Concentration (µg/L)	Compound
6.00	2.4	m,p-Xylenes
6.00	1.7	m,p-Xylenes
12.00	1.1	m,p-Xylenes

Sample Depth (ft)	Concentration (µg/L)	Compound
12.00	1.1	m,p-Xylenes
