**RE: NOTICE OF VIOLATION NO. R9-2010-0036 &
REQUIRED TECHNICAL REPORT, STATE HIGHWAY 52 and 67
CONNECTION CONSTRUCTION SITE**

NOTICE OF VIOLATION
NO. R9-2010-0036
EA No.
11-2T0104 and 11-2T004

Subject Site: State Highway 52 and 67 Connection

FACILITY INSPECTION REPORT

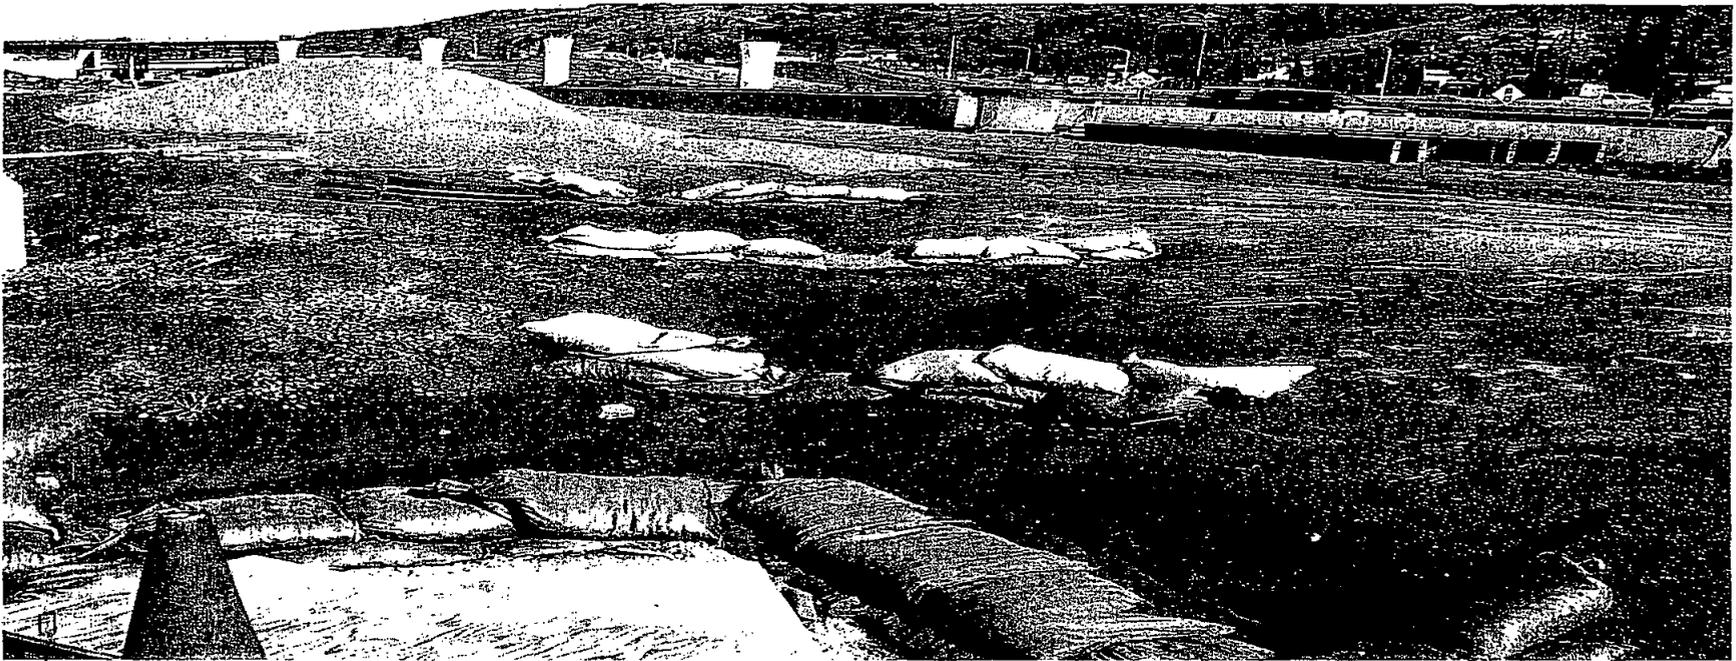
Image IMG P0038 CALTRANS 11-2T004 and 11-2T0104
Taken by Dat Quach, RWQCB-SD, between 0930 and 1200 on 01-20-2010
Site: CALTRANS HW 52 and 67
Location: San Diego County
Image shows: construction site lacking erosion BMPs, sediment BMPs is not adequate, signs of erosion occurred

6. CALTRANS failed to provide an effective combination of erosion and sediment control BMPs in many areas in their construction site. To prevent further sediment discharges, CALTRANS should installed erosion BMPs and strengthened sediments BMPs in these areas immediately.

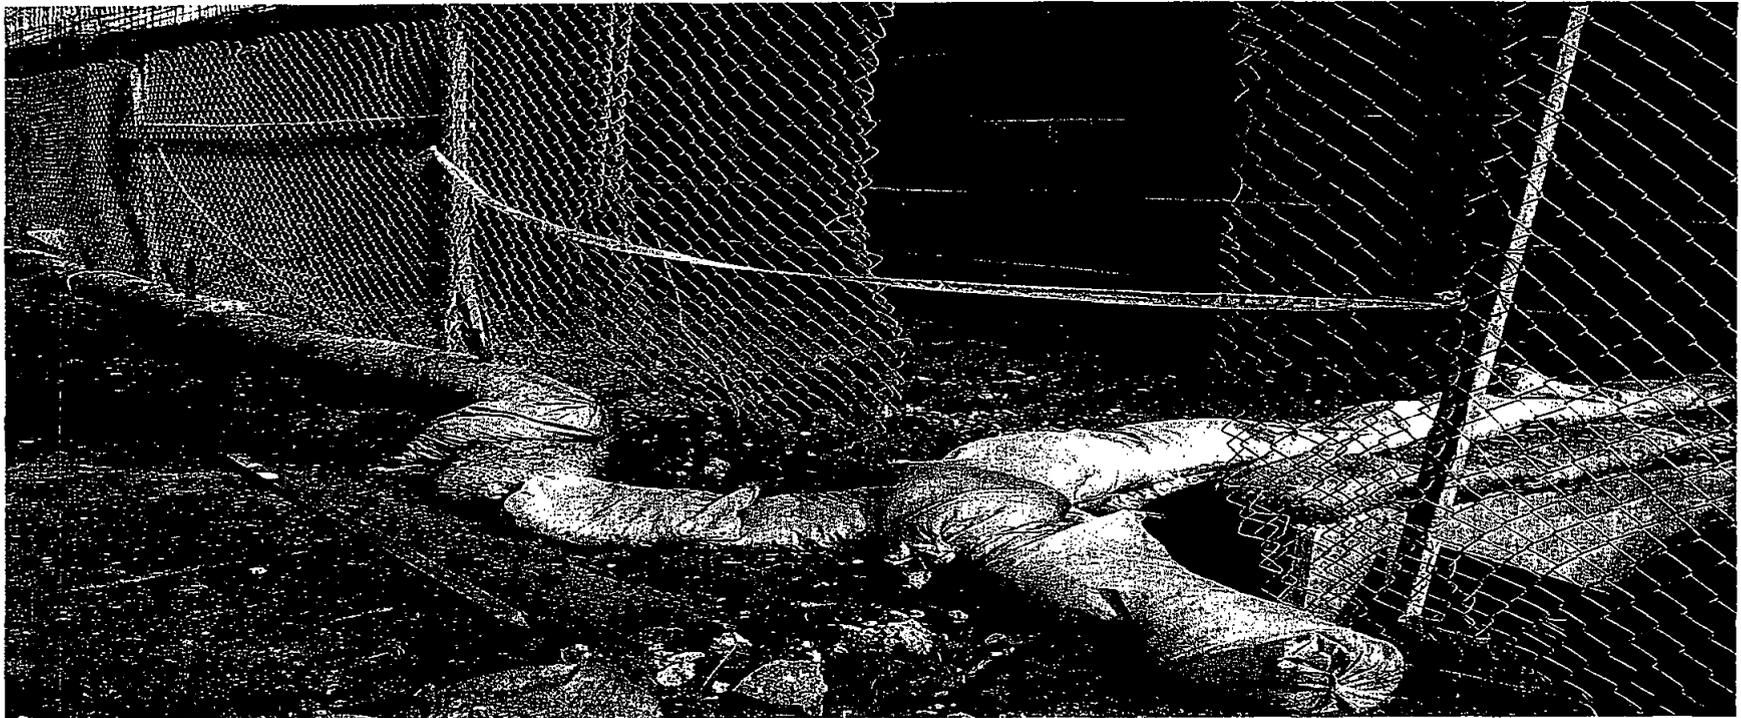
Image IMG P0039 CALTRANS 11-2T004 and 11-2T0104
Taken by Dat Quach, RWQCB-SD, between 0930 and 1200 on
01-20-2010
Site: CALTRANS HW 52 and 67
Location: San Diego County
Image shows: construction site lacking erosion BMPs, sediment
BMPs is not adequate, signs of erosion occurred.

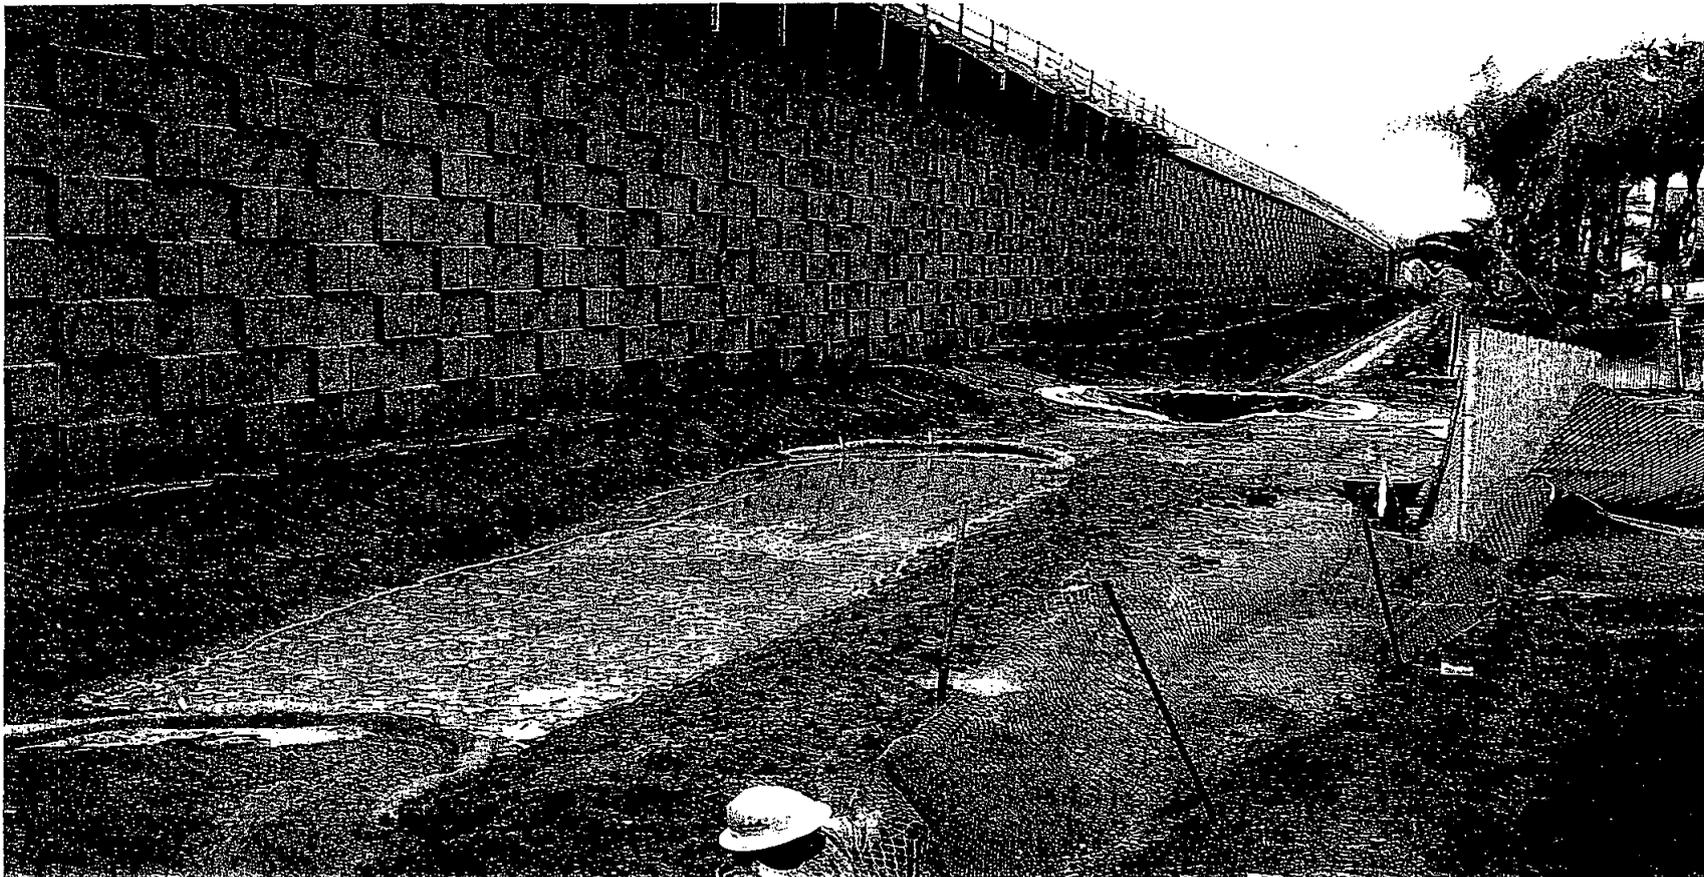
Image IMG P0044 CALTRANS 11-2T004 and 11-2T0104
Taken by Dat Quach, RWQCB-SD, between 0930 and 1200 on 01-20-2010

3. Sediment was discharged to street either by failing/inadequate sediment control BMPs; (See Images IMG P0053, and P0057)
4. Evidence that the sediment was discharged to MS4 system. Many storm drain inlets are right in the middle of the construction sites (north and south of the 52 construction site) and these storm drain inlets had some forms of sediment control BMB such as sand bag; however, there were evidence that sediment passed the BMPs and got into the MS4 system. (See Image IMG P0044, P0050, and P0051)

Image shows: construction site lacking erosion BMPs, sediment BMPs is not adequate, signs of discharging sediment to MS4

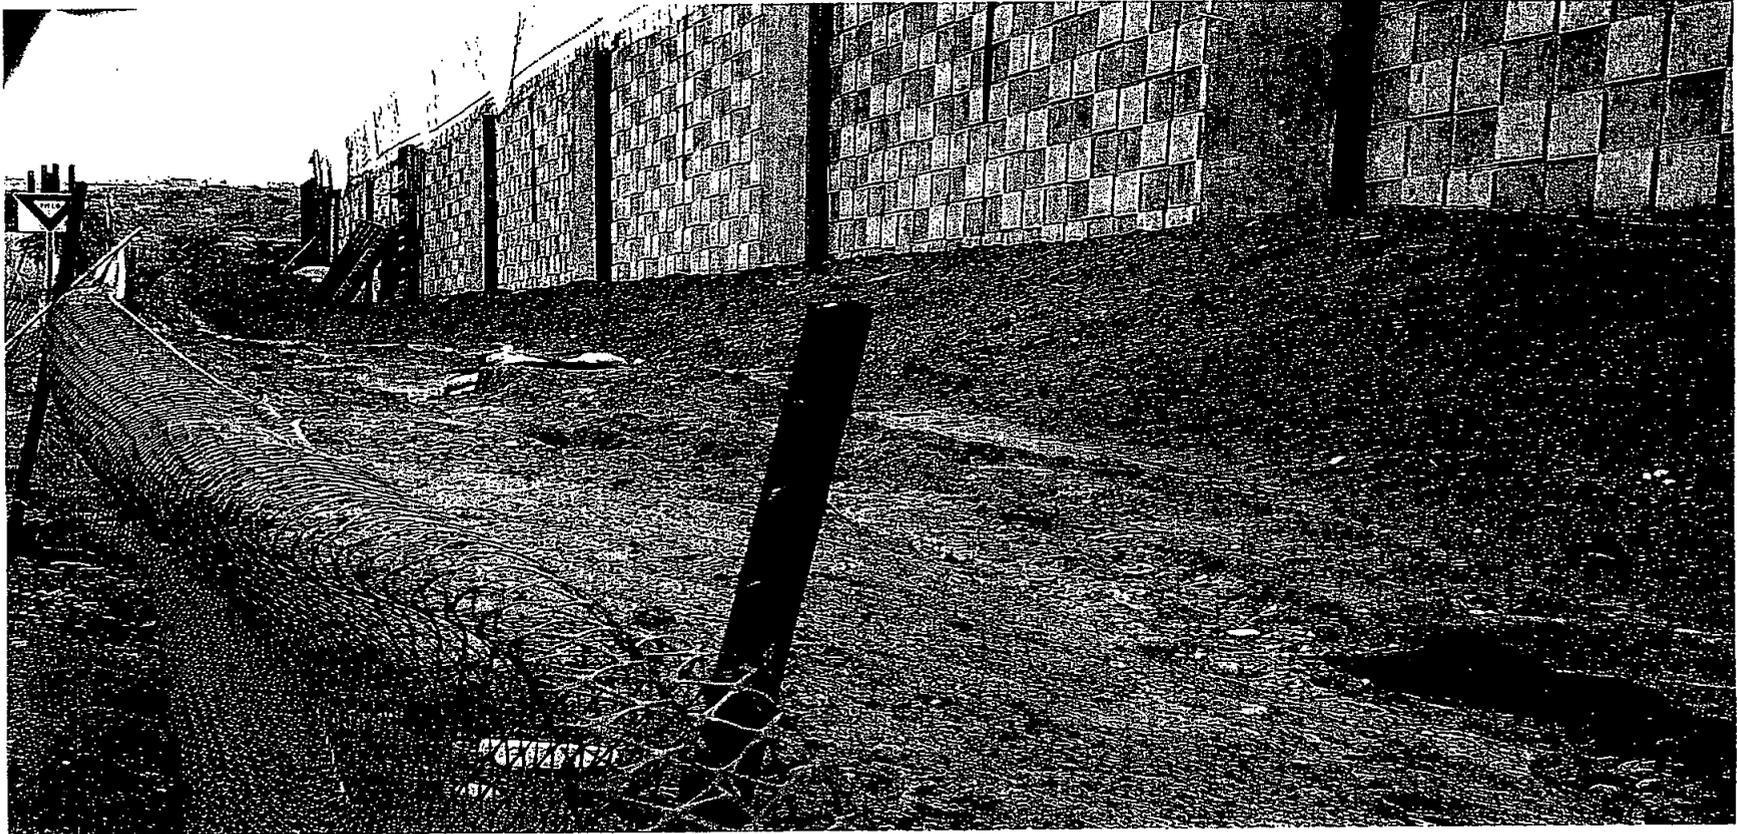
Image IMG P0046 CALTRANS 11-2T004 and 11-2T0104
Taken by Dat Quach, RWQCB-SD, between 0930 and 1200 on
01-20-2010
Site: CALTRANS HW 52 and 67
Location: San Diego County
Image shows: construction site lacking erosion and sediment
BMPs

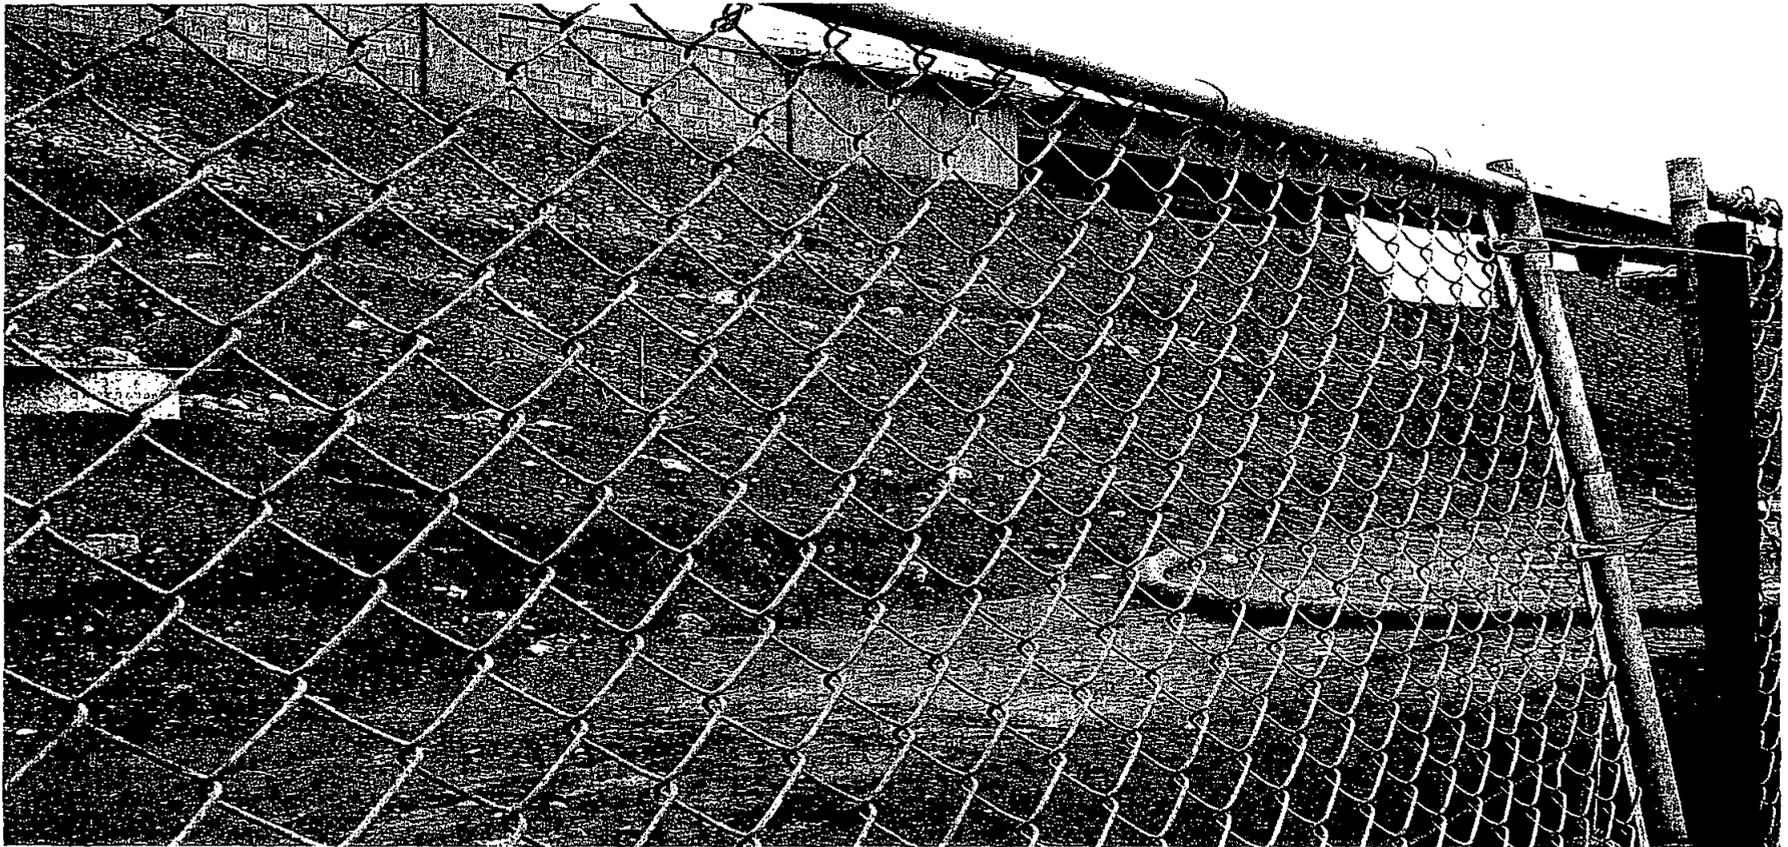
5. Many slopes appear not having any erosion BMPs. CALTRANS indicated that all slopes have been sprayed with some kinds of erosion protection BMPs before the rain, however, the rain was too heavy and washed away the erosion protection. (see Image IMG P0048)

Image IMG P0048 CALTRANS 11-2T004 and 11-2T0104
Taken by Dat Quach, RWQCB-SD, between 0930 and 1200 on 01-20-2010
Site: CALTRANS HW 52 and 67
Location: San Diego County
Image shows: slope lacking erosion BMPs and sediment BMPs. CALTRANS stated that this slope was sprayed with erosion BMP prior to the rain

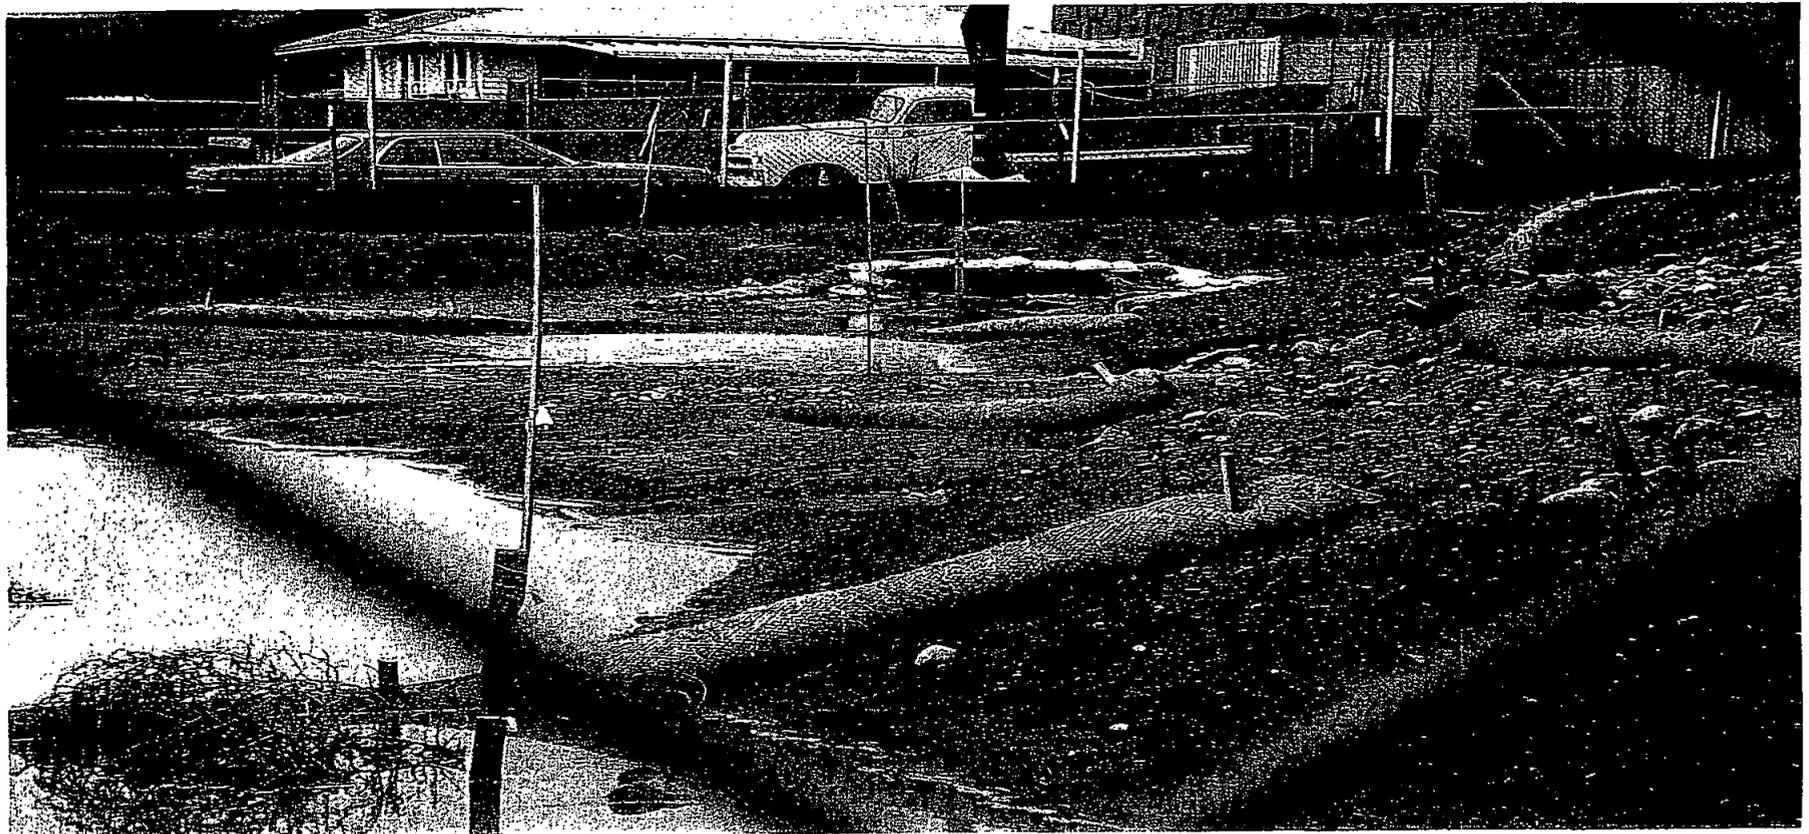
Image IMG P0050 CALTRANS 11-2T004 and 11-2T0104
Taken by Dat Quach, RWQCB-SD, between 0930 and 1200 on 01-20-2010
Site: CALTRANS HW 52 and 67
Location: San Diego County
Image shows: construction site lacking erosion BMPs, sediment BMPs is not adequate, signs of discharging sediment to storm drain inlet

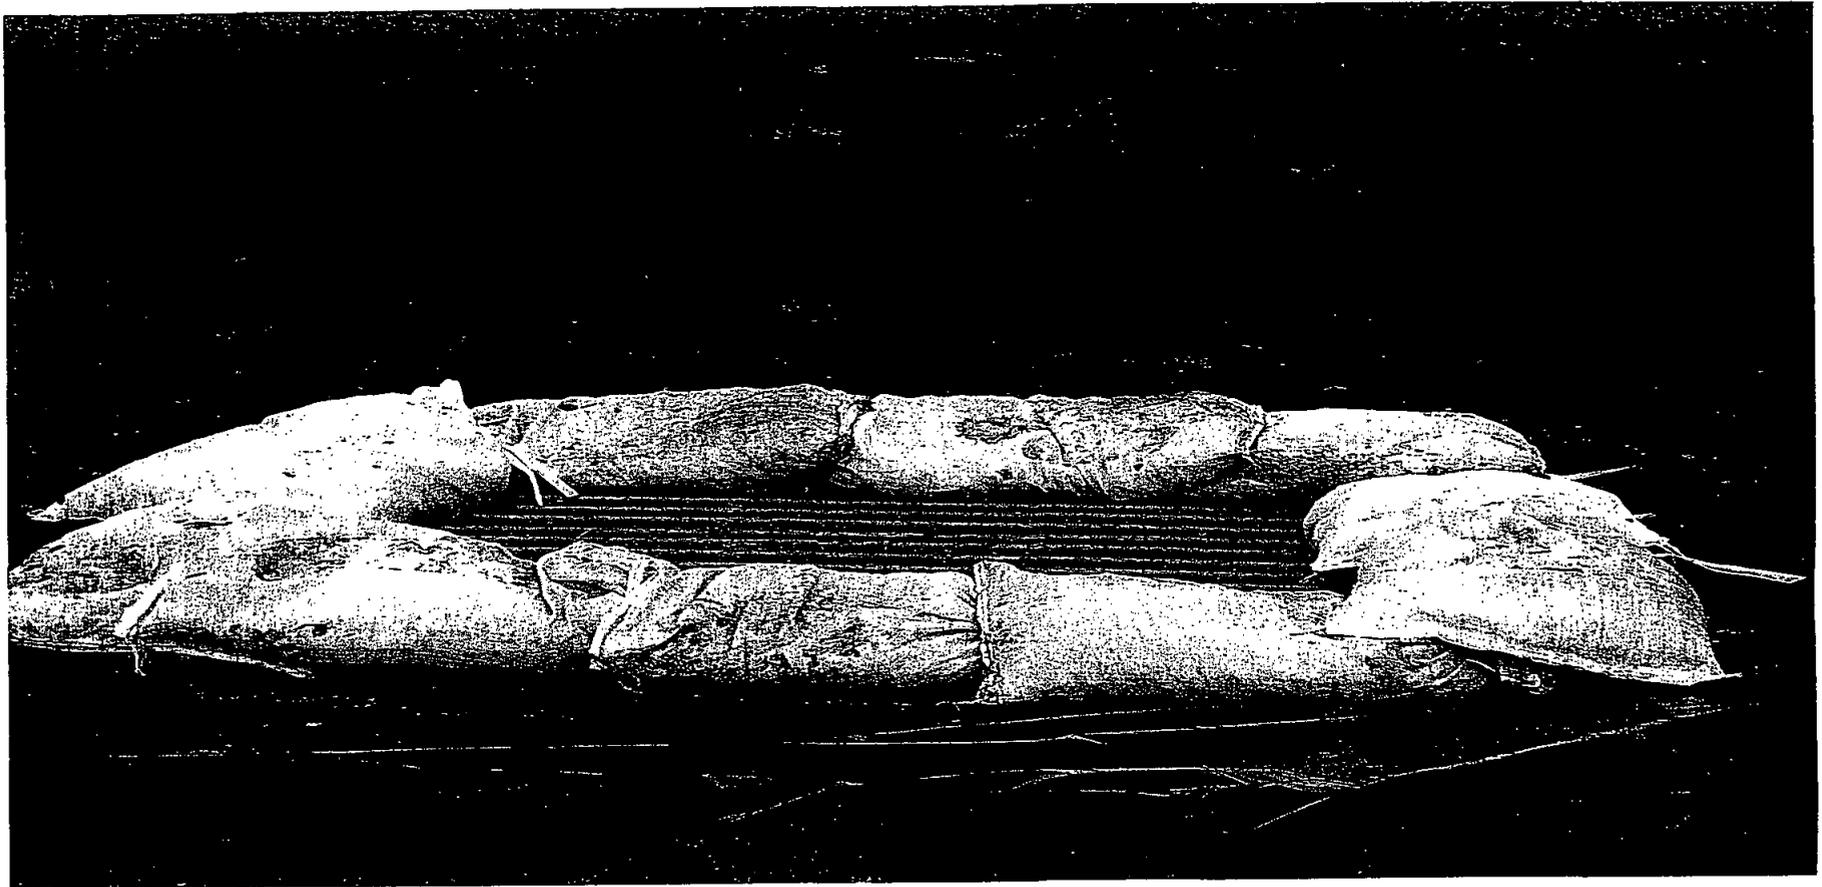
Image IMG P0051 CALTRANS 11-2T004 and 11-2T0104
Taken by Dat Quach, RWQCB-SD, between 0930 and 1200 on 01-20-2010
Site: CALTRANS HW 52 and 67
Location: San Diego County
Image shows: even though this site has been cleaned up, the sign of sediment at the iron grills indicated that sediment was discharged to the MS4 storm drain inlet during the rain

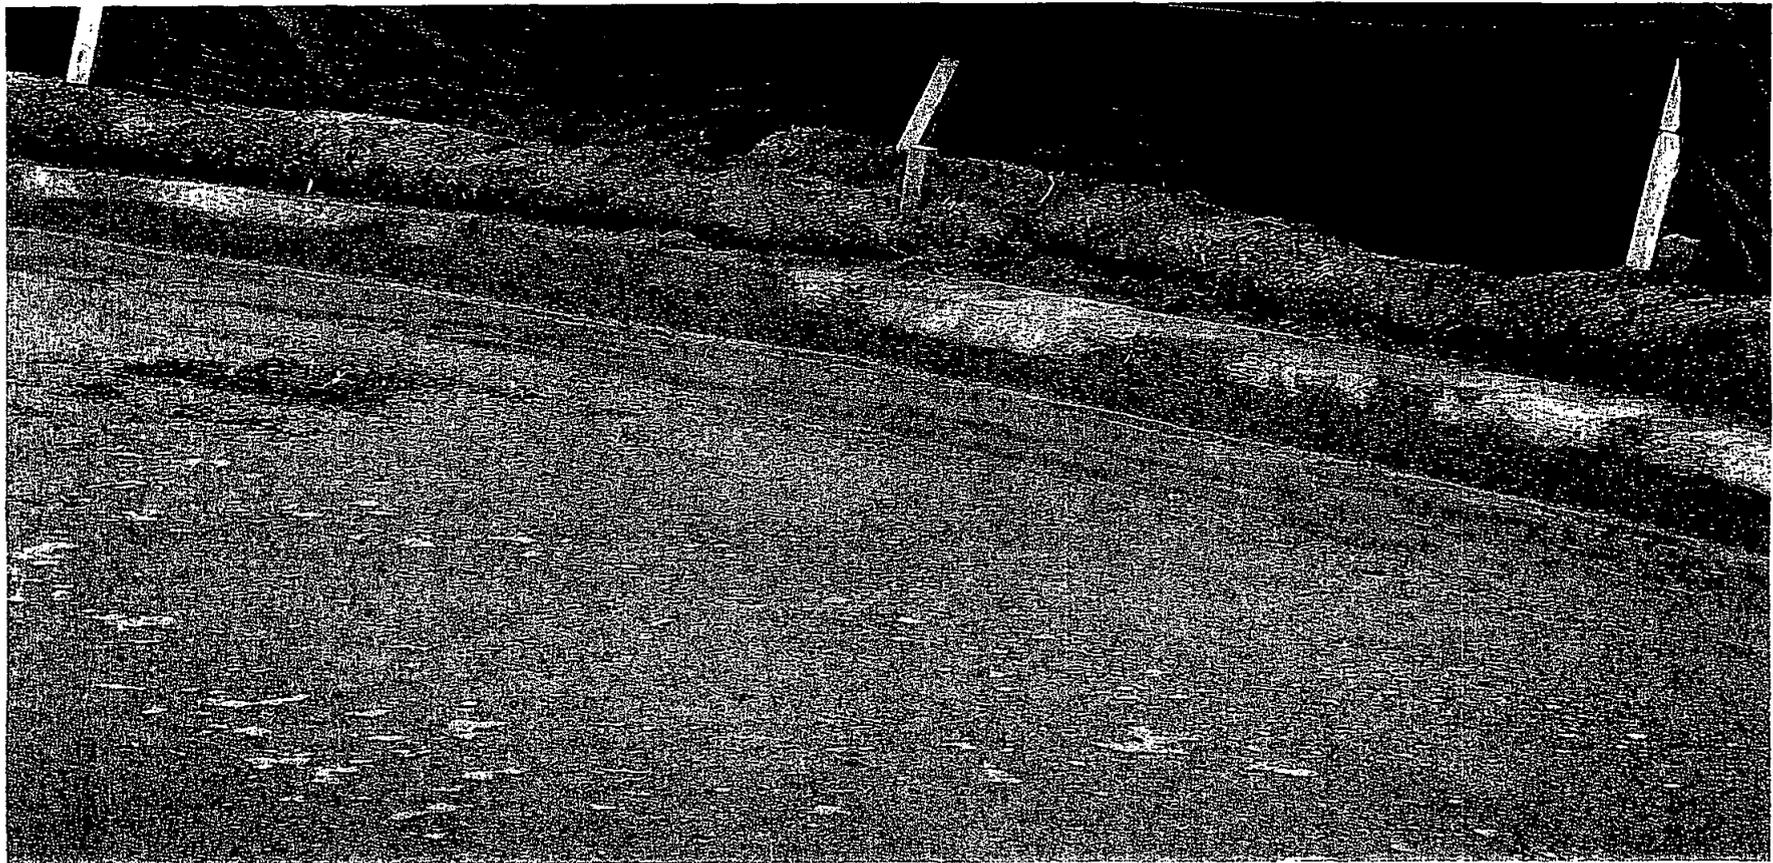
Image IMG P0057 CALTRANS 11-2T004 and 11-2T0104
Taken by Dat Quach, RWQCB-SD, between 0930 and 1200 on 01-20-2010

Image shows: Sediment leaving the construction site and discharged to the street
