### **Subject: Notice of Violation No. R9-2014-0078**

**NOTICE OF VIOLATION  
No. R9-2014-0078**

Glenwood Palmilla Commercial  
Development Project

**Violations of Order No. 2009-0009-DWQ,  
Statewide Construction General Storm  
Water Permit and California Water Code  
Section 13376**

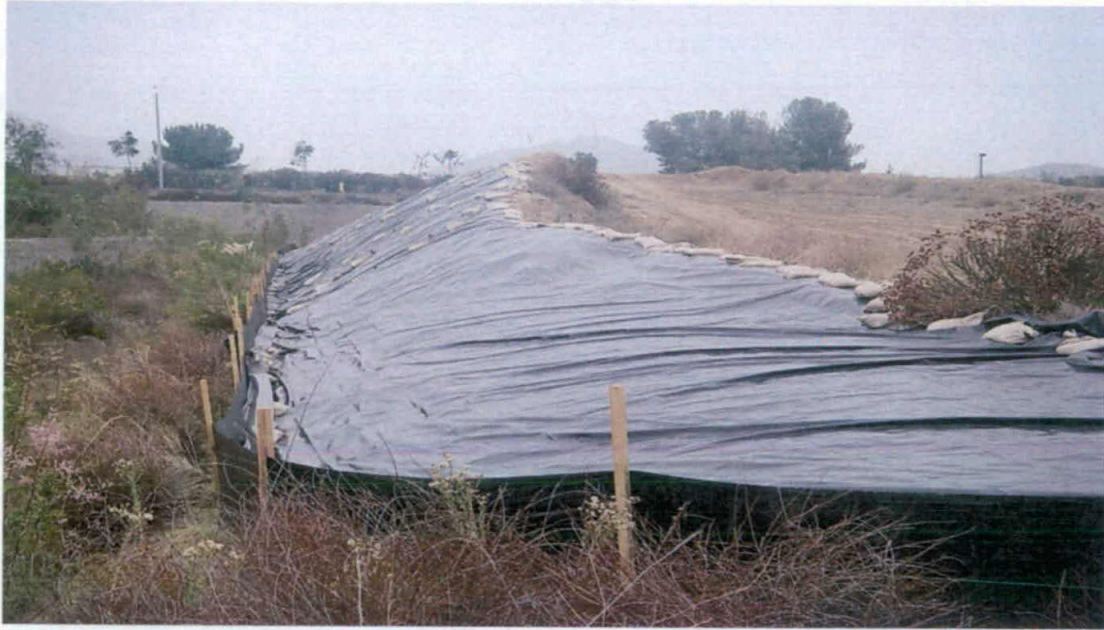
**Photo 1:** San Diego Water Board inspection on 10/24/13 noted a large stockpile in the northern corner of the lower portion of the site, adjacent to the mitigation area. Erosion control was in place. The City of Murrieta requested that the stockpile be removed.

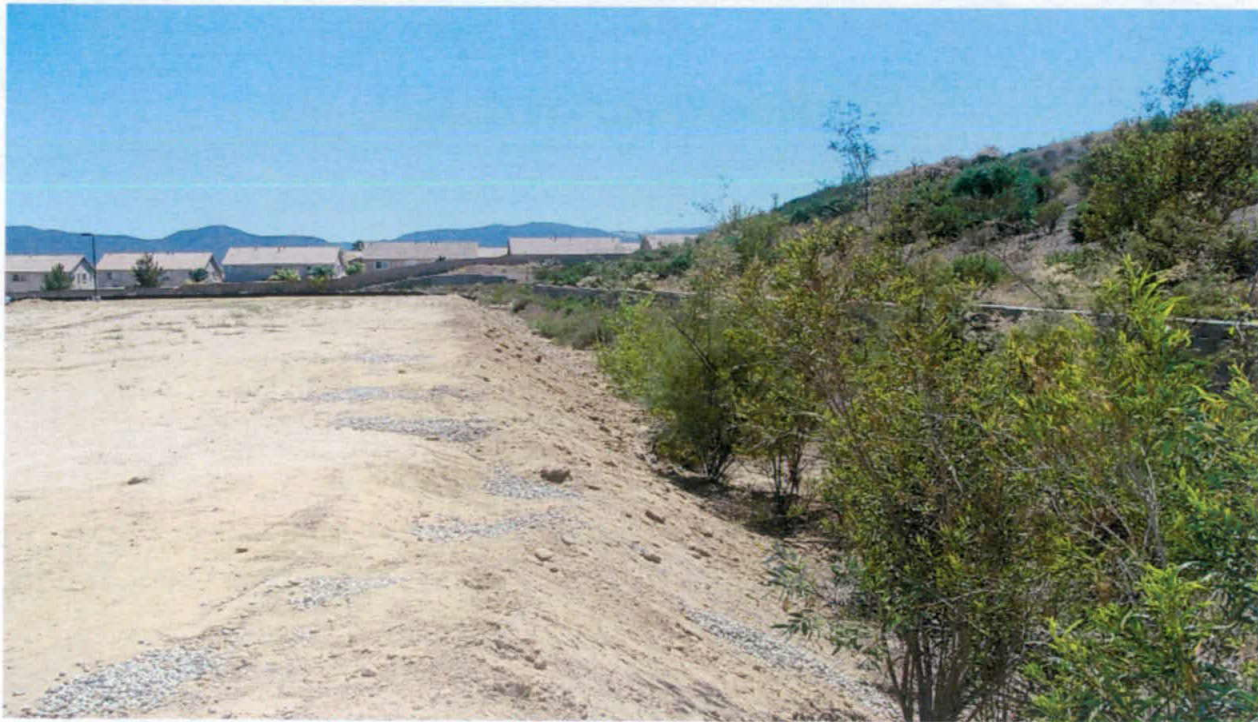
- b. **Observation:** Due to stockpile removal activities the slope adjacent to the northern portion of the mitigation area is devoid of any vegetation (see photo 2).

**Photo 2:** San Diego Water Board inspection on 07/03/14. Stockpile has been removed, lower building pad and slope adjacent to northern corner of mitigation area is devoid of vegetation and slope poses a threatened discharge of sediment to the mitigation area.

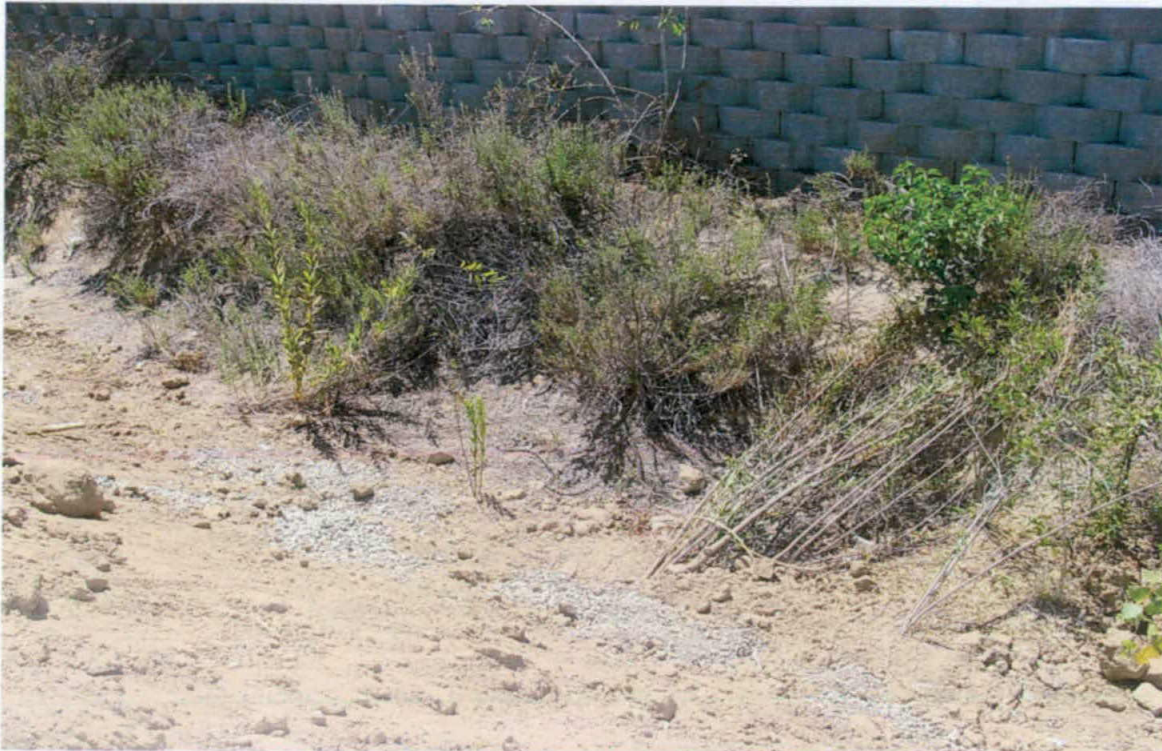
- c. Observation:** On July 3, 2014 San Diego Water Board staff Christopher Means observed the discharge of sediment from stockpile removal activities into the ephemeral drainage mitigation area. Sediment and large rocks were apparent in the mitigation area and had damaged native vegetation planted in the mitigation area. A check dam comprised of gravel bags has been placed within the mitigation stream channel, constituting an unauthorized discharge of fill to the waters of the US/State (see Attachment A, photos 1-5).

**Photo 3:** Stockpile removal and grading activities have resulted in sediment discharge into mitigation area and impacts to native vegetation (mulefat plantings are knocked over by sediment in this photo). These discharges of sediment are in violation of discharge prohibitions in the Basin Plan For the San Diego Region, Order 2009-0009-DWQ and 401 cert 08C-073. Photo taken 07/03/14.

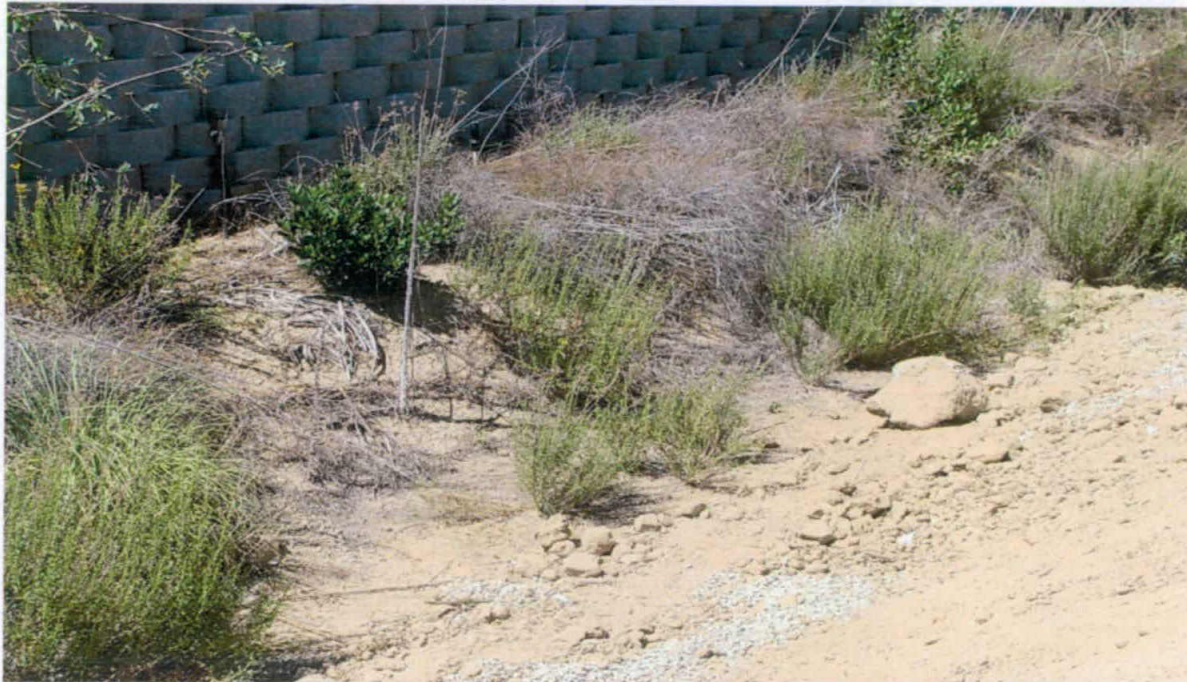
**Photo 4:** Photo taken 07/03/14 shows additional sediment discharge to mitigation area, including gravel from prior gravel bag sediment controls that were in place.

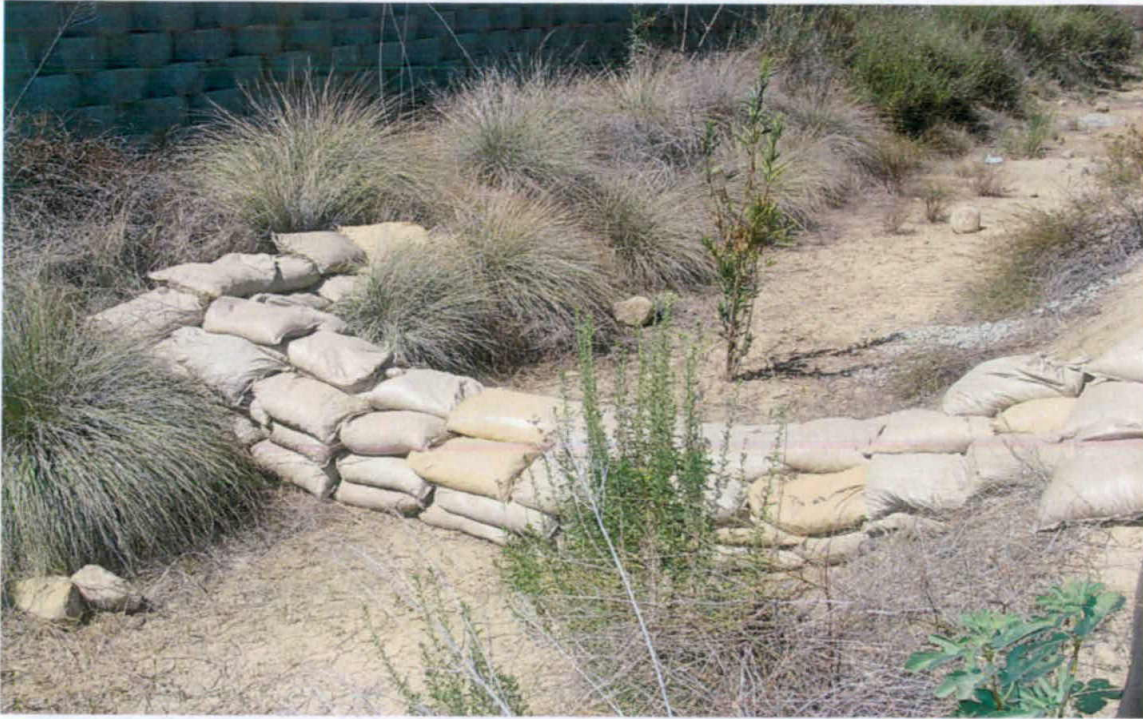
**Photo 5:** A gravel bag check dam of indeterminate purpose has been placed within the mitigation channel and constitutes an unauthorized discharge of fill into waters of the State.

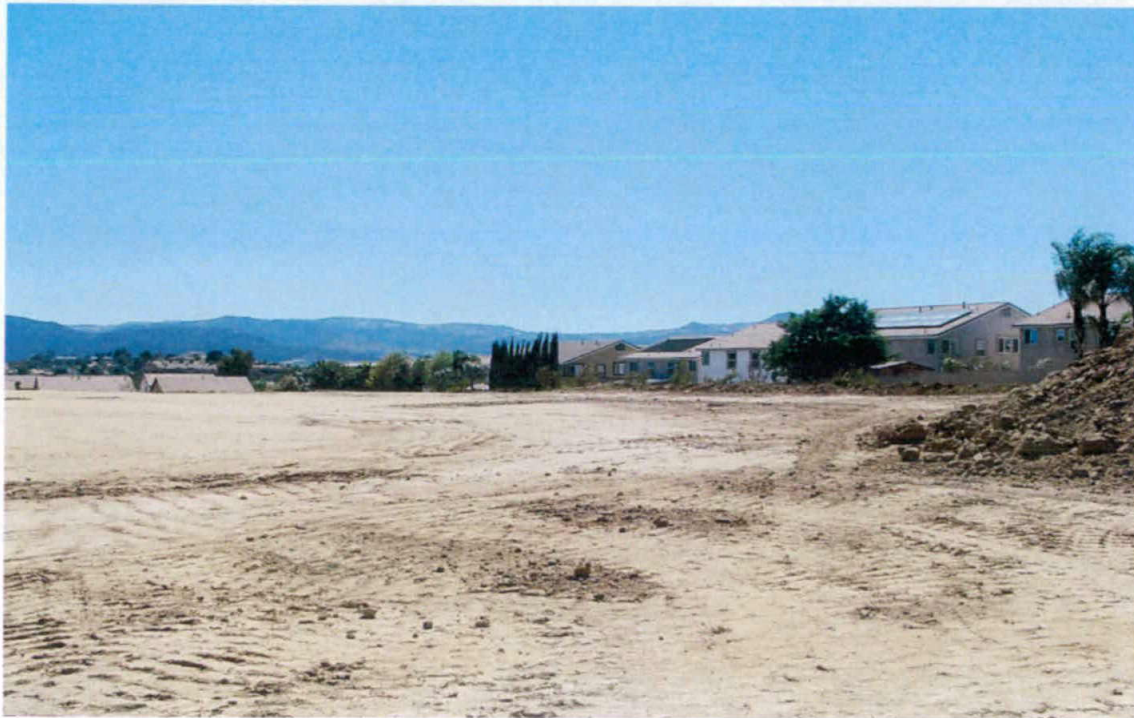
- b. **Observation:** On July 3, 2014 both the upper and lower pads appeared inactive and were devoid of vegetation (see photos 6 and 9).

**Photo 6:** Upper proposed residential pad is inactive, and devoid of erosion control BMPs in violation of Order 2009-0009-DWQ and 401 certification conditions.

1. SA REFKA LLC should immediately implement adequate erosion control BMPs on site in accordance with the SWPPP developed for the site, and coordinate with City of Murrieta Staff to address other violations noted in their previous inspection reports. All inactive pads should be revegetated or have other temporary erosion control such as bonded fiber matrix, or soil bonding glue implemented.

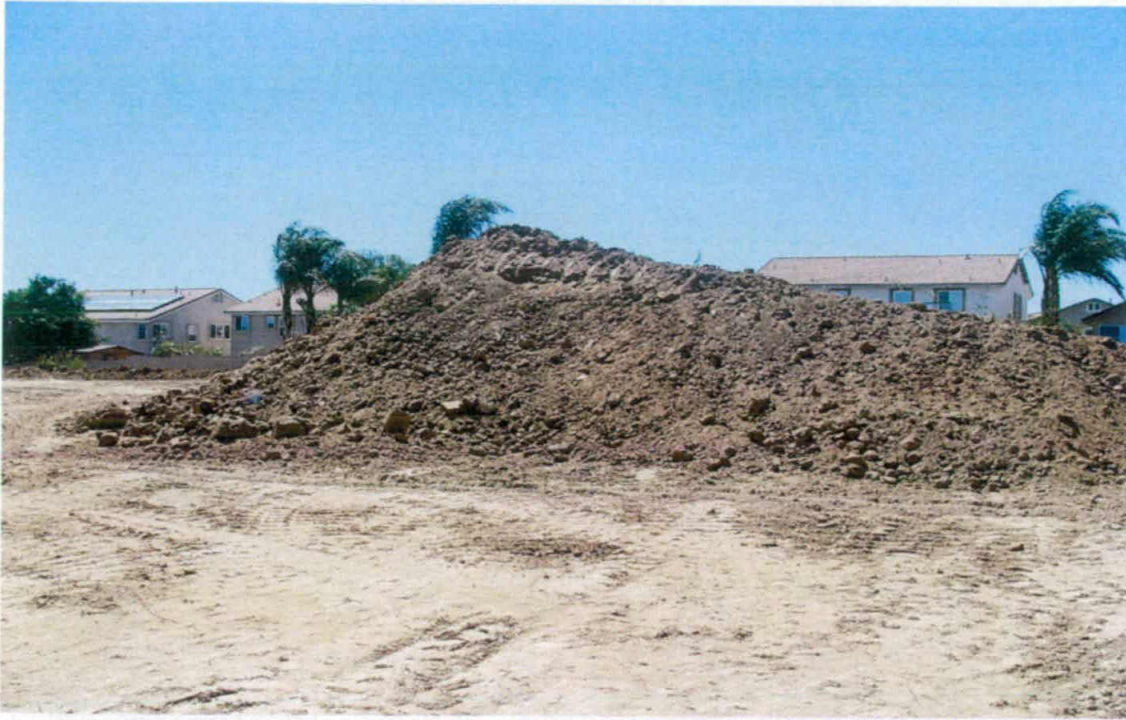
- b. **Observation:** Several inspections by City of Murrieta Storm Water Staff (3/13/14, 5/6/14, and 6/3/14), and San Diego Water Board staff (9/24/13, 10/24/13, and 7/3/14) found erosion control BMPs to be in violation of municipal storm water regulations and Order No. 2009-0009-DWQ. On July 3, 2014 San Diego Water Board Staff noted that erosion control BMPs were still missing. The upper proposed residential pad was at this time inactive and devoid of any erosion control BMPs (see photo 6). A large soil stockpile was present on the upper pad without any BMPs to prevent erosion of the stockpile during a rain event (see photo 7). Rill erosion was observed on the upper northwestern corner of the pad (see photo 8).

**Photo 7:** Large stockpile of soil is unstabilized on upper proposed residential pad. Stockpile is lacking any sediment or erosion control BMPs. Photo taken 07/03/14

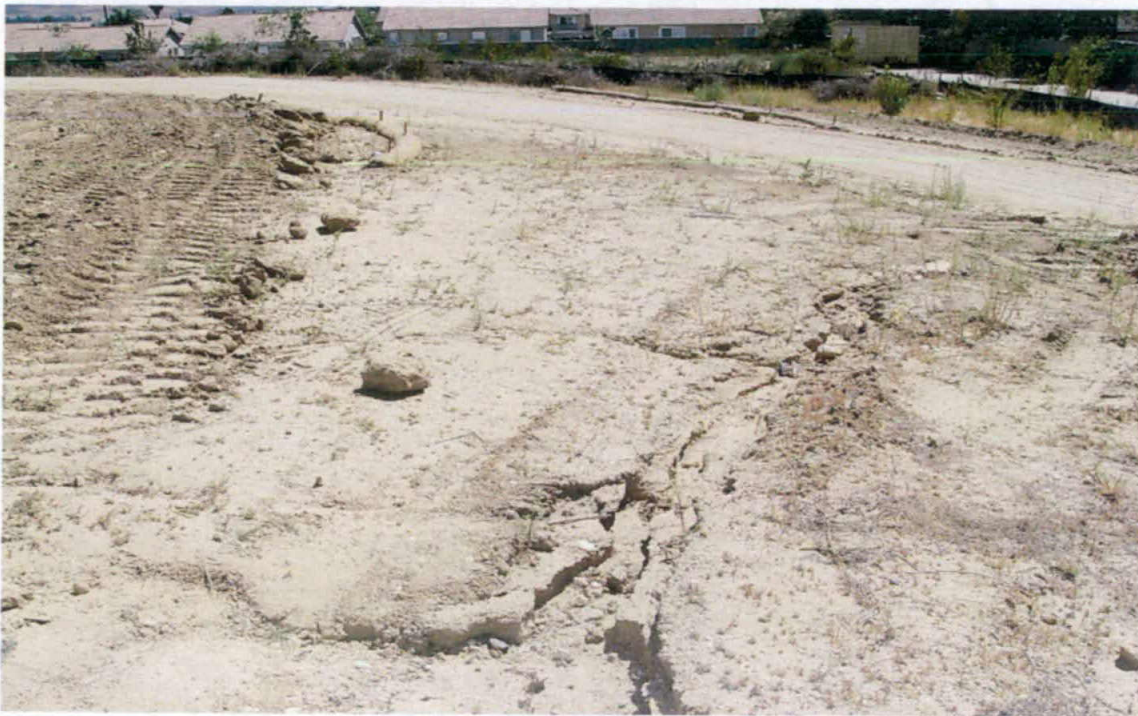
**Photo 8:** Rill erosion was noted on upper pad near the bend in the mitigation channel. Photo taken 07/03/14

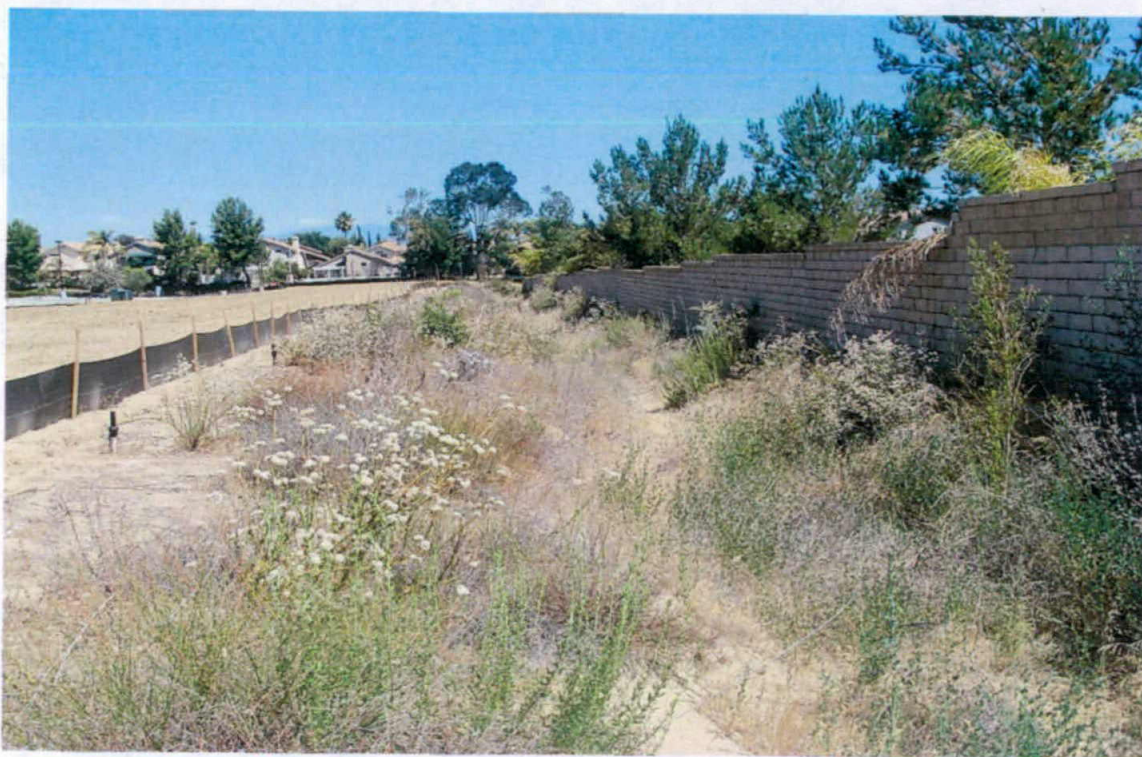
**Photo 10:** The southwest portion of the mitigation area is in better condition than the northern segment. Both banks of the channel are vegetated, but it is still in need of maintenance and invasive species removal in accordance with 401 certification requirements. (photo taken 07/03/14)

3. SA REFKA LLC should hire a qualified environmental consultant to review the state of the mitigation area and its compliance with the mitigation plan developed for the project (Mitigation and Monitoring Plan prepared by TeraCor Resource Management, May 3, 2006, amended by Vandermost Consulting September 25, 2008). This evaluation should determine the steps necessary to bring the mitigation up to the final success criteria outlined in the plan, and to provide for proper maintenance of the site and monitoring reports as required by the 401 certification conditions.

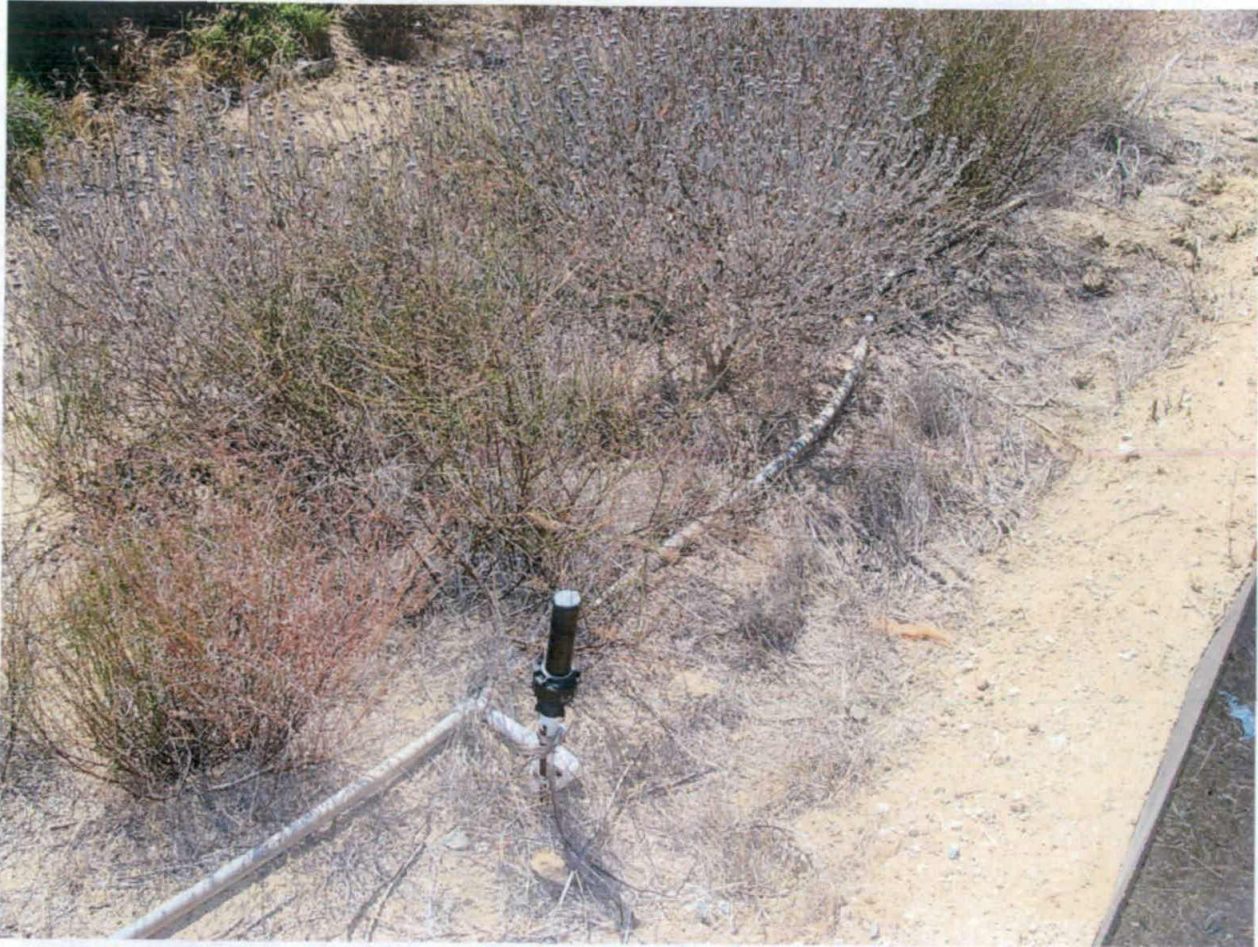
**Photo 11:** The southwestern portion of the mitigation area still has temporary irrigation in place, but it was not apparent that it had been used for quite some time, as piping and sprinkler heads were damaged. Irrigation and channel maintenance should resume until final success criteria in 401 mitigation plan is achieved. (photo taken 07/03/14)
