California Regional Water Quality Control Board, San Diego Region

Subject: Notice of Violation No. R9-2014-XXXX, Temecula Valley High School Athletic Fields, Order No. 2009-0009-DWQ, NPDES Permit No. CAS000002

NOTICE OF VIOLATION
No. R9-2014-0091

July 23, 2014
Inspection Photos

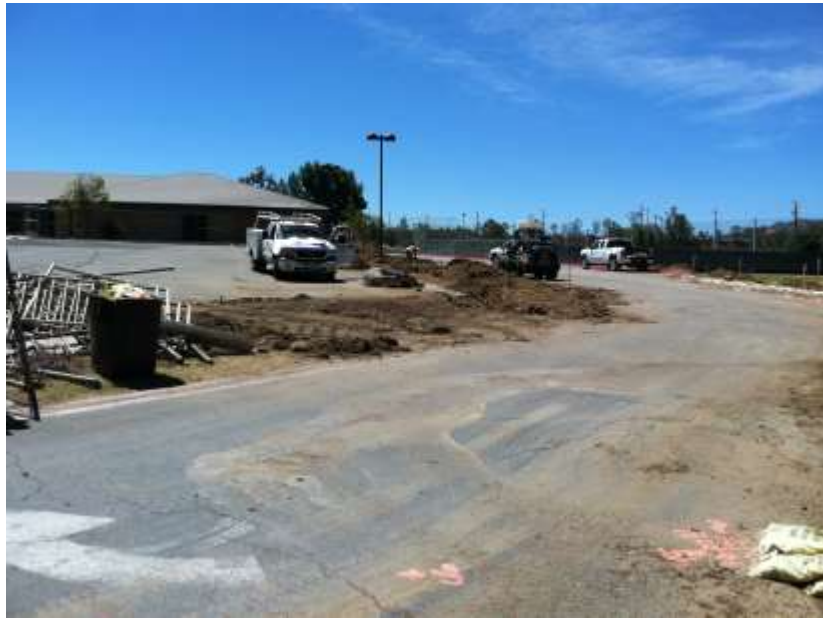
Evidence of non-storm water from site that flowed through inadequately managed and controlled sediment from construction activities. Photo 1 also shows evidence of lack of perimeter controls and runoff controls to control sediment discharges and debris from construction activities off the site..

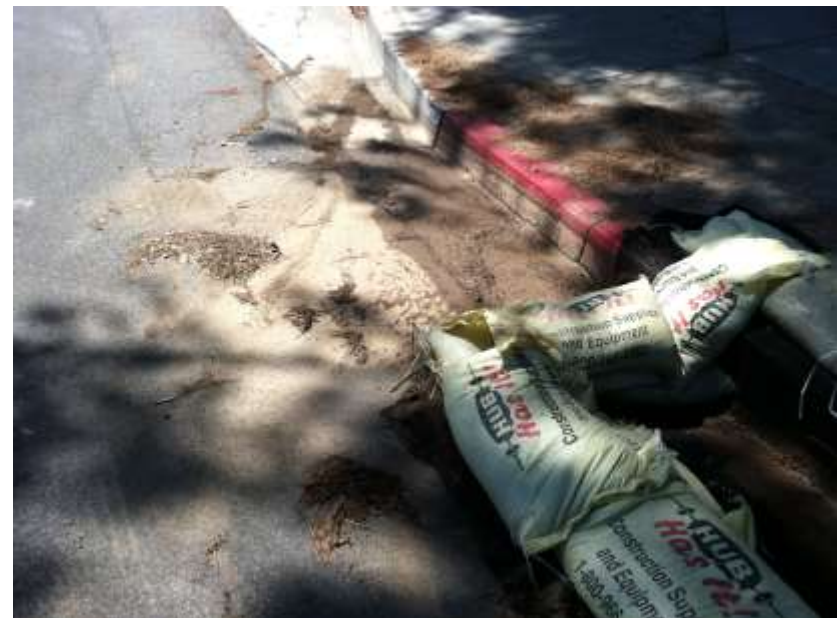
Photo 3

Evidence of sediment transported by non-storm water flows off site to City of Temecula storm drain system. Significant sediment build up behind gravel bags and evidence of non-storm water and sediment flow around gravel bags.

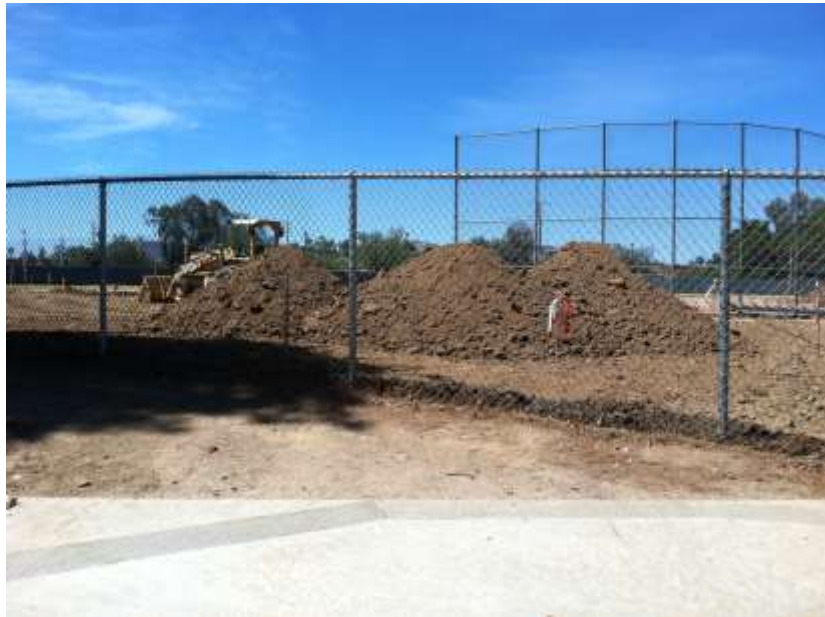
Photo 4

Evidence of lack of perimeter controls and runoff controls to control sediment discharges and debris from construction activities off the site.
