**CALIFORNIA REGIONAL WATER QUALITY CONTROL BOARD - SAN DIEGO REGION
WATERSHED MANAGEMENT PROGRAM**

FACILITY INSPECTION REPORT

FACILITY: **Moritz Residence (APN # 321-040-49)**

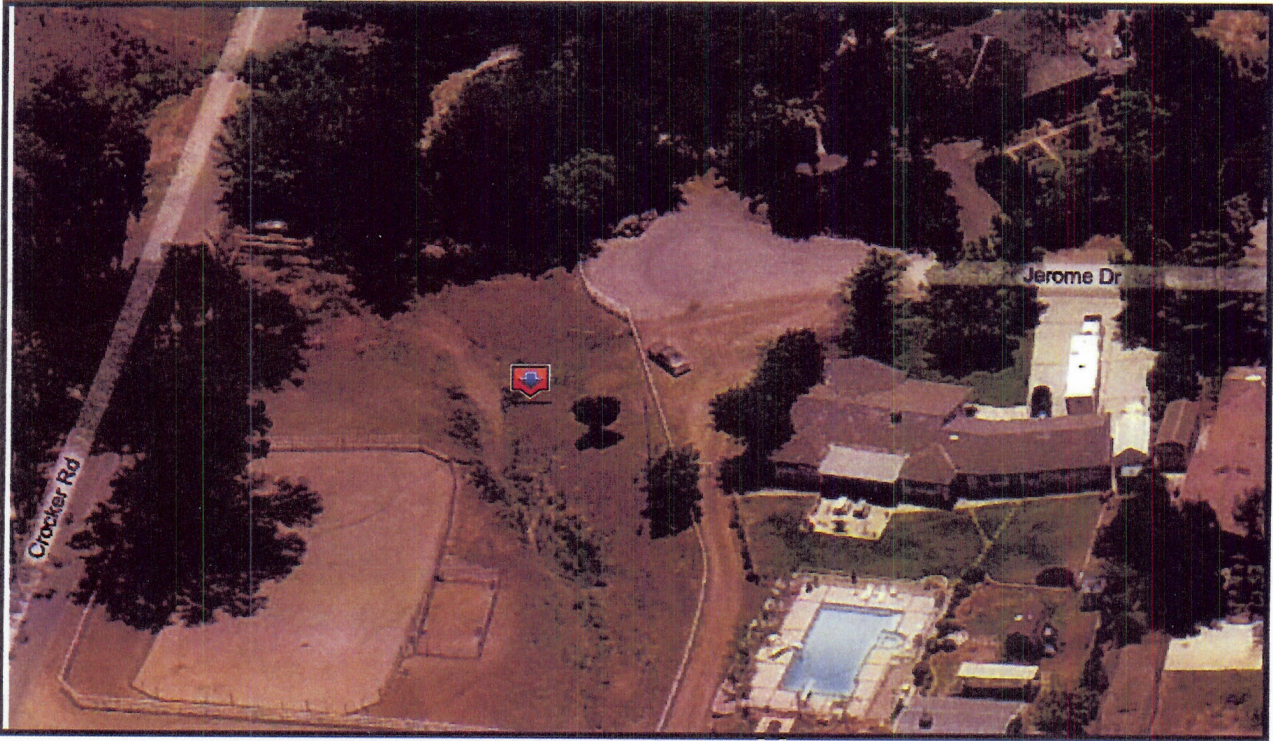
- An in-house review of aerial photos obtained from the internet (see photo 1-2), historical photos taken by CDFG staff in April 2005 (photo 3), and a review of topographic maps at the June 9, 2008 meeting established the existence of a vegetated ephemeral drainage on the Moritz property, which connects to a blue line stream on the adjacent property tributary to Rattlesnake Creek, and ultimately Poway Creek (HSA 906.20). The ephemeral stream generally ran in a North to South direction just west of a horse riding ring on his property.

Aerial photo looking south of property.

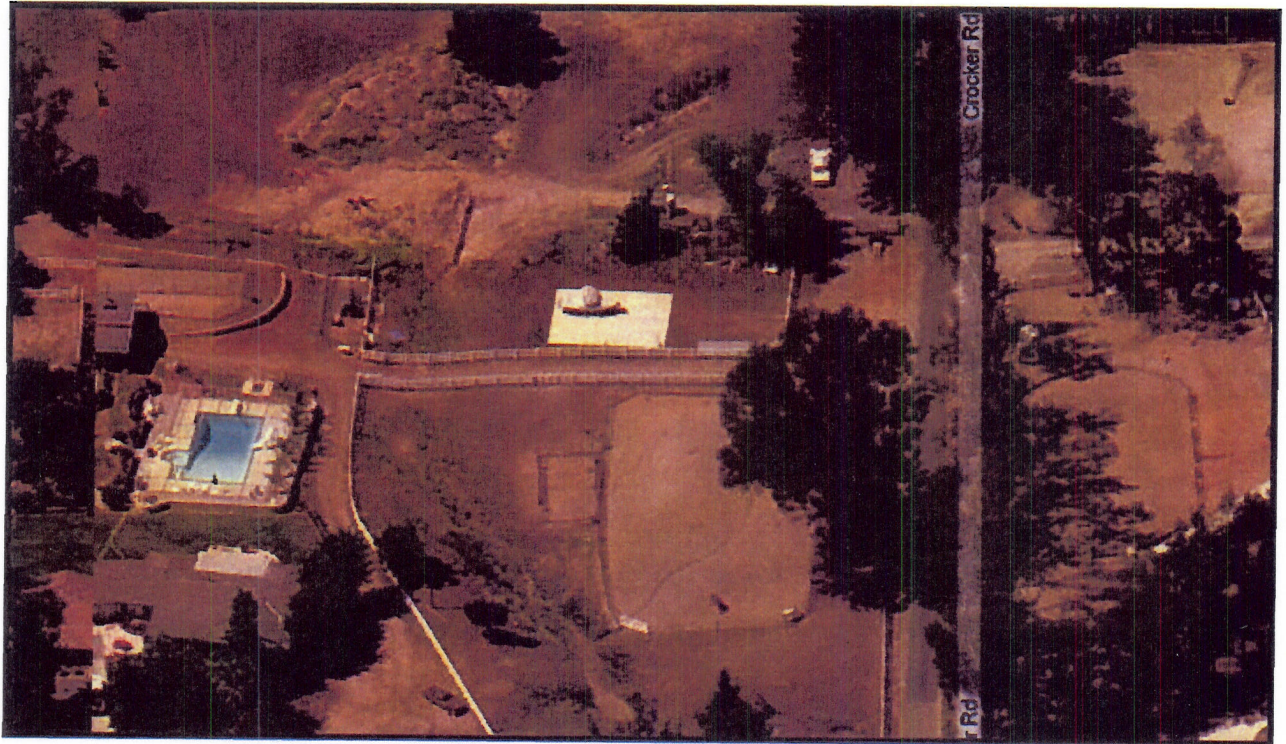
This photo was taken April 11, 2005 from the adjacent parcel, looking downstream onto the Moritz property.

- Site needs to be stabilized immediately. Erosion and sediment controls should be implemented
- Consistent with previous instances of unauthorized fill in the City of Poway, a Cleanup and Abatement Order should be prepared requiring removal of fill and restoration of the creek.

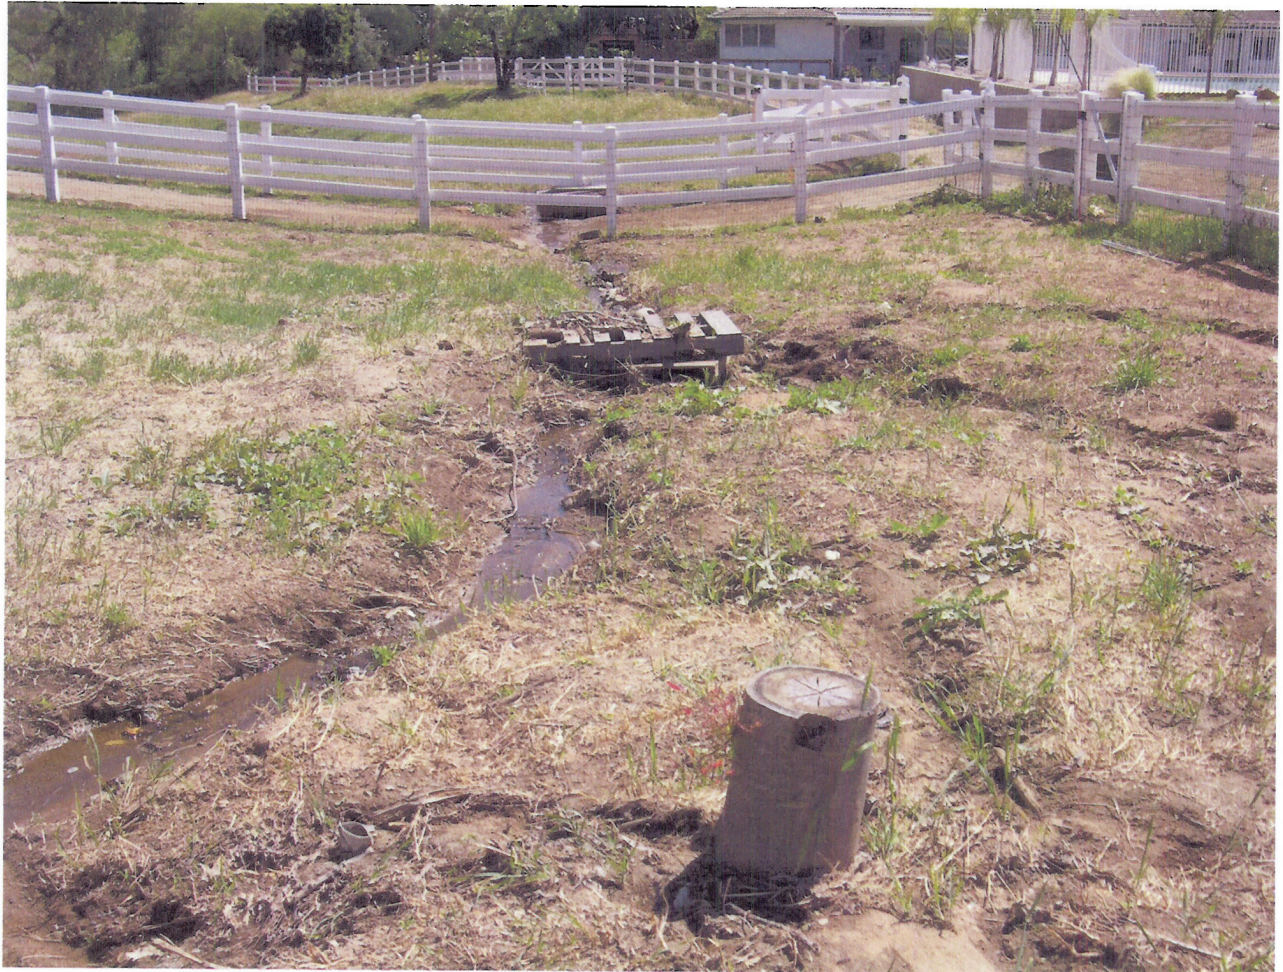
Photo provided by Kelly Fisher of CDFG

- Additionally, Dr. Moritz installed a 24-inch HDPE pipe to convey upstream drainage across his property. The outlet of the pipe has been placed out of line with where the creek continued onto the adjacent property, and threatens to cause a condition of erosion, and nuisance to the adjacent property owned by Sean Marsden. (see photo 4)
