**FINAL
HINES GROWERS
BIOASSESSMENT REPORT
FIELD SURVEY FROM JUNE 2013
FALLBROOK, CALIFORNIA**

**Prepared for:
Hines Growers, Inc.
Rainbow Branch
Fallbrook, California 92028**

**Submitted by:
AMEC Environment & Infrastructure, Inc.
9210 Sky Park Court, Suite 200
San Diego, California 92123
(858) 300-4300**

December 2013

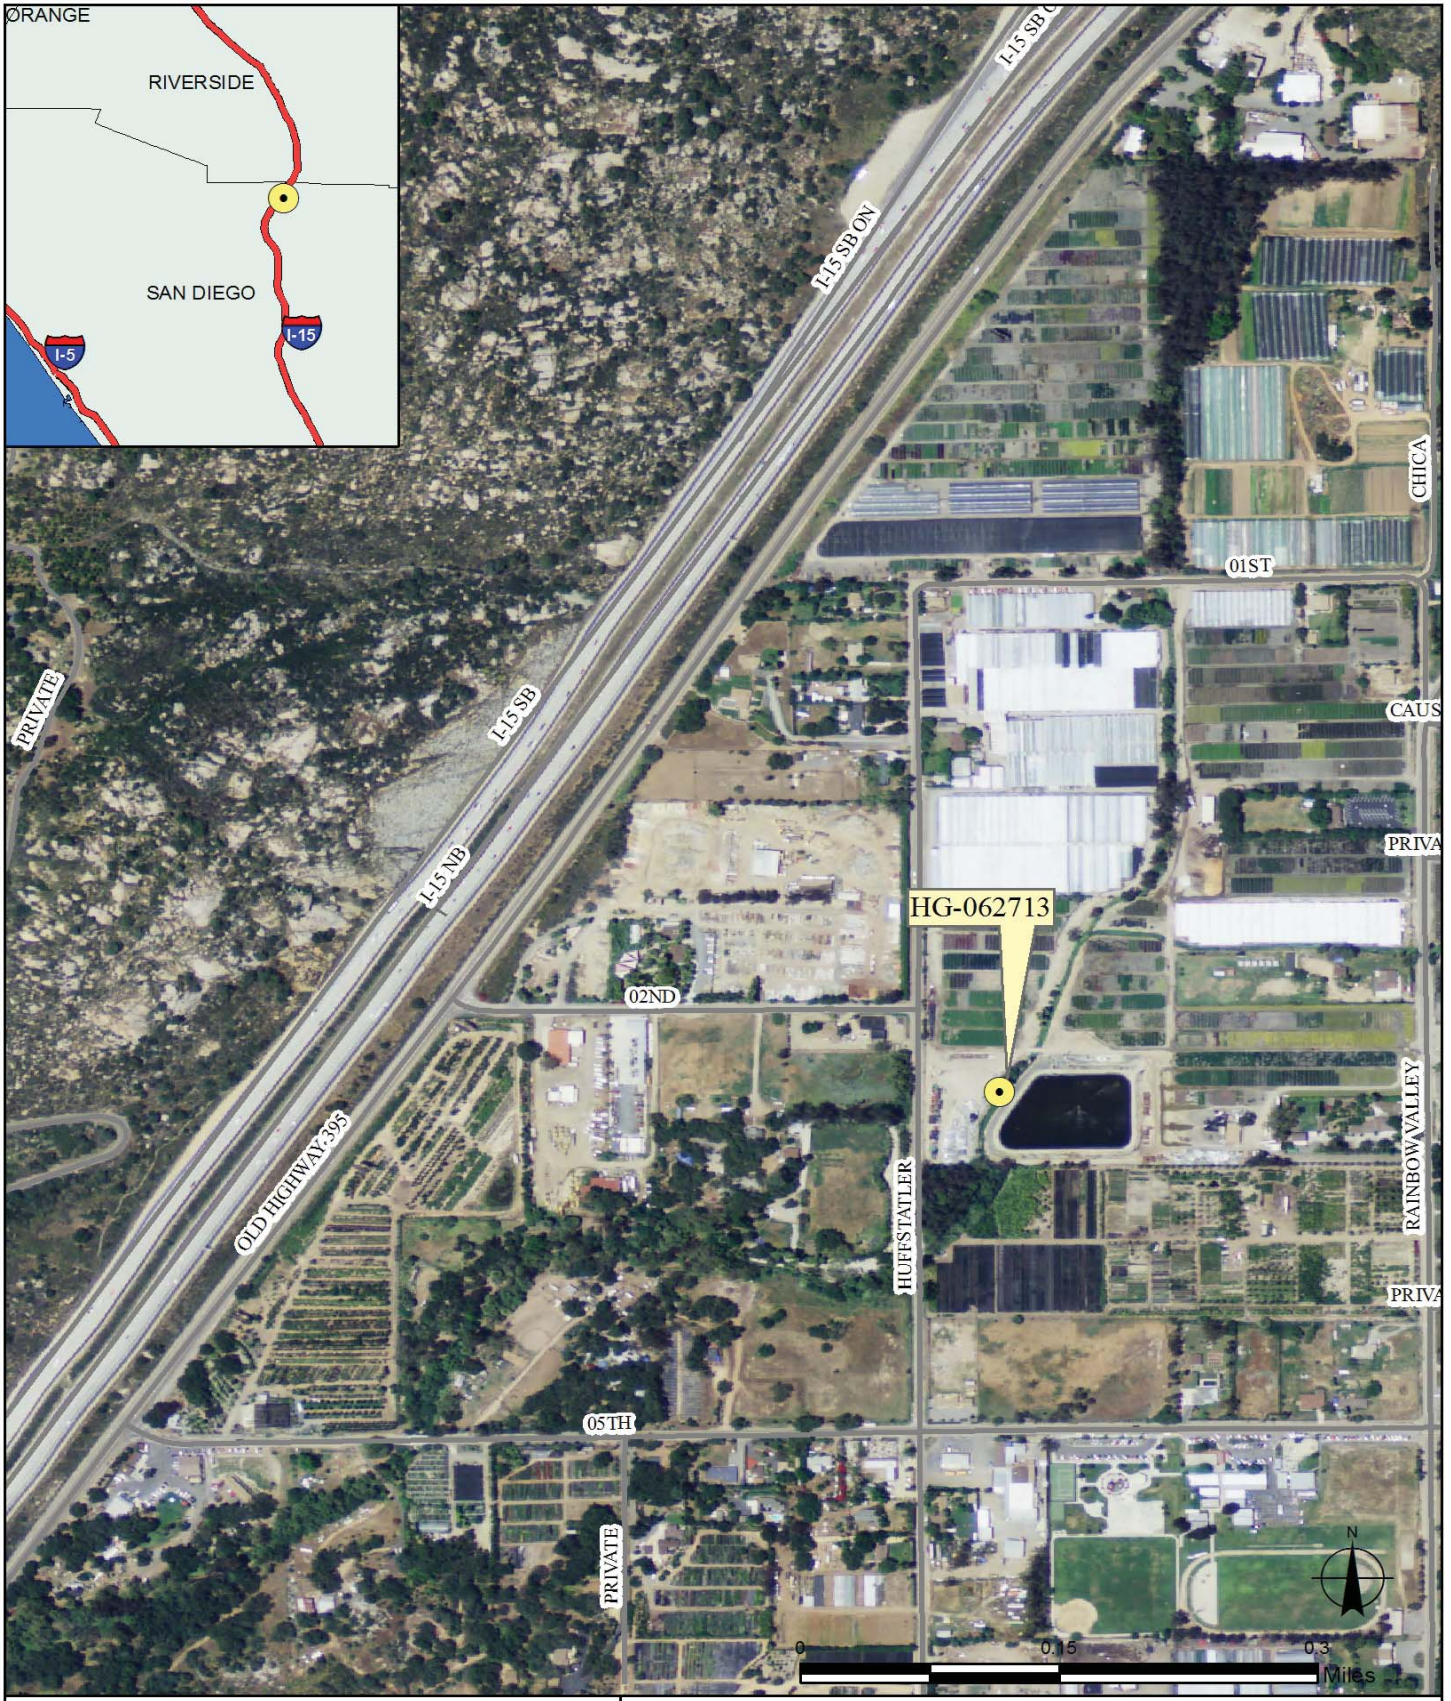
Legend
 ● Monitoring Location
 — Roads

The proposed project is on private property within the Hines Growers, Inc. facility (facility) in Rainbow, California (Figure 1 in Appendix A). The 261-acre facility footprint consists of several non-contiguous areas approximately 6 miles northeast of downtown Fallbrook, California. Hines Growers, Inc. grows containerized ornamental plants on the site for subsequent sale and distribution. The facility borders RC for approximately 1.1 miles, just prior to its passing beneath I-15 highway. During the “dry season”, the stretch of RC that passes through the facility consists of intermittent flow, with large dry sections separated by small segments of low flow.

Bioassessment monitoring was performed at the facility location on June 27, 2013. The station ID and location of the monitoring station are presented in Table 2-1 and shown in Figure 1 (Appendix A).
