Subject: Notice of Violation No. R9-2018-0030 and Investigative Order No. R9-2018-0045 Related to Alleged Violations of Clean Water Act Section 401 Water Quality Certification No. R9-2012-0075 for the Atherton Tr 32627 Project

**NOTICE OF VIOLATION
No. R9-2018-0030**

Atherton Tr 32627 Project
Stream crossing at Monte Verde Drive,
Riverside County, California

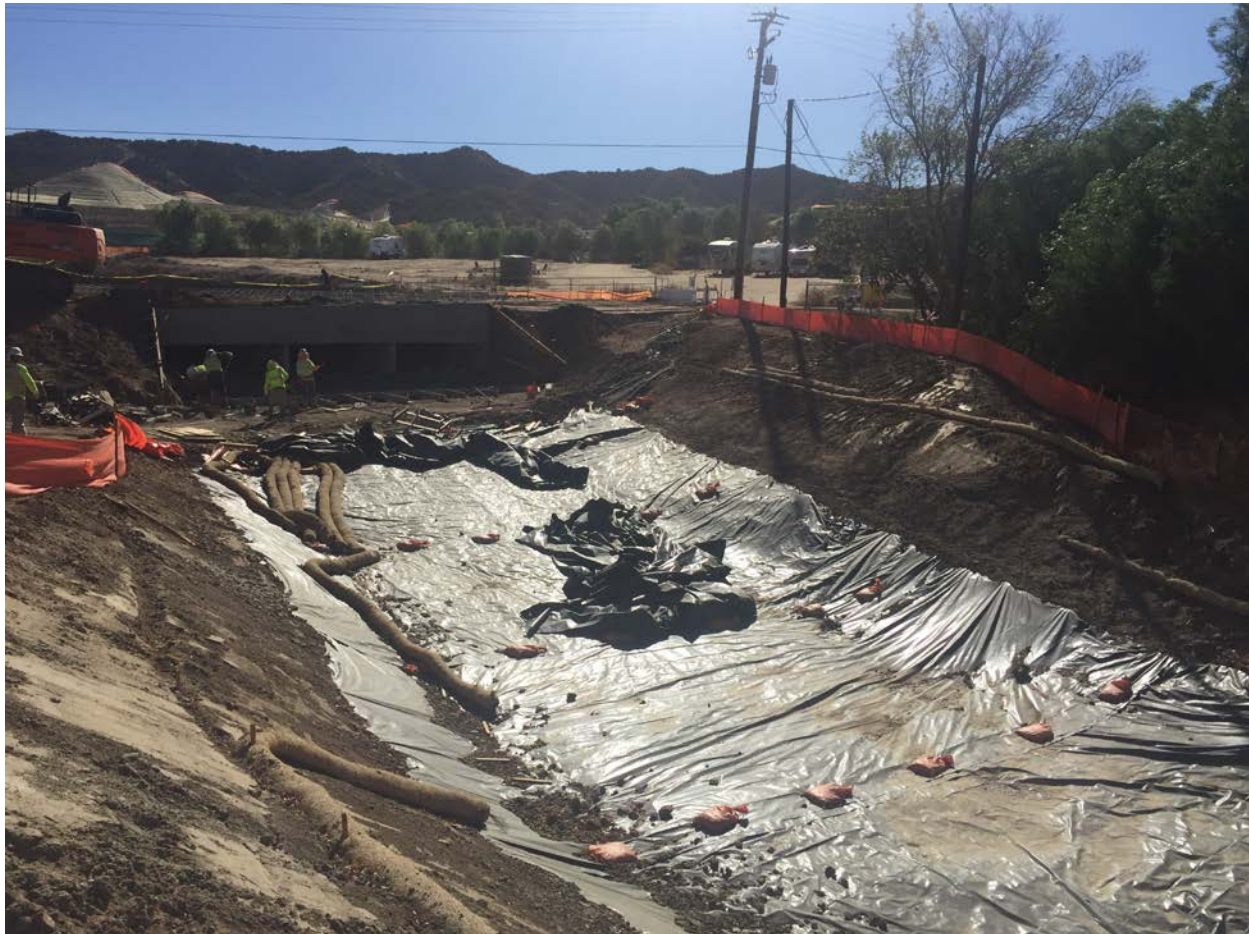
1: Downstream side of Monte Verde Drive culvert prior to the January 9, 2018 rain event. During construction, the existing ground at the outlet of the culvert at Monte Verde Road was discovered to be approximately 6 feet lower than indicated on the original topography map.

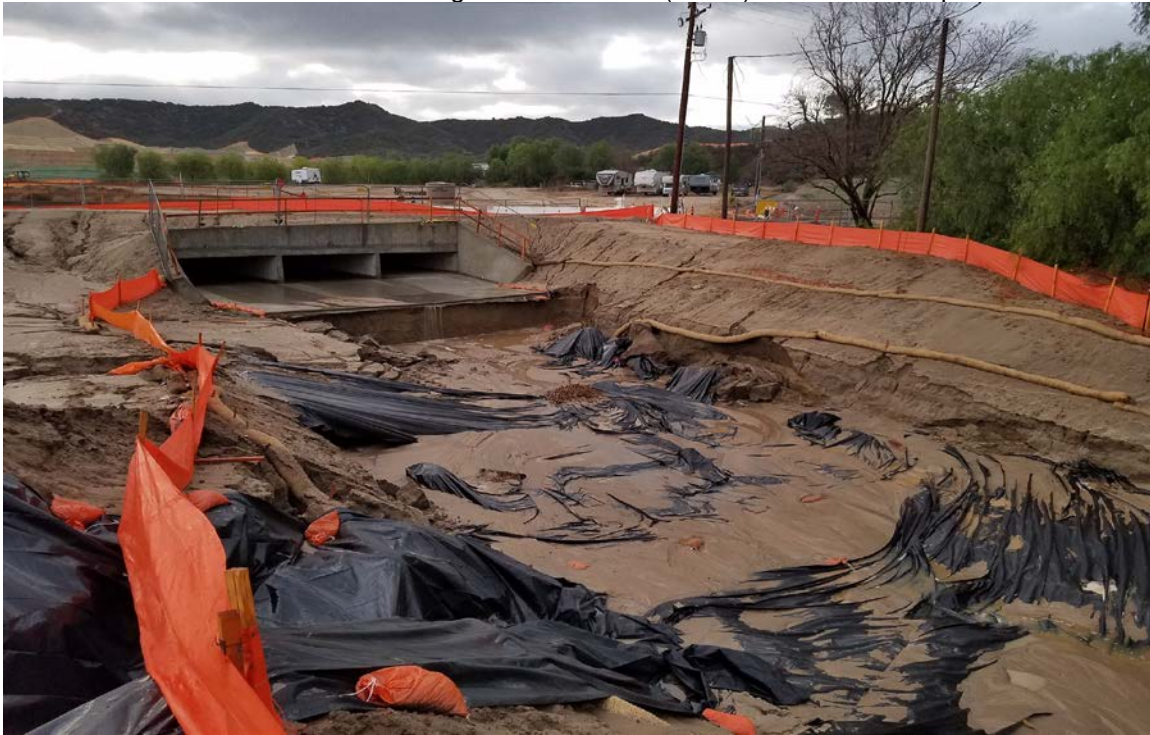
Observation: A storm event that occurred on January 9, 2018, resulted in channel bottom erosion to approximately 3-4 feet below the concrete sill of the newly installed box culvert. Eroded bank and channel sediments were carried downstream (see attached photos, Exhibit B). On-site compensatory mitigation for the Atherton Tr 32627 Project and the Terracina Project is located downstream of the Monte Verde Drive culvert. Downstream erosion and deposition pose an ongoing threat to the success of the compensatory mitigation site and downstream receiving waters.

2: Culvert after rain event. Best Management Practices (BMPs) have been compromised.

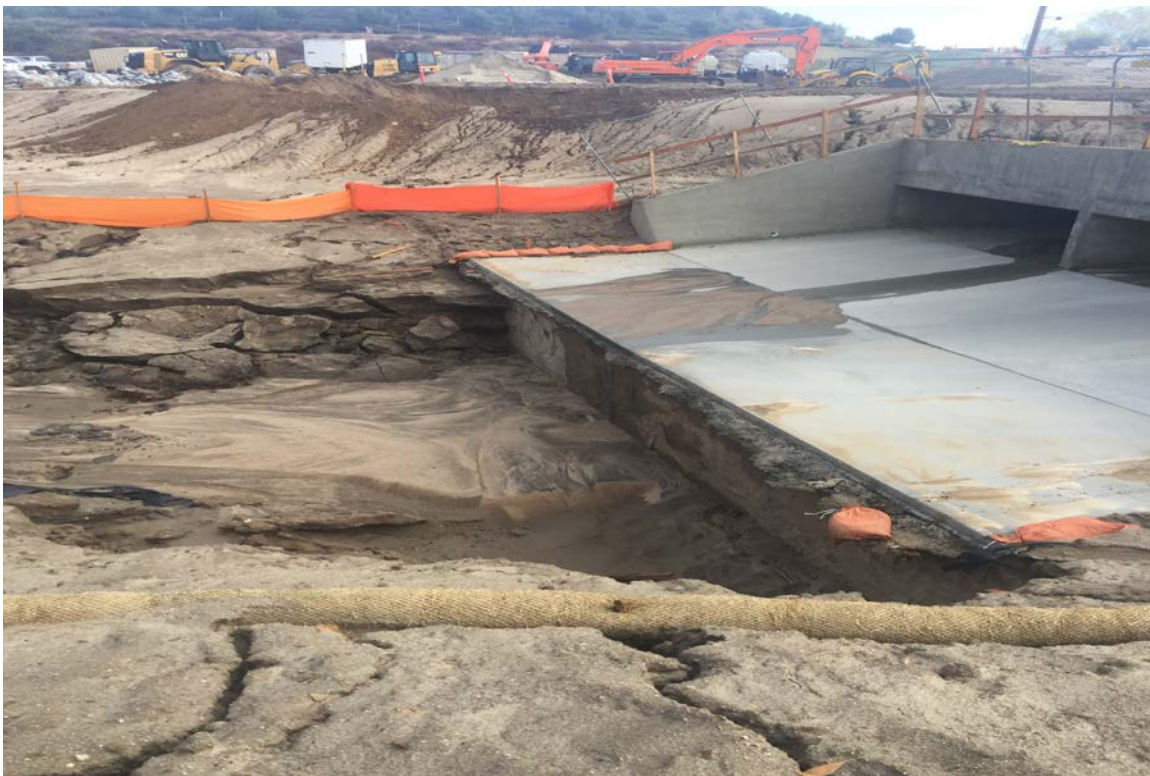
Observation: A discharge of waste including earthen materials has occurred to waters of the United States and/or State which has resulted in a discharge of 3-4 feet of sediment to downstream receiving waters. Additionally, the elevated culvert and steep channel grade threaten further sediment and debris delivery to waters of the United States and/or State, including the downstream mitigation area, through erosion or catastrophic slope failure.

3: Approximately 3-4 feet of sediment eroded and washed downstream of culvert.

- a. An evaluation addressing removal of the existing culvert with reinstallation at the proper grade.
 - b. A recommended alternative to address the noncompliance issues identified in the NOV in all respects;
