## FINAL CLEANUP AND ABATEMENT COMPLETION REPORT SAN DIEGO SHIPYARD SEDIMENT SITE – SOUTH SHIPYARD

National Steel and Shipbuilding Company

Anchor QEA, LLC

**June 2014**

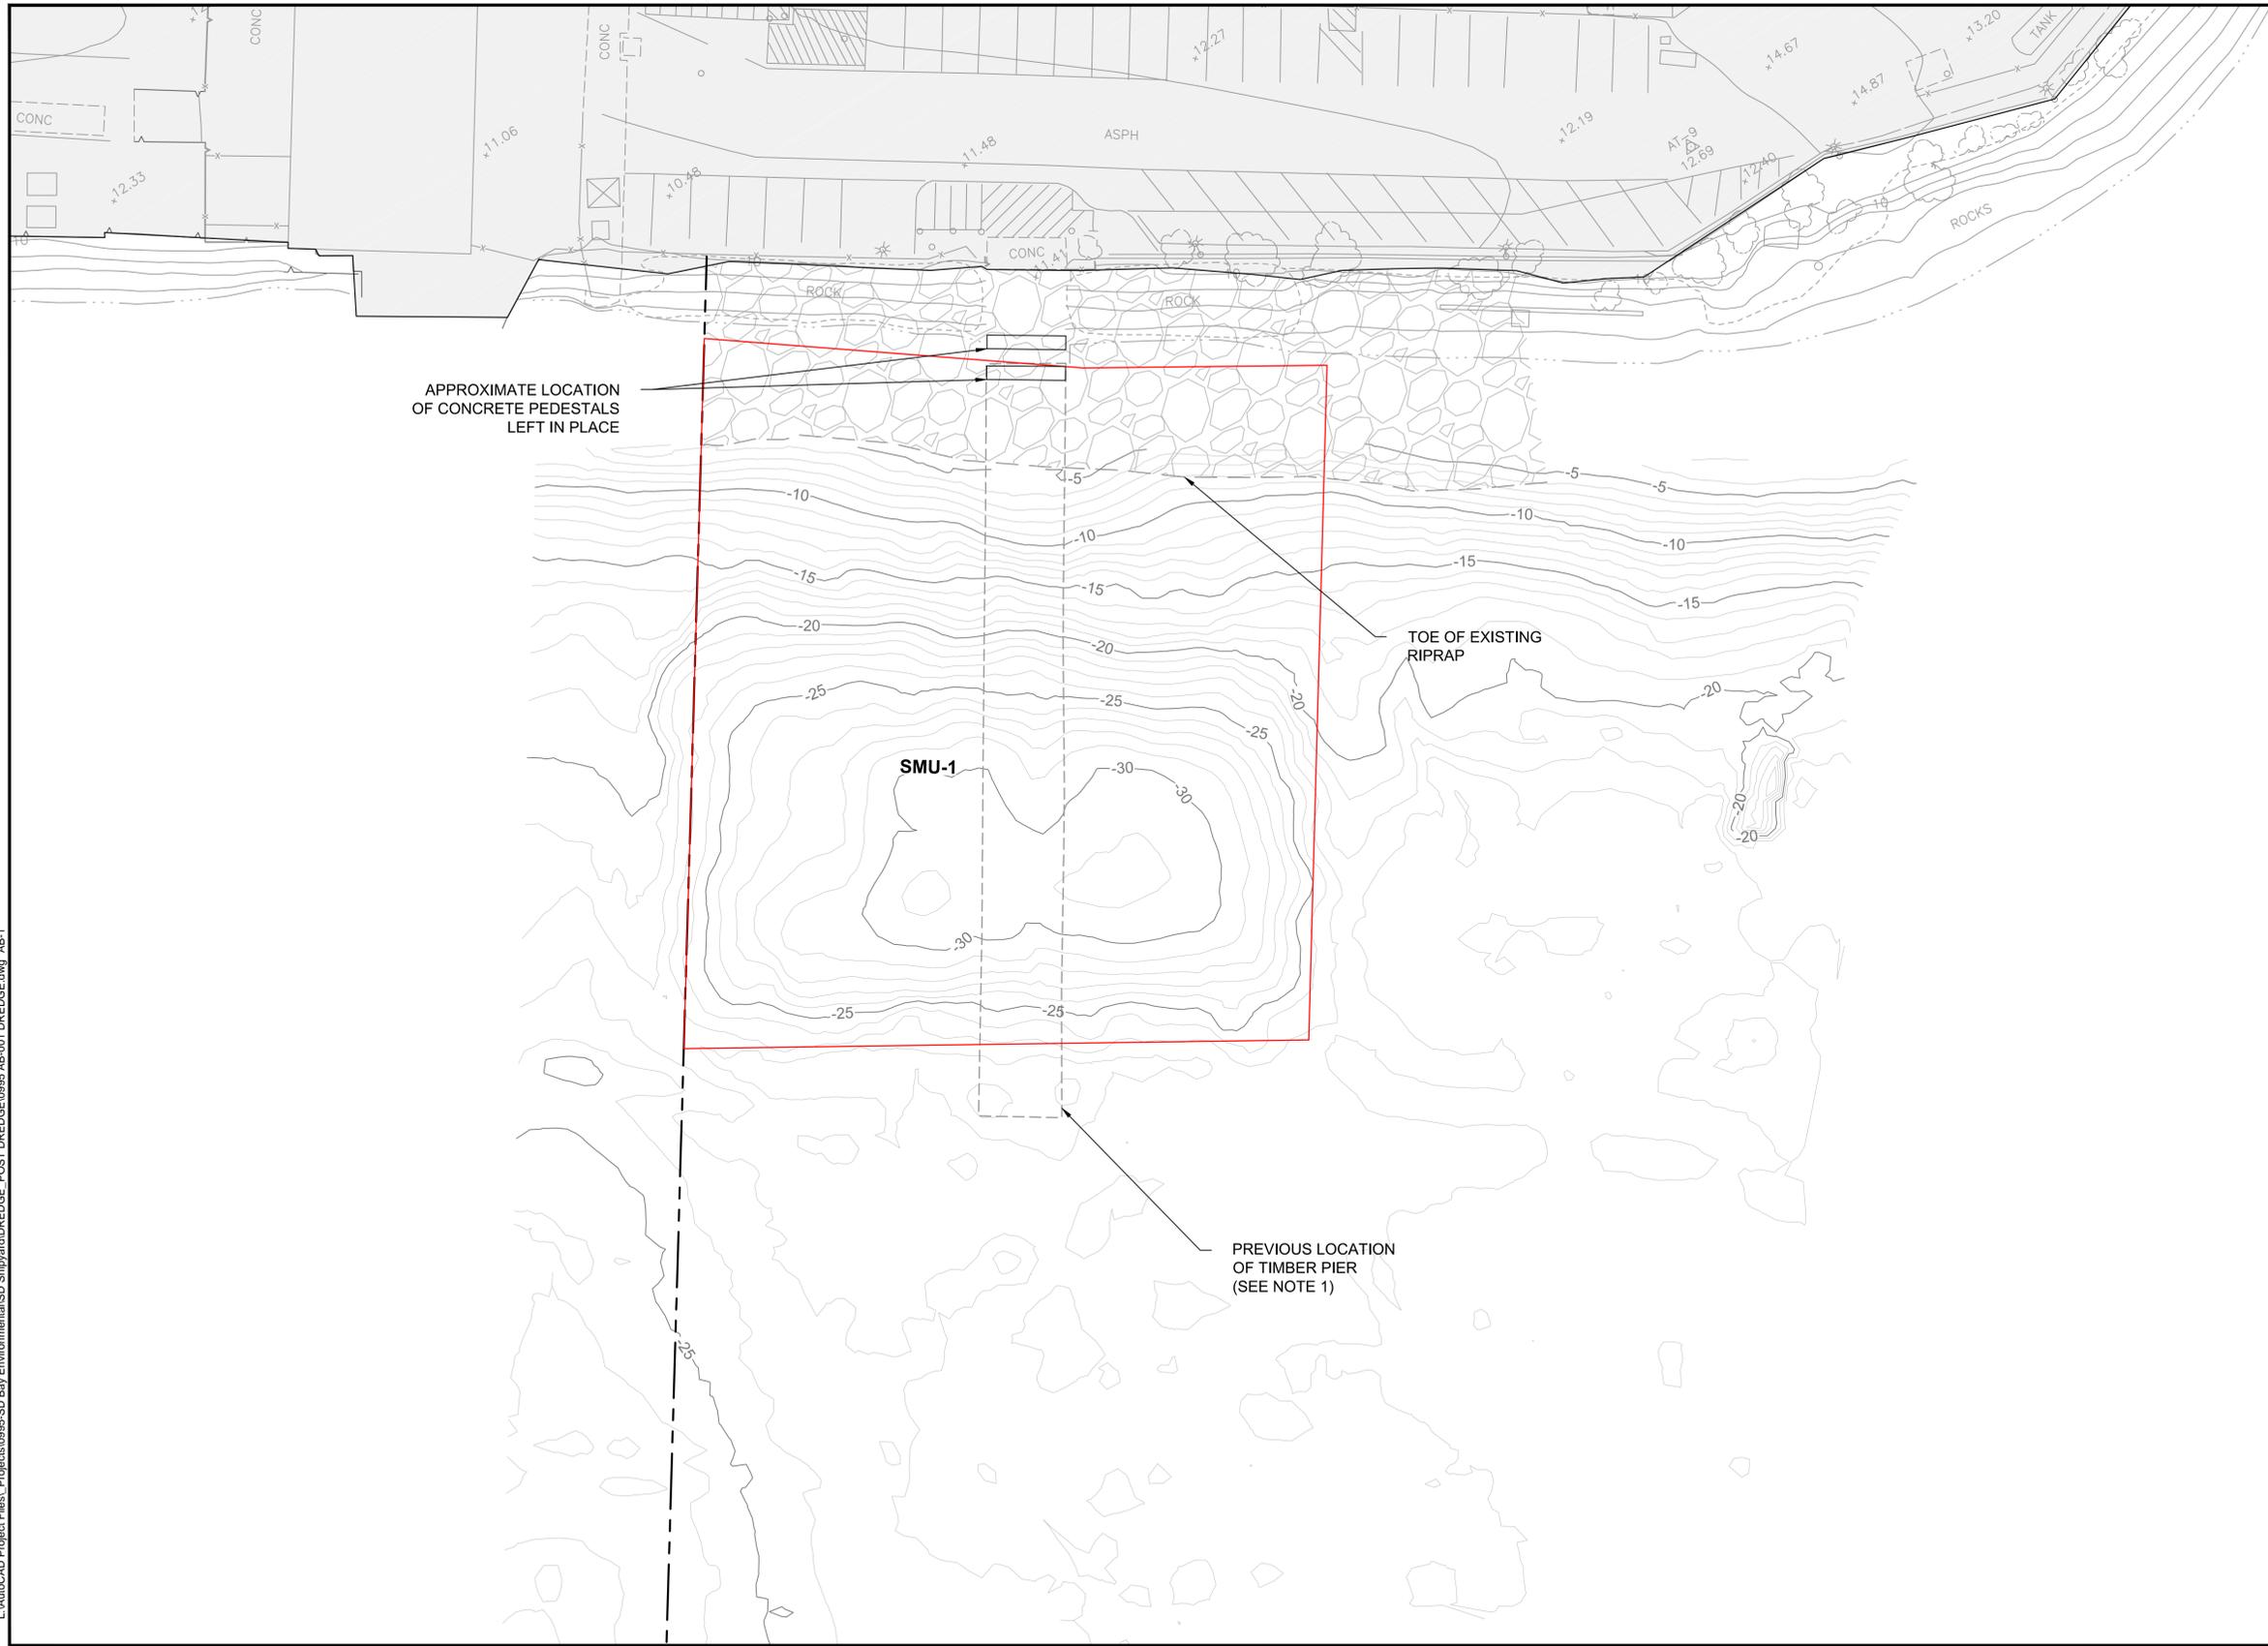
**AS-BUILT CONDITIONS (1)**

APPROXIMATE LOCATION  
OF CONCRETE PEDESTALS  
LEFT IN PLACE

TOE OF EXISTING  
RIPRAP

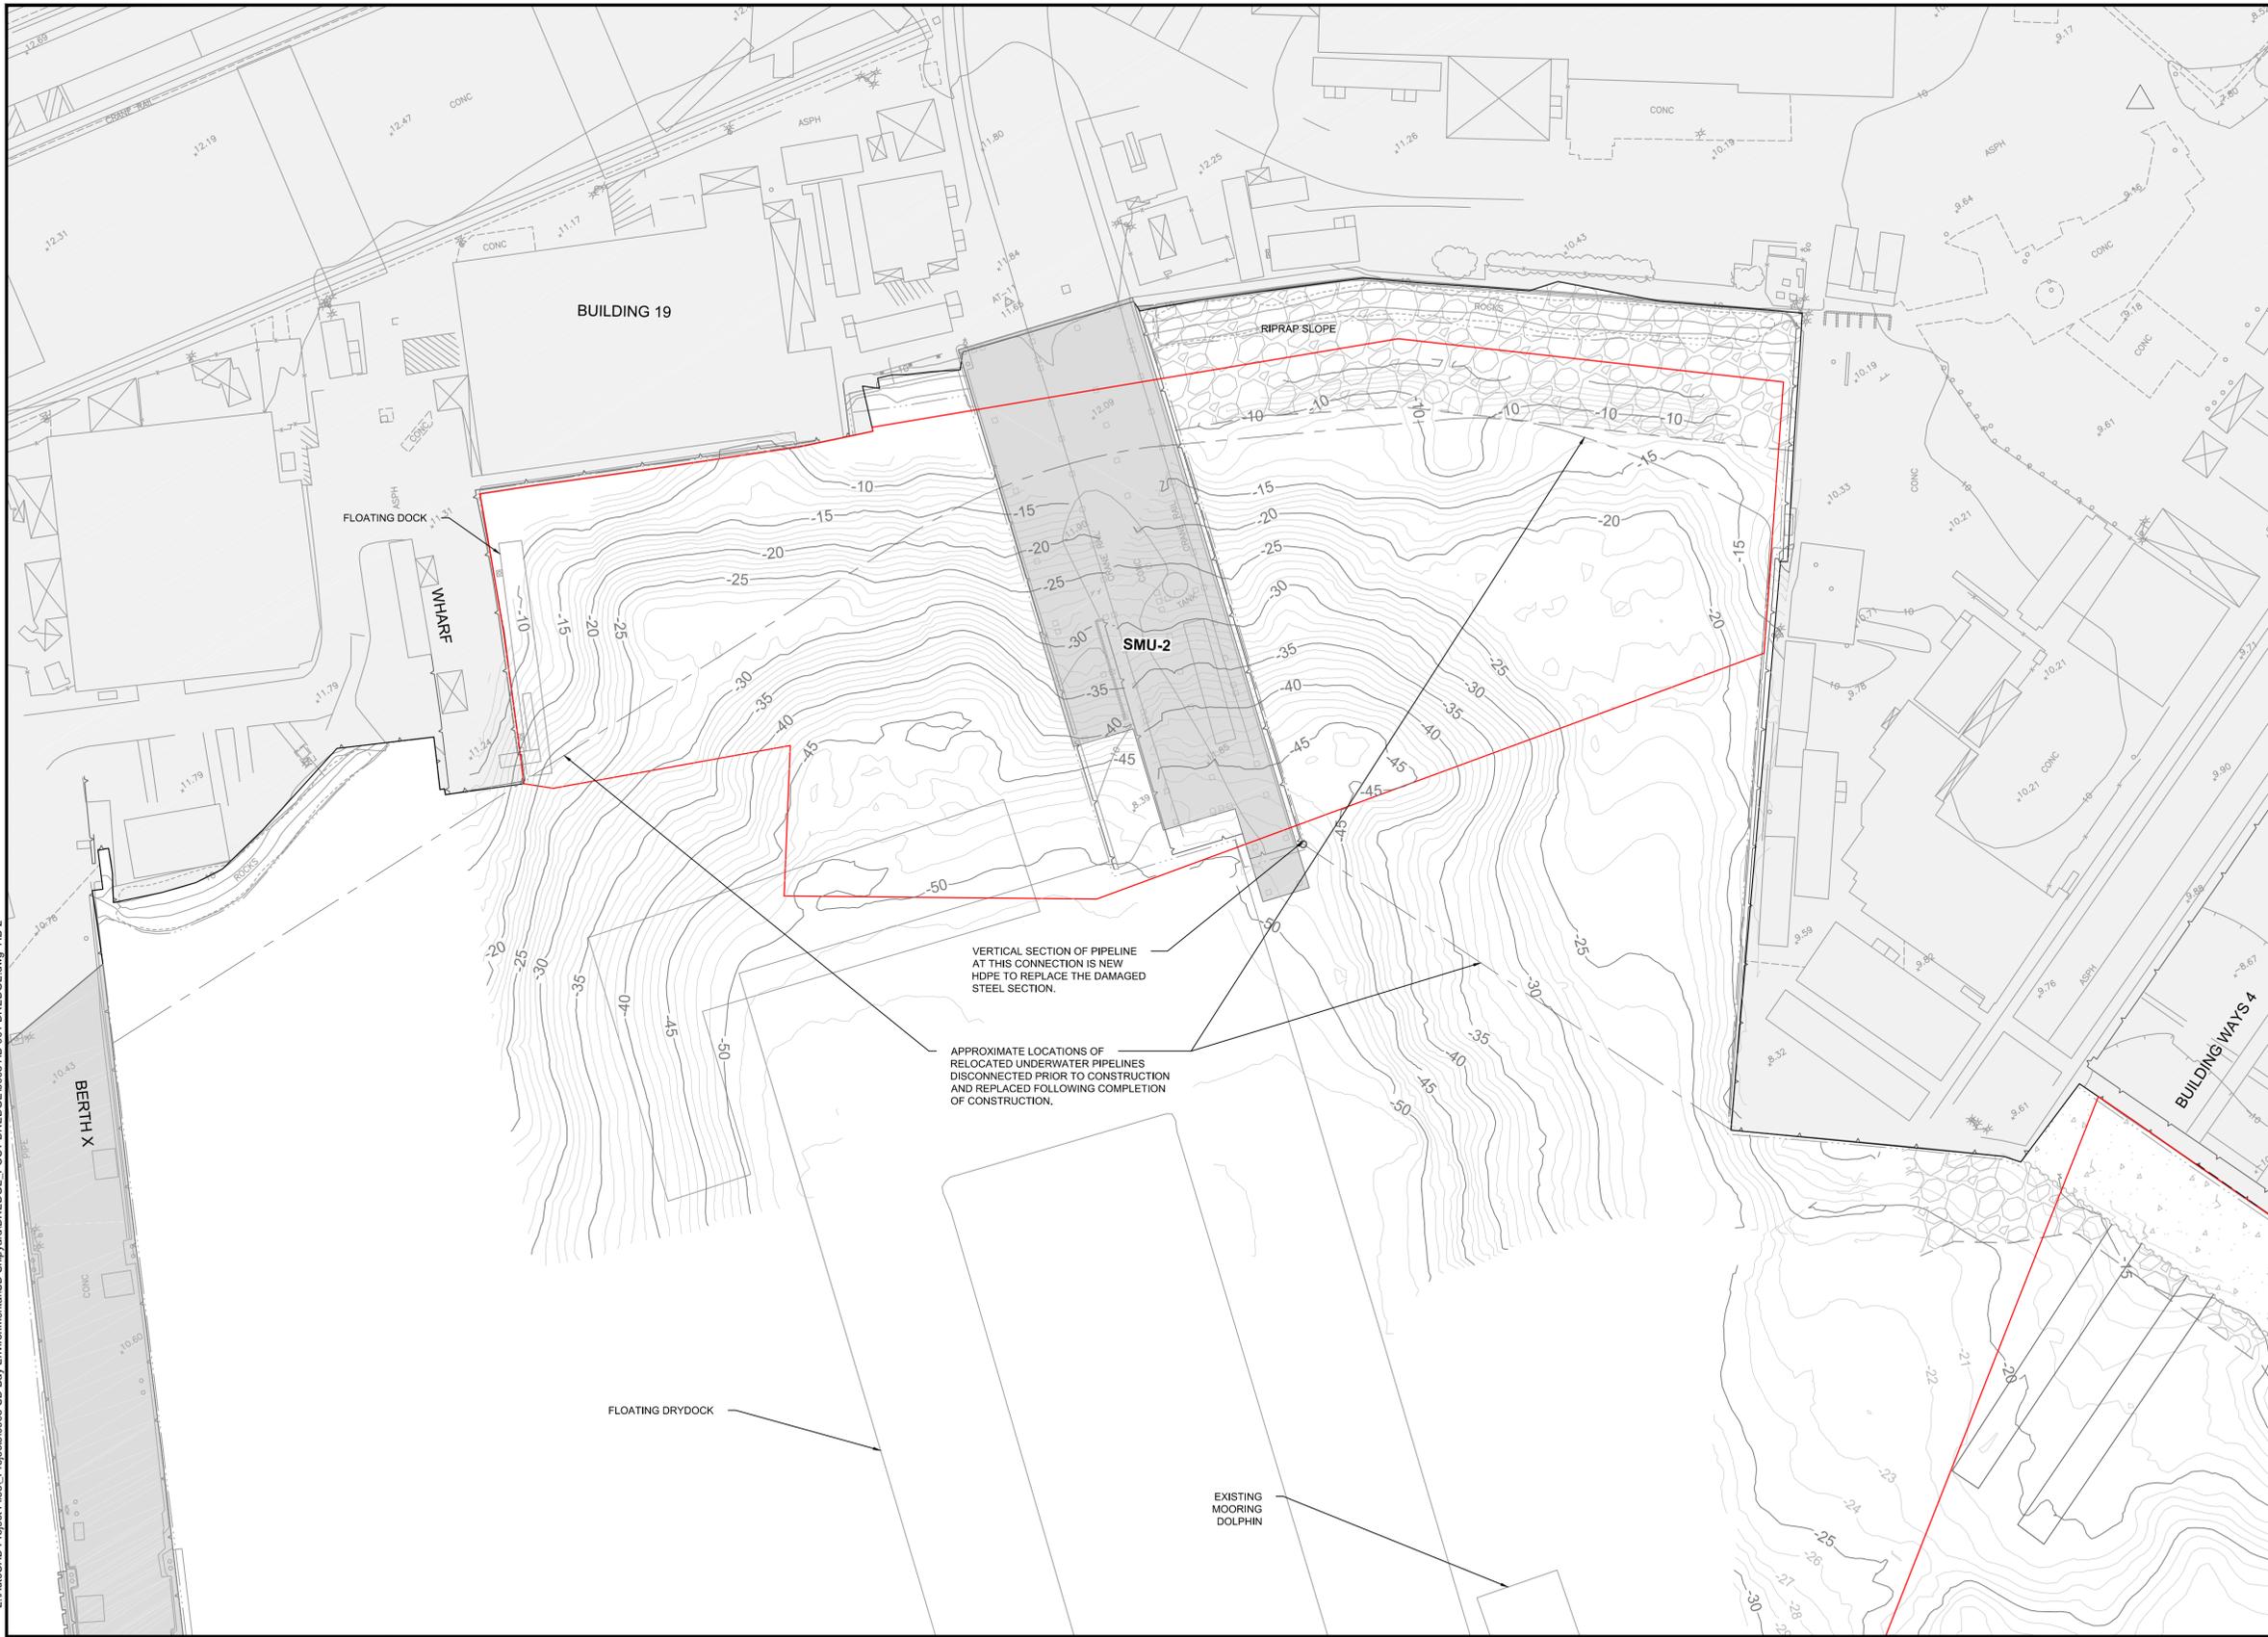
**AS-BUILT CONDITIONS (2)**

**NOTE:**  
 1. BATHYMETRY FROM SURVEYS PERFORMED BY GAHAGAN & BRYANT ASSOCIATES, INC., ON FEBRUARY 27 AND MARCH 25, 2014.

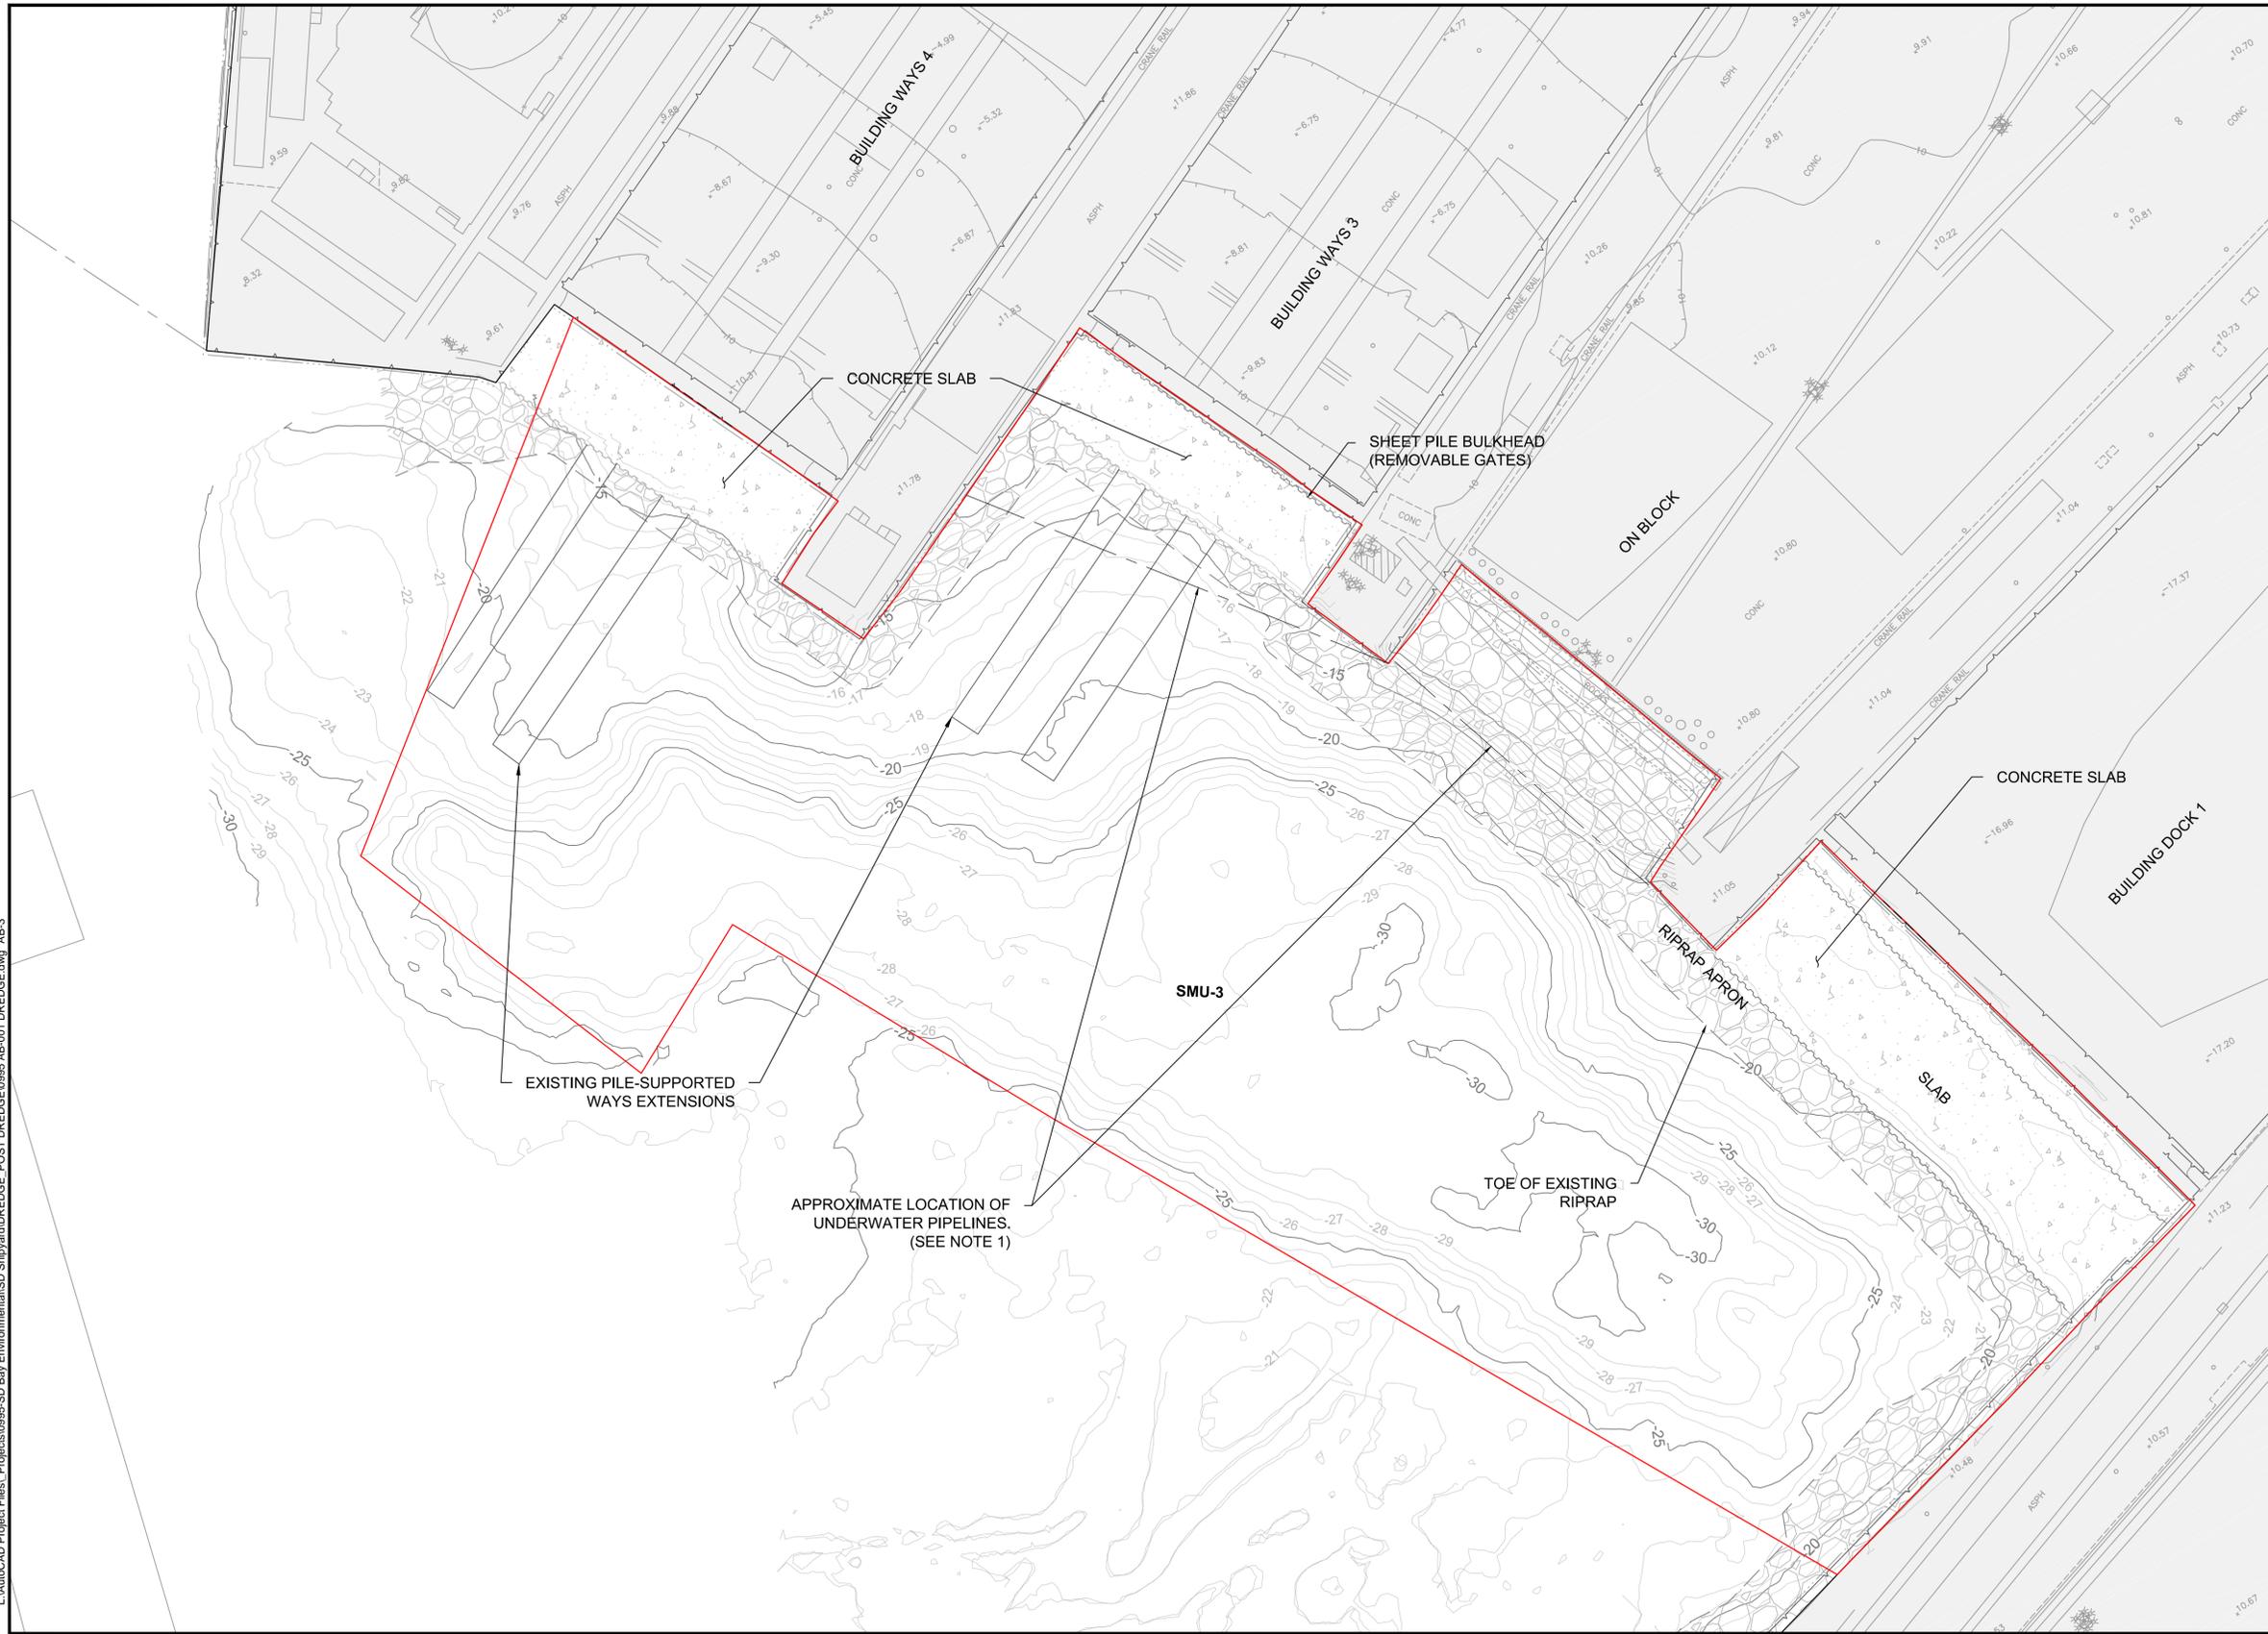
**AS-BUILT CONDITIONS (3)**

1. RELOCATION OF UNDERWATER PIPELINE IN SMU-3 WAS NOT REQUIRED FOR REMEDIAL DREDGING.
2. BATHYMETRY FROM SURVEY PERFORMED BY GAHAGAN & BRYANT ASSOCIATES, INC., ON MARCH 24, 2014.

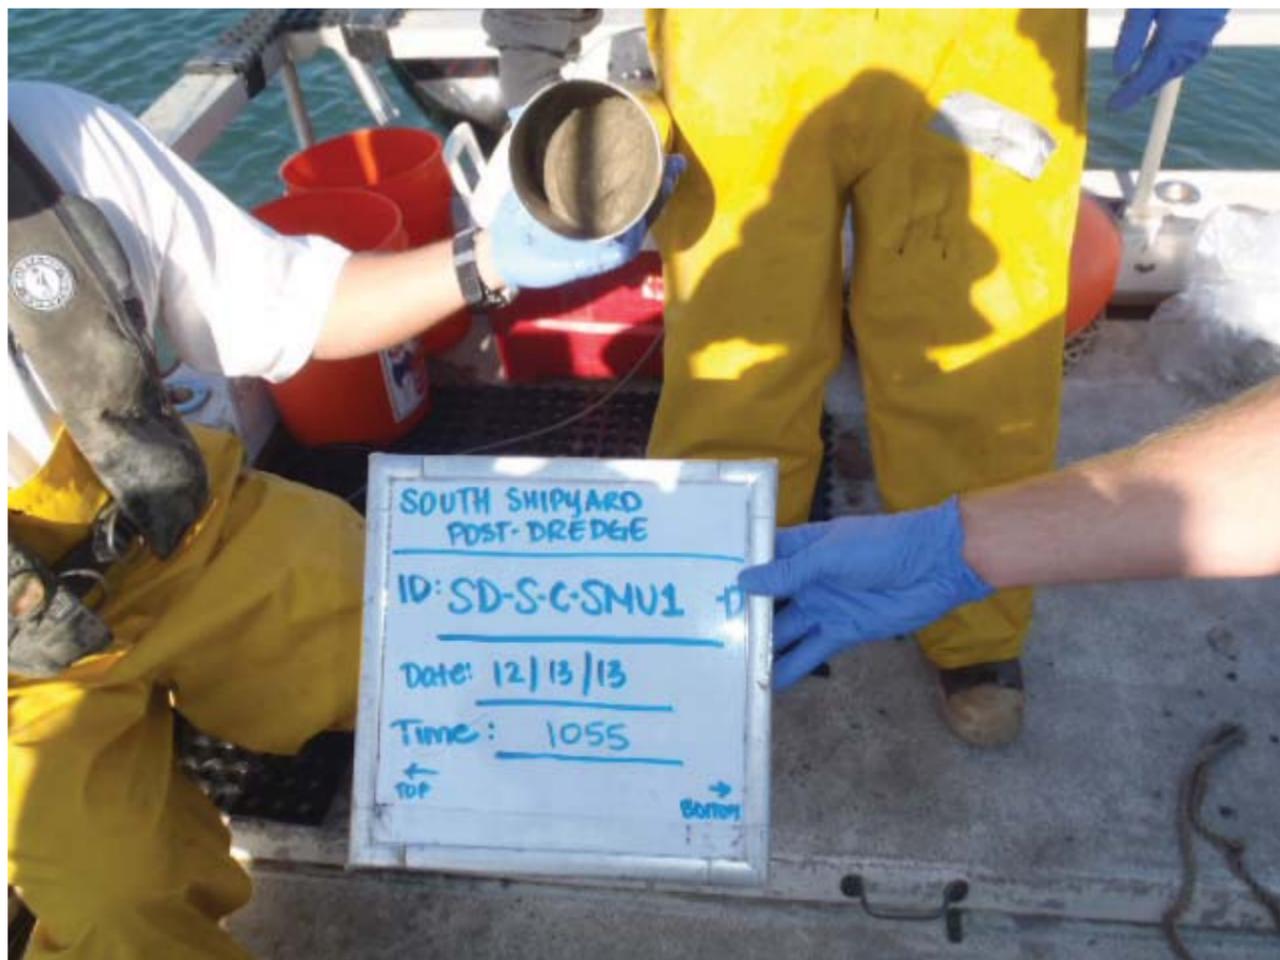
Location: South Shipyard - San Diego Bay  
Sample ID: SD-S-C-SMU1A-D  
Core Length: Plug  
Sample Date & Time: 12/13/2013 1055

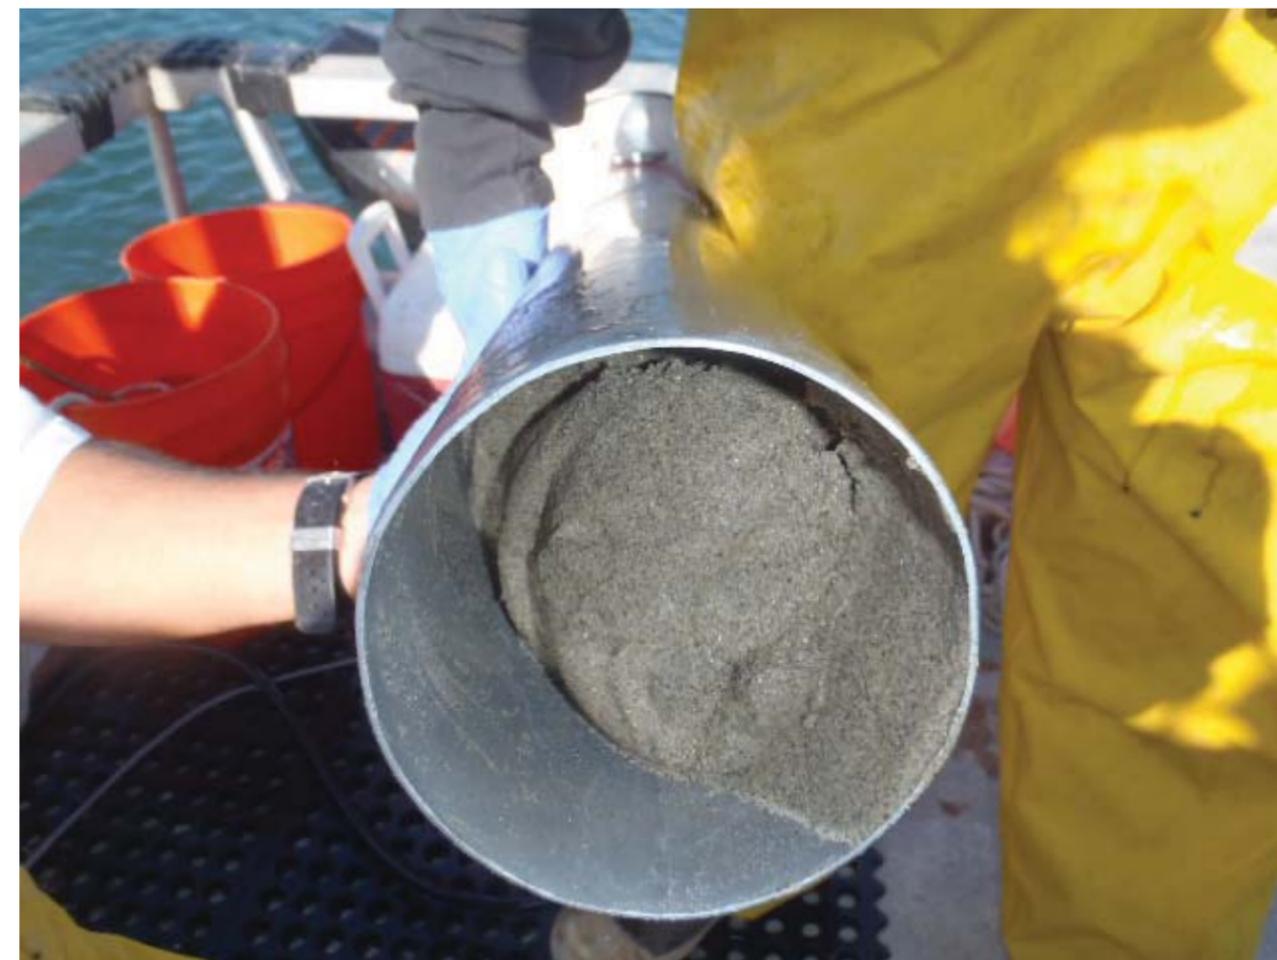
Location: South Shipyard - San Diego Bay  
Sample ID: SD-S-C-SMU1A-D  
Core Length: Plug Closeup  
Sample Date & Time: 12/13/2013 1055

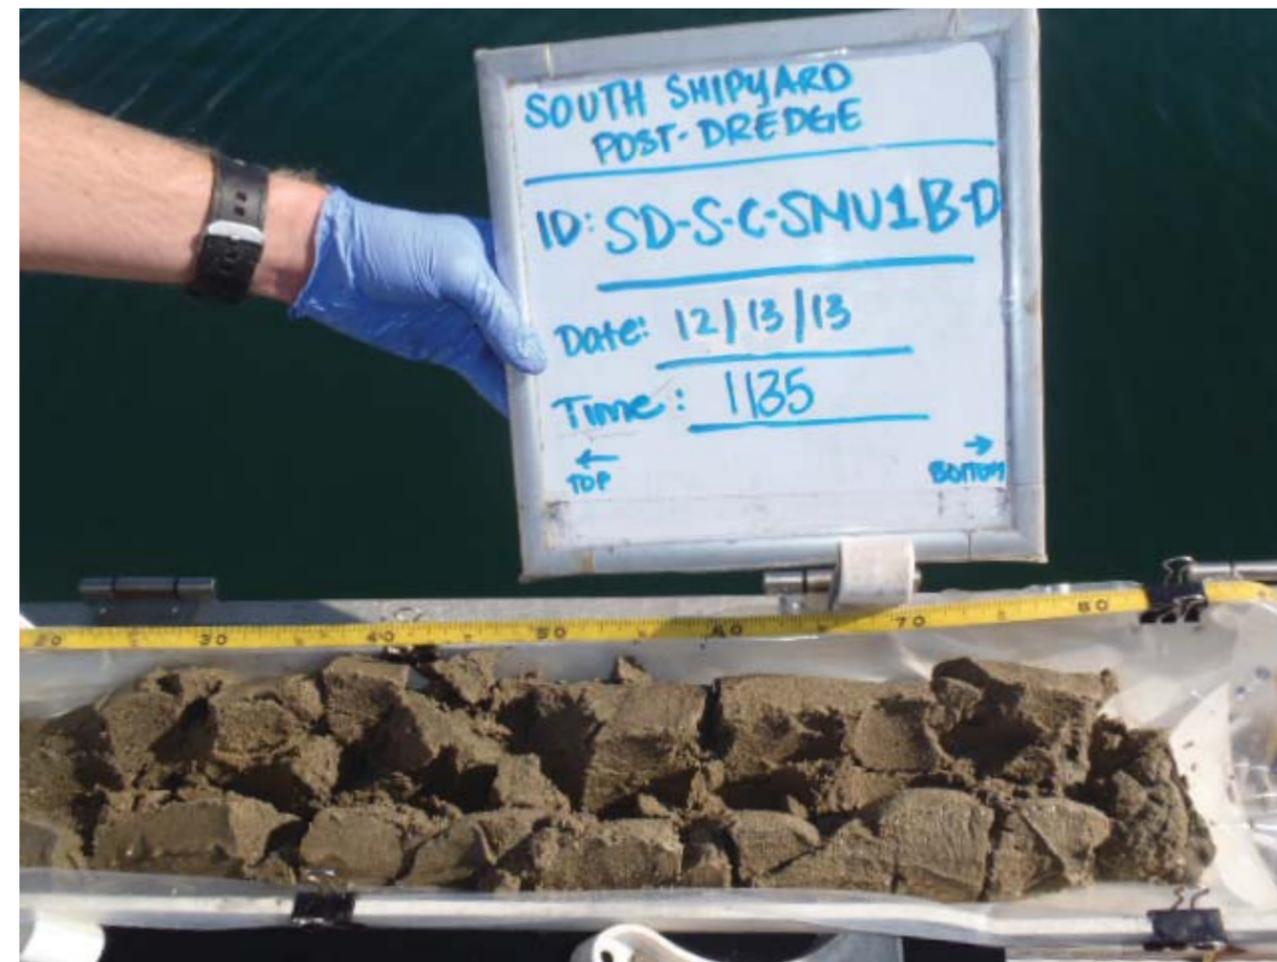
Location: South Shipyard - San Diego Bay  
Sample ID: SD-S-C-SMU1B-D  
Core Length: 20 - 80 cm.  
Sample Date & Time: 12/13/2013 1135

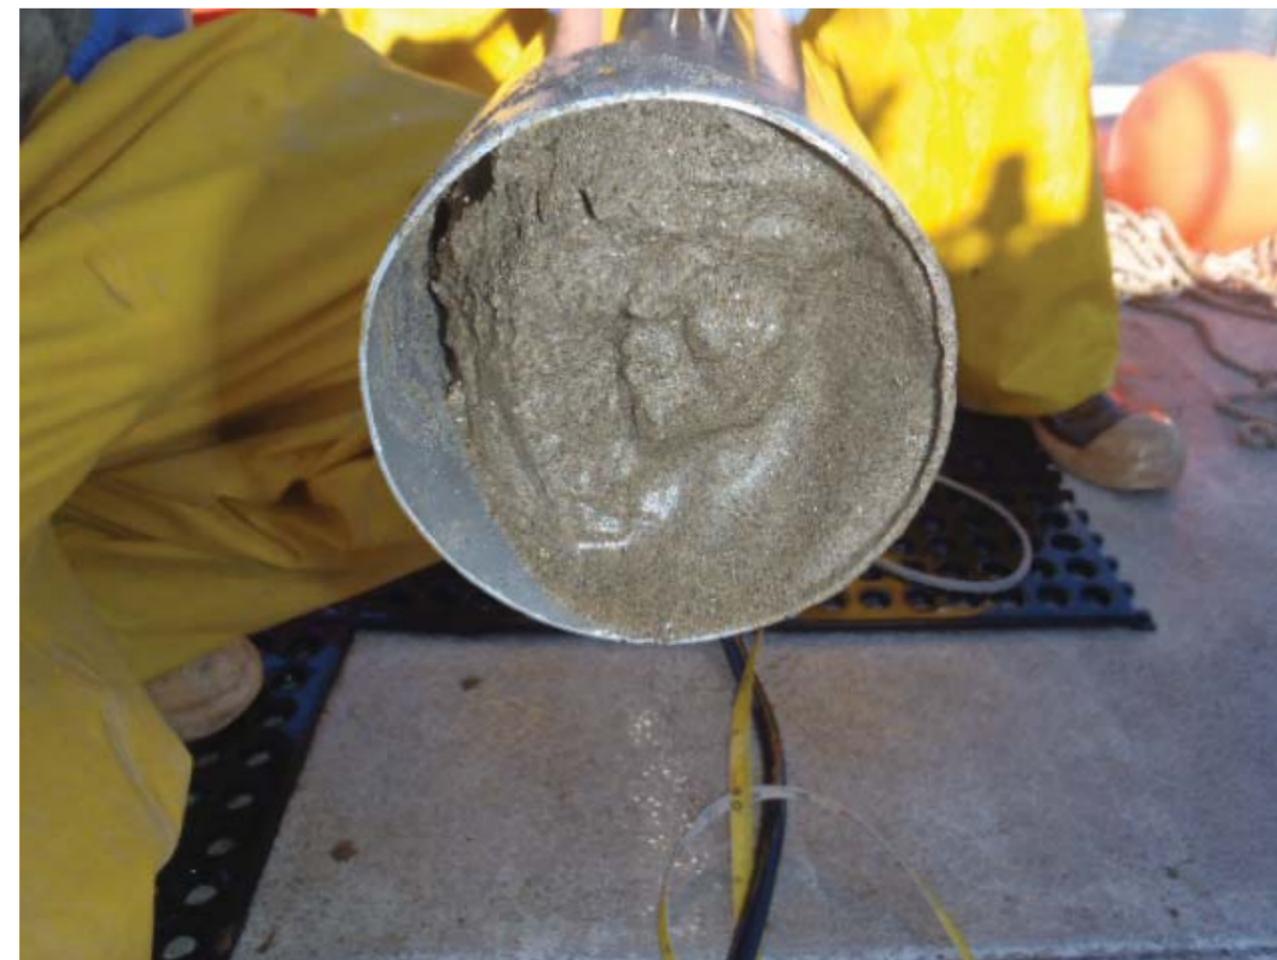
Location: South Shipyard - San Diego Bay  
Sample ID: SD-S-C-SMU1B-D  
Core Length: Plug Closeup  
Sample Date & Time: 12/13/2013 1135

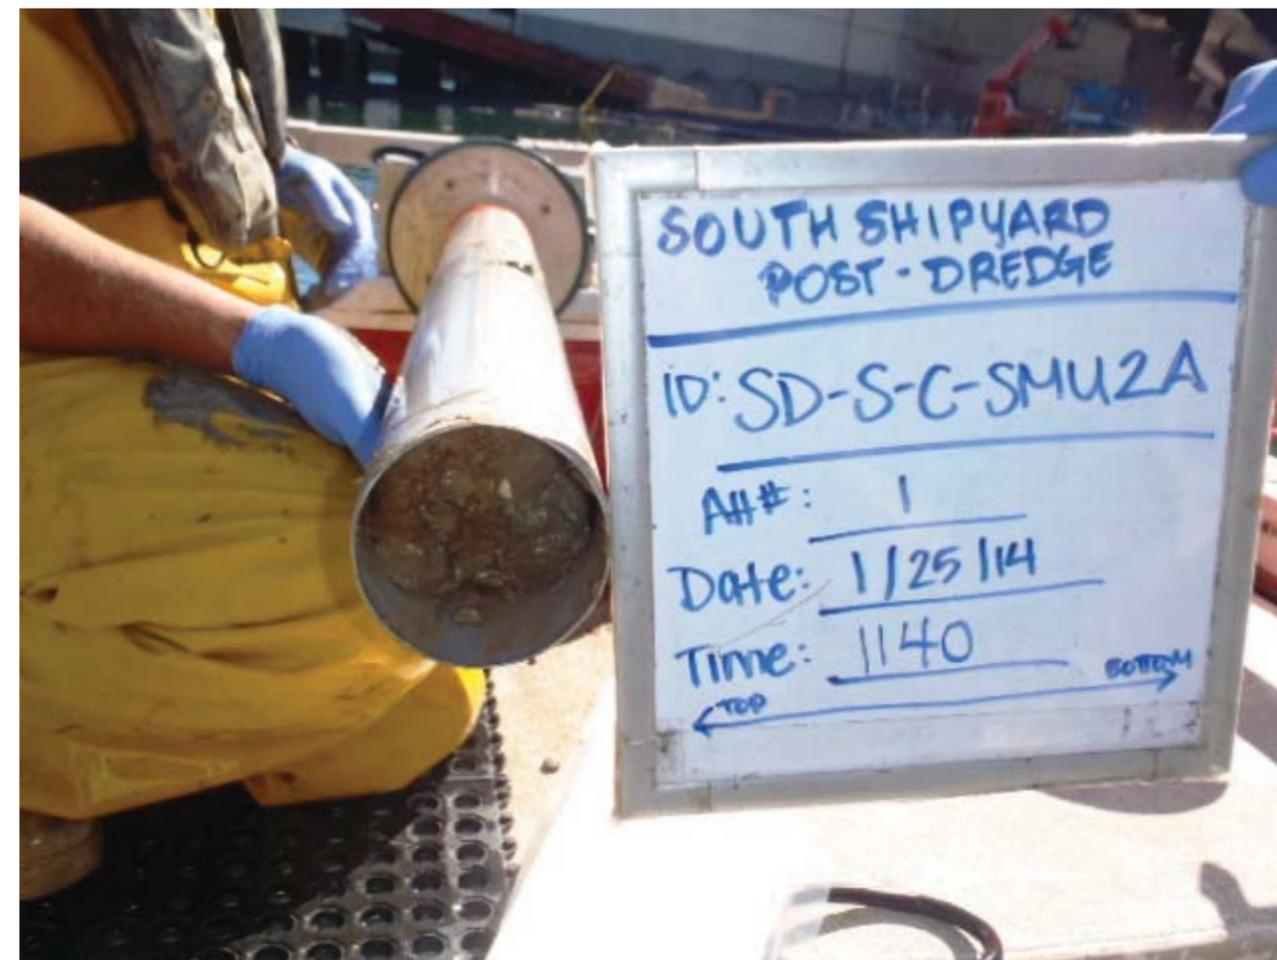
Location: South Shipyard - San Diego Bay  
Sample ID: SD-S-C-SMU2A  
Core Length: Plug  
Sample Date & Time: 01/25/2014 1140

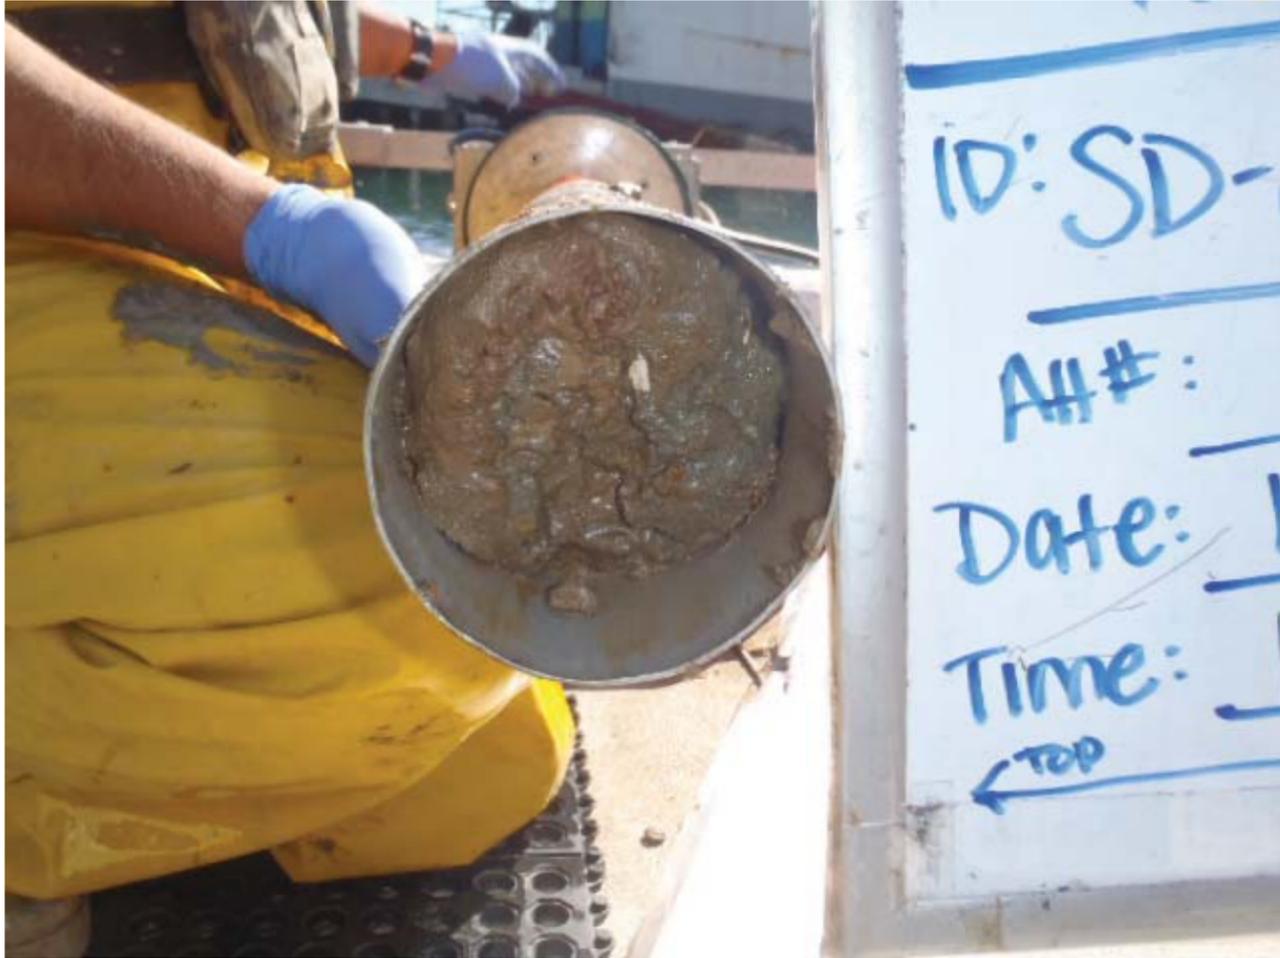
Location: South Shipyard - San Diego Bay  
Sample ID: SD-S-C-SMU2A  
Core Length: Plug Closeup  
Sample Date & Time: 01/25/2014 1140

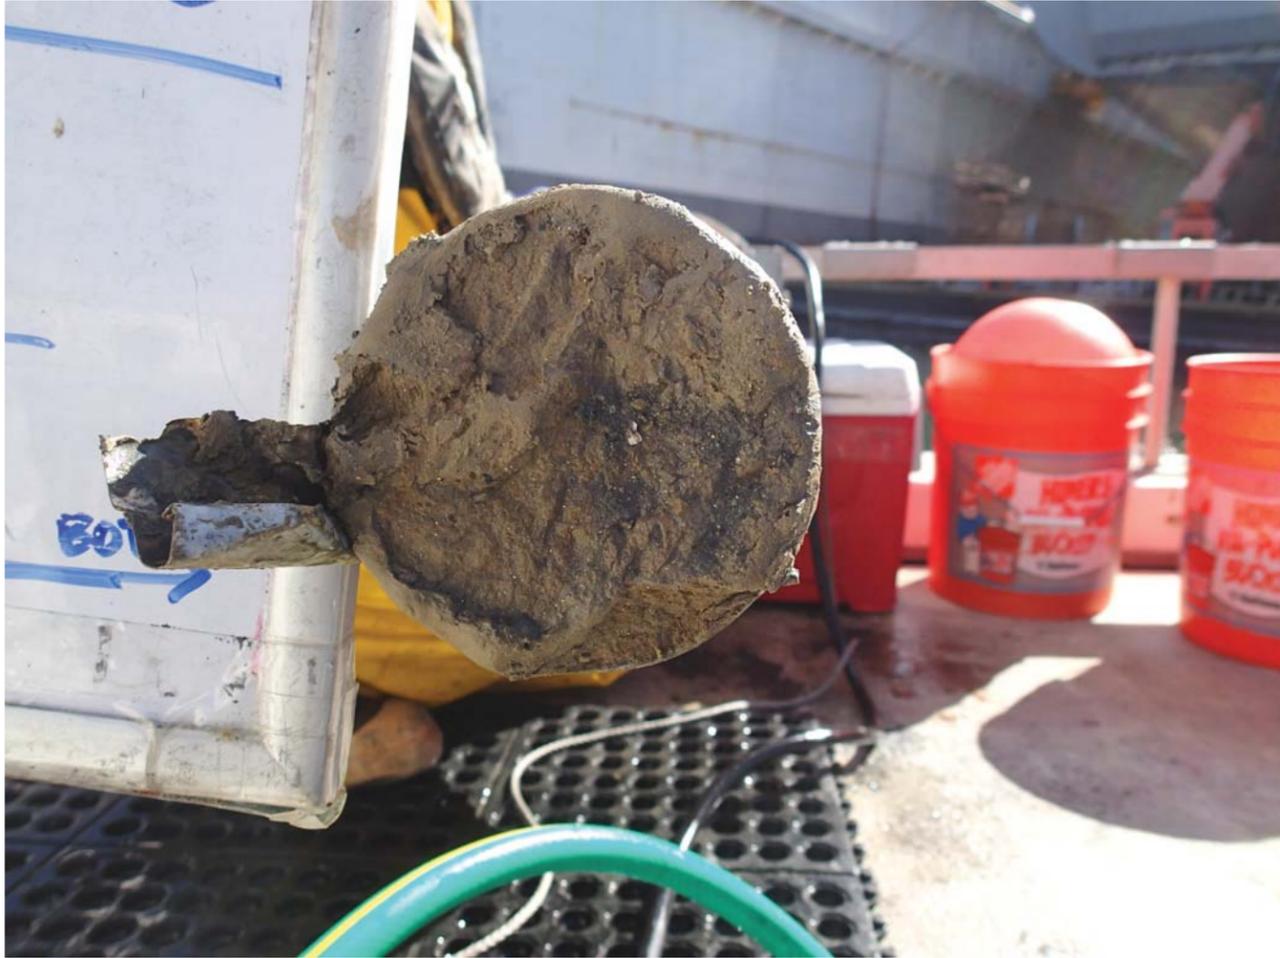
Location: South Shipyard - San Diego Bay  
Sample ID: SD-S-C-SMU2B  
Core Length: Plug Closeup  
Sample Date & Time: 01/25/2014 1245

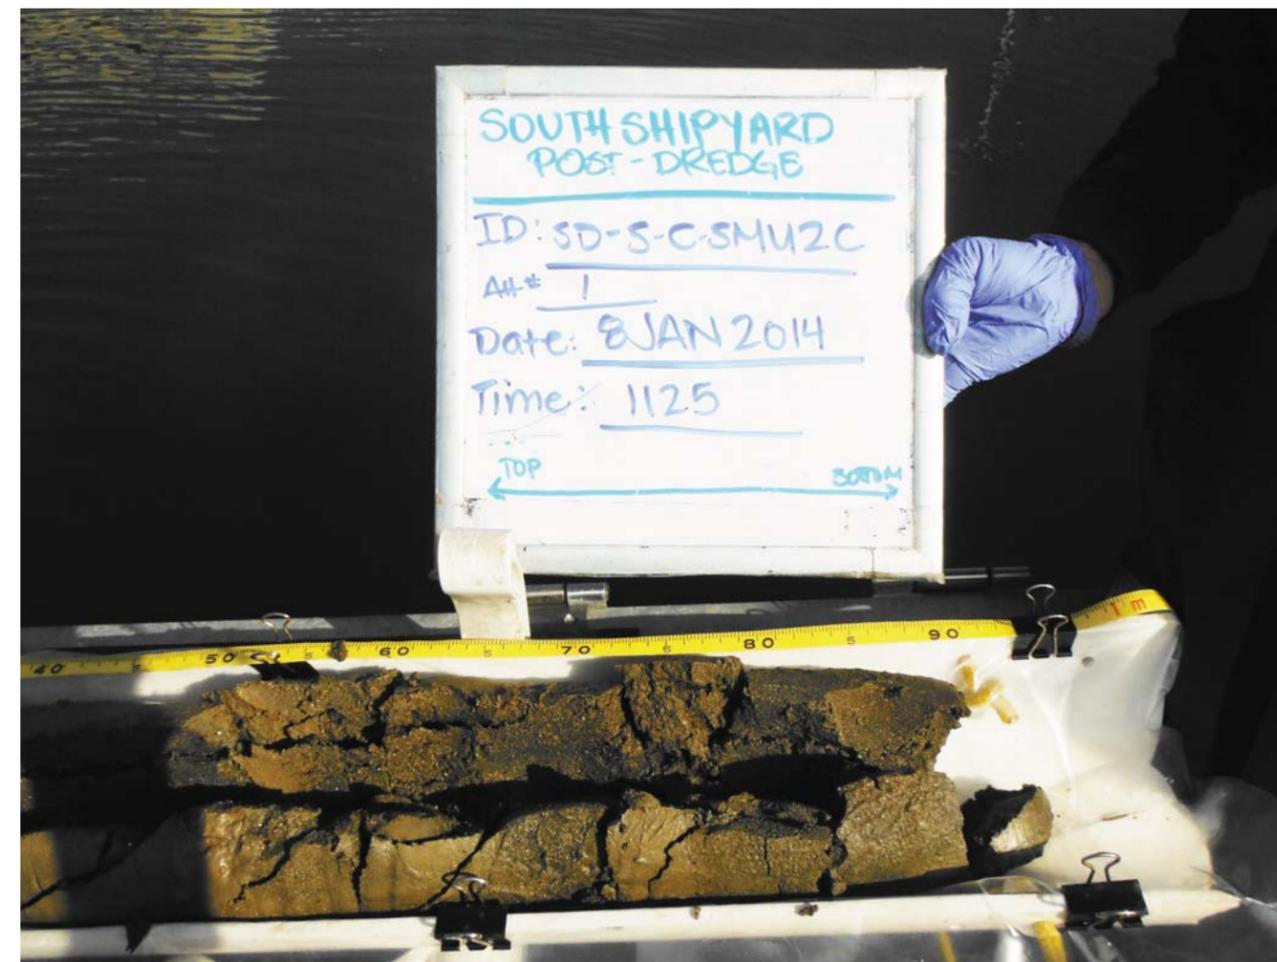
Location: South Shipyard - San Diego Bay  
Sample ID: SD-S-C-SMU2C  
Core Length: 50 - 90 cm.  
Sample Date & Time: 1/8/2014 1125

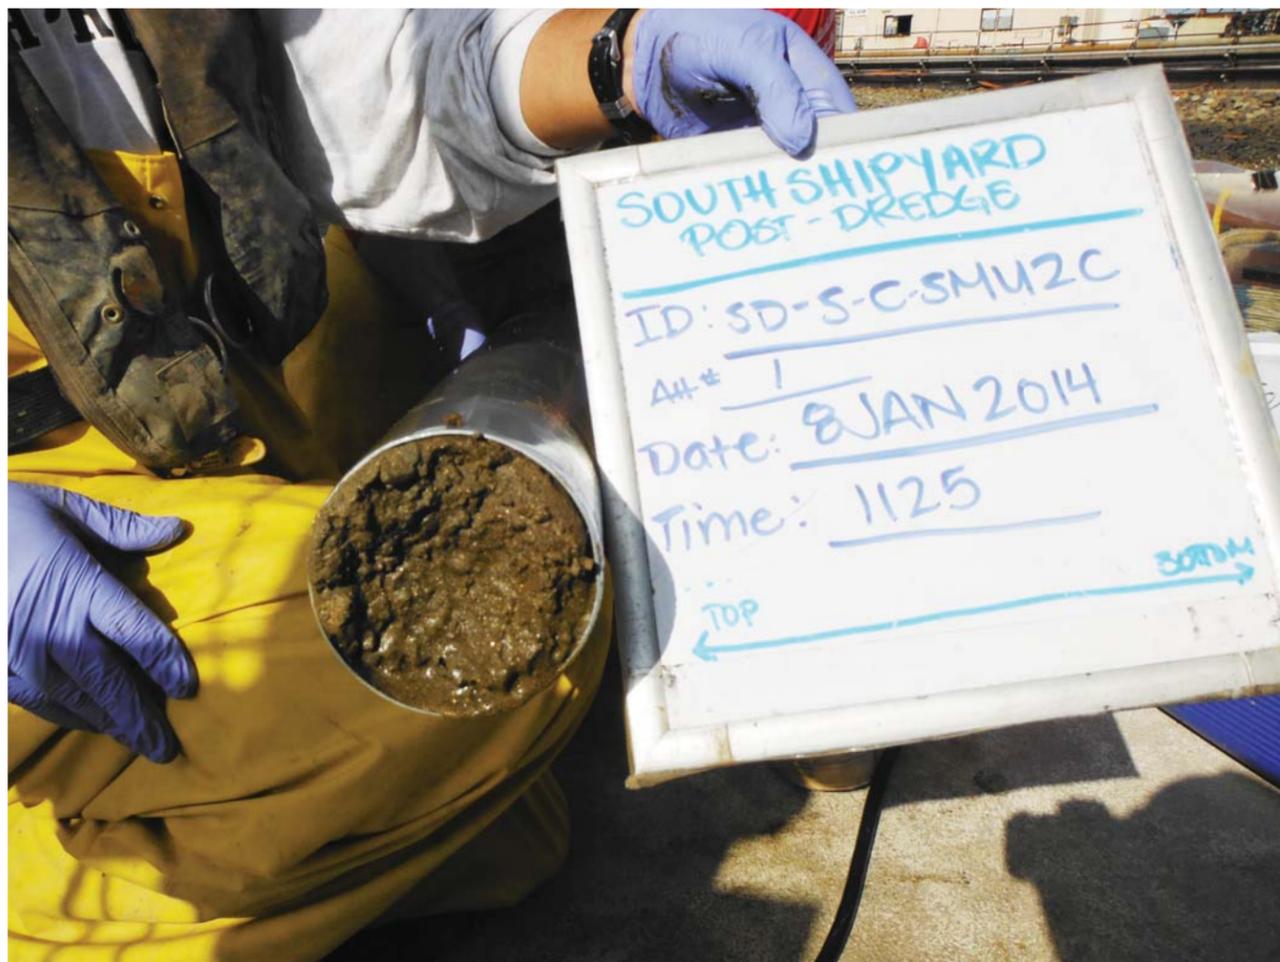
Location: South Shipyard - San Diego Bay  
Sample ID: SD-S-C-SMU2C  
Core Length: Plug  
Sample Date & Time: 1/8/2014 1125
