## FINAL CLEANUP AND ABATEMENT COMPLETION REPORT SAN DIEGO SHIPYARD SEDIMENT SITE – SOUTH SHIPYARD

National Steel and Shipbuilding Company

Anchor QEA, LLC

**June 2014**

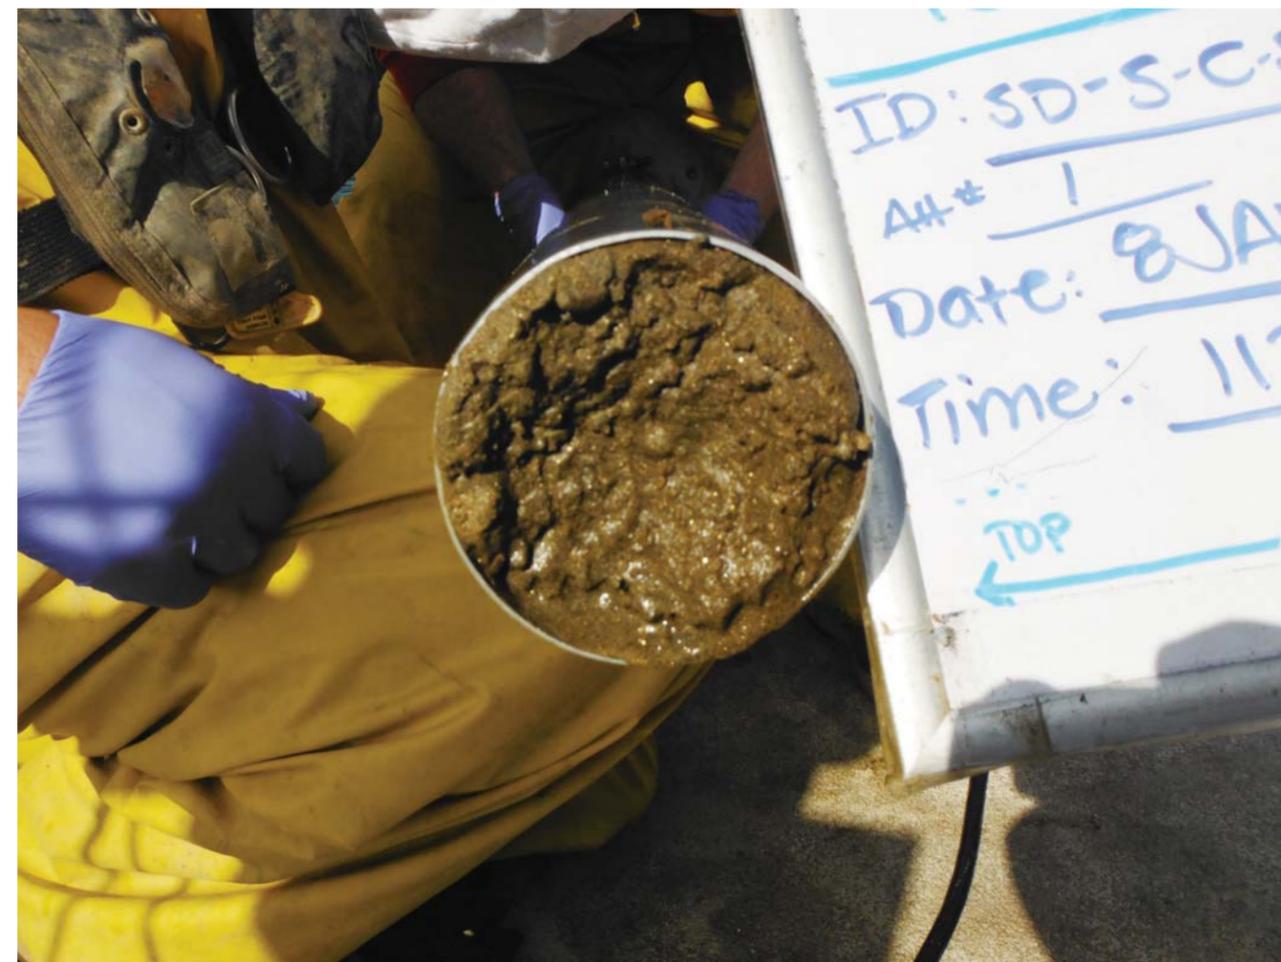
Location: South Shipyard - San Diego Bay  
Sample ID: SD-S-C-SMU2C  
Core Length: Plug Closeup  
Sample Date & Time: 1/8/2014 1125

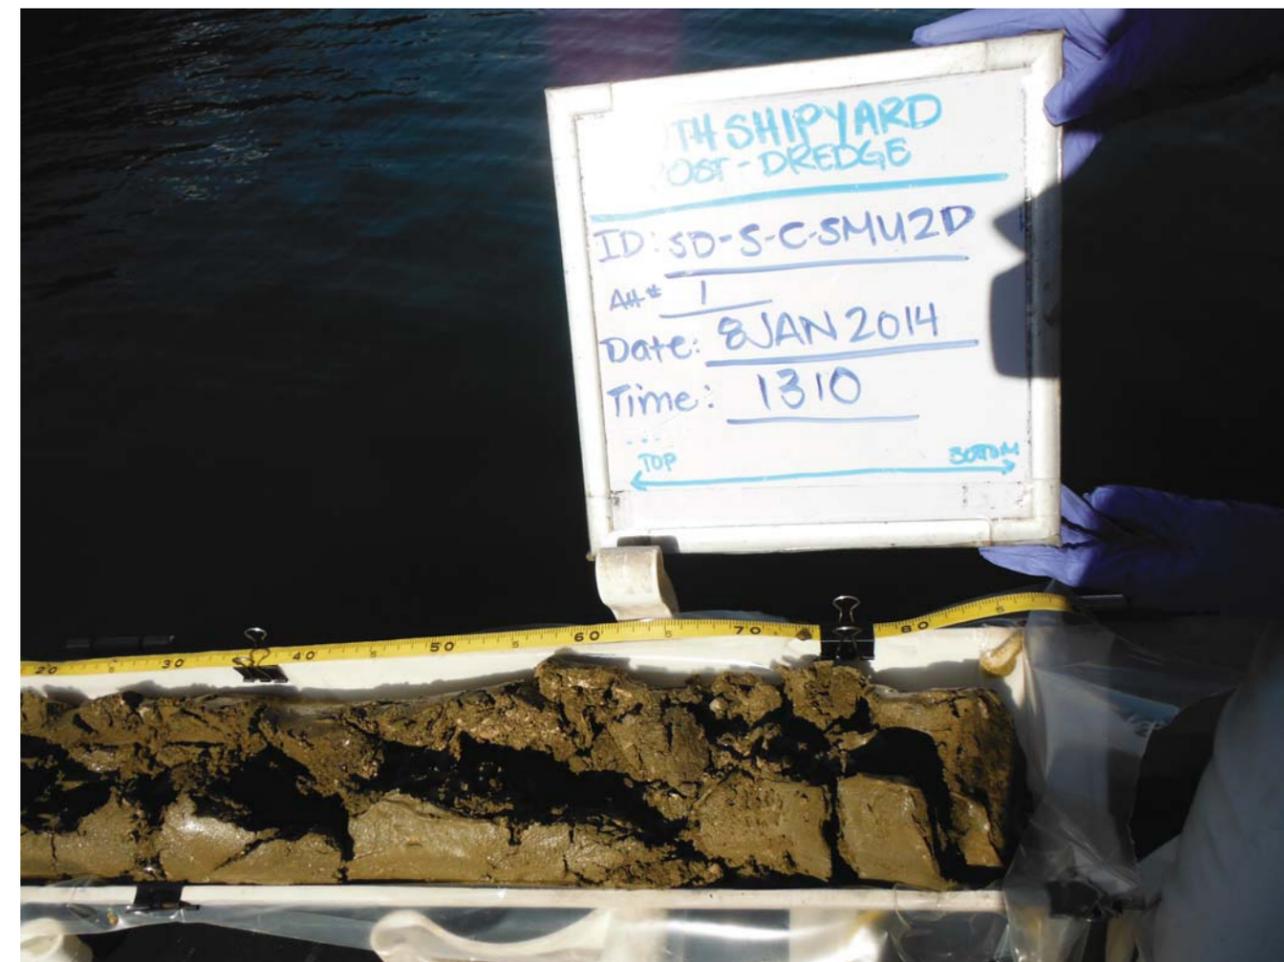
Location: South Shipyard - San Diego Bay  
Sample ID: SD-S-C-SMU2D  
Core Length: 30 - 85 cm.  
Sample Date & Time: 1/8/2014 1310

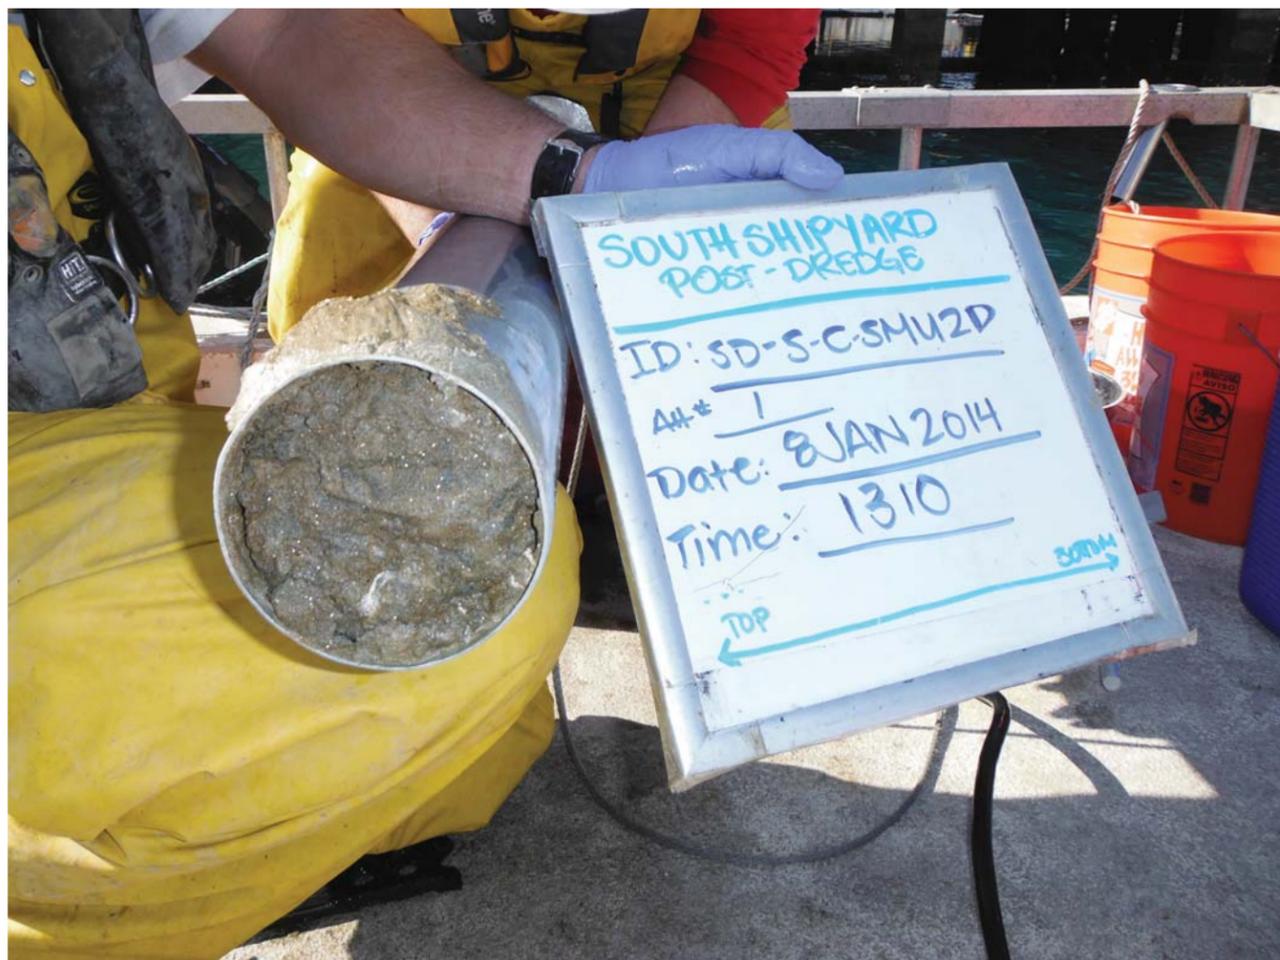
Location: South Shipyard - San Diego Bay  
Sample ID: SD-S-C-SMU2D  
Core Length: Plug  
Sample Date & Time: 1/8/2014 1310

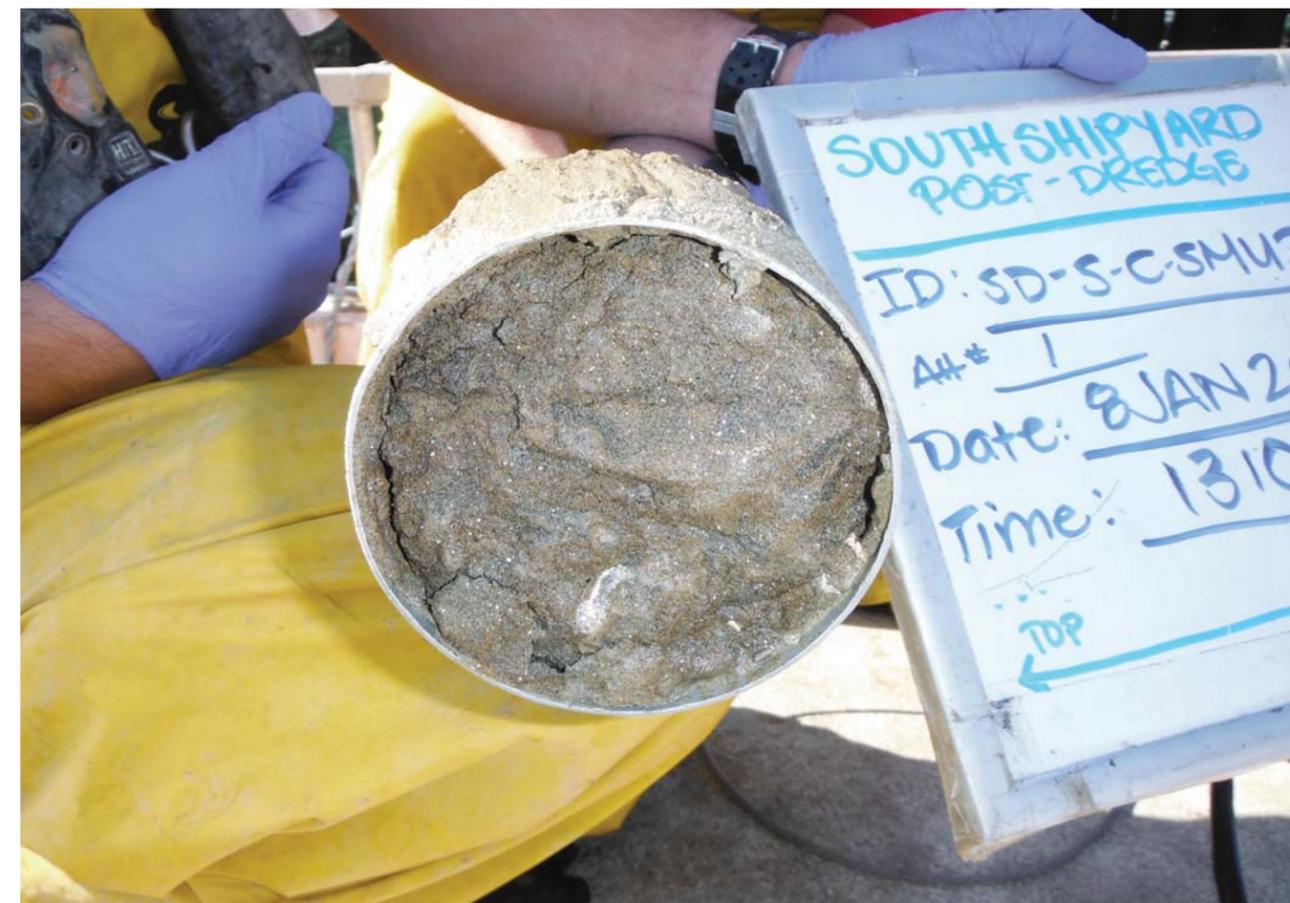
Location: South Shipyard - San Diego Bay  
Sample ID: SD-S-C-SMU2D  
Core Length: Plug Closeup  
Sample Date & Time: 1/8/2014 1310

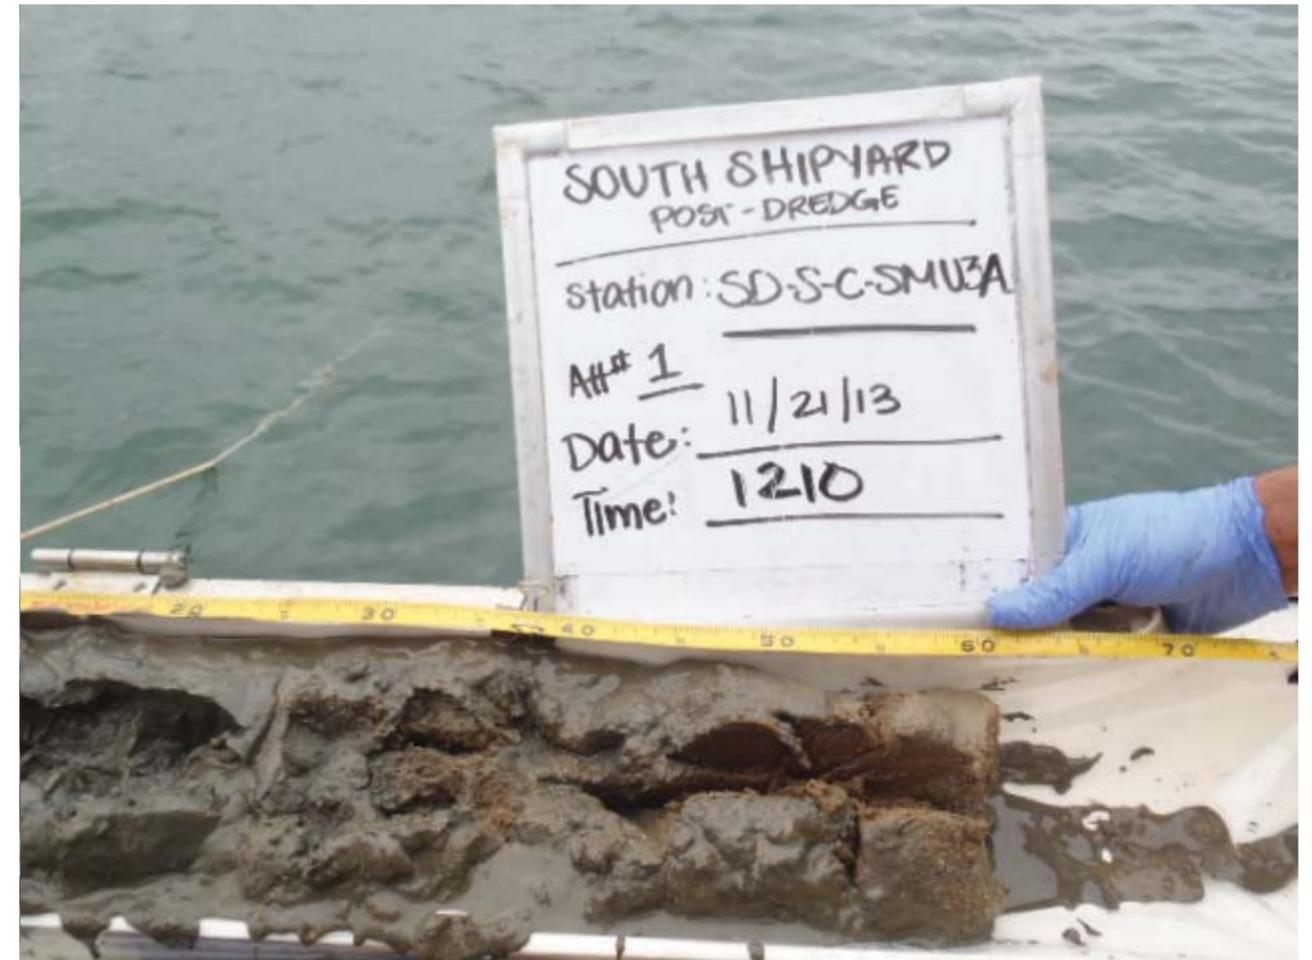
Location: South Shipyard - San Diego Bay  
Sample ID: SD-S-C-SMU3A-D  
Attempt #: 1  
Core Length: 15 - 60 cm.  
Sample Date & Time: 11/21/2013 1210

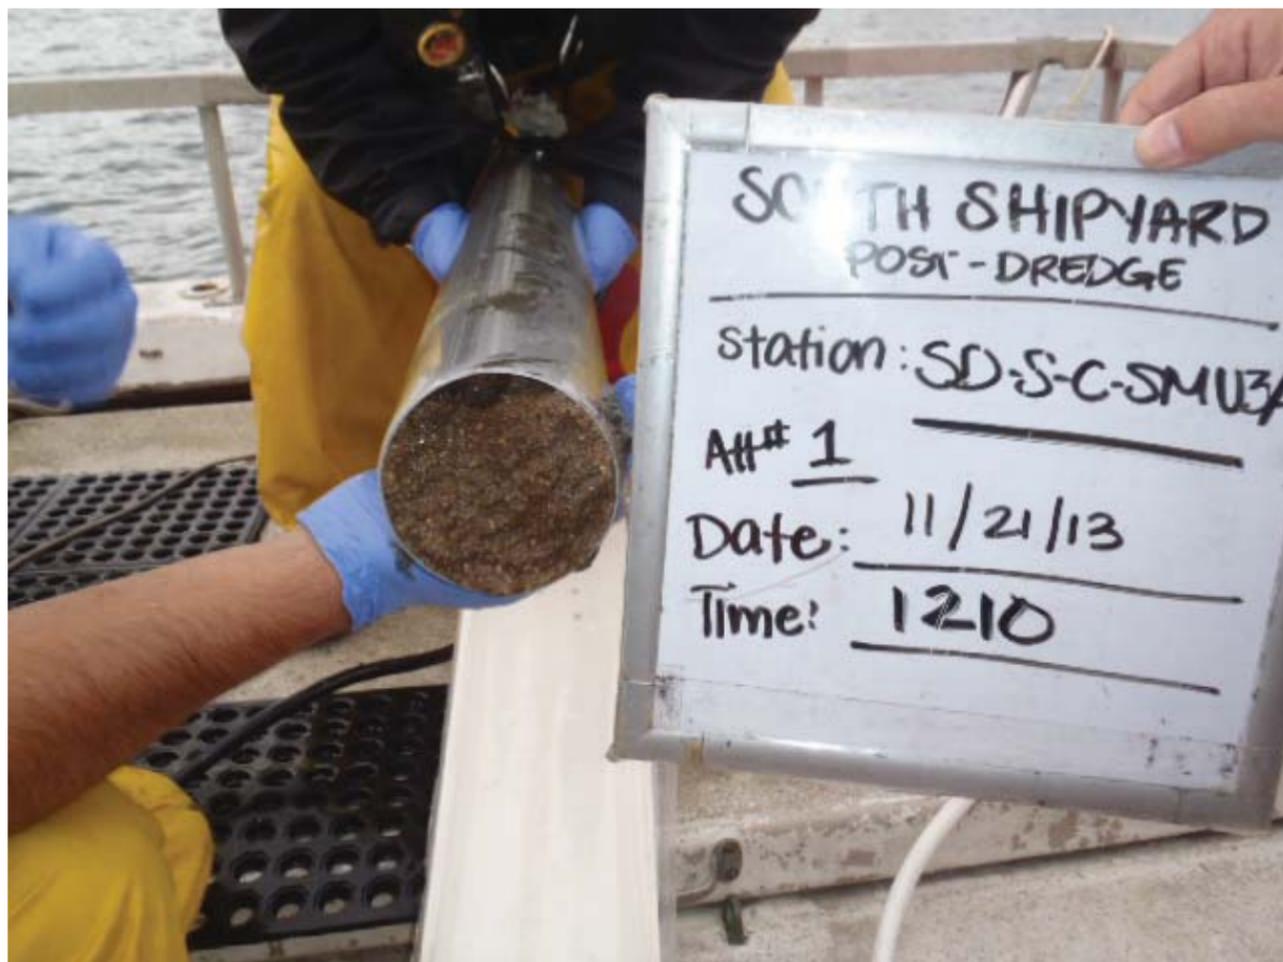
Location: South Shipyard - San Diego Bay  
Sample ID: SD-S-C-SMU3A-D  
Attempt #: 1  
Core Length: Plug  
Sample Date & Time: 11/21/2013 1210

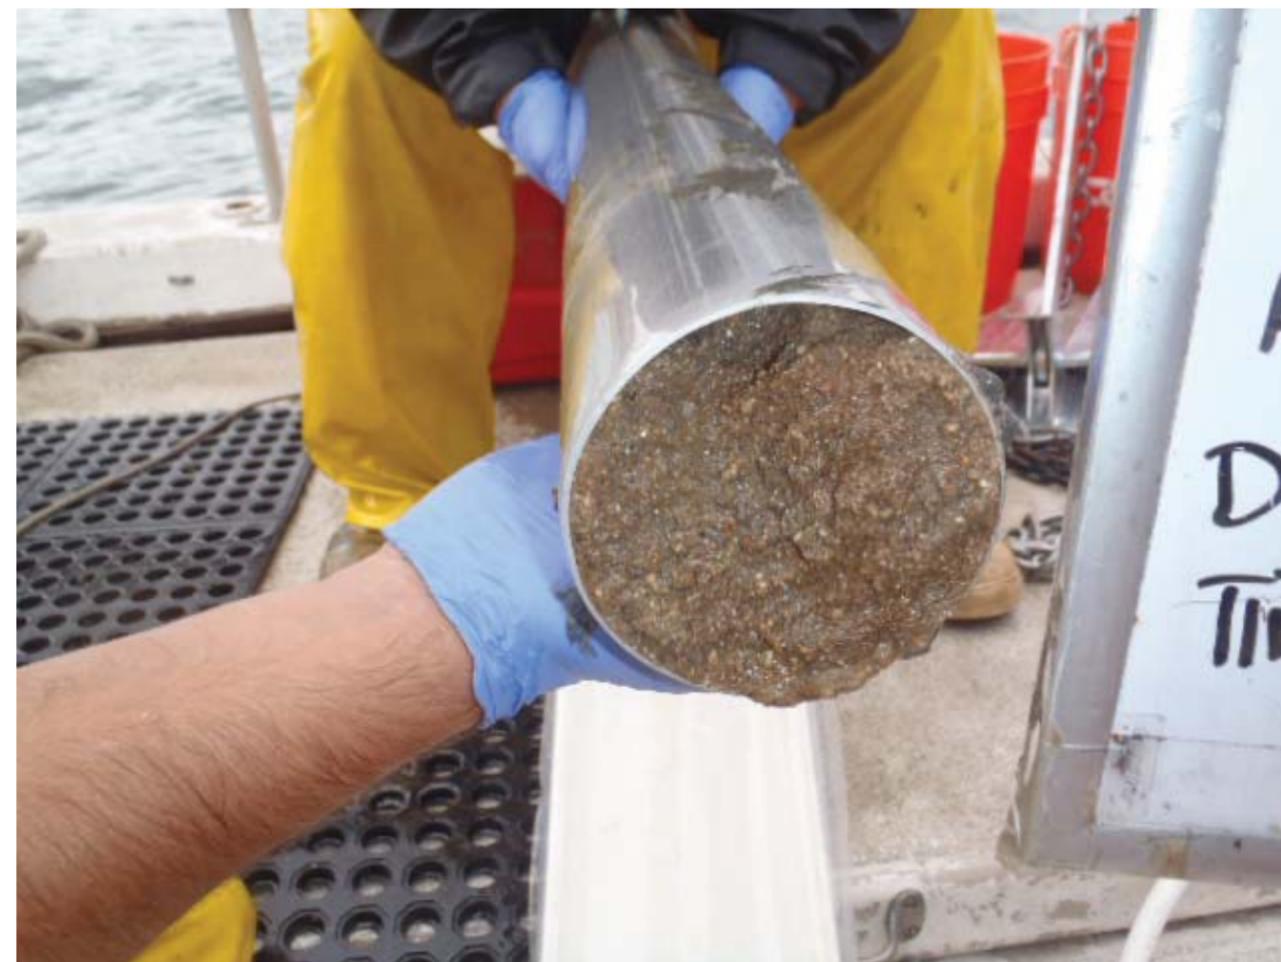
Location: South Shipyard - San Diego Bay  
Sample ID: SD-S-C-SMU3A-D  
Attempt #: 1  
Core Length: Plug Closeup  
Sample Date & Time: 11/21/2013 1210

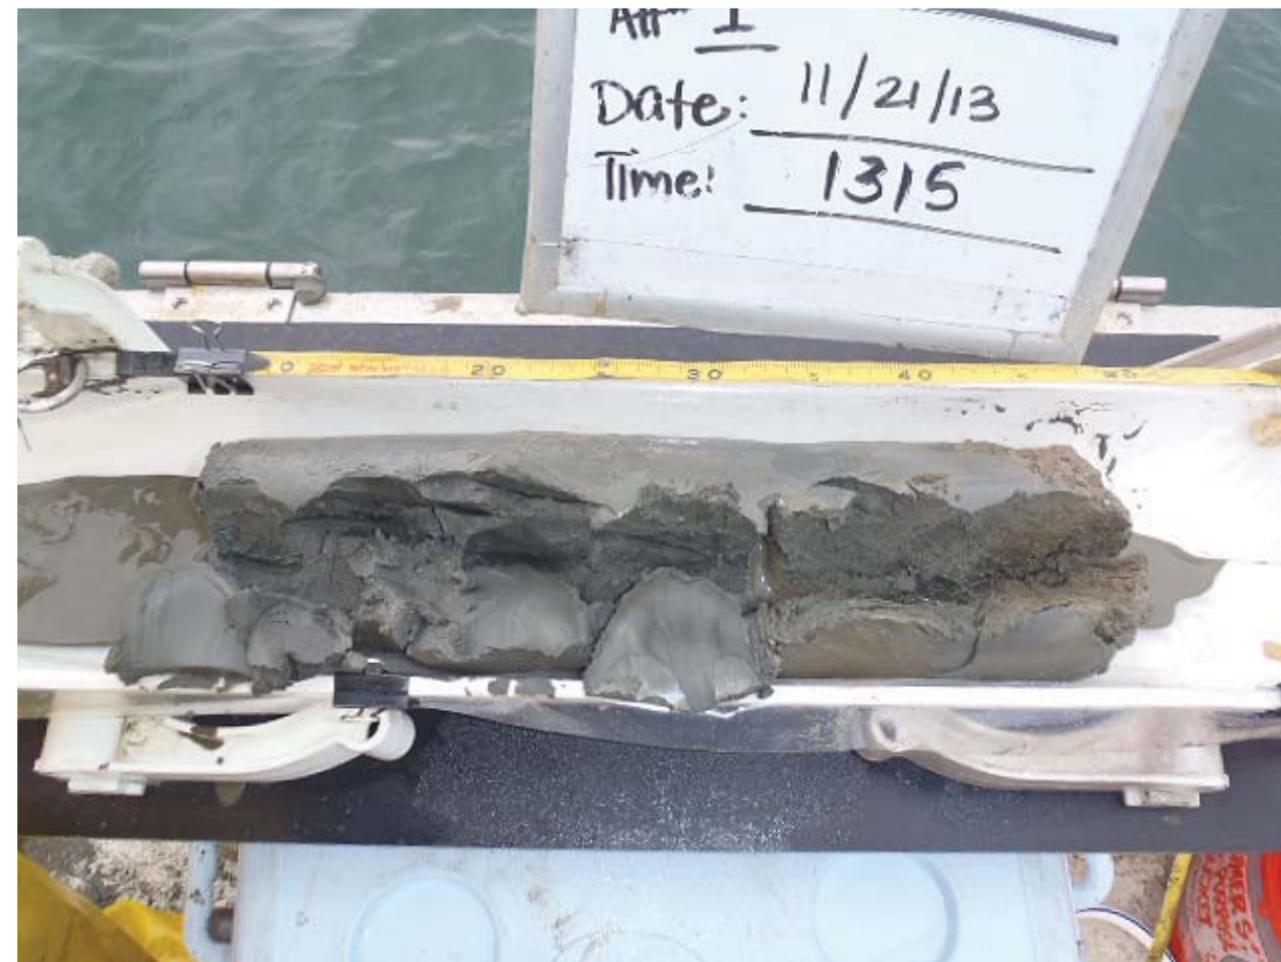
Location: South Shipyard - San Diego Bay  
Sample ID: SD-S-C-SMU3B-D  
Attempt #: 1  
Core Length: 0 - 43 cm. Closeup  
Sample Date & Time: 11/21/2013 1315

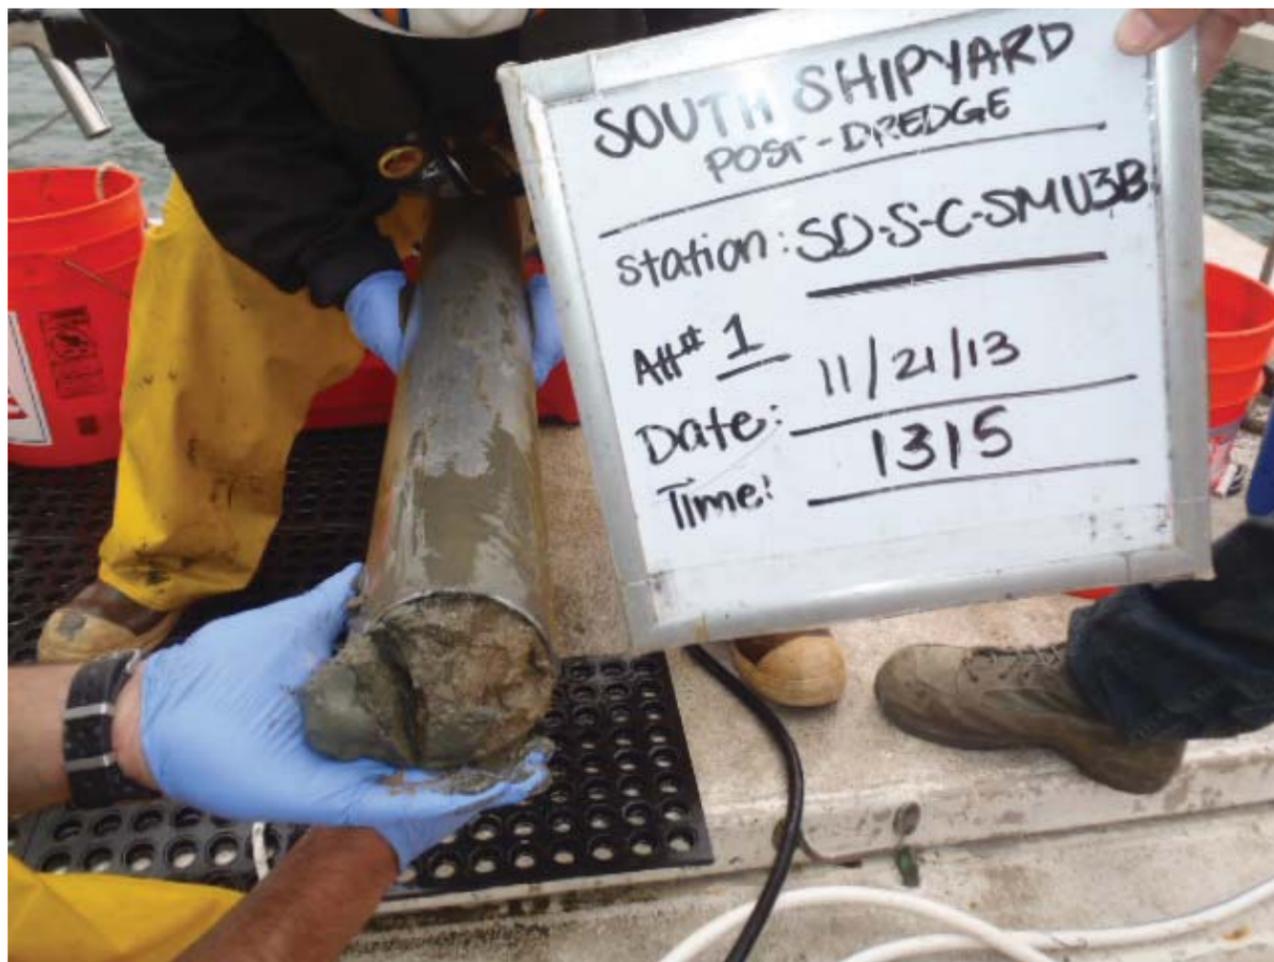
Location: South Shipyard - San Diego Bay  
Sample ID: SD-S-C-SMU3B-D  
Attempt #: 1  
Core Length: Plug  
Sample Date & Time: 11/21/2013 1315

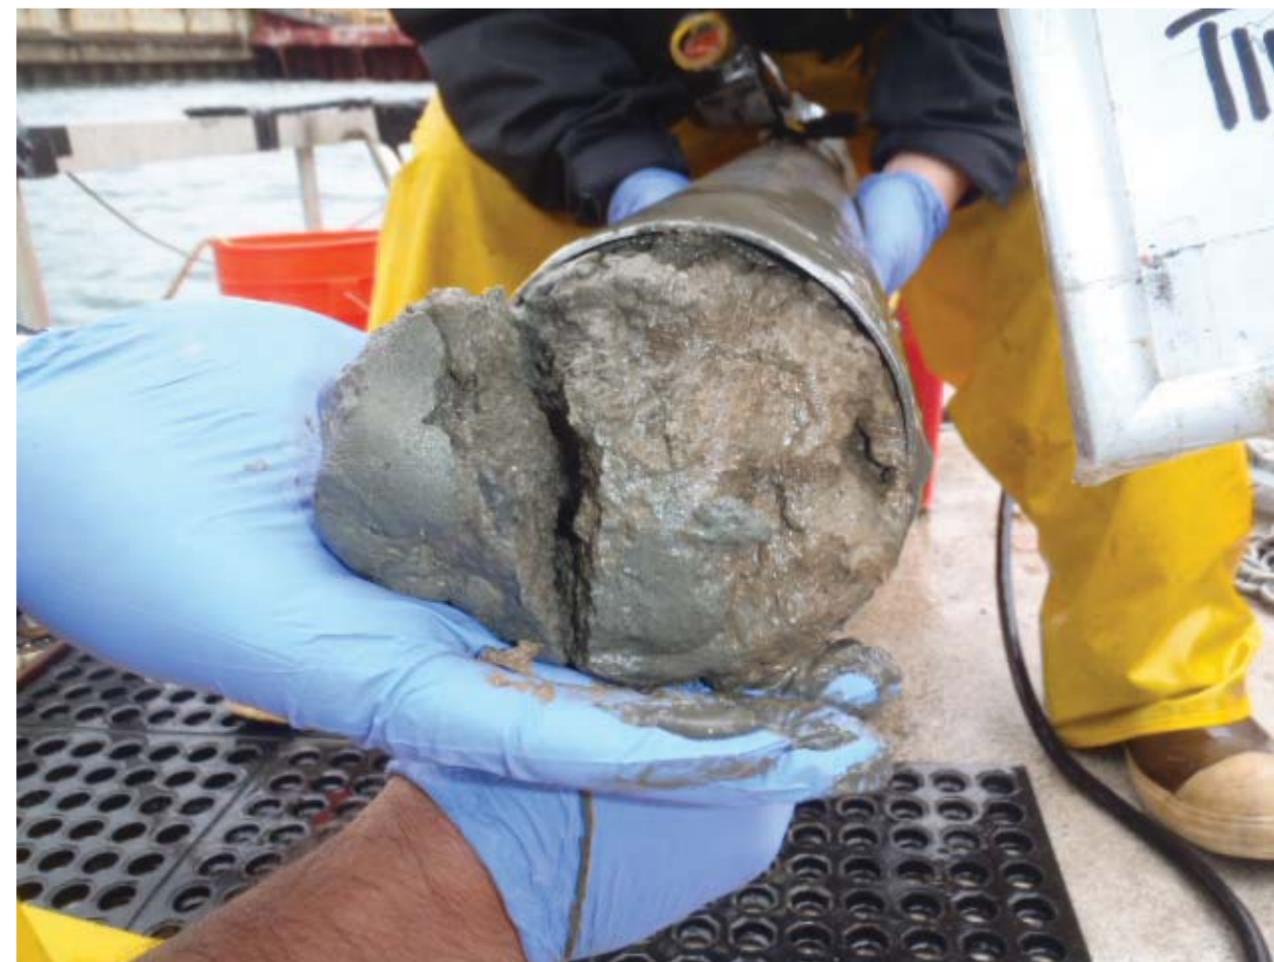
Location: South Shipyard - San Diego Bay  
Sample ID: SD-S-C-SMU3B-D  
Attempt #: 1  
Core Length: Plug Closeup  
Sample Date & Time: 11/21/2013 1315

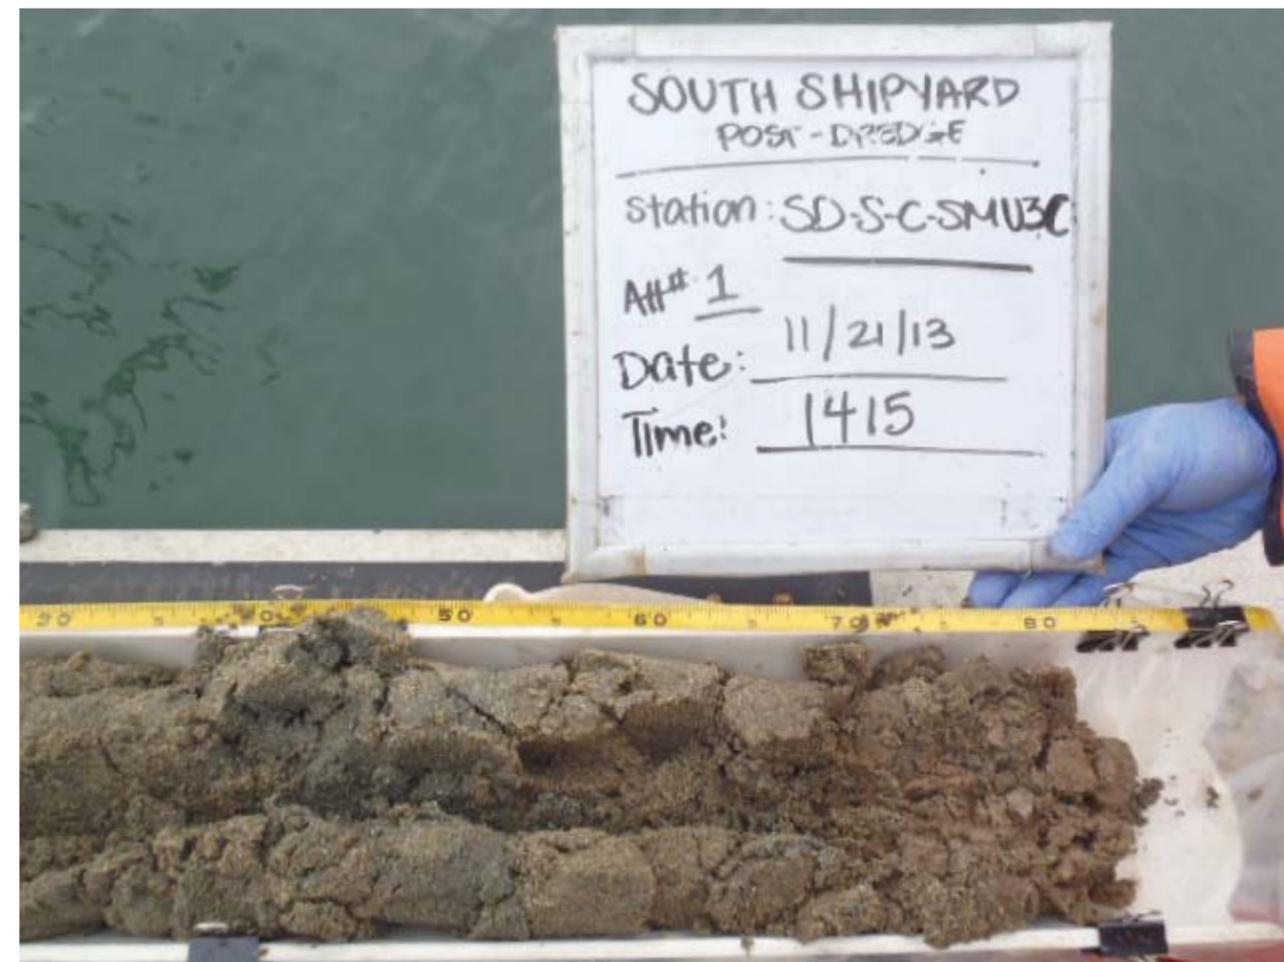
Location: South Shipyard - San Diego Bay  
Sample ID: SD-S-C-SMU3C-D  
Attempt #: 1  
Core Length: 30 - 82 cm.  
Sample Date & Time: 11/21/2013 1415

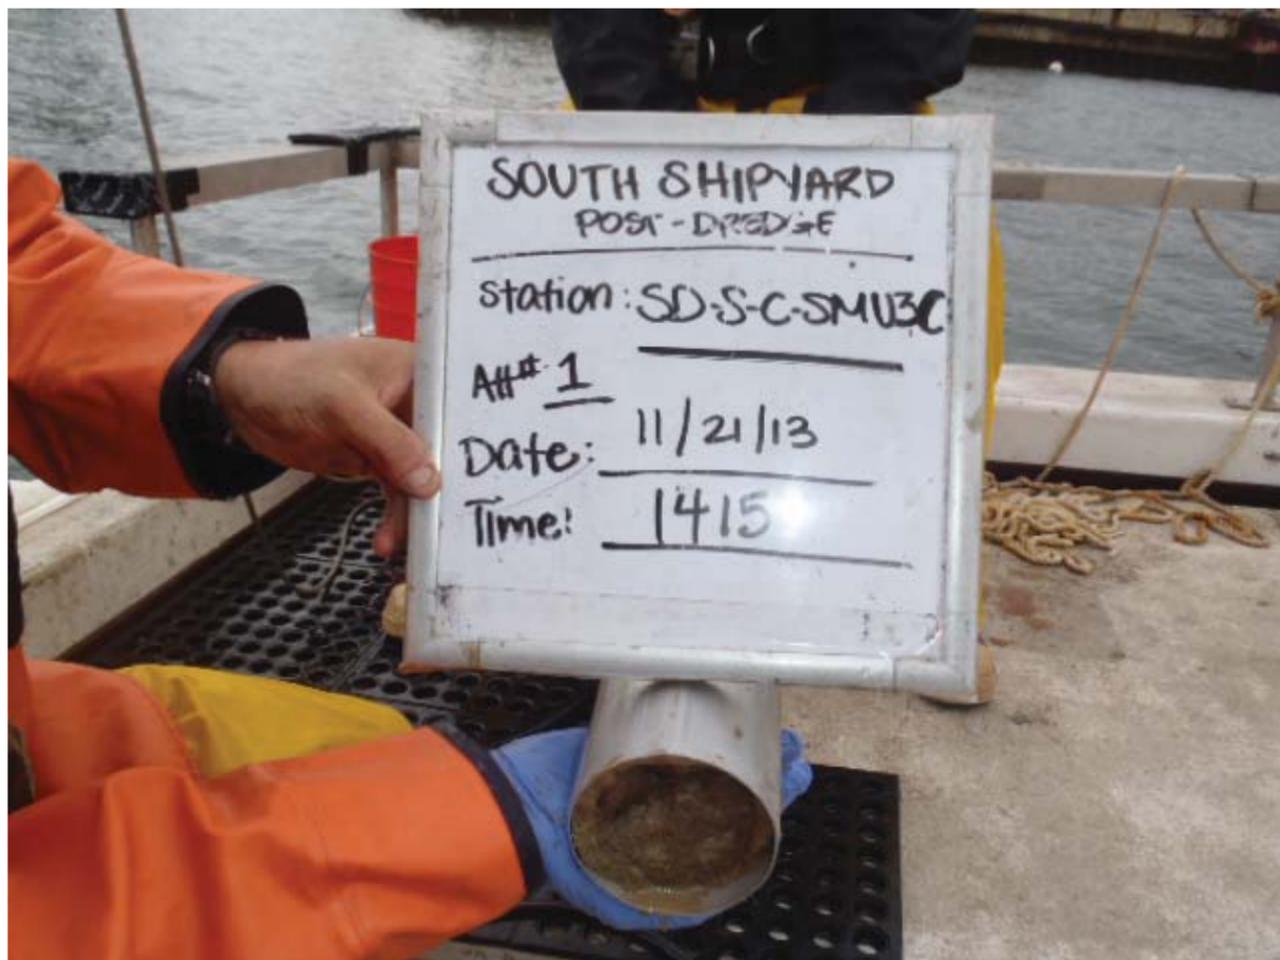
Location: South Shipyard - San Diego Bay  
Sample ID: SD-S-C-SMU3C-D  
Attempt #: 1  
Core Length: Plug  
Sample Date & Time: 11/21/2013 1415

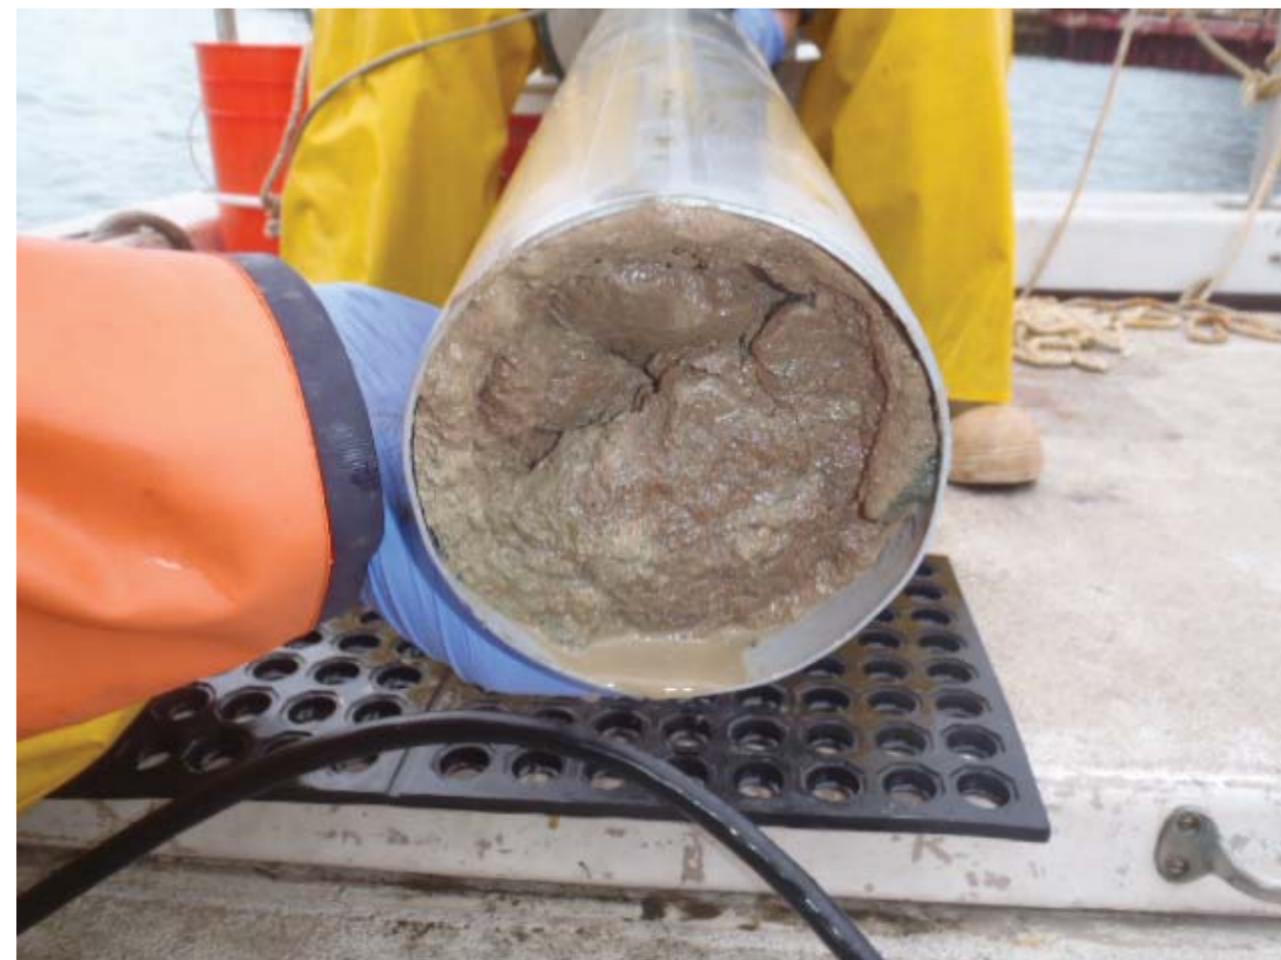
Location: South Shipyard - San Diego Bay  
Sample ID: SD-S-C-SMU3C-D  
Attempt #: 1  
Core Length: Plug Closeup  
Sample Date & Time: 11/21/2013 1415

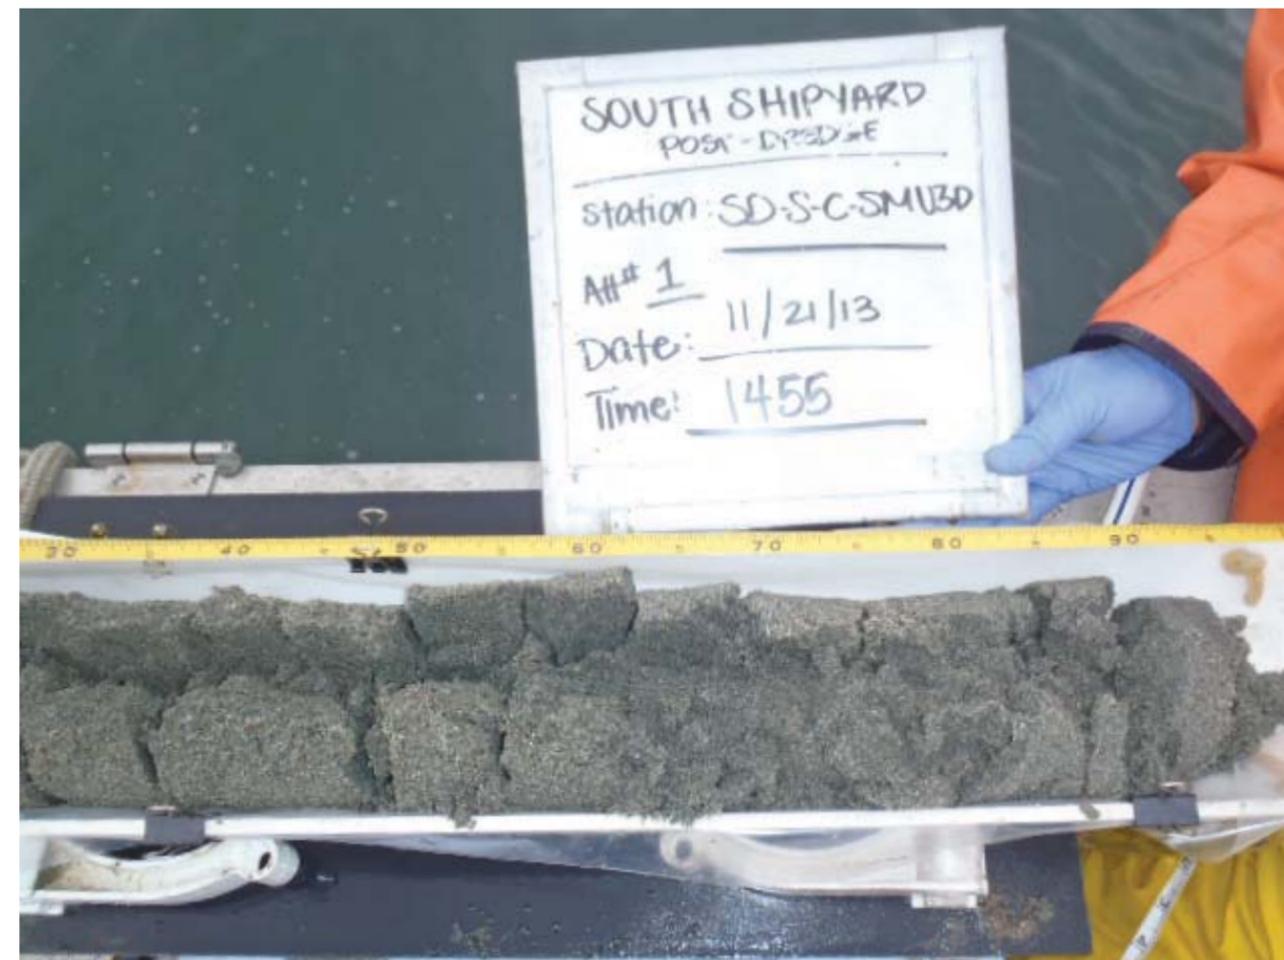
Location: South Shipyard - San Diego Bay  
Sample ID: SD-S-C-SMU3D-D  
Attempt #: 1  
Core Length: 30 - 95 cm.  
Sample Date & Time: 11/21/2013 1455

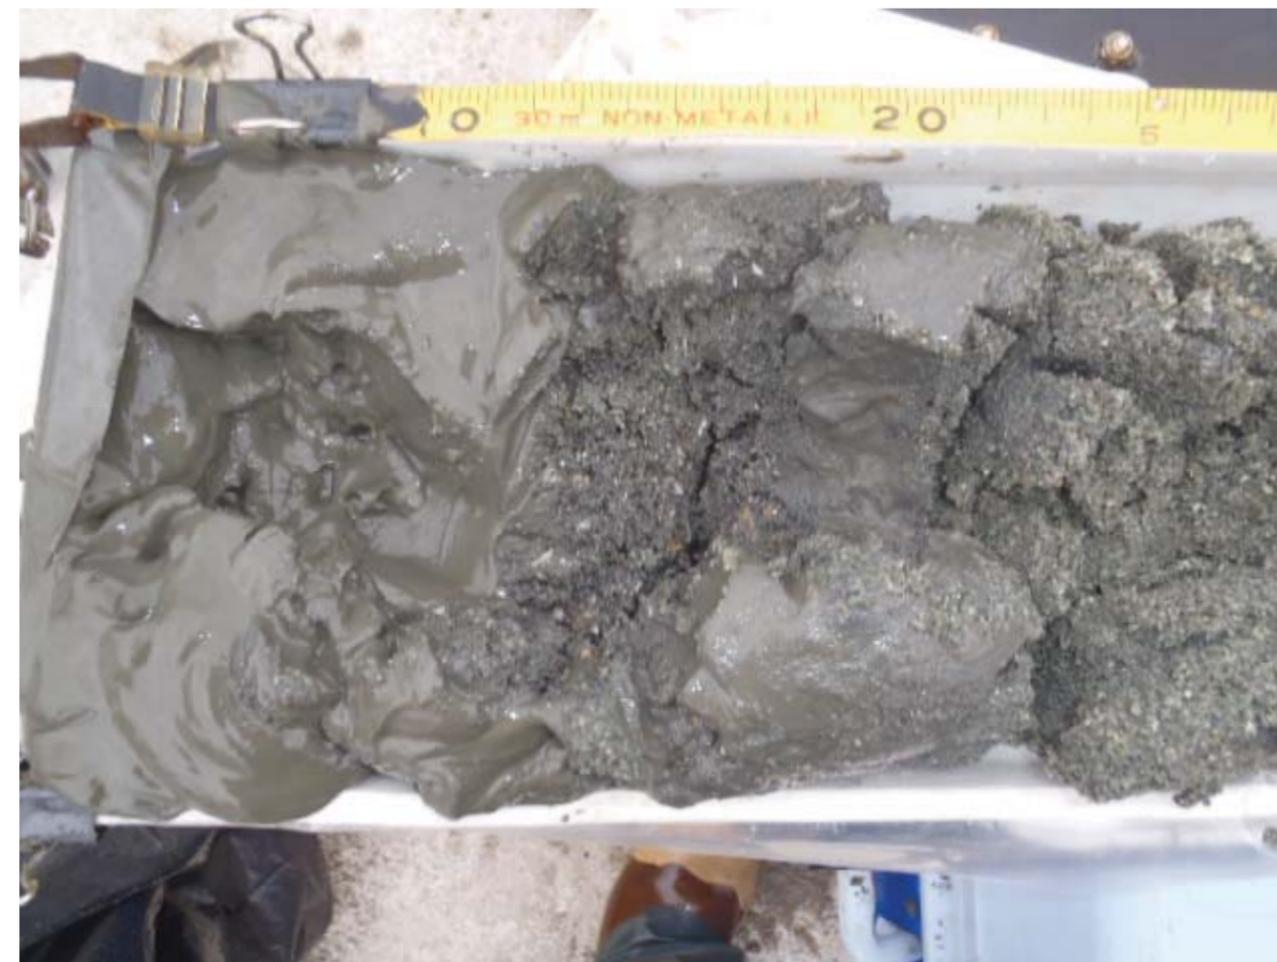
Location: South Shipyard - San Diego Bay  
Sample ID: SD-S-C-SMU3D-D  
Attempt #: 1  
Core Length: 0 - 20 cm. Sample Closeup  
Sample Date & Time: 11/21/2013 1455

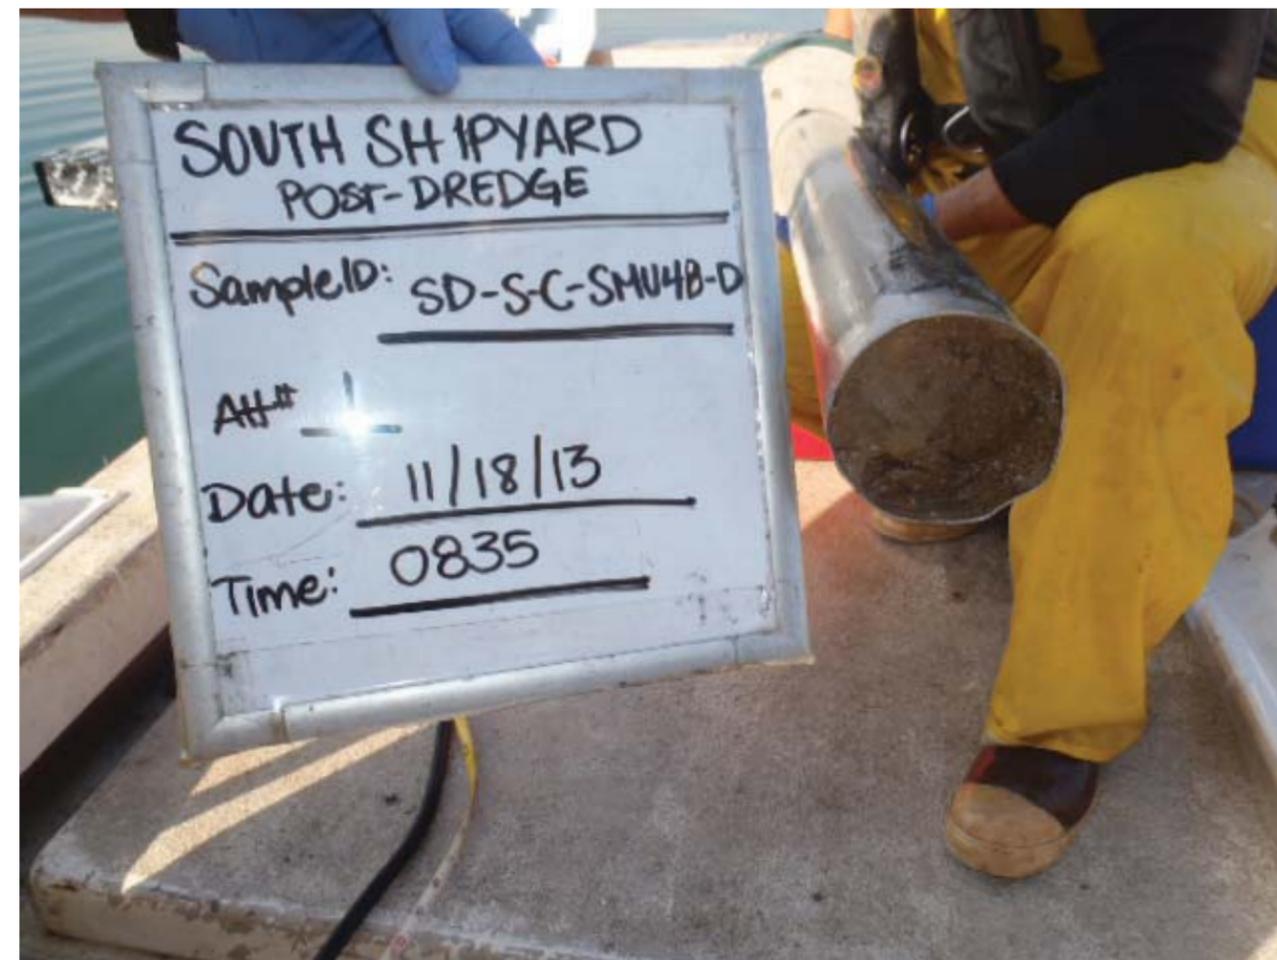
Location: South Shipyard - San Diego Bay  
Sample ID: SD-S-C-SMU4B-D  
Attempt #: 1  
Core Length: Plug  
Sample Date & Time: 11/18/2013 0835
