**Re: In the Matter of: Tentative Cleanup and Abatement Order No. R9-2011-0001
Reply Submissions by San Diego Gas & Electric Company**

Under the terms of investigation Number 52-9-1, the Department of Fish and Game undertook an investigation to determine the extent and character of bottom deposits in San Diego Harbor and to make an evaluation of the effects of pollution on the aquatic life in the Bay.

Object: The object of this investigation was to determine the location and extent of sludge beds in San Diego Harbor and, if possible, the effects of the sludge beds on the benthic marine invertebrates of the region. The field work for this study was done on 9, 10, 13, 14 August, 1951.

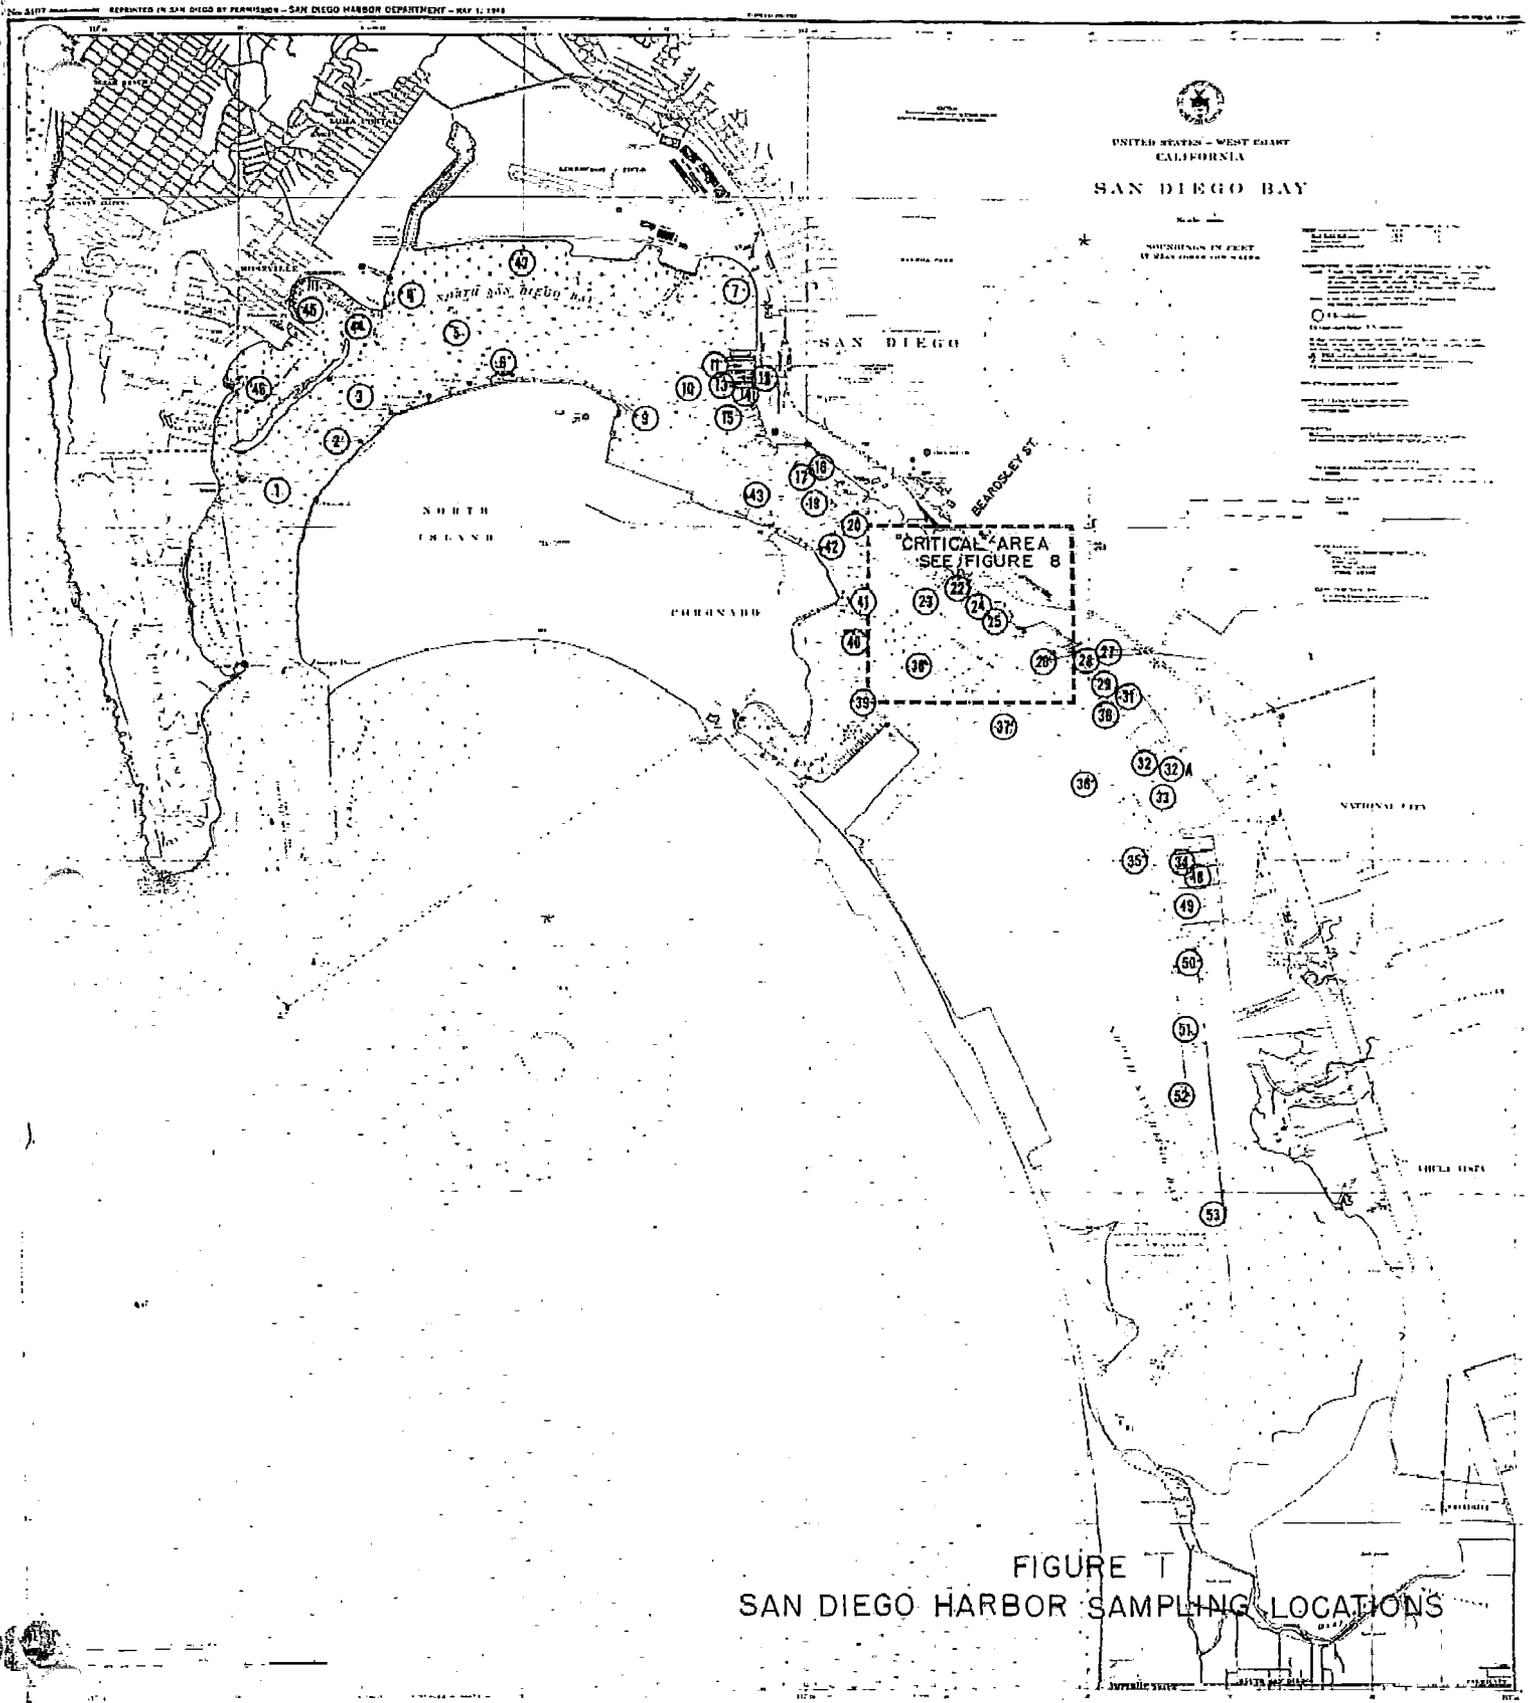
FIGURE T
 SAN DIEGO HARBOR SAMPLING LOCATIONS

Location: (Figure 1) San Diego Bay is located in San Diego County, California between 32° 36' and 32° 41' North Latitude and 117° 4' and 117° 15' West Longitude. It is a fairly large bay offering some apparently unique hydrographic conditions (USNR Project No. 1). It covers an area of about 519×10^6 square feet at mean low water (USNR Project No. 1, Appendix 3). The bay is shallow, generally not exceeding a depth of 60 feet near the entrance and 2-5 feet at the blind southern end.

Preliminary study: A preliminary survey of the harbor was made on 9 August, 1951. This consisted of taking bottom samples at 51 stations around the bay. The station numbers are shown on Figure 1. These samples were screened and notes were taken on the nature of the bottom and the presence or

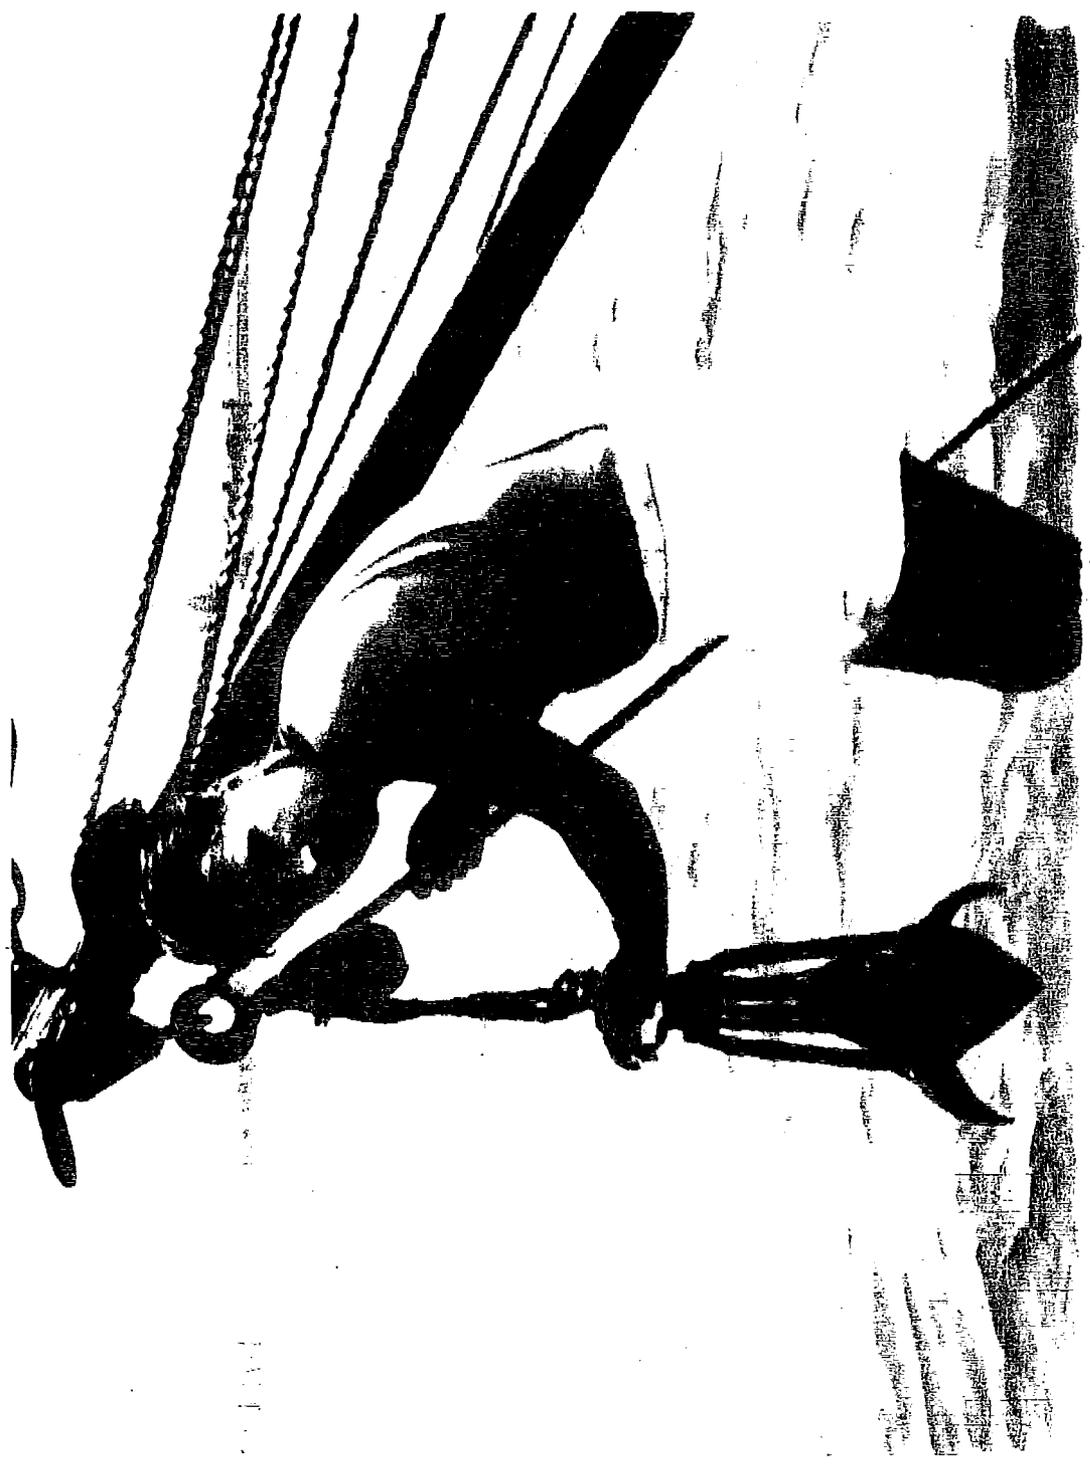
FIGURE 2 .

Bottom samples were collected with an "orange peel" grab (Figure 2) which was also loaned to us by the Scripps Institution of Oceanography. This grab covered about 100 inches area and took about 200 cc of sample, penetrating approximately 10 inches into the bottom. Hence the material collected could be studied from a quantitative standpoint.

PHOTOGRAPH OF "ORANGE PEEL" GRAB

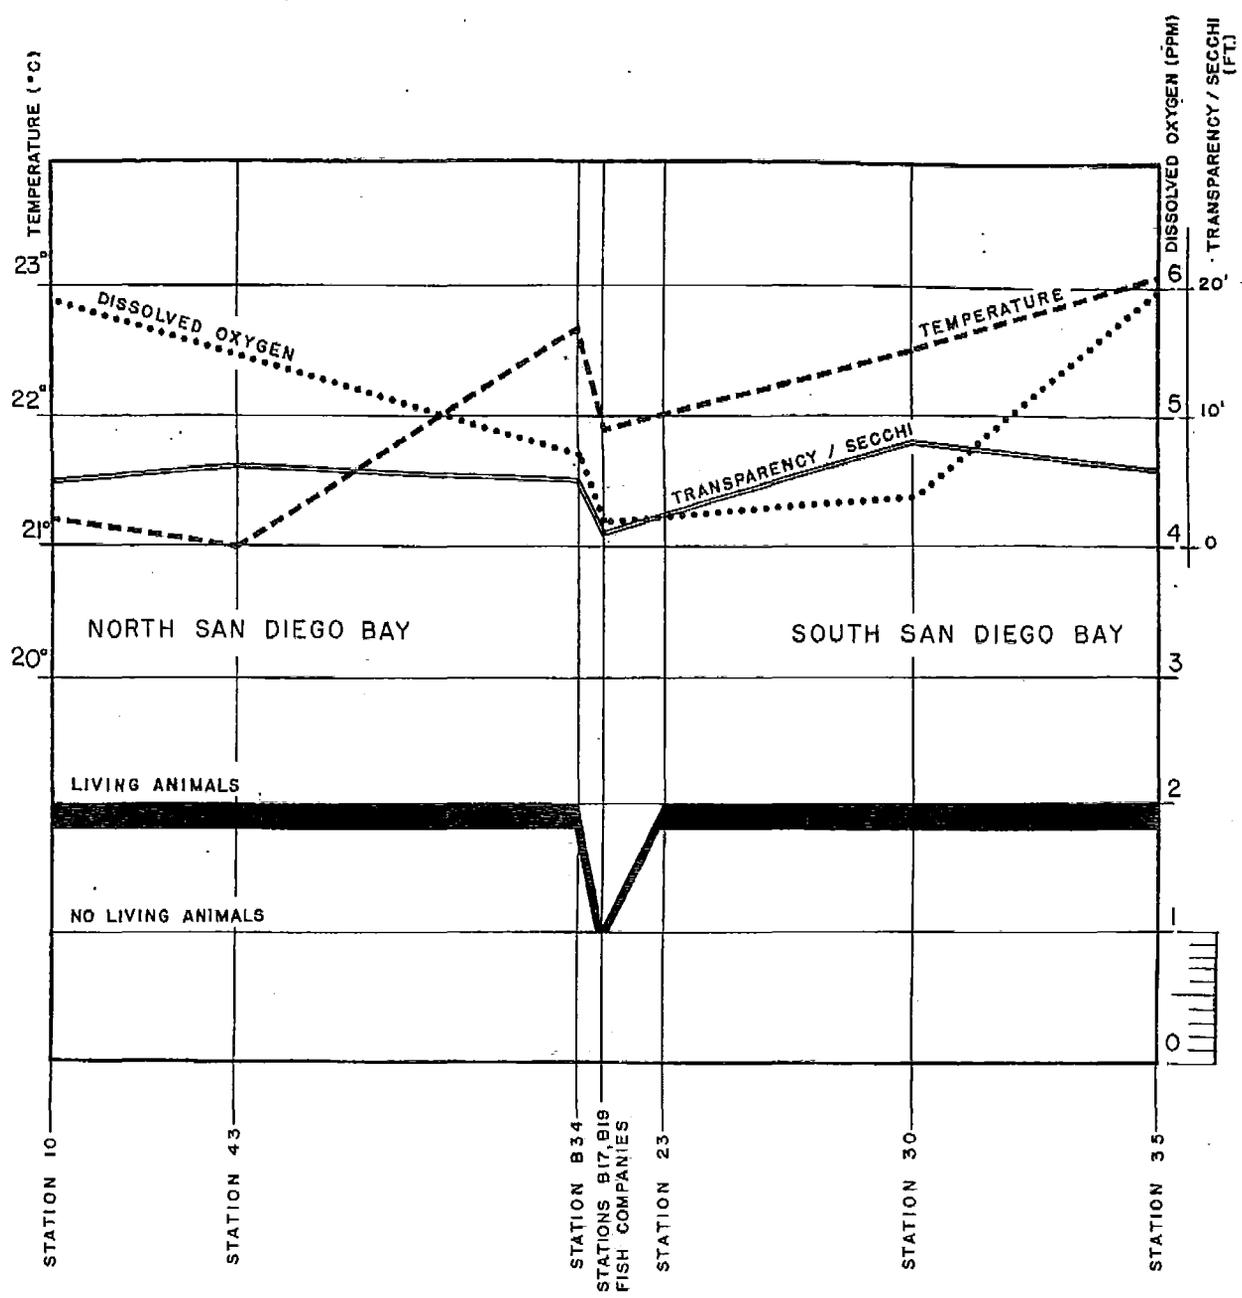
Dissolved oxygen: The amount of dissolved oxygen in the surface water was found to be high (6.0-6.7 ppm) in the northern part of the harbor and equally high in the southern part of the harbor (5.8-6.4 ppm). The central part of the harbor showed lower values of dissolved oxygen, particularly in the areas of heavy industry and suspected pollution (3.0-4.8 ppm). It is interesting to note that Unit 11-5 (USNR Project No. 1, Figure 3) did not obtain similar results, that is, they found a gradual decline in dissolved oxygen from the entrance (5.8 ppm) to the southern end of the bay. Their measurements, however, were taken largely in the center of the channel and at a significant distance from the regions of heavy industrial activity. The low dissolved oxygen values in the industrial area can be accounted for only by the presence of pollution in the industrial areas with the utilization of the dissolved oxygen at a faster rate than it is replaced by photosynthesis, mixing, and diffusion. This drop in dissolved oxygen in the region of industrial activity is shown clearly on Figure 4.

FIGURE 4. GRAPHIC REPRESENTATION OF A SECTION OF WATER FROM STATION 10 (NORTH SAN DIEGO BAY) TO FISH CANNERIES AND TO STATION 35 (SOUTH SAN DIEGO BAY)

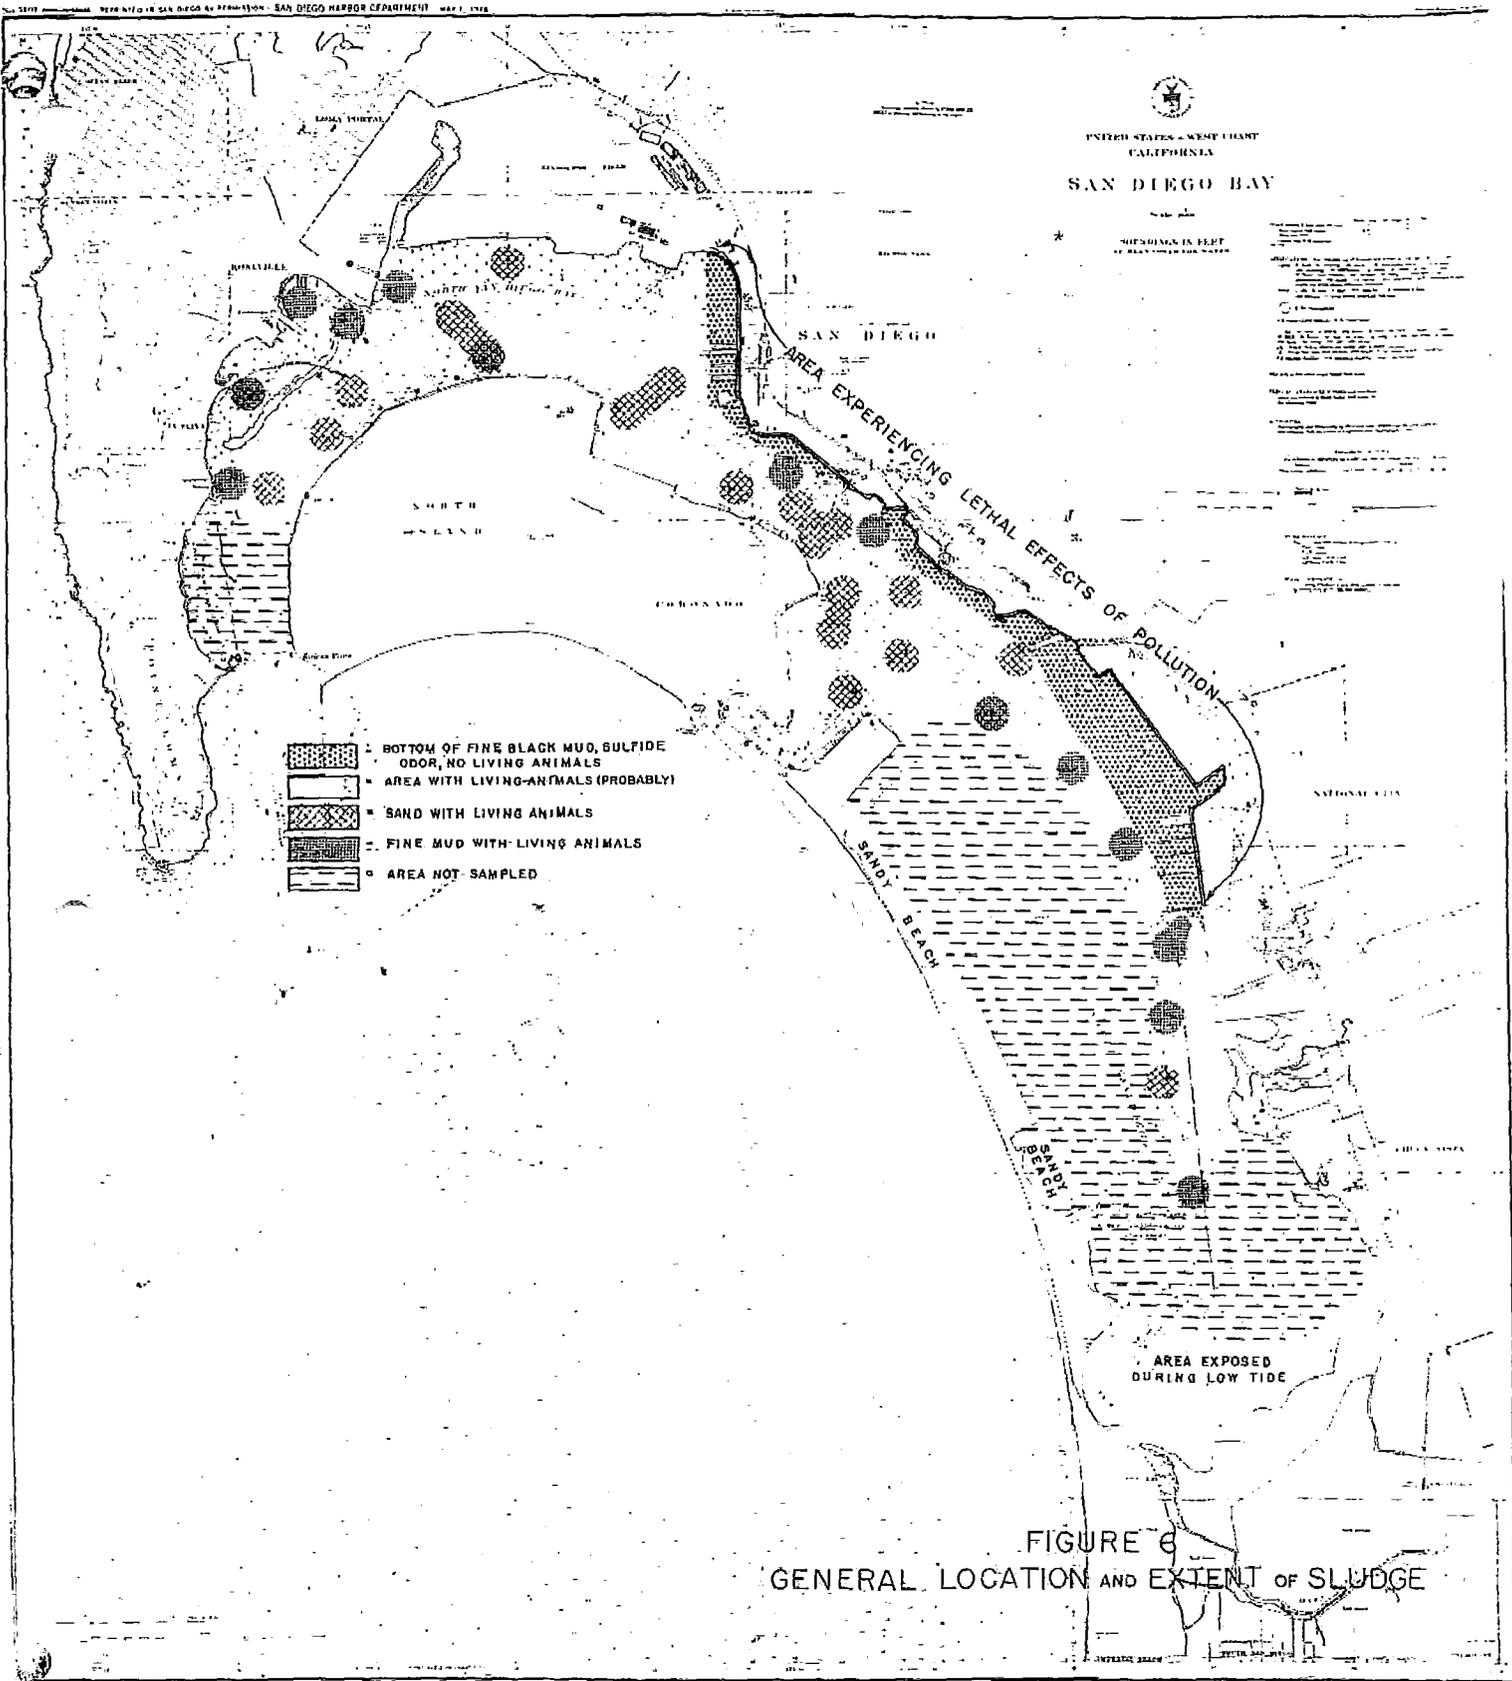
FIGURE 5
ANALYSIS AND LOCATION OF BOTTOM SAMPLES

absence of animals. This information is shown on Figures 5-6, based on data from Appendix A. The following abbreviations are used:

- CL : clay
- MS : mud and sand
- FM : fine mud
- O : no animals
- FS : fine sand
- S : sand
- H₂S : sulfide odor
- SH : shell fragments
- L : living animals
- * : location of the station

This information is diagrammatically shown on Figure 6. From this figure it is clear that deposits of fine mud exist in several regions of the harbor.

1. In the basin off Fisherman's Point.
 2. Along much of the northeast shore of the bay from the Civic Center south to Chula Vista.
 3. In the channel between the Mole Pier and Chula Vista.
- In general the channel regions and western shores of the harbor lack fine mud deposits of more than an inch.

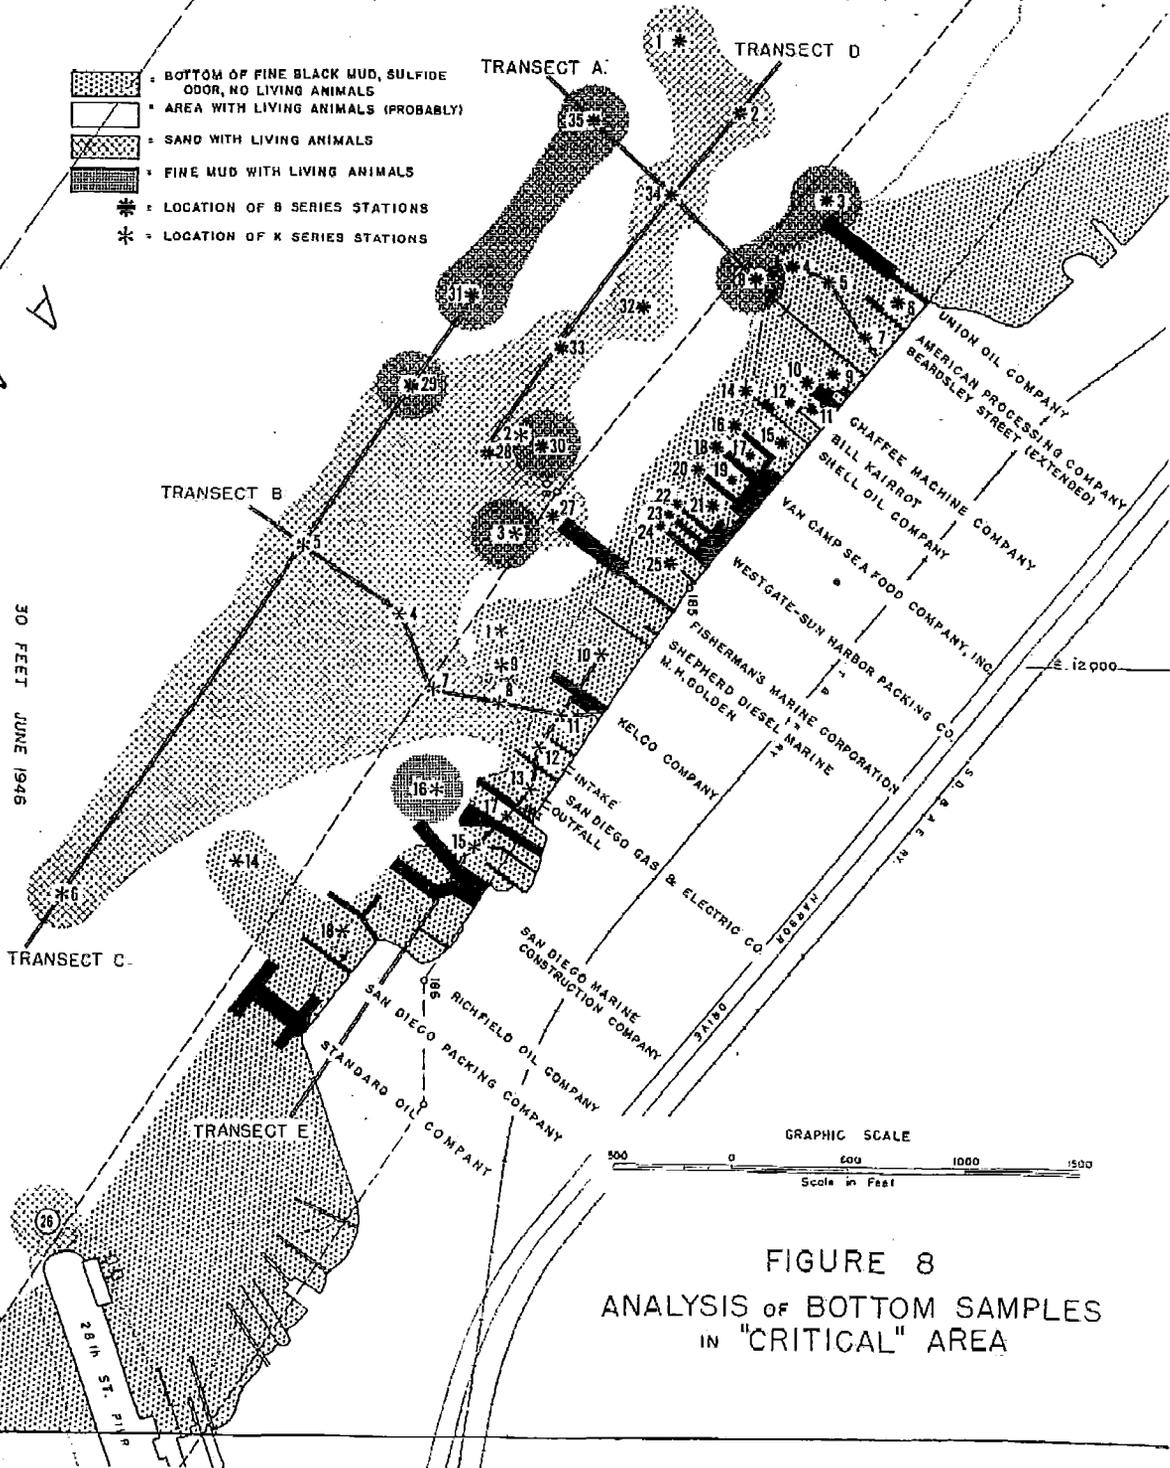
The types of bottom encountered in the area are shown on Figure 8. From this map, the most obvious feature is the restriction of the sludge area to the regions largely within the pier line. No sludge was found in the channel. Laterally, the sludge extended throughout the "critical" area without a break.

FIGURE 8
ANALYSIS OF BOTTOM SAMPLES
IN "CRITICAL" AREA

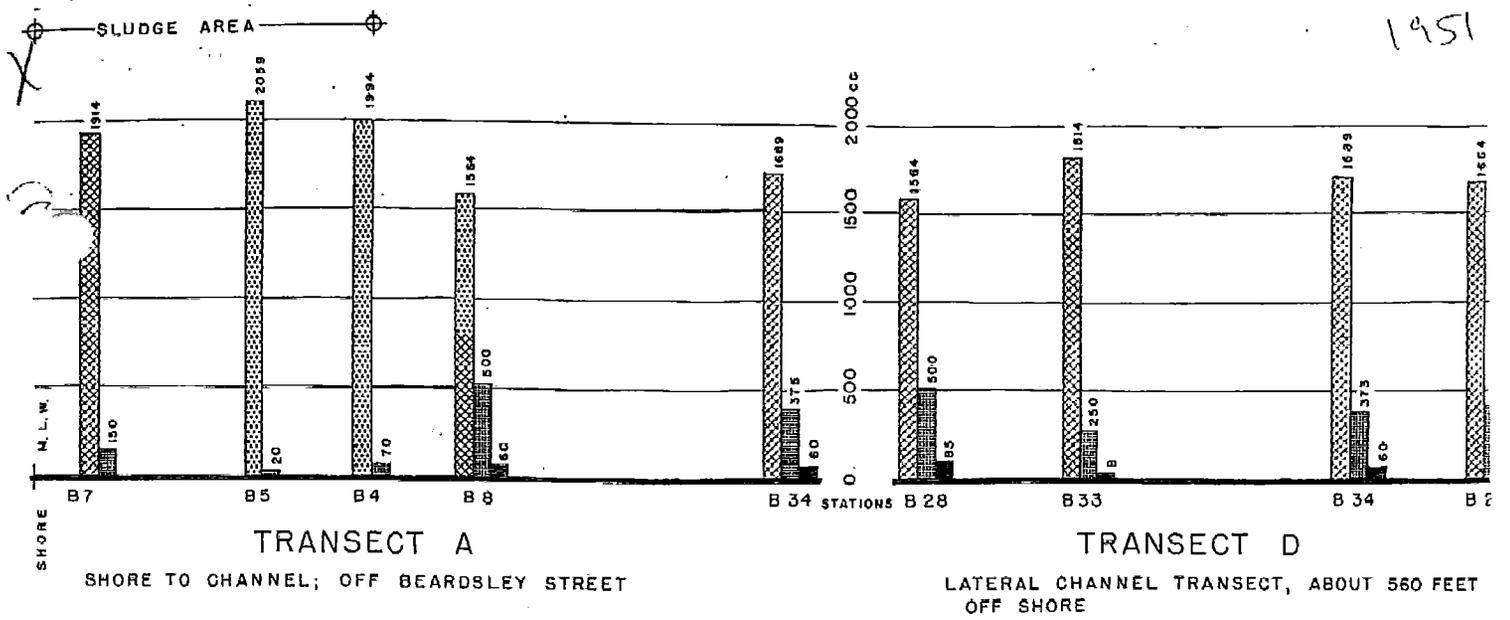
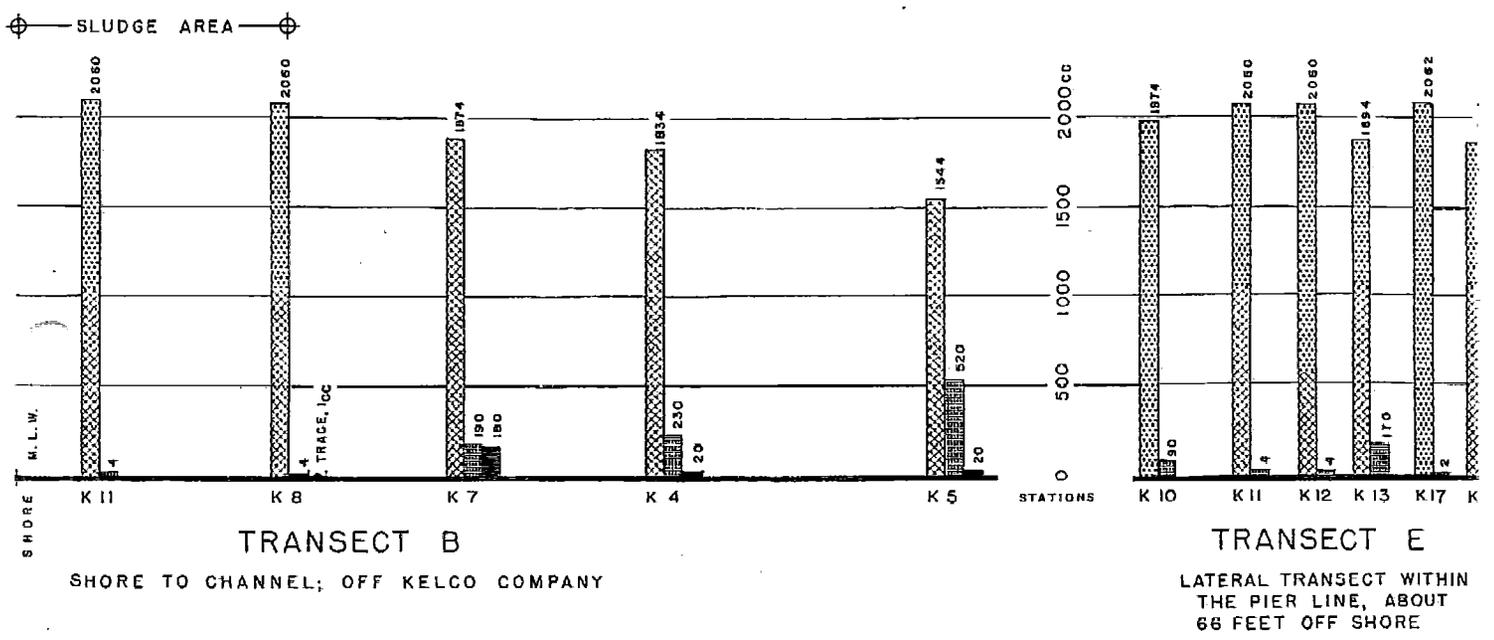
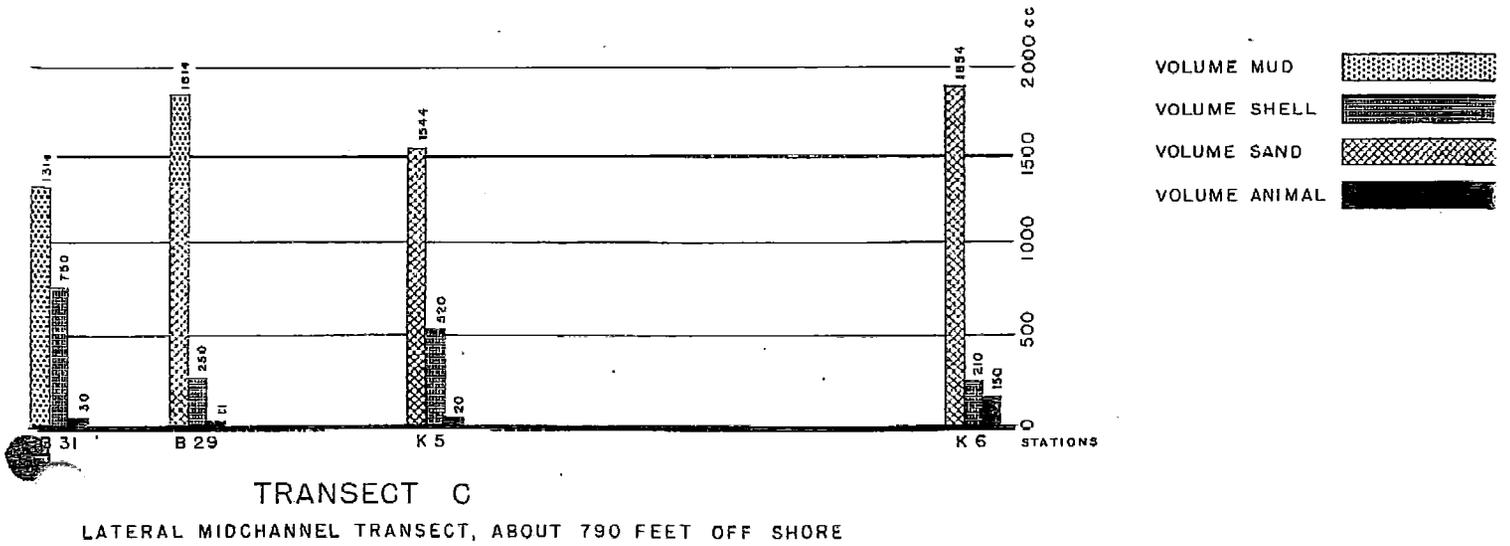
Types of bottom found at the various stations are shown on five transects taken in various directions in the "critical" area:

Transect A: shore to channel; off Beardsley Street

Transect B: shore to channel; off Kelco Company

Transect C: lateral midchannel transect, about 700 feet off shore

Transect D: lateral channel transect, about 500 feet off shore

Transect E: lateral transect within the pier line, about 60 feet off shore

Several important relationships are brought out by this analysis. Both transects A and B show a significant drop in fine particulate matter (1.5 mm diameter, or less) when animals occur, and a corresponding increase in coarse particles (shell fragments and the like). This relationship, however, is not important in the definition of sludge because animals occurred at Station 61 where fine mud constituted 2054 cc of the volume of the sample, large particles 10 cc of the volume of the sample, and animals 4 cc of the volume of the sample. That a lethal area may consist almost entirely of sand is shown in Transect A (Station B-7) within the "critical" area. Usually, however, animals were present when sand was present.

FIGURE 9. GRAPHICAL ANALYSIS OF BOTTOM IN "CRITICAL" AREA
