Subject: Annual Report of Stormwater Program Implementation for FY 2013/2014

Enclosed is the City of Livermore's Annual Report of Stormwater Program Implementation for the FY 2013/2014.

Stormwater Trash Reduction Plan

September 2014

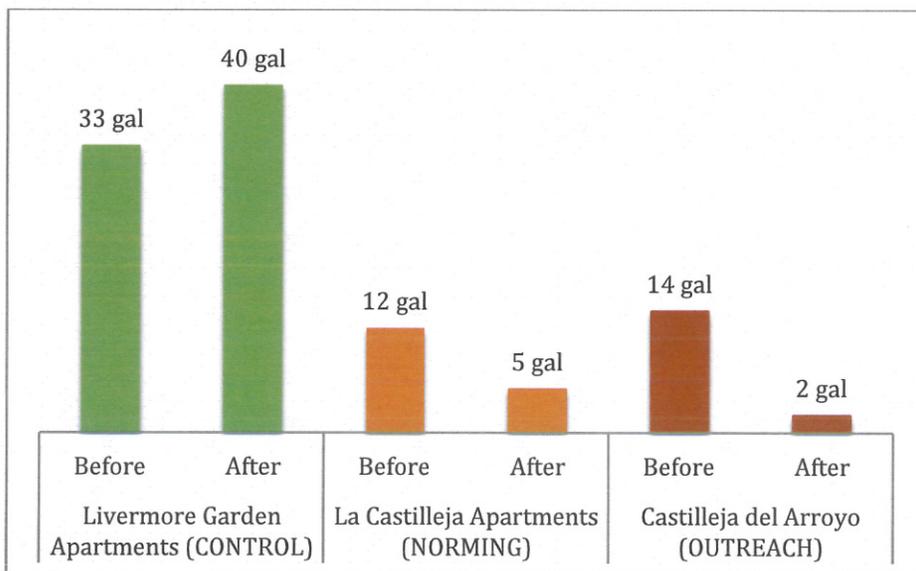
a. Litter by Volume

The amount of litter found on the two pilot properties that received treatment (“norming” or “outreach”) decreased overall, compared to the pre-pilot measurement. While the amount of litter collected in one week at the “norming” property went down by 58% (from 12 gal to 5 gal per week), litter found at the “outreach” property decreased by 86% (from 14 gal to 2 gal). **The amount of litter collected in one week at the control property (no activities) increased by 21% compared to pre-pilot measurement, from 33 gal to 40 gal.**

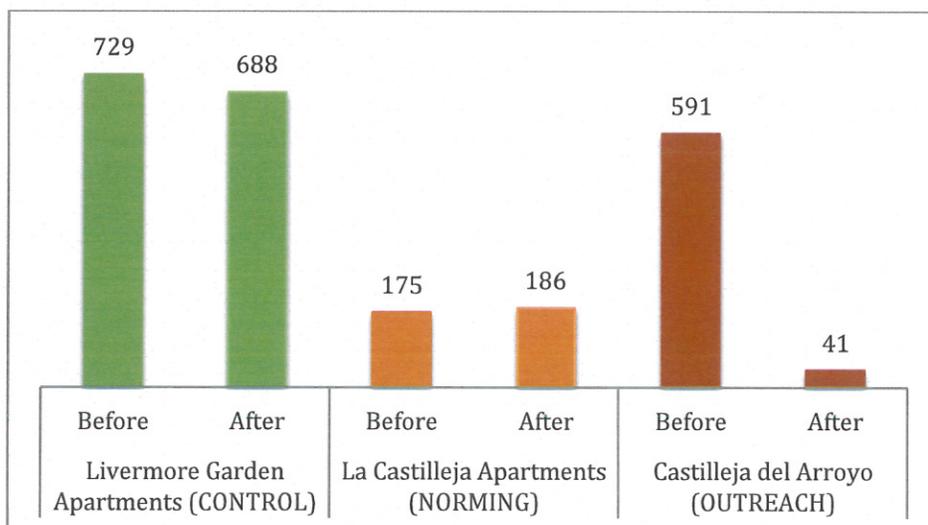
b. Litter by Count

Comparing the count of litter items collected, the “control” and “norming” properties remained roughly the same with a 6% decrease and 6% increase respectively. However, **the “outreach” property had a significant decrease in the number of litter items counted, with 93% fewer items** compared to pre-pilot measurement.

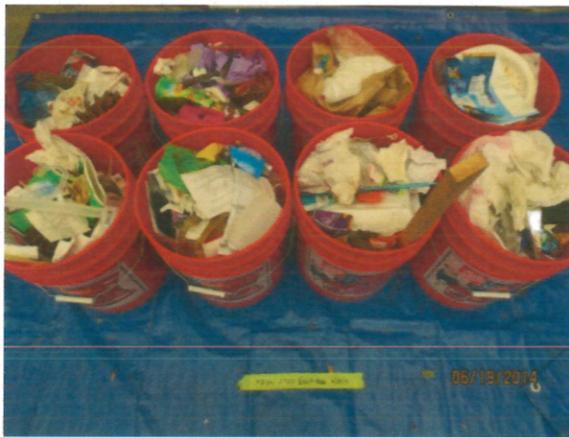
Post-campaign measurement: Total volume of one week's worth of litter at the "control" site.

1. Pick up and label bags with one week's worth of litter collected from each site.
2. Slowly empty each bag into 5-gallon buckets placed on tarp, filling each bucket as much as possible before moving to the next.
3. Count total number of full 5-gallon buckets, and measure volume of partially filled buckets.
4. Slowly pour litter from the buckets into a pile on the tarp.
5. Categorize the materials using Coastal Commission's 2013 Volunteer Ocean Trash Data Form: pick and identify litter items and place them in their respective piles.
6. Count number of items in each pile of categorized litter. Record number.

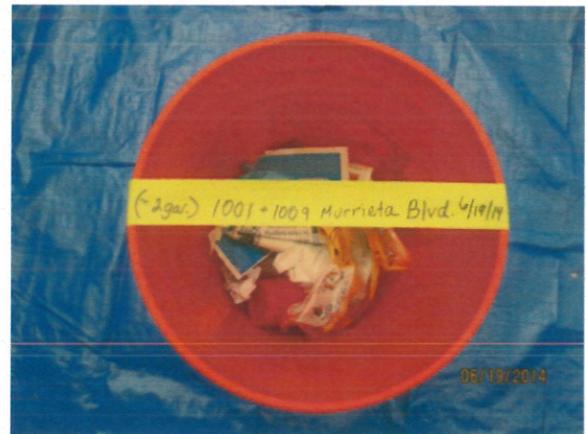
Post-campaign measurement: Total volume of one week's worth of litter at the "outreach" site.

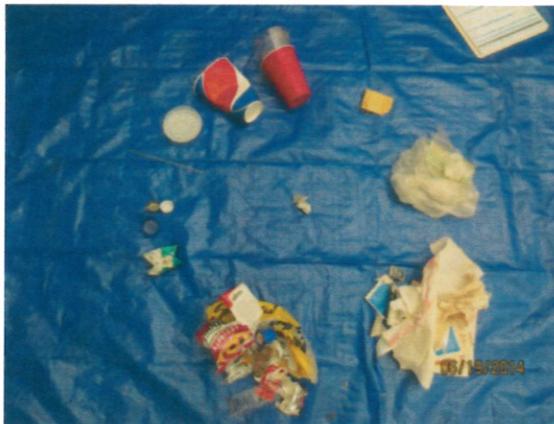
Litter items, categorized according to the Coastal Commission's guidelines.
