MONTEREY
COASTKEEPER
www.montereycoastkeeper.org

Re: Comment Letter - CEQA - Wetland Area Protection Policy and Dredge and Fill Regulations

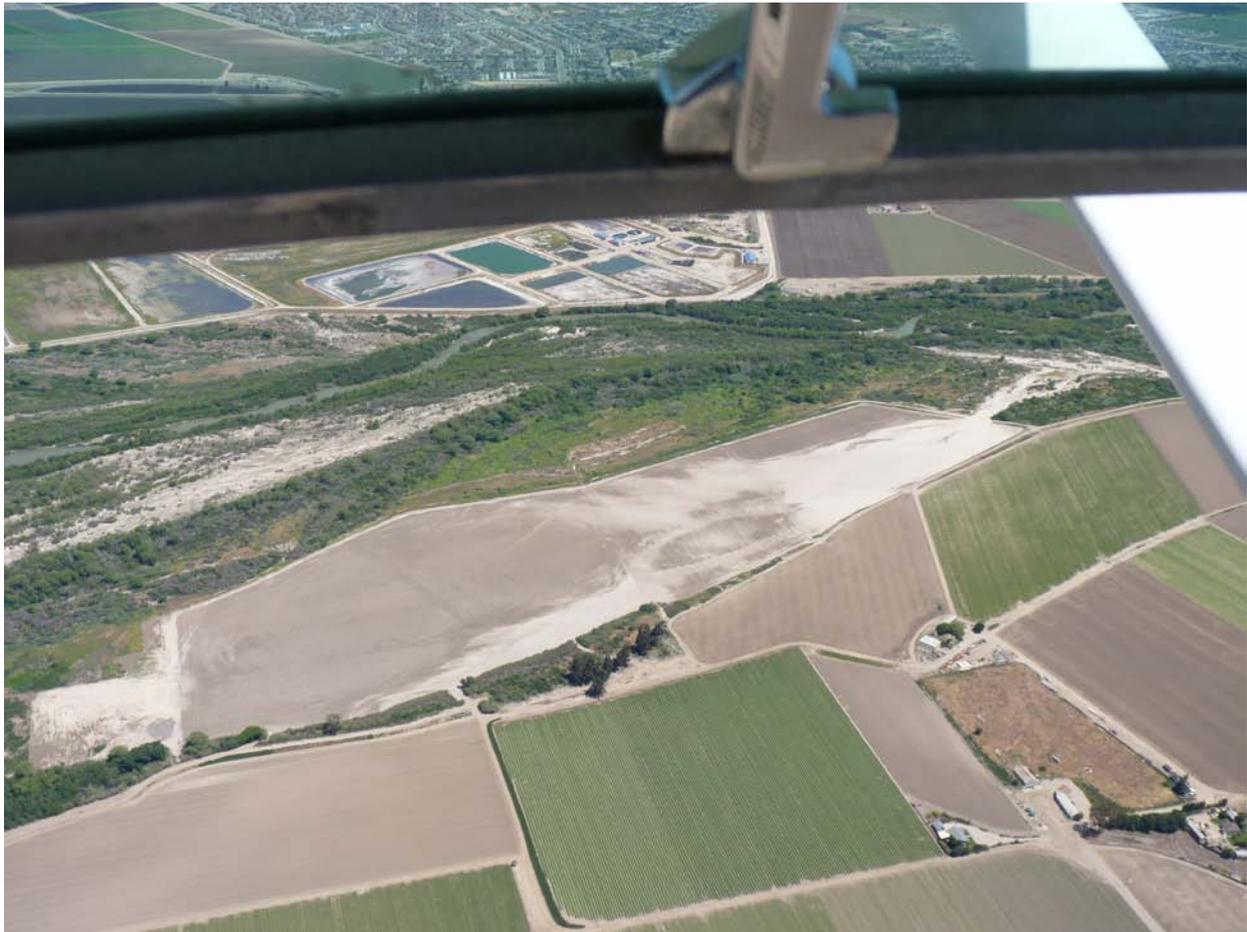
Photo 1. The fallow farm field that has flooded has obviously been cut from the Salinas River riparian corridor (see square borders to each side of the field). We do not know if the field was cut legally or illegally. It is impossible to keep fields such as this from flooding.

Example 2: Salinas River Channel Maintenance. As noted above, growers actively farm the Salinas River bottom (see photo 1). In addition, there are numerous situations where existing drainages truncate into farm lands (see photos 2 and 3). Flooding of "valuable and productive cropland" leads to calls for channel clearing and maintenance. Growers have an unrealistic expectation that they should be protected from inundation even though they are farming in a floodplain and sometimes in the river bottom itself. County Supervisors and State and Federal legislators all join the chorus demanding action and protection of property. All lands simply cannot be protected and farming in a floodplain has associated risks.

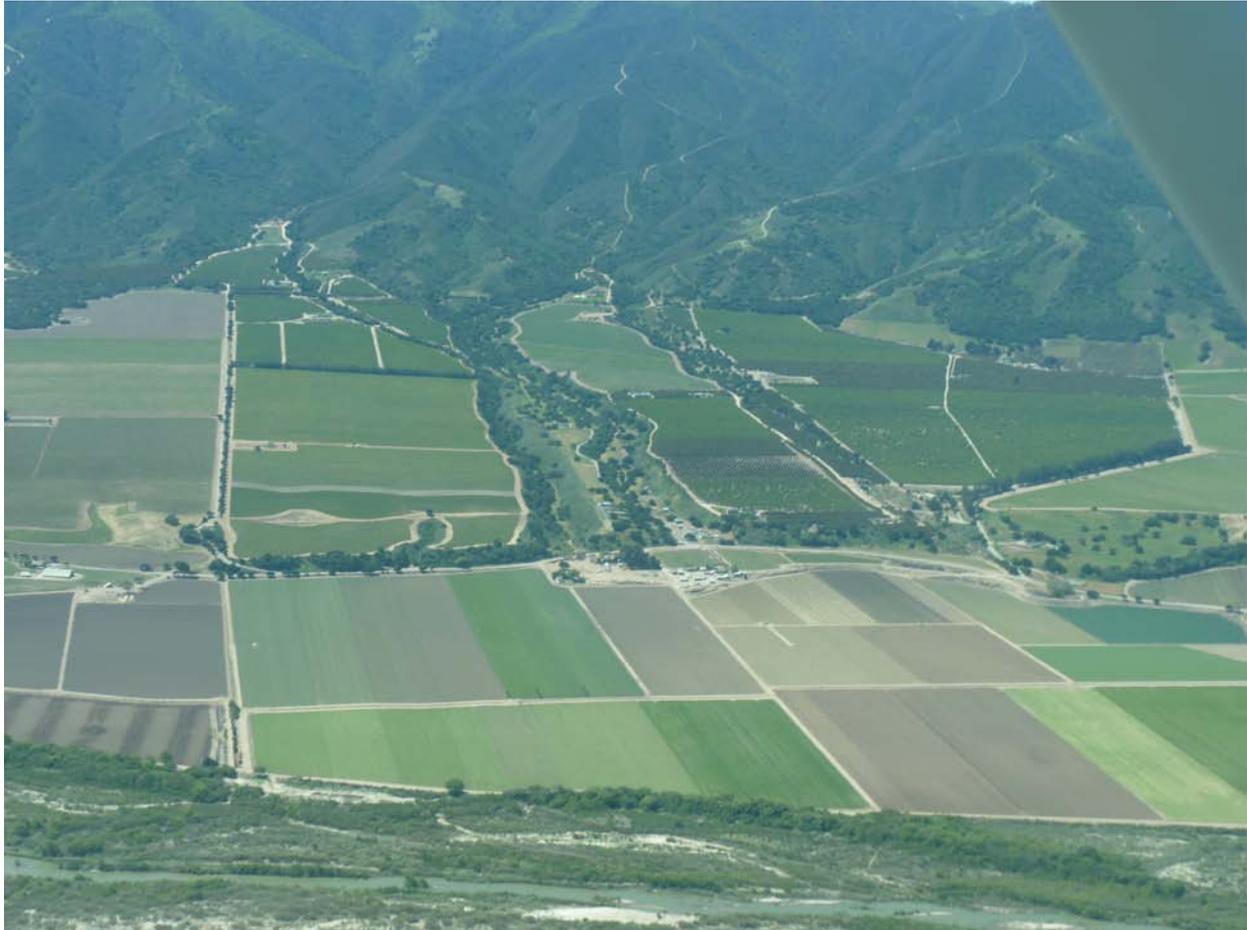
Photo 2. Very frequently drainages from the bordering mountains or hills are cut off and drain directly into farmlands. Usually, a low-capacity ditch adjacent to fields can carry some water, but larger rain events flood the fields.

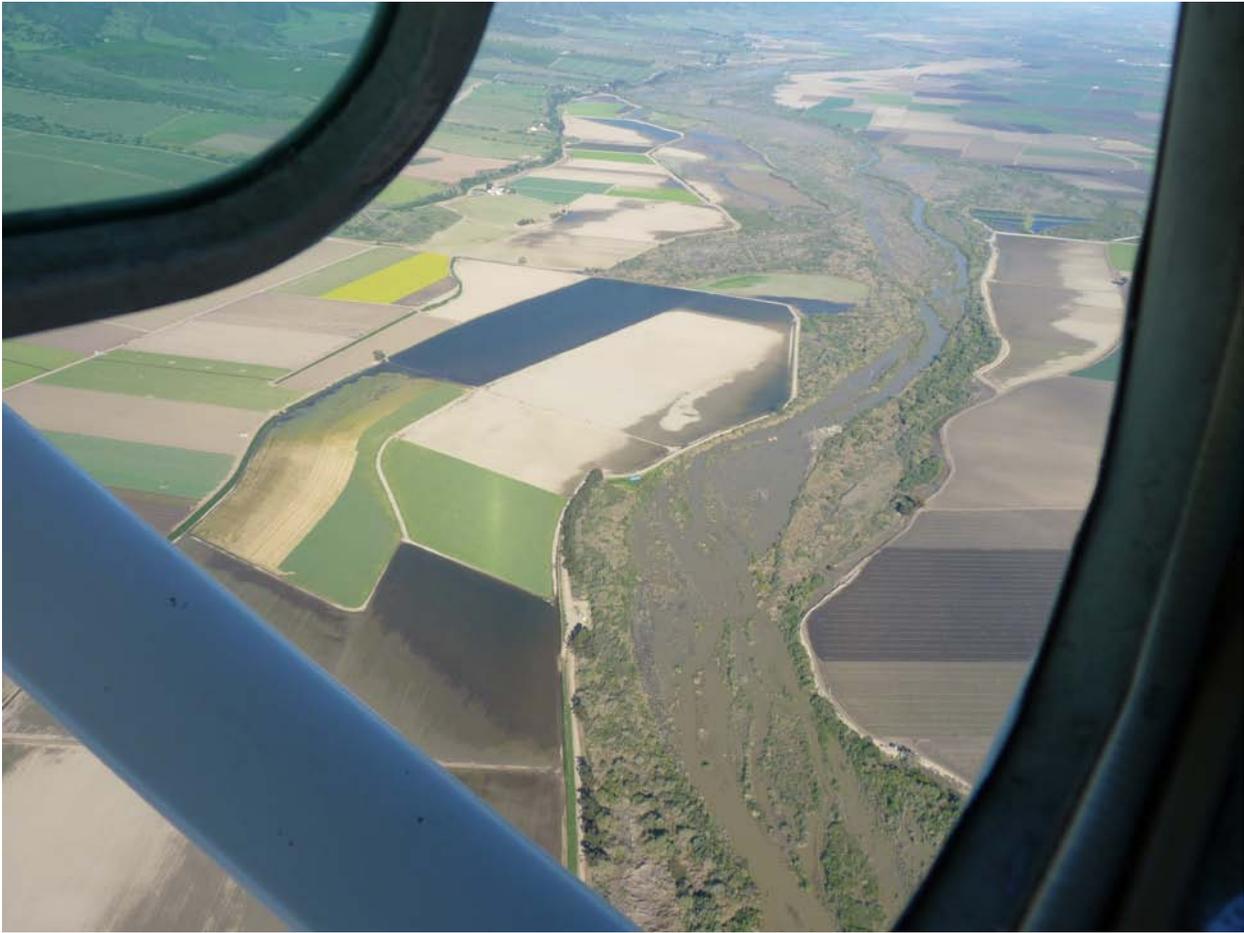
Photo 3. In this situation a grower has farmed the bottom of an intermittent arm of the Salinas River. The field has flooded.

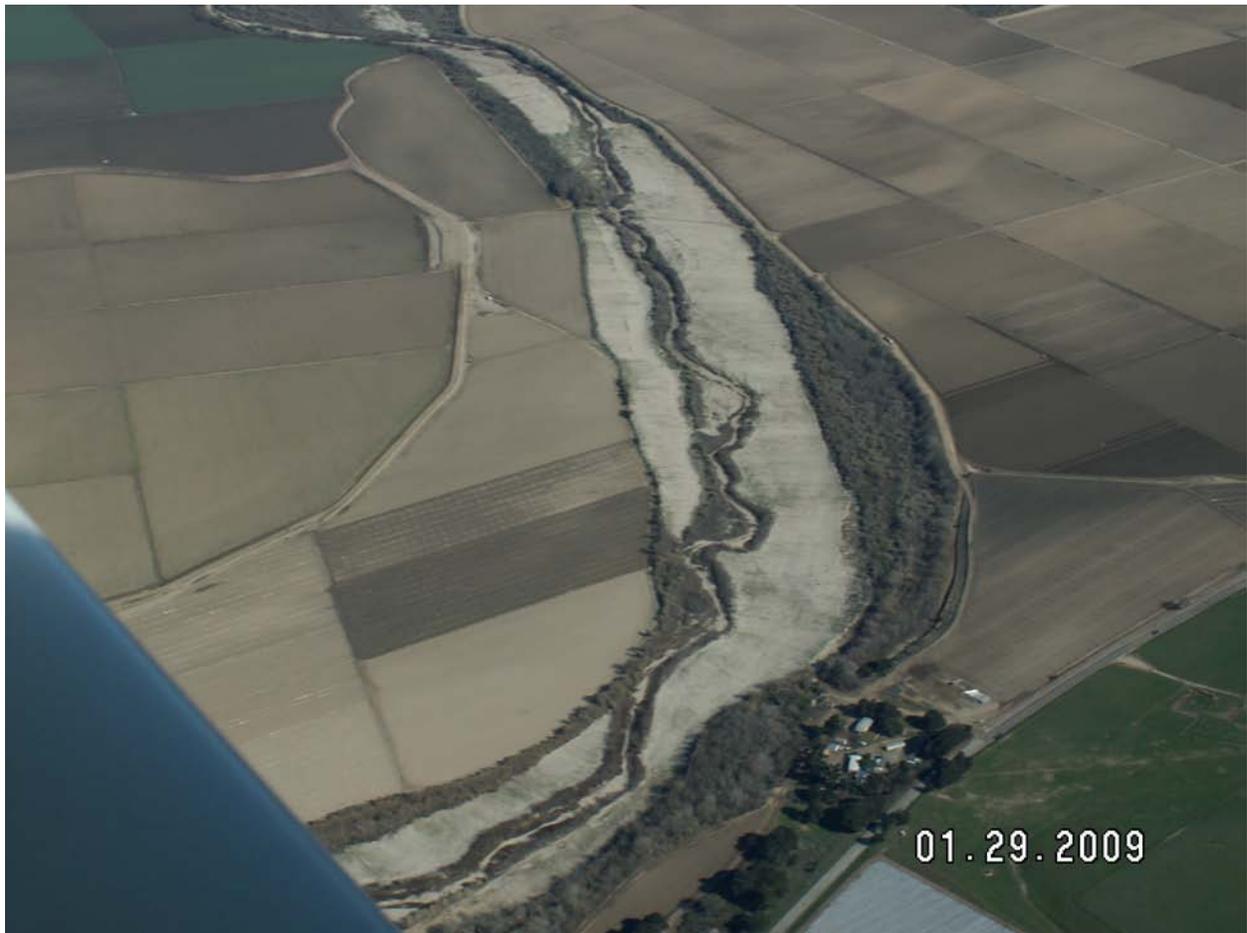
Photo 4 was shown to many interested people and agencies and most had no idea that the outcome of the 404, 401, and 1600 permits they were issuing resulted in these extreme measures. The SWRCB should not rely on a Waterkeeper who happens to be a pilot and happens to recognize what he is seeing.

Photo 4 - Channel Maintenance. The white areas are bare sand. This project was part of the 2004-2009 Salinas River Channel Maintenance Program permitted to clear over 60 miles of the Salinas River. The program was granted an ACE 404 permit after receiving a 401 certification from the RWQCB. The environmental review was a cursory Initial Study and Mitigated Negative Declaration. Landowners were each responsible for clearing their own stretch of River and obtaining DFG 1600 permits. All vegetation has been removed except for a very thin strip along the low water channel. The farmstead in the lower right offers scale.

As stated in your IS, 27% of fill acres in 2003 were due to "Channel Flood Control." We believe the Wetland Area Protection Policy and Dredge and Fill Regulations should anticipate projects and tensions such as outlined here. All farmland cannot be protected from inundation and creation of regulations to protect every acre are inappropriate. In addition, the permit should anticipate outcomes on the land such as shown in Photo 4.

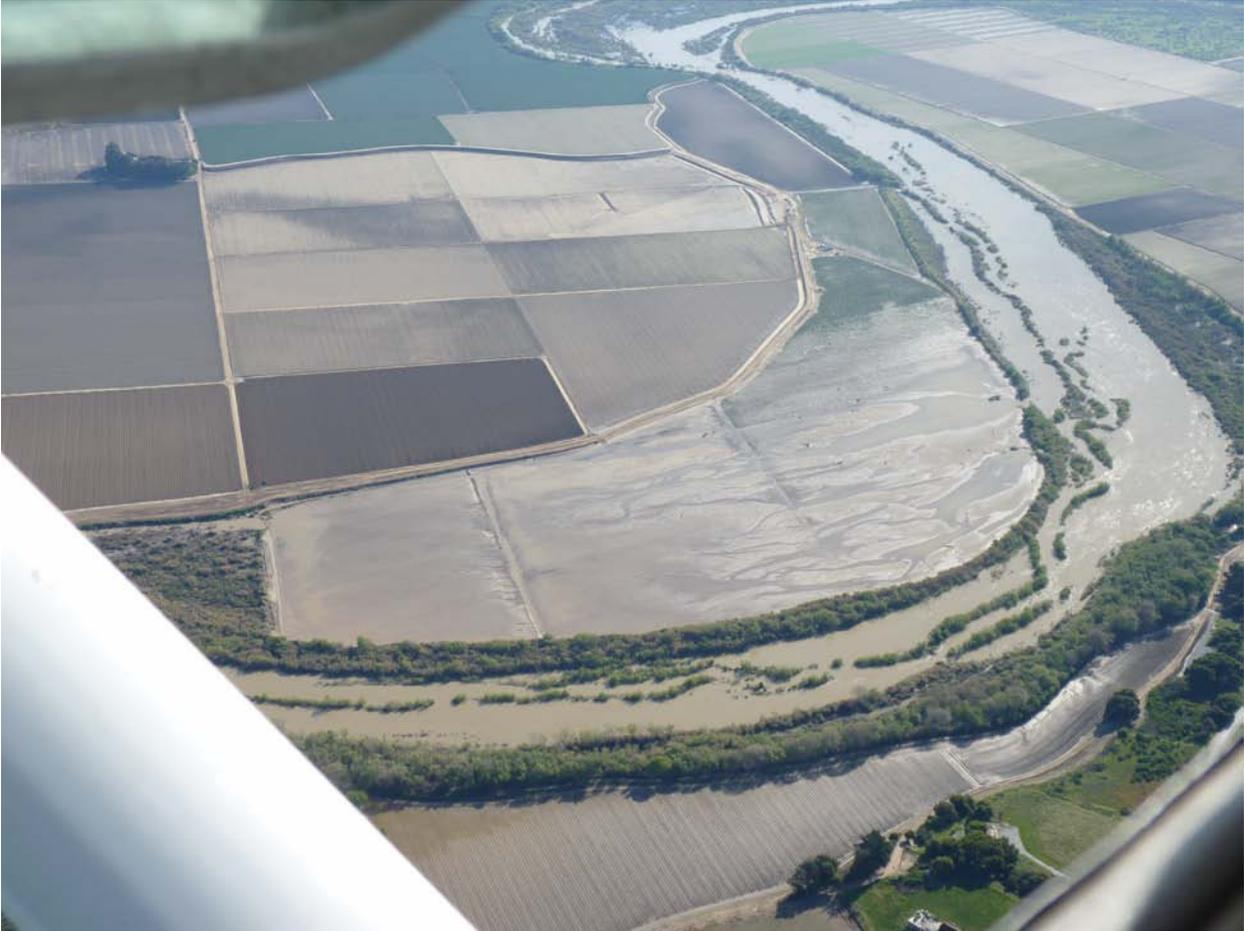
Exacerbating the problem, the Salinas River channel has been confined to an un-naturally narrow channel. Some growers perceive that given the narrowed channel (that they have created) the best way to provide flood protection is through channelization and the removal of all vegetation. When practiced, the outcome on the Salinas River is illustrated in Photo 4. The removal of vegetation results in both the removal of wildlife habitat and removal of the vegetated treatment that offers water quality benefits. The Lower Salinas River is impaired for nutrients, toxicity, and sediment. As shown in Photo 5, channel clearing and "maintenance" often does not result in flood control.

Photo 5. This is a view of the same section of the Salinas River after a storm event. The channel clearing obviously did not offer flood protection.
