State Water Resources Control Board San Joaquin River Restoration Program Workshop

Operational Perspective Alicia Gasdick Forsythe, Project Manager Bureau of Reclamation November 15, 2010

# **Interim Flows Project Description**

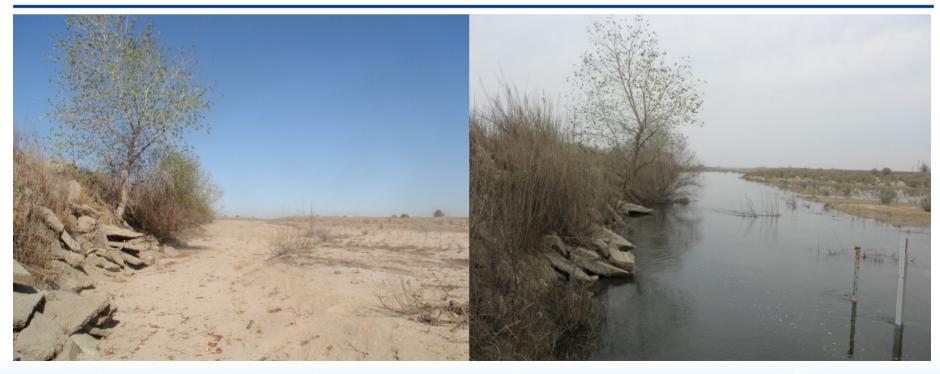
#### Reach 2 in July 2009

#### Reach 2 in November 2009

- Began October 1, 2009
- Peak release of 1,550 cfs from Friant Dam
- Released 260,000 acre-feet of Interim Flows; recaptured 46,000 acre-feet
- Reconnected the upper San Joaquin River with the Delta in 2010

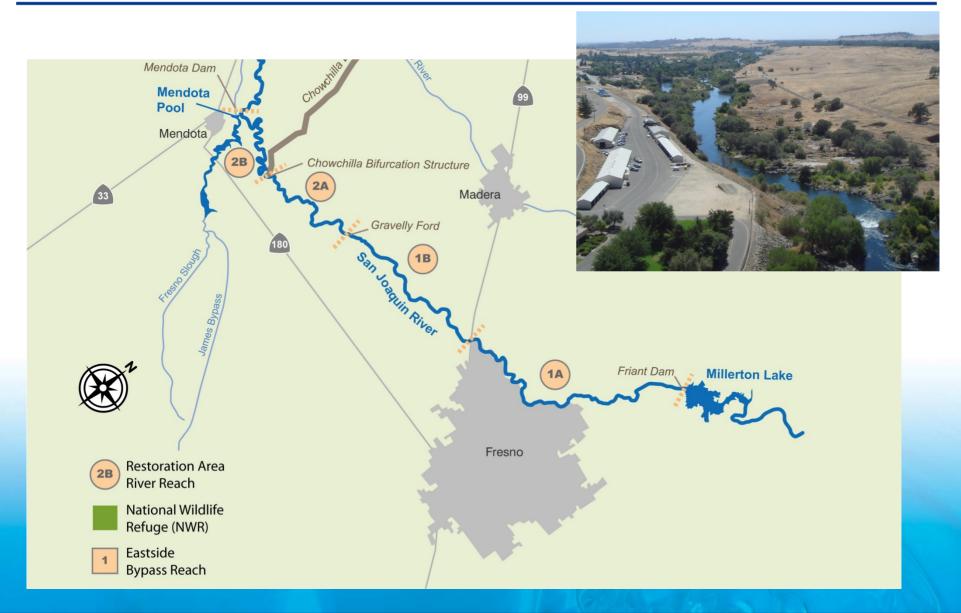
# Reach 1 – Friant to Gravelly Ford

- WY 2010 Key Monitoring Activities:
  - Flow, water quality, water surface profiles, and temperature
  - Mesohabitat mapping
  - Bed material sampling
  - Gravel and cobble mobilization studies
  - Sand source assessments
  - Shallow groundwater / seepage
- Future Monitoring:
  - Similar to above plus efforts to address gravel pits and spawning habitat availability
- Challenges:
  - Managing flows to meet Gravelly Ford targets
  - Managing flows to address flashy tributary inflows

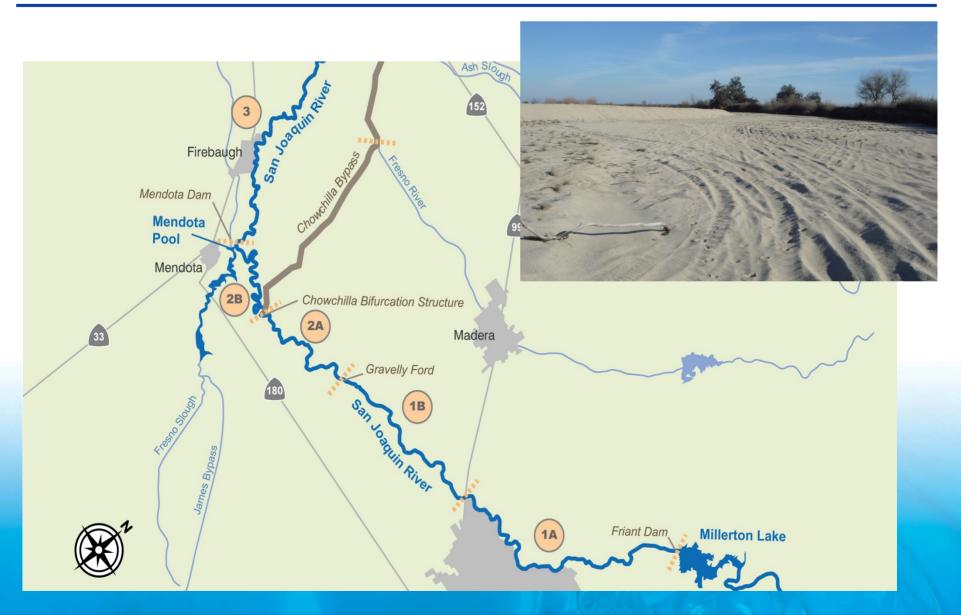
#### Reach 2 – Gravelly Ford to Mendota Pool

- WY 2010 Key Monitoring Activities:
  - Flow, water quality, water surface profiles
  - Water temperature
  - Bed material mobilization studies
  - Shallow groundwater / seepage
  - Vegetation surveys
- Future Monitoring:
  - Similar and expanded on above
- Challenges:
  - Possible sediment build-up near the Chowchilla Bypass structure
  - Limited channel capacity and high groundwater elevations in Reach 2B

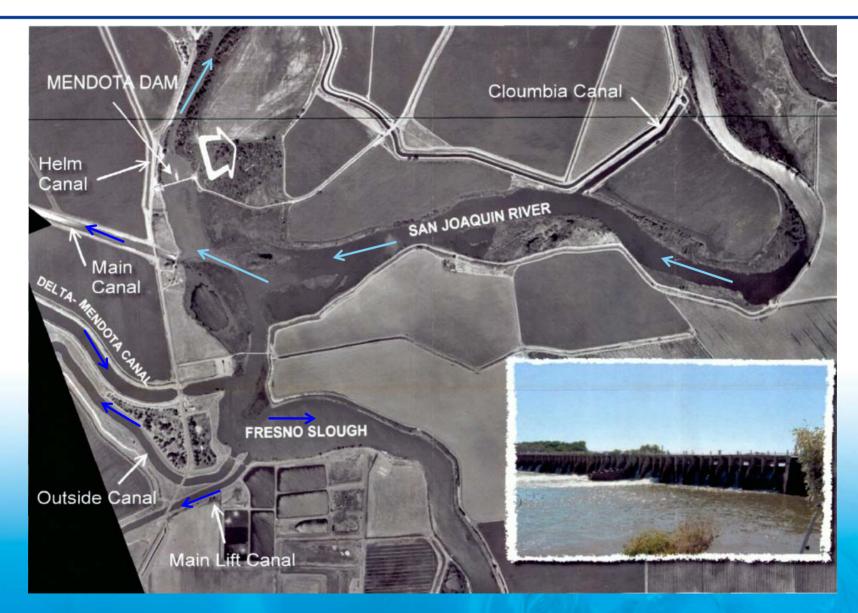
# Mendota Pool

- WY 2010 Key Monitoring Activities:
  - Flow, water quality, water temperature
  - Shallow groundwater / seepage
- Future Monitoring:
  - Similar and possibly expanded on above
- Challenges:
  - Coordination with local agencies on Pool operations
  - Levee stability and pool elevations
  - High groundwater elevations
  - Reduced water mixing leading to poor water quality
  - Inflow / outflow accounting

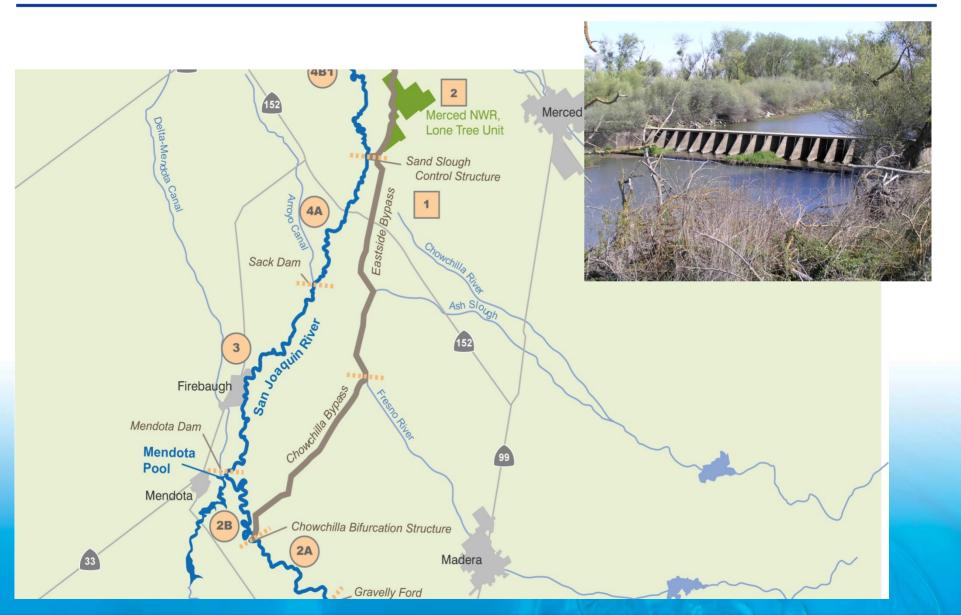
### Reach 3 – Mendota Pool to Sack Dam

- WY 2010 Key Monitoring Activities:
  - Flow, water quality, water temperature
  - Shallow groundwater / seepage
  - Fish habitat surveys
- Future Monitoring:
  - Similar and possibly expanding on above
- Challenges:
  - Coordination with local agencies on water deliveries

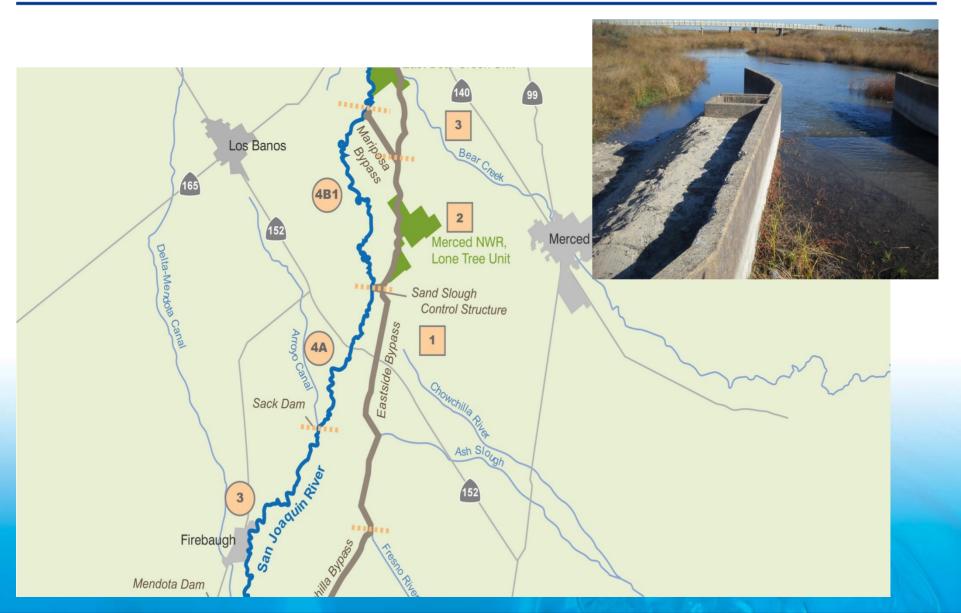
# Reach 4A – Sack Dam to Bypass

- WY 2010 Key Monitoring Activities:
  - Flow, water quality, and temperature
  - Shallow groundwater / seepage
  - Fish habitat surveys
- Future Monitoring:
  - Similar and expanded seepage monitoring
- Challenges:
  - High groundwater elevations resulted in holding flows below anticipated levels
  - Channel constrictions raising water elevations Sand Slough Control Structure

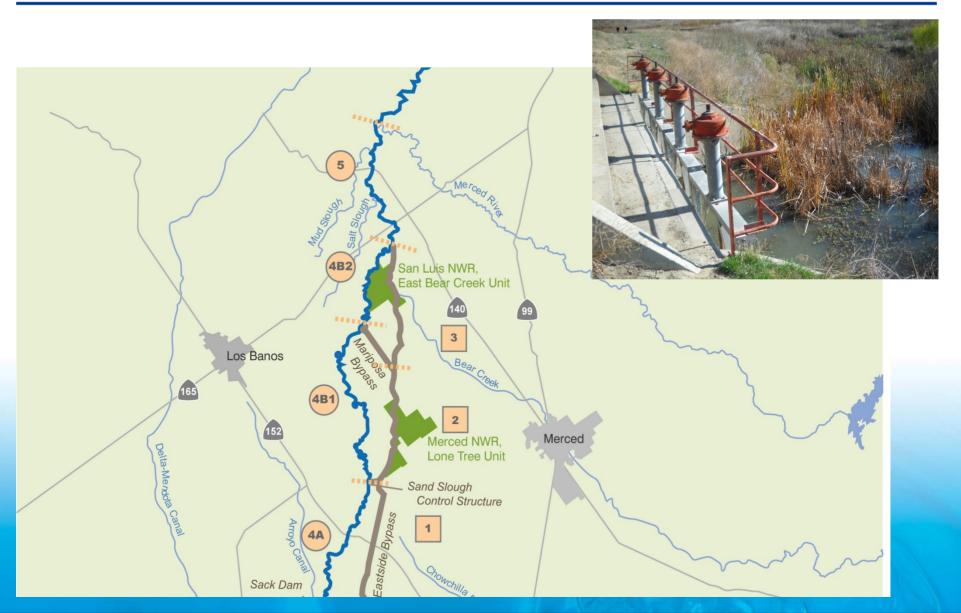
#### Reach 4B1 – Headgates to Mariposa Bypass

- WY 2010 Key Monitoring Activities:
  - None No flows in this reach as flow-through capacity is limited
- Future Monitoring & Studies:
  - Quantify channel capacity
  - Biological and cultural surveys
  - Groundwater monitoring well installation
- Challenges:
  - Limited historical flows
  - High groundwater elevations

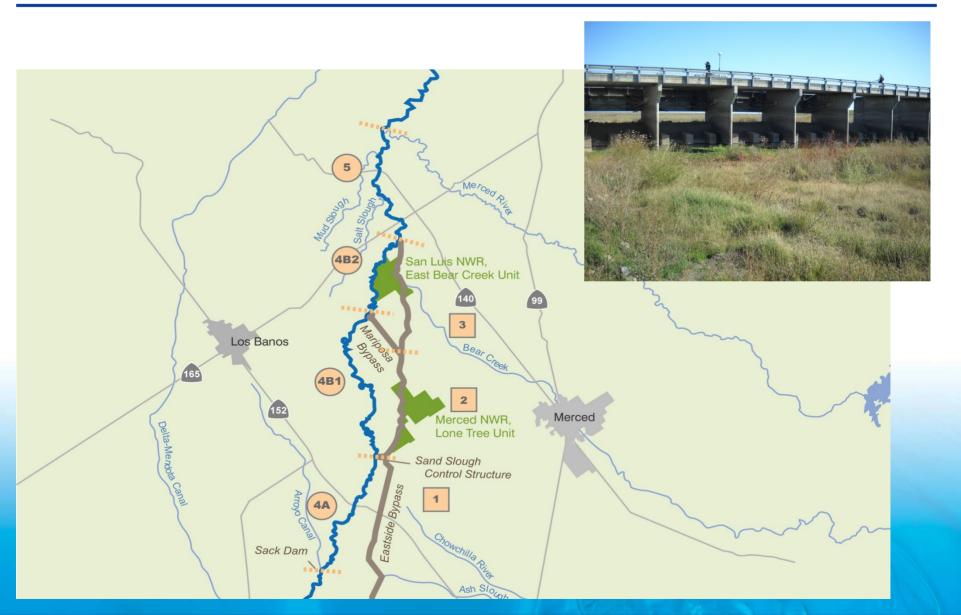
# Eastside Bypass

- WY 2010 Key Monitoring Activities:
  - Flow, water quality, and temperature
  - Shallow groundwater / seepage
- Future Monitoring:
  - Similar and expanded seepage and fisheries habitat monitoring
- Challenges:
  - Sand accumulation
  - Conflicts between restoration actions and the Flood Control Project
