State Water Resources Control Board

June 18, 2015

**SUBJECT: SITE INSPECTION OF WEST SIDE IRRIGATION DISTRICT (WSID) PUMPING STATION
LOCATED IN TRACY, CA.**

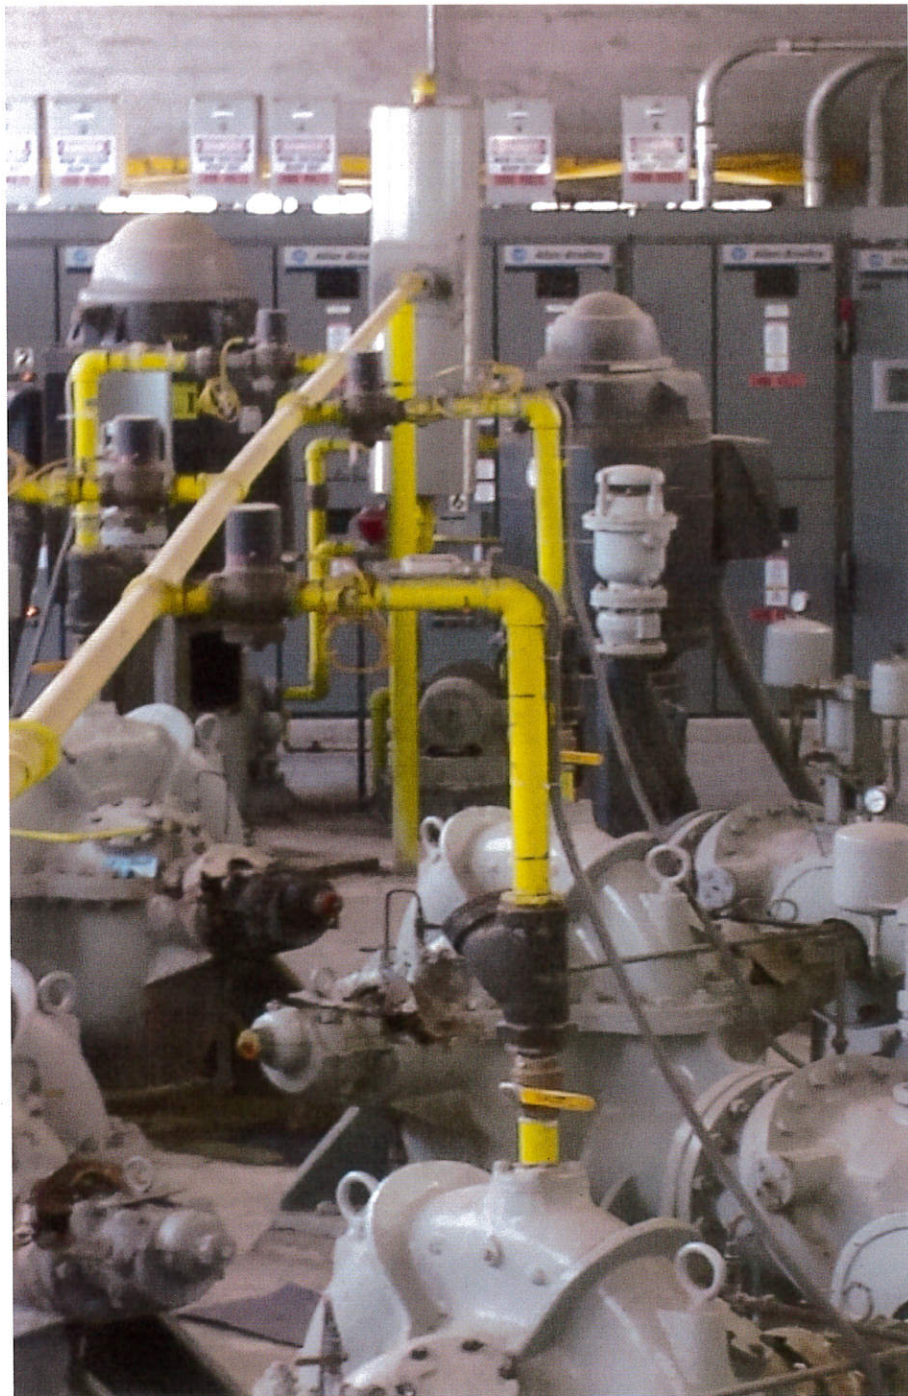
I met with Rick Martinez who was the individual responsible for operating the WSID pump station on the day of my visit. Mr. Martinez stated that the large pumps (grey) were turned off and not diverting water (Photo 1). Mr. Martinez also stated that the two smaller pumps (black) were running. I witnessed the smaller pumps operating. Mr. Martinez further stated that the smaller (black) pumps were capturing tail water runoff from Bethany Drain at an estimated rate of 8 cubic feet per second (Photo 2 & 3). According to Mr. Martinez, the black pumps were re-capturing tail water and re-diverting the tailwater to farmers within the boundaries of WSID that have trees as their main crop.

Photo 1: WSID Pump House. Gray pumps were turned off and the black pumps were running and capturing tailwater from Old River Cut.

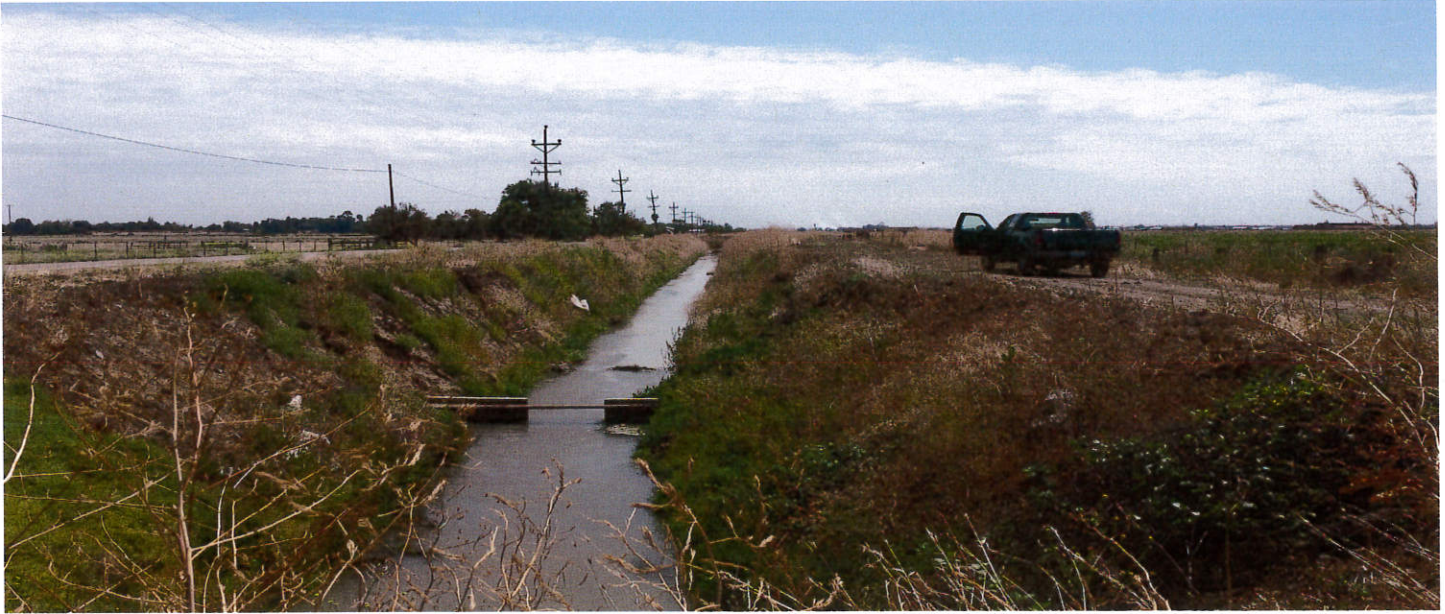
Photo 2: Photo looking east along the drain that borders Bethany Road within the WSID boundary. The drain collects tailwater which then flows back into Old River Cut.

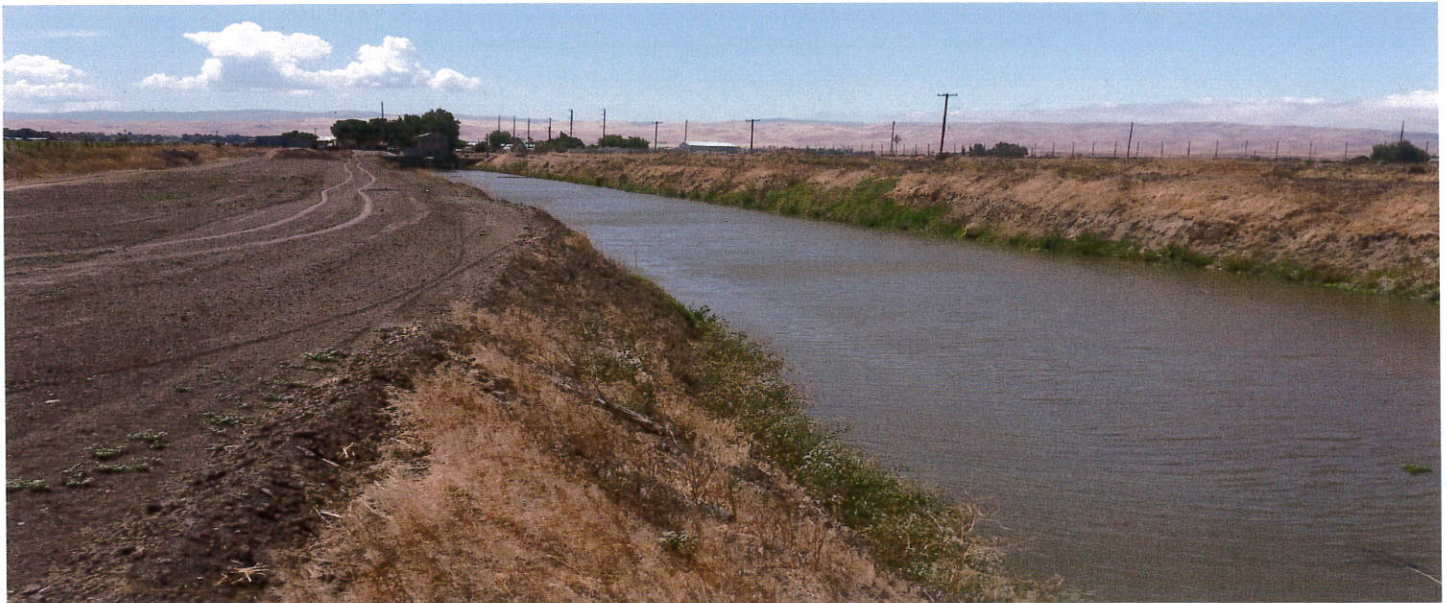
Photo 3: Looking south along Old River Cut in which the WSID Pumping House can be seen in the photo. Tailwater in Old River Cut was being recaptured and rediverted to farmers within WSID area for irrigation of trees.
