CHANNEL EROSION ALONG THE CARMEL RIVER, MONTEREY COUNTY, CALIFORNIA

G. MATHIAS KONDOLF

Historic maps, photographs, and channel cross-sections show that the channel of the Carmel River underwent massive bank erosion, channel migration, and aggradation in a major flood in 1911, then narrowed and incised by 1939. The channel was stable until 1978 and 1980, when bank erosion affected some reaches but not others. The narrowing and incision were in response to a lack of major floods after 1914 and construction in 1921 of a dam that cut off sediment supply from the most actively eroding half of the basin. Localized erosion in 1978 and 1980 occurred during low magnitude events along reaches whose bank strength had been reduced by devegetation. These events illustrate that the stability of a fluvial system can be disrupted either by application of a large erosive force in a high magnitude event (the 1911 flood) or in a low magnitude event, by reducing the resistance to erosion (bank devegetation).

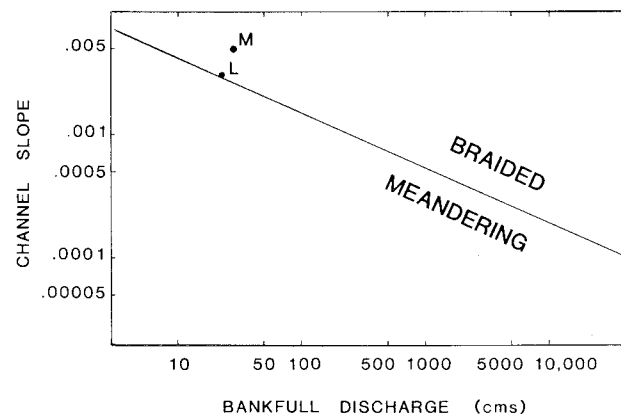
Figure 4. Channel patterns plotted by slope and bankfull discharge, with Middle (M) and Lower (L) Carmel plotted on graph. Original figure from Leopold *et al.* (1964, p. 293)

In contrast, the Middle Carmel showed continued change from 1939 to 1965, and 1965 to the present. The channel became less braided from 1939 to 1965. From 1965 to 1982 the channel continued to incise and migrated laterally in many locations. Some specific causes contributing to the incision and lateral erosion can be identified (such as local straightening of the river for highway improvement) but much of the change may be due to the inherent instability of this steeper reach of the river. The overall gradient of the Middle Carmel is 0.005 compared to 0.003 for the Lower Carmel. The Middle Carmel plots in the braided portion of the graph defining channel pattern for streams on the slope vs. discharge plot of Leopold *et al.* (1964, p. 293; Figure 4).

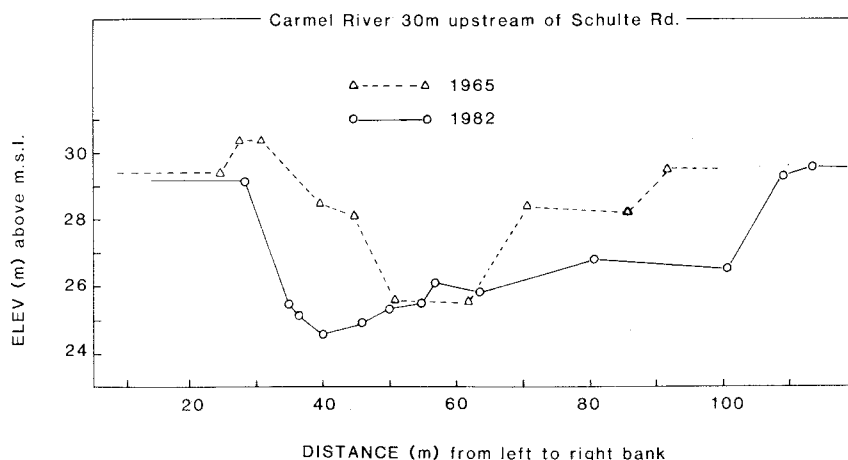
Figure 5. Sequential changes in channel cross-section of the Carmel River 30 m upstream of Schulte Road bridge. 1965 data from U.S. Army Corps of Engineers, San Francisco Office. 1965 section was not documented, so location may not be precise

Although the Middle Carmel was still undergoing adjustments from 1939 to 1978, the Lower Carmel was essentially stable over those four decades. Since 1978, however, the 15 km long Lower Carmel exhibited two distinctly different behaviour patterns: the downstream half remained stable, while the upstream half experienced extensive bank erosion. Bank erosion began in 1978 and increased in 1980. The most extensive bank erosion occurred in the reach upstream of Schulte Road bridge, where relocation of a U.S. Army Corps of Engineers cross-section site 30 m upstream of Schulte Bridge shows an increase in width from 25 to 65 m between 1965 and 1982 (Figure 5). The degradation apparent in this section occurred after 1980, and was subsequent to, not a cause of, bank erosion.

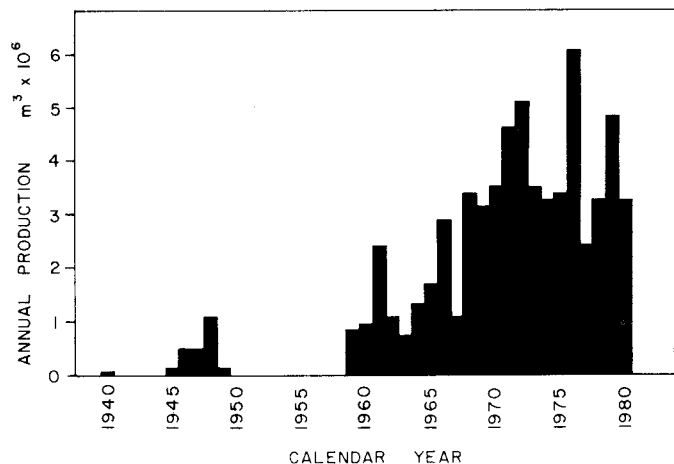
Figure 7. Annual production, Mid-Valley wells through 1980. Values are cumulative annual production for Scarlett, Berwick, Manor, Schulte, Dollar, Thacker, and Begonia wells. With exception of Dollar and Thacker, all wells located on Figure 1. Source: Cal-Am production records

As the demand for water increased, more wells were drilled and pumping increased, especially during the severe drought of 1976–1977 (Figure 7). Production from the wells reached a peak in 1976 and then decreased in 1977 because the aquifer (unconfined alluvium about 30 m thick and 0.5 km wide) was locally depleted.
