**Department of Water Resources**  
**Testimony for SWRCB Hearing on Cease and Desist Order**  
**Regarding**  
**The South Delta Temporary Barriers Project <sup>1</sup>**

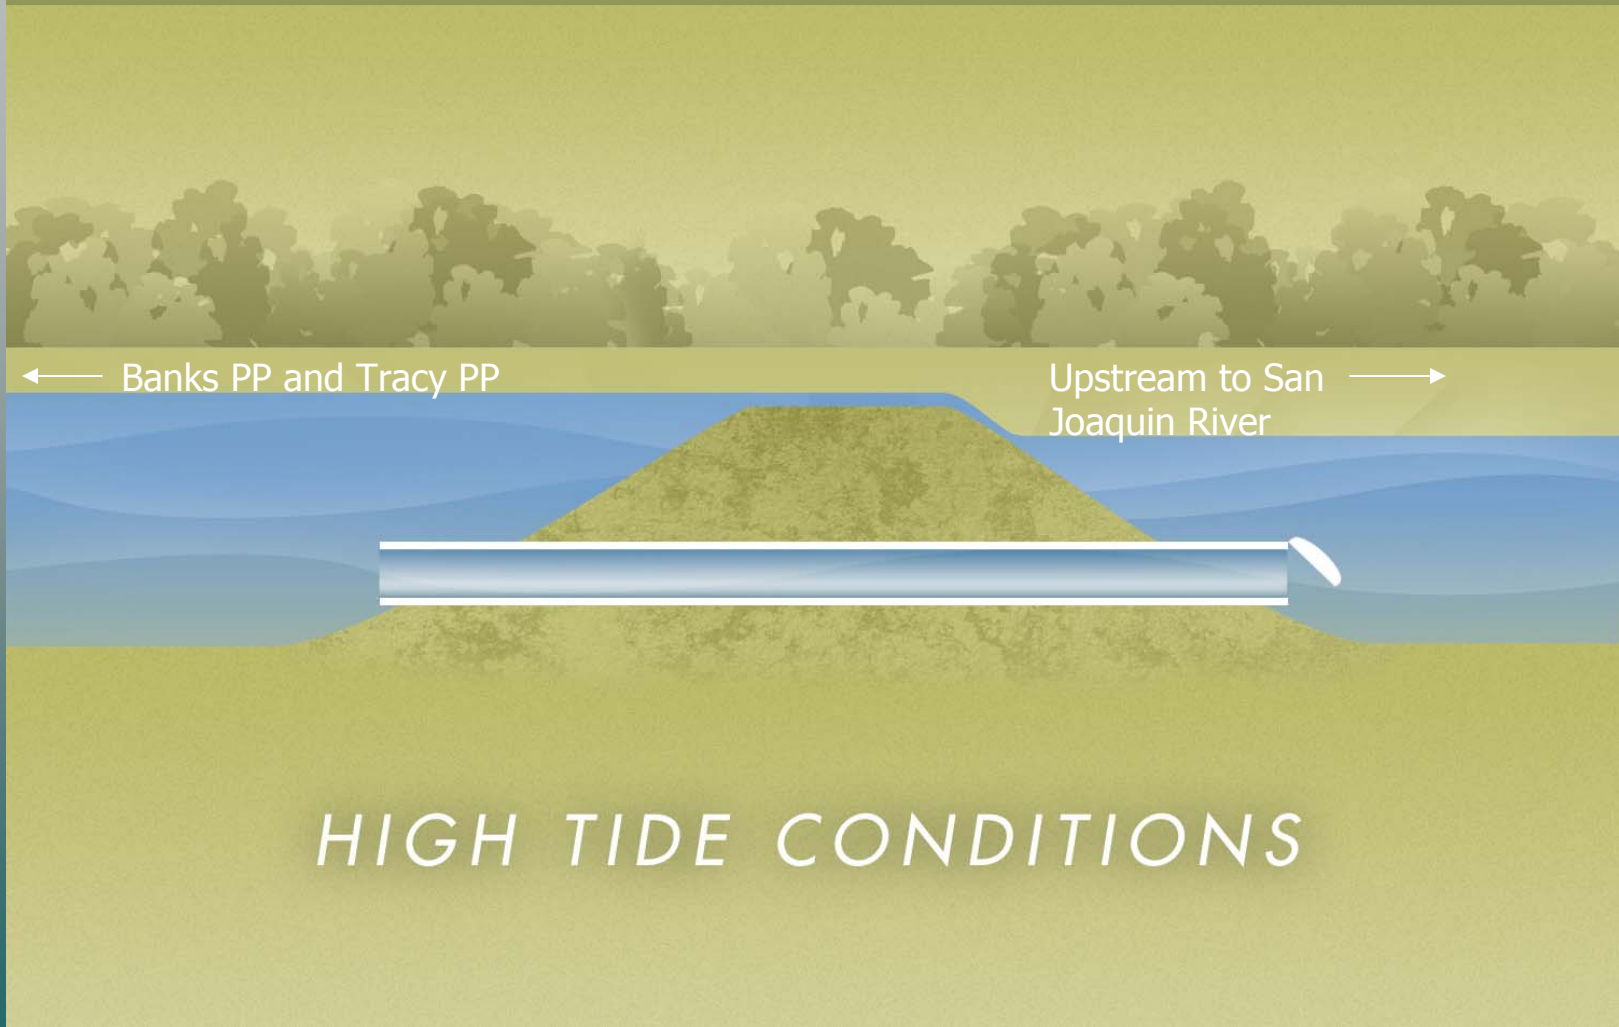
Figure 5

The first slide [Figure 7] shows how the rising or “flood” tide forces water over the barrier and through the culverts. The hydrostatic pressure of the flood tide forces water against the flap gates on the culverts and opens the flap gates on the upstream side to enable water to flow into the channel upstream of the barrier. .

# AGRICULTURAL BARRIER

The next three slides [Figures 7-9] depict how the culverts at the temporary barriers work to allow water to fill the upstream reaches on

the rising tides and then maintain the higher water levels while the tide recedes. Three of the barriers have six 4-foot diameter culverts. The barrier on Old River at Tracy has nine culverts 4-foot diameter culverts.

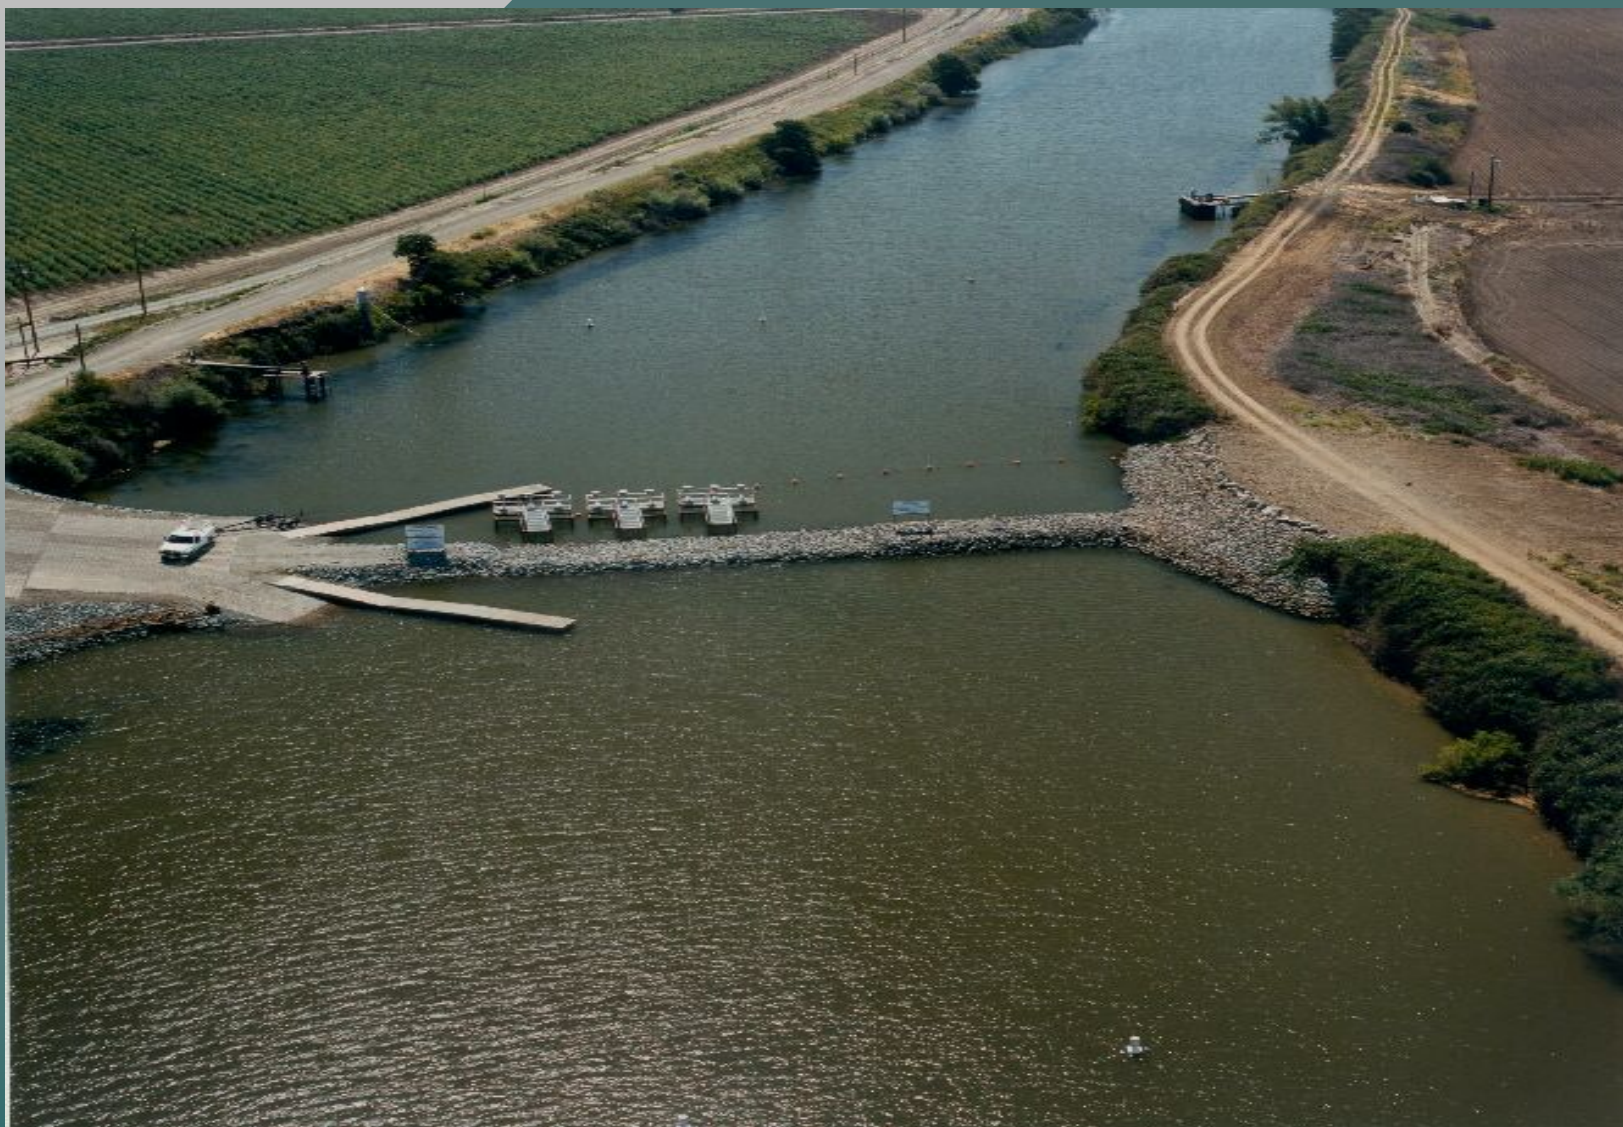
The next four slides [Figures 10-13] are aerial views of the barriers. The first slide shows the Old River at Tracy barrier with the boat ramp for recovering and launching recreational boaters on the left and the culvert structure near the center of the barrier. The next slide shows the Grant Line Canal barrier at a time in the tidal cycle when water flows over the weir portion of the barrier from upstream. This barrier also has a boat portage ramp. Here you can see the culvert structure, which at this barrier stays in place in the channel all year long. At the far right side of the barrier a fish weir operates using flashboards to adjust the amount of flow for fish passage. In the next

Old River at Tracy Barrier

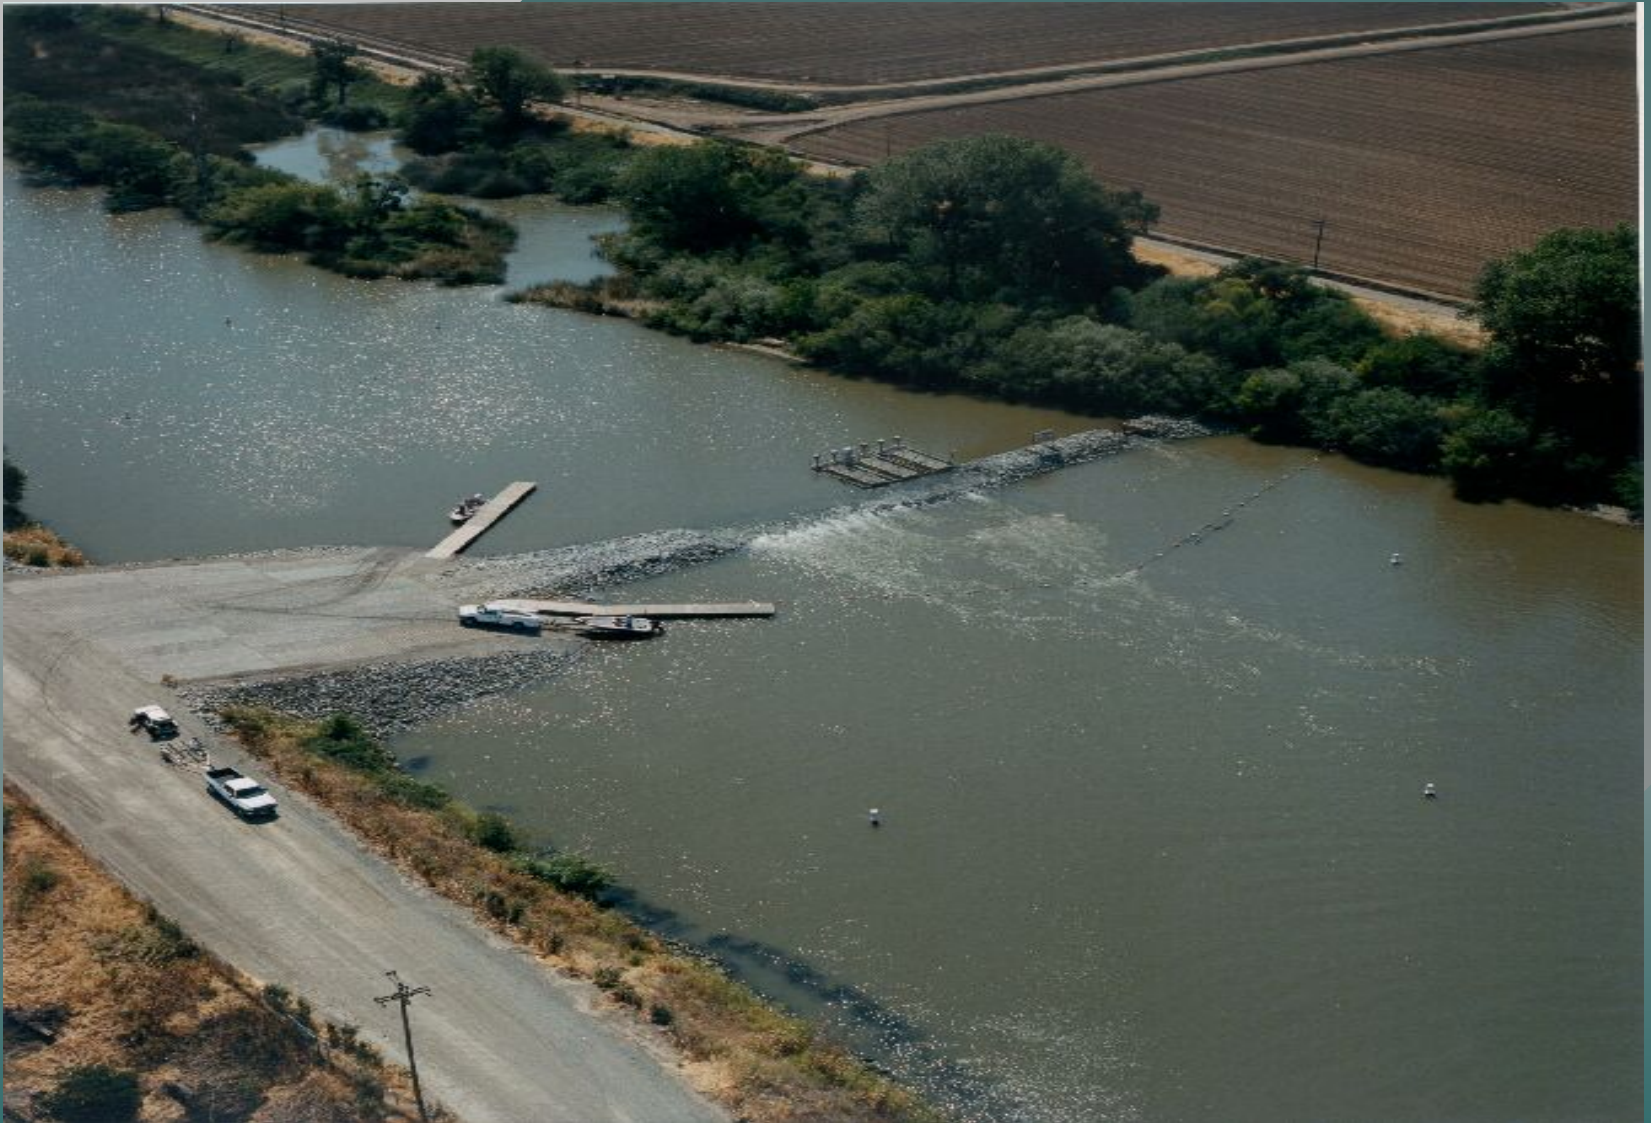
Grant Line Canal Barrier

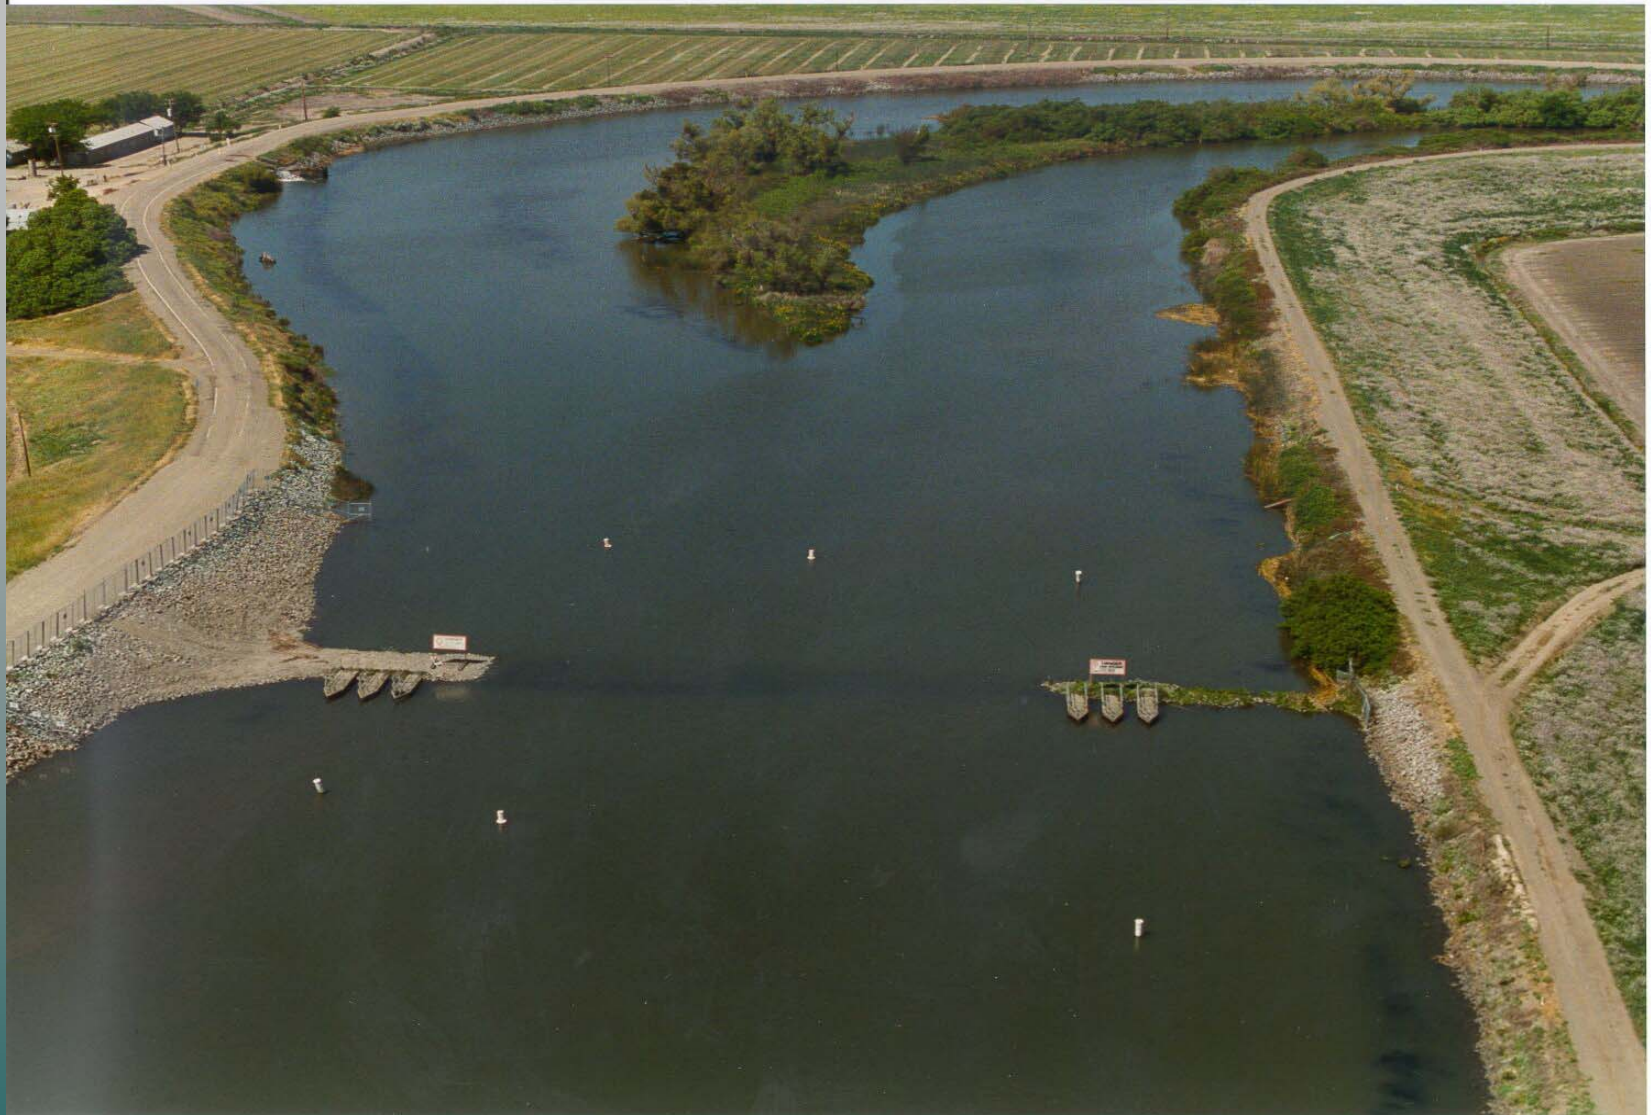
slide is the Middle River barrier. This barrier also has culvert structures that are in place in the channel all year. Installation of this barrier only requires placing of rock in the center to create a weir. Note that in this picture water is flowing over the MR weir, so it's difficult to see. This next slide shows the HOR barrier, installed at the confluence of Old River and the San Joaquin River. The San Joaquin River is in the background. Notice in the center of the barrier is a portion that is not rip-rapped. In the spring only, we install a clay "plug" that can wash away in an extreme high flow situation, thus controlling the breach in the barrier to reduce damage to nearby levee slopes. In the fall, instead of a clay plug, we install a notch that allows continuous flow for migrating adult salmon that might otherwise get trapped on the Old River side of the barrier.

Middle River Barrier

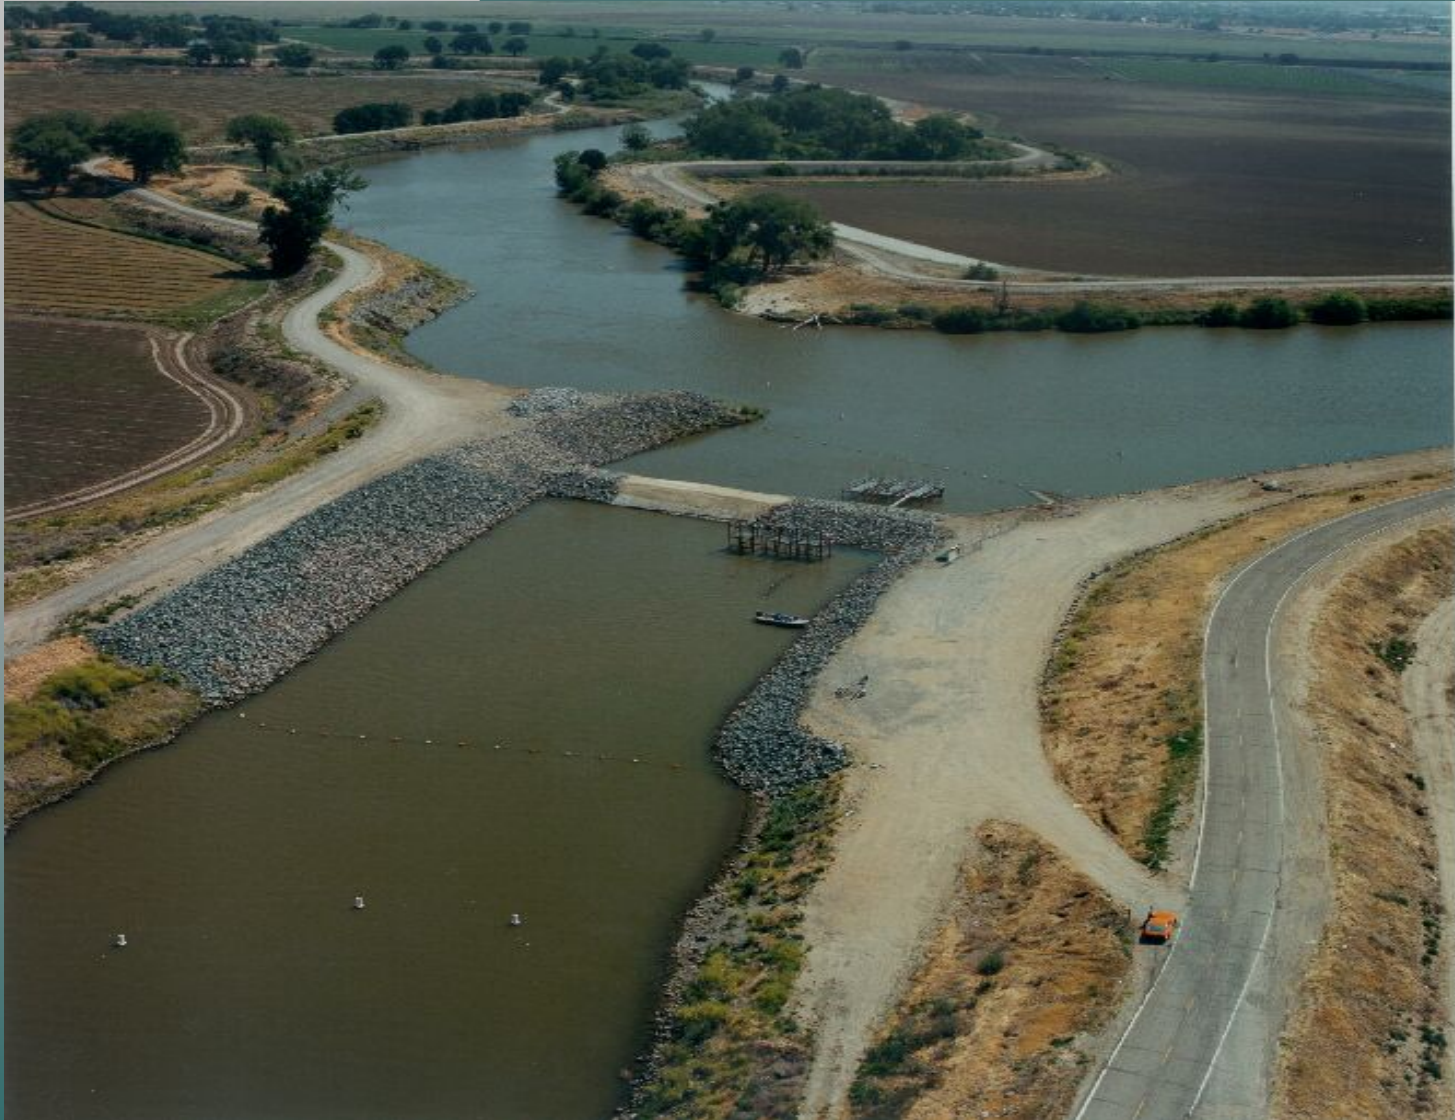
Head of Old River Barrier

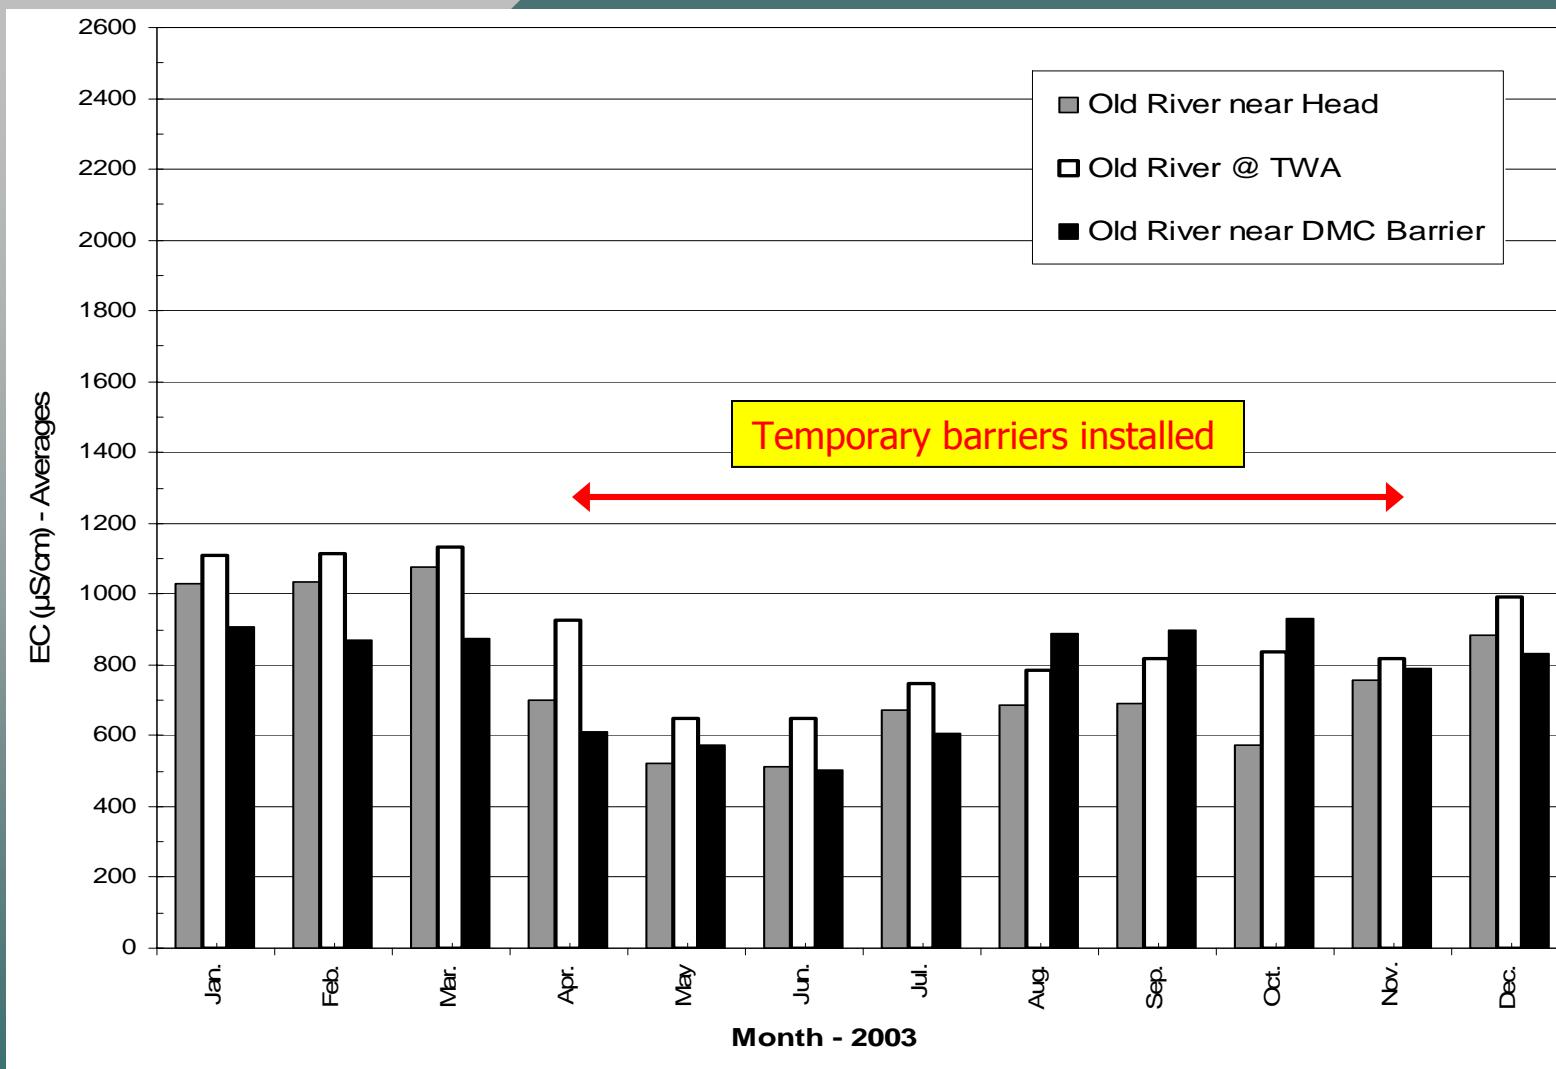
Figure 13

the Vernalis Adaptive Management Plan experiment. Higher flows improve the water quality entering the south Delta area, which is generally SJR water during this time. Two, when the HOR barrier isn't operating during the summer months, when SJR flows are low and poorer quality, the three agricultural barriers reduce the amount of SJR flows entering the south Delta and change circulation dynamics. Three, the barriers hold a greater volume of water in the channels above the barriers than would normally be present without the barriers. Higher volumes provide greater dilution of salt from upstream and agricultural sources.

## Typical TBP Water Quality Improvements
