Muni/Western Ex. 9-2
Seven Oaks Dam

SEVEN OAKS DAM
SANTA ANA RIVER BASIN, CALIFORNIA
WATER CONTROL MANUAL

**SEVEN OAKS DAM
STORAGE ALLOCATION
DIAGRAM**

U.S. ARMY CORPS OF ENGINEERS
LOS ANGELES DISTRICT

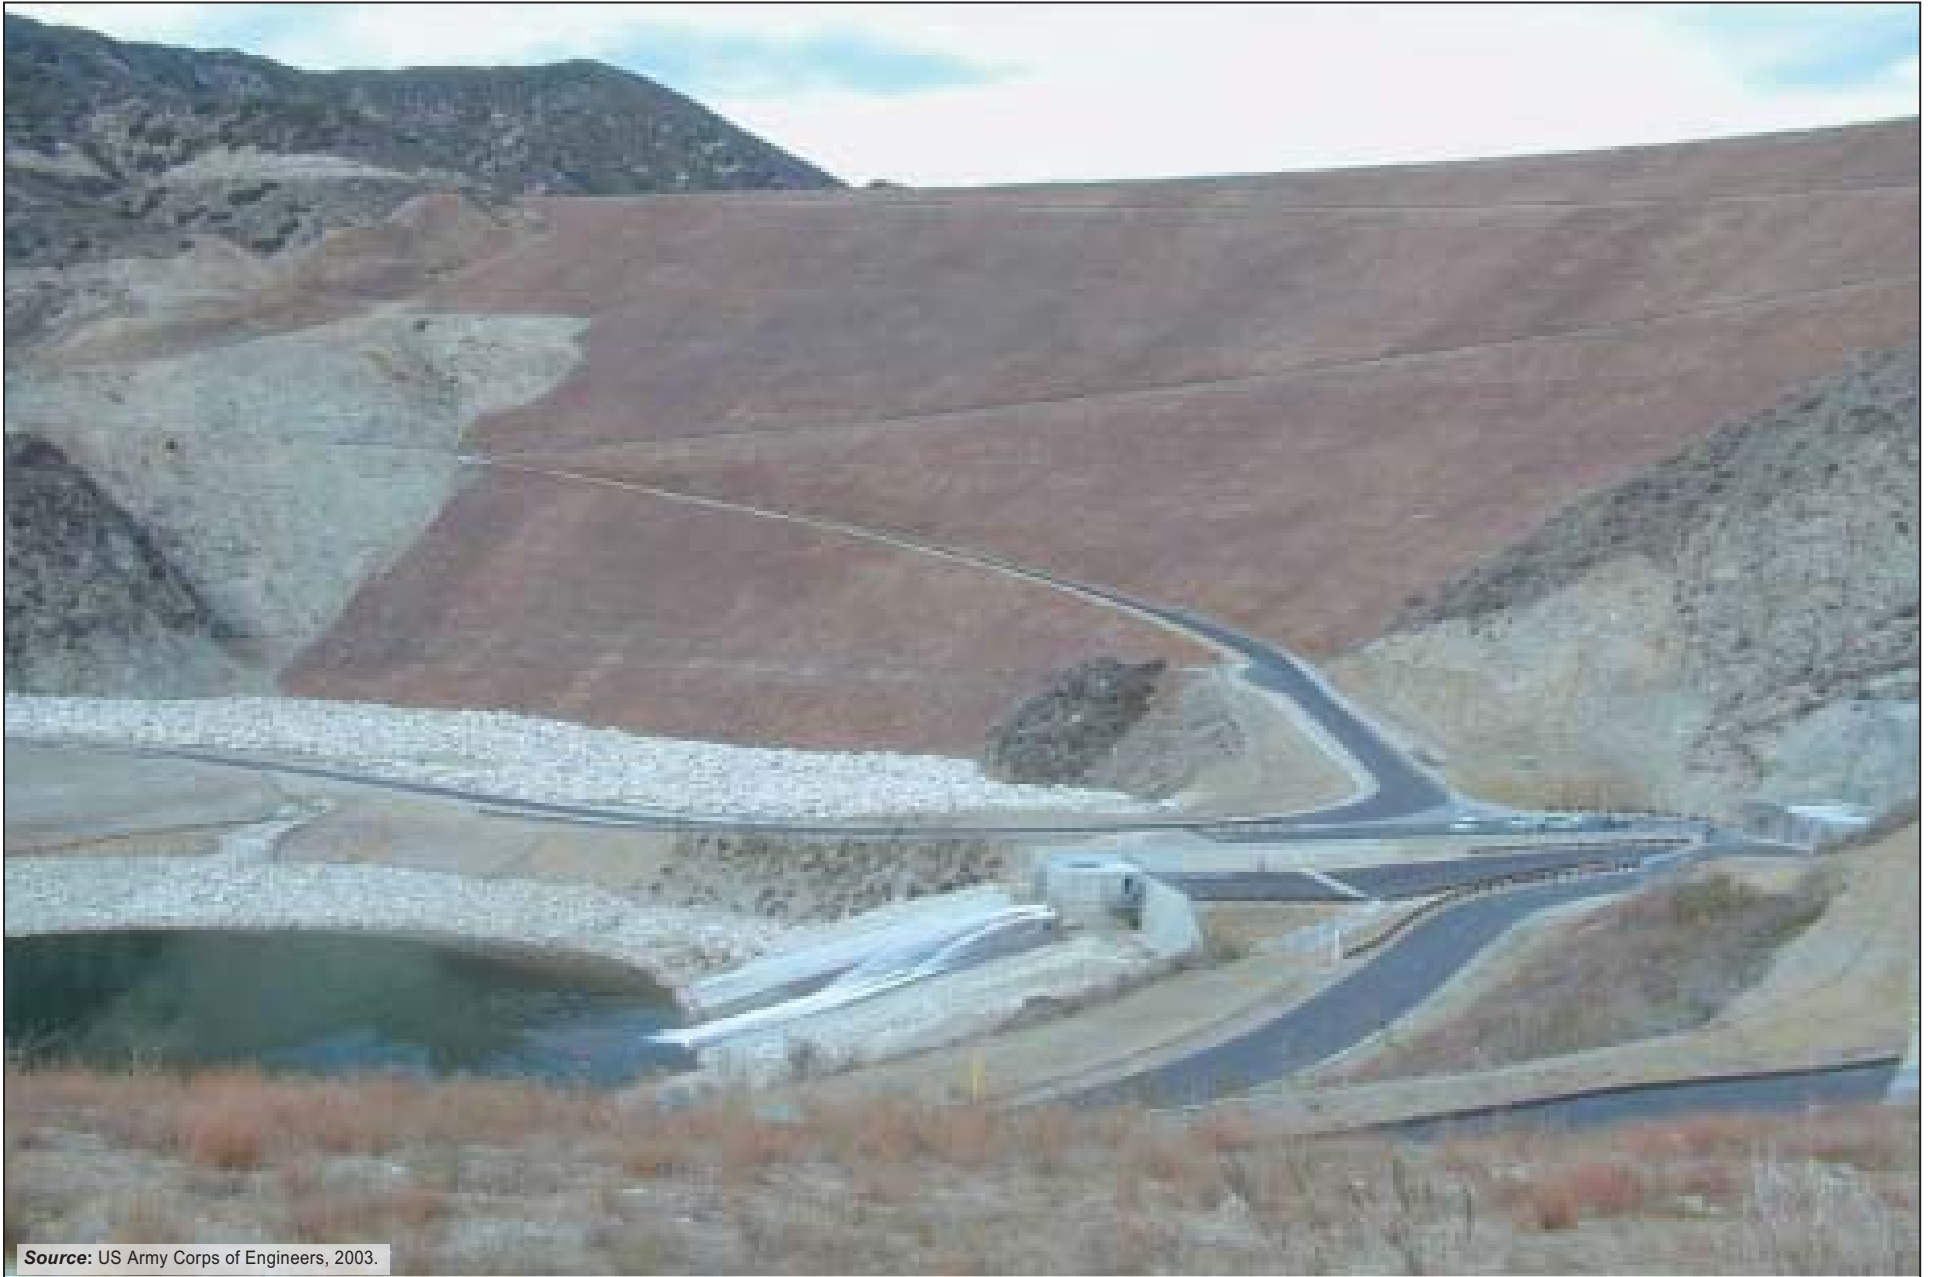
1. Storage and Area values based on year 1999 survey
2. The top of sediment pool is determined by the current top of stop logs elevation. Additional stop logs will be placed as additional sediment accumulates over the life of the project.

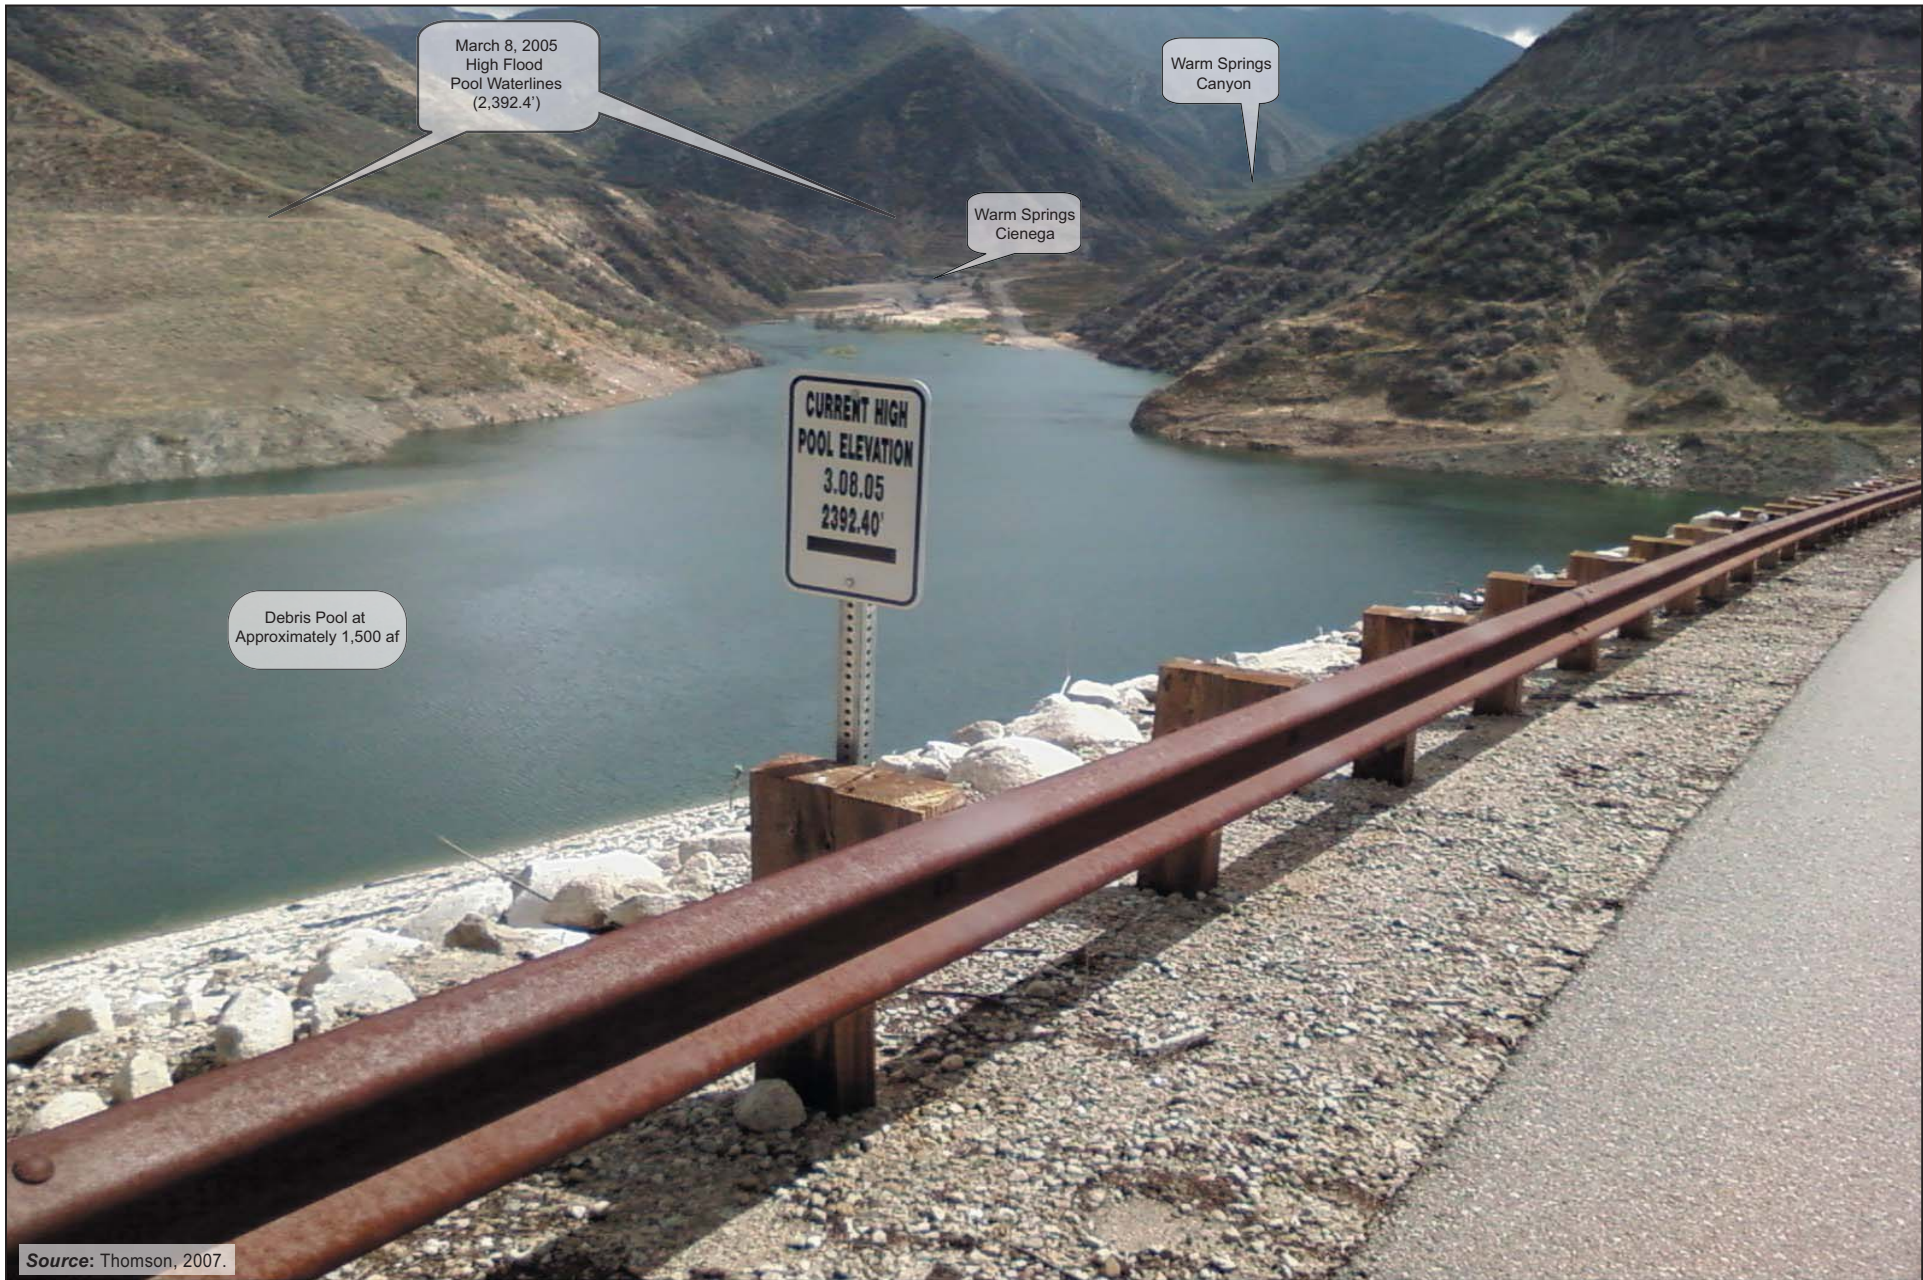
Muni/Western Ex. 9-10

Debris Pool from Seven Oaks Dam on 27 March 2007, Flood Pool High Waterline Reached on 8 March 2005

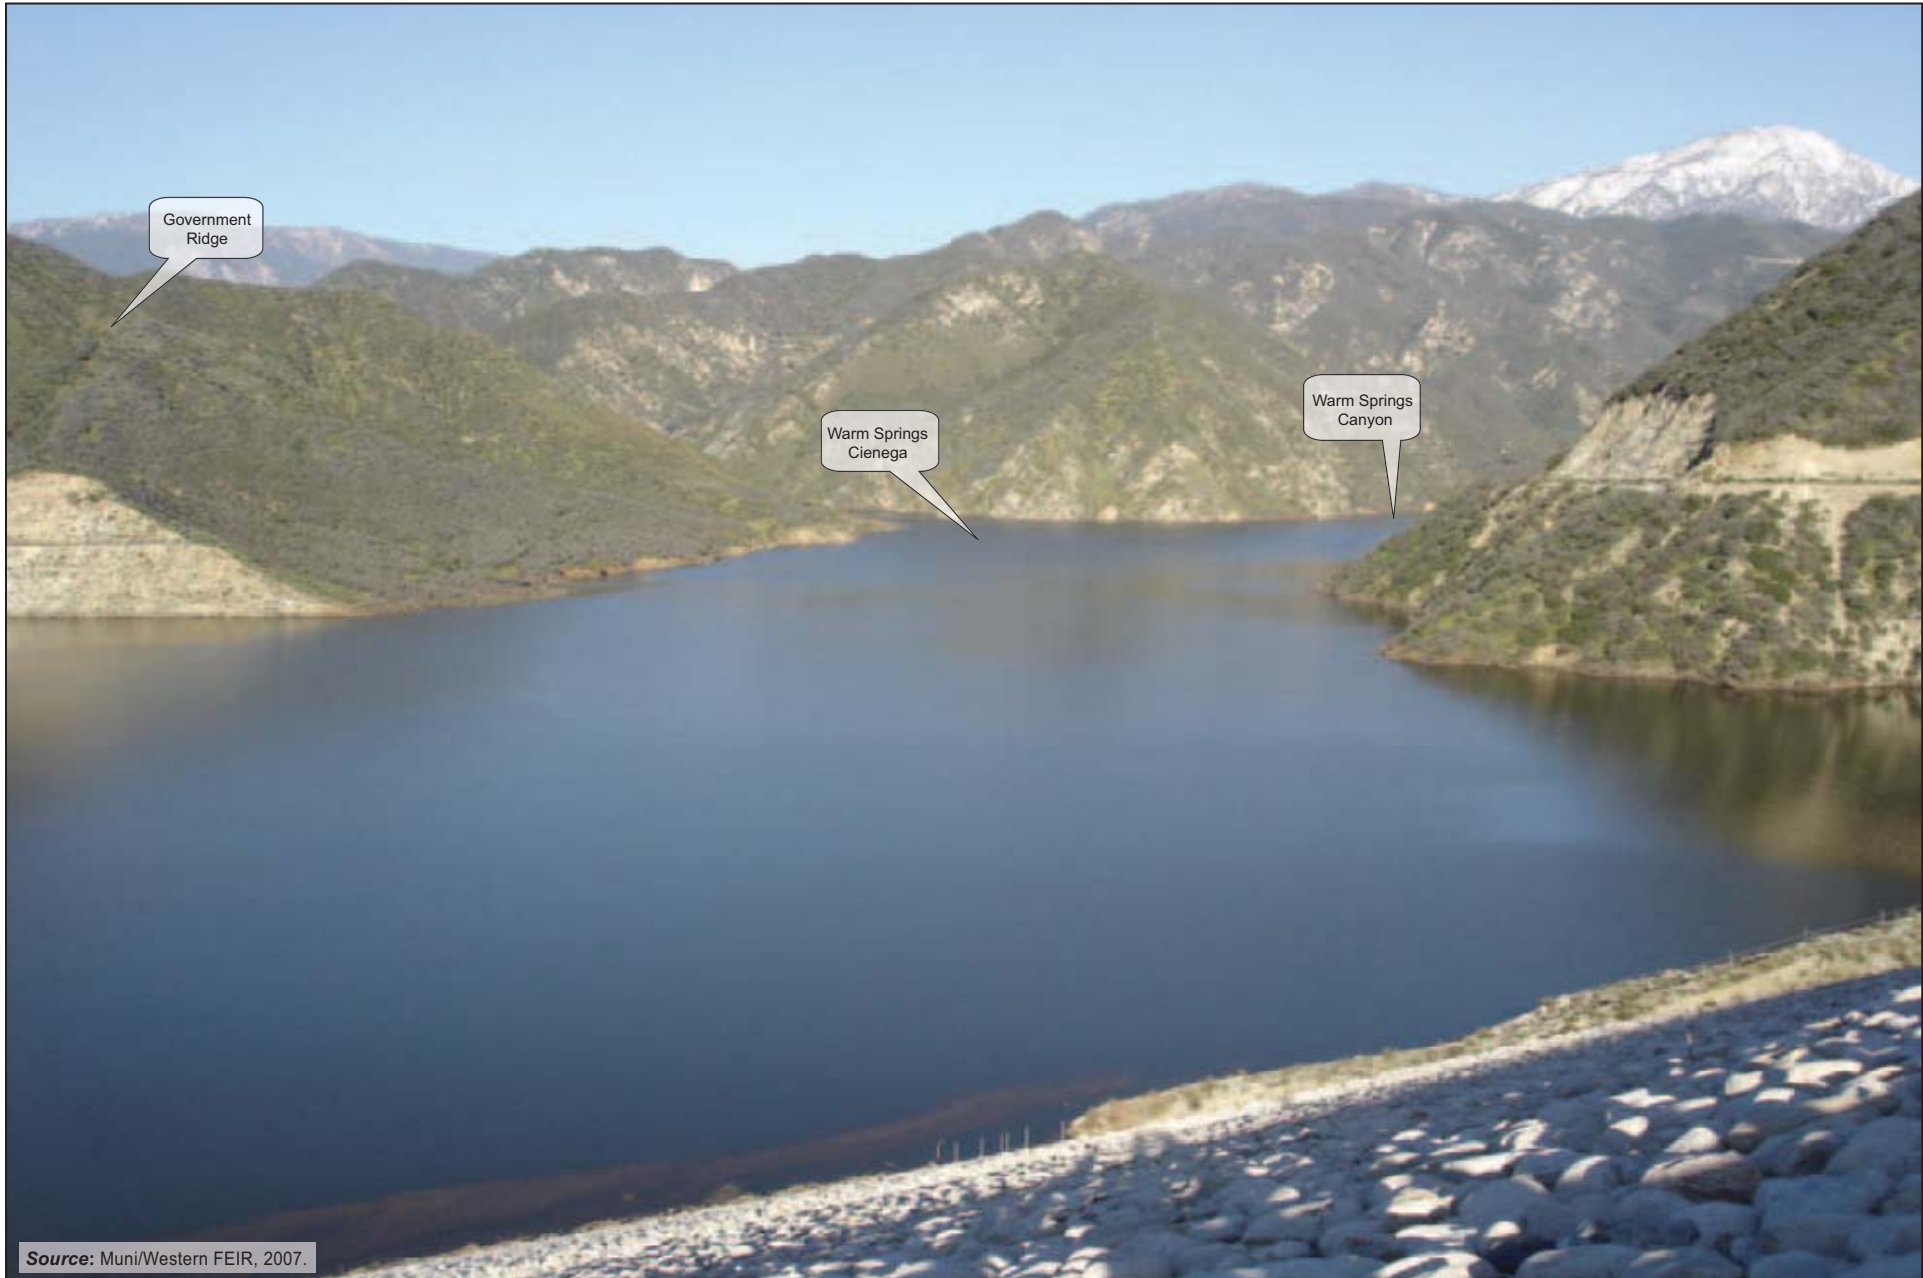
Muni/Western Ex. 9-13

Northeast View from Seven Oaks Dam of the Flood Pool Near Maximum Elevation During the 2004-2005 Flood Season

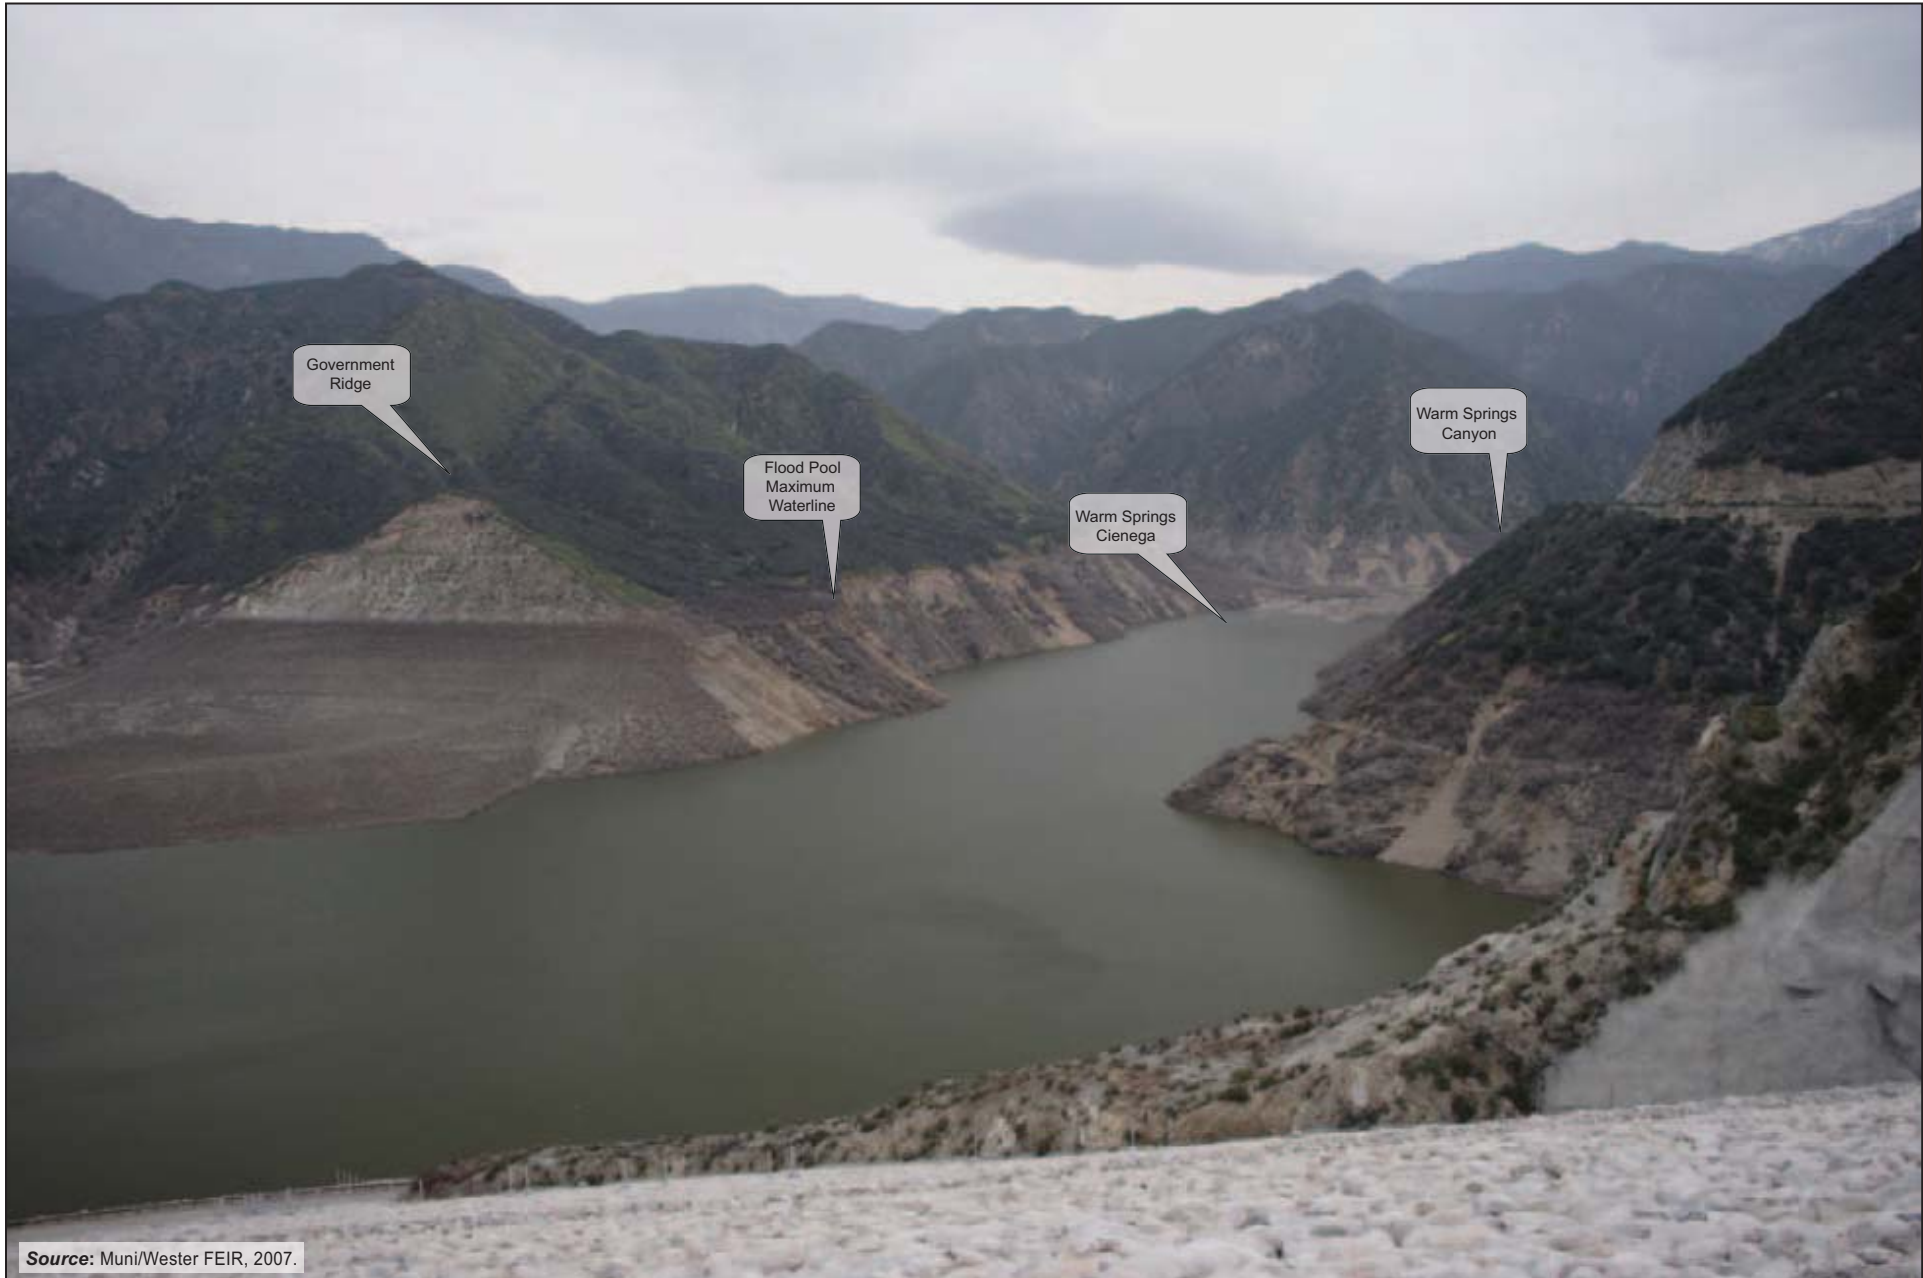
Muni/Western Ex. 9-14

Northeast View from Seven Oaks Dam of the Flood Pool after Receding in April 2005

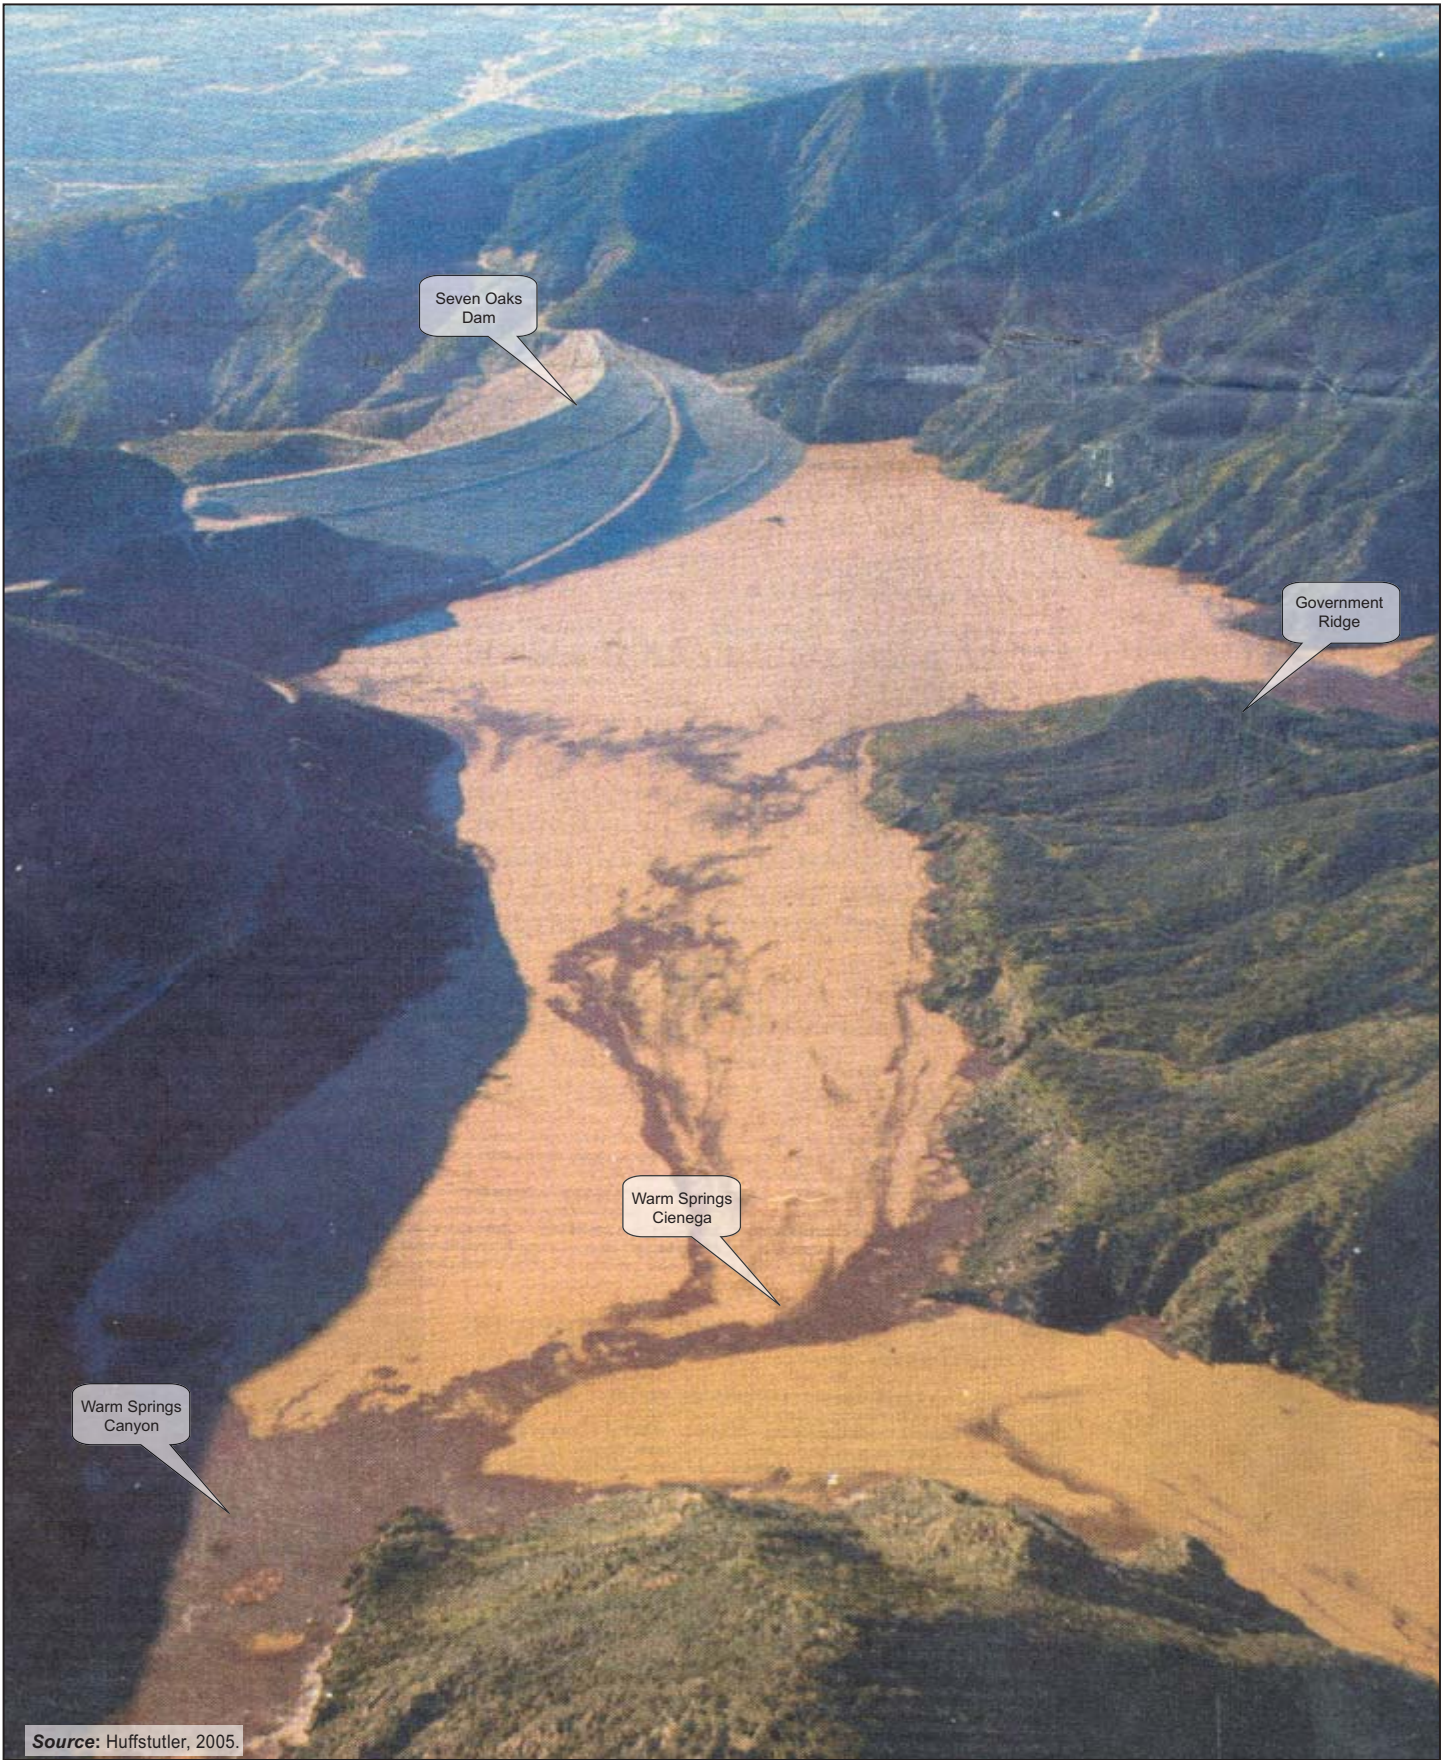
Muni/Western Ex. 9-15
**Aerial View of Flood Pool Behind Seven Oaks Dam During 2004-2005
Flood Season**

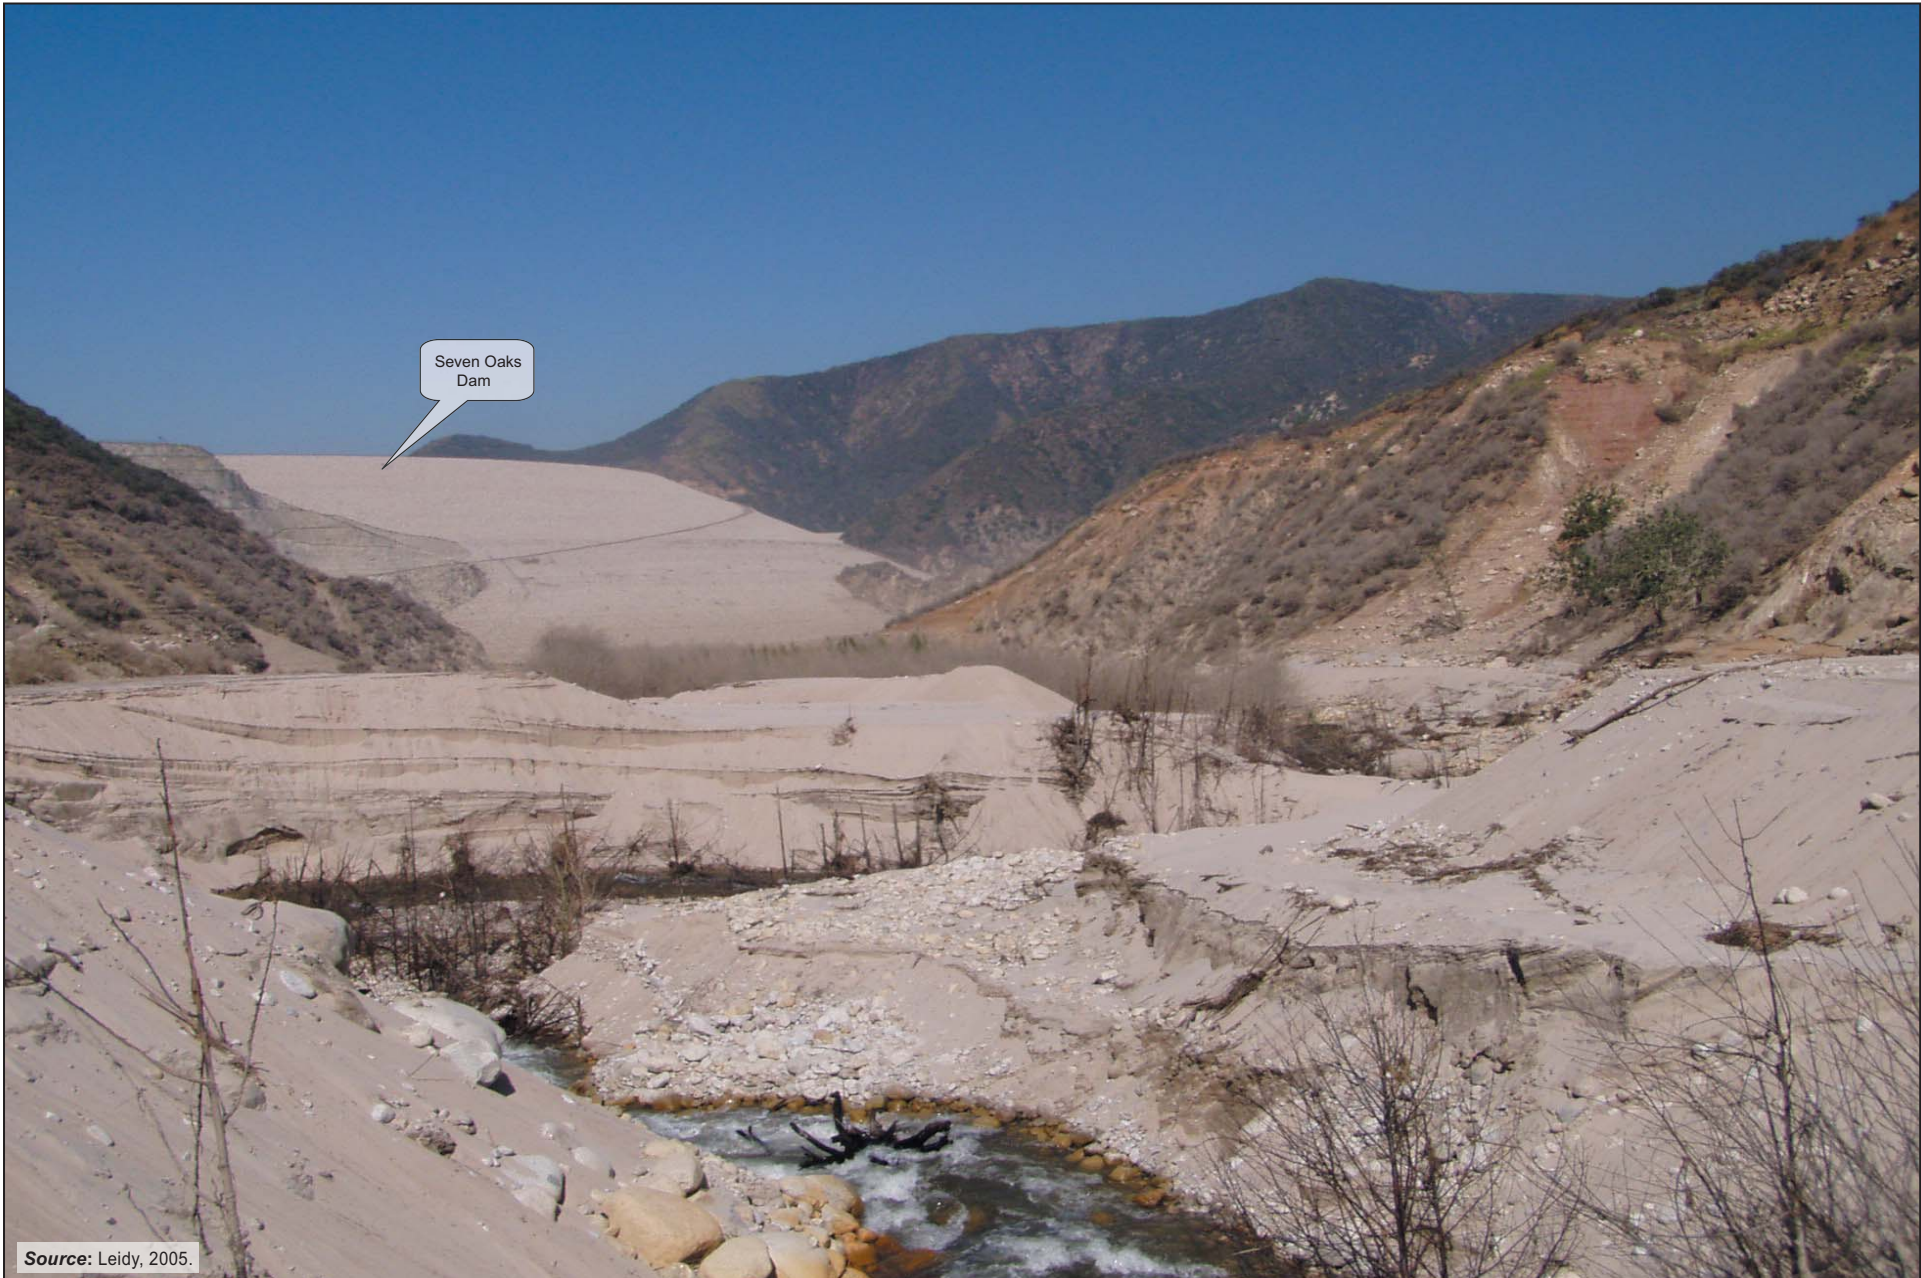
Muni/Western Ex. 9-18

Accumulated Sediment within the Warm Springs Cienega Following the 2004-2005 Flood Season

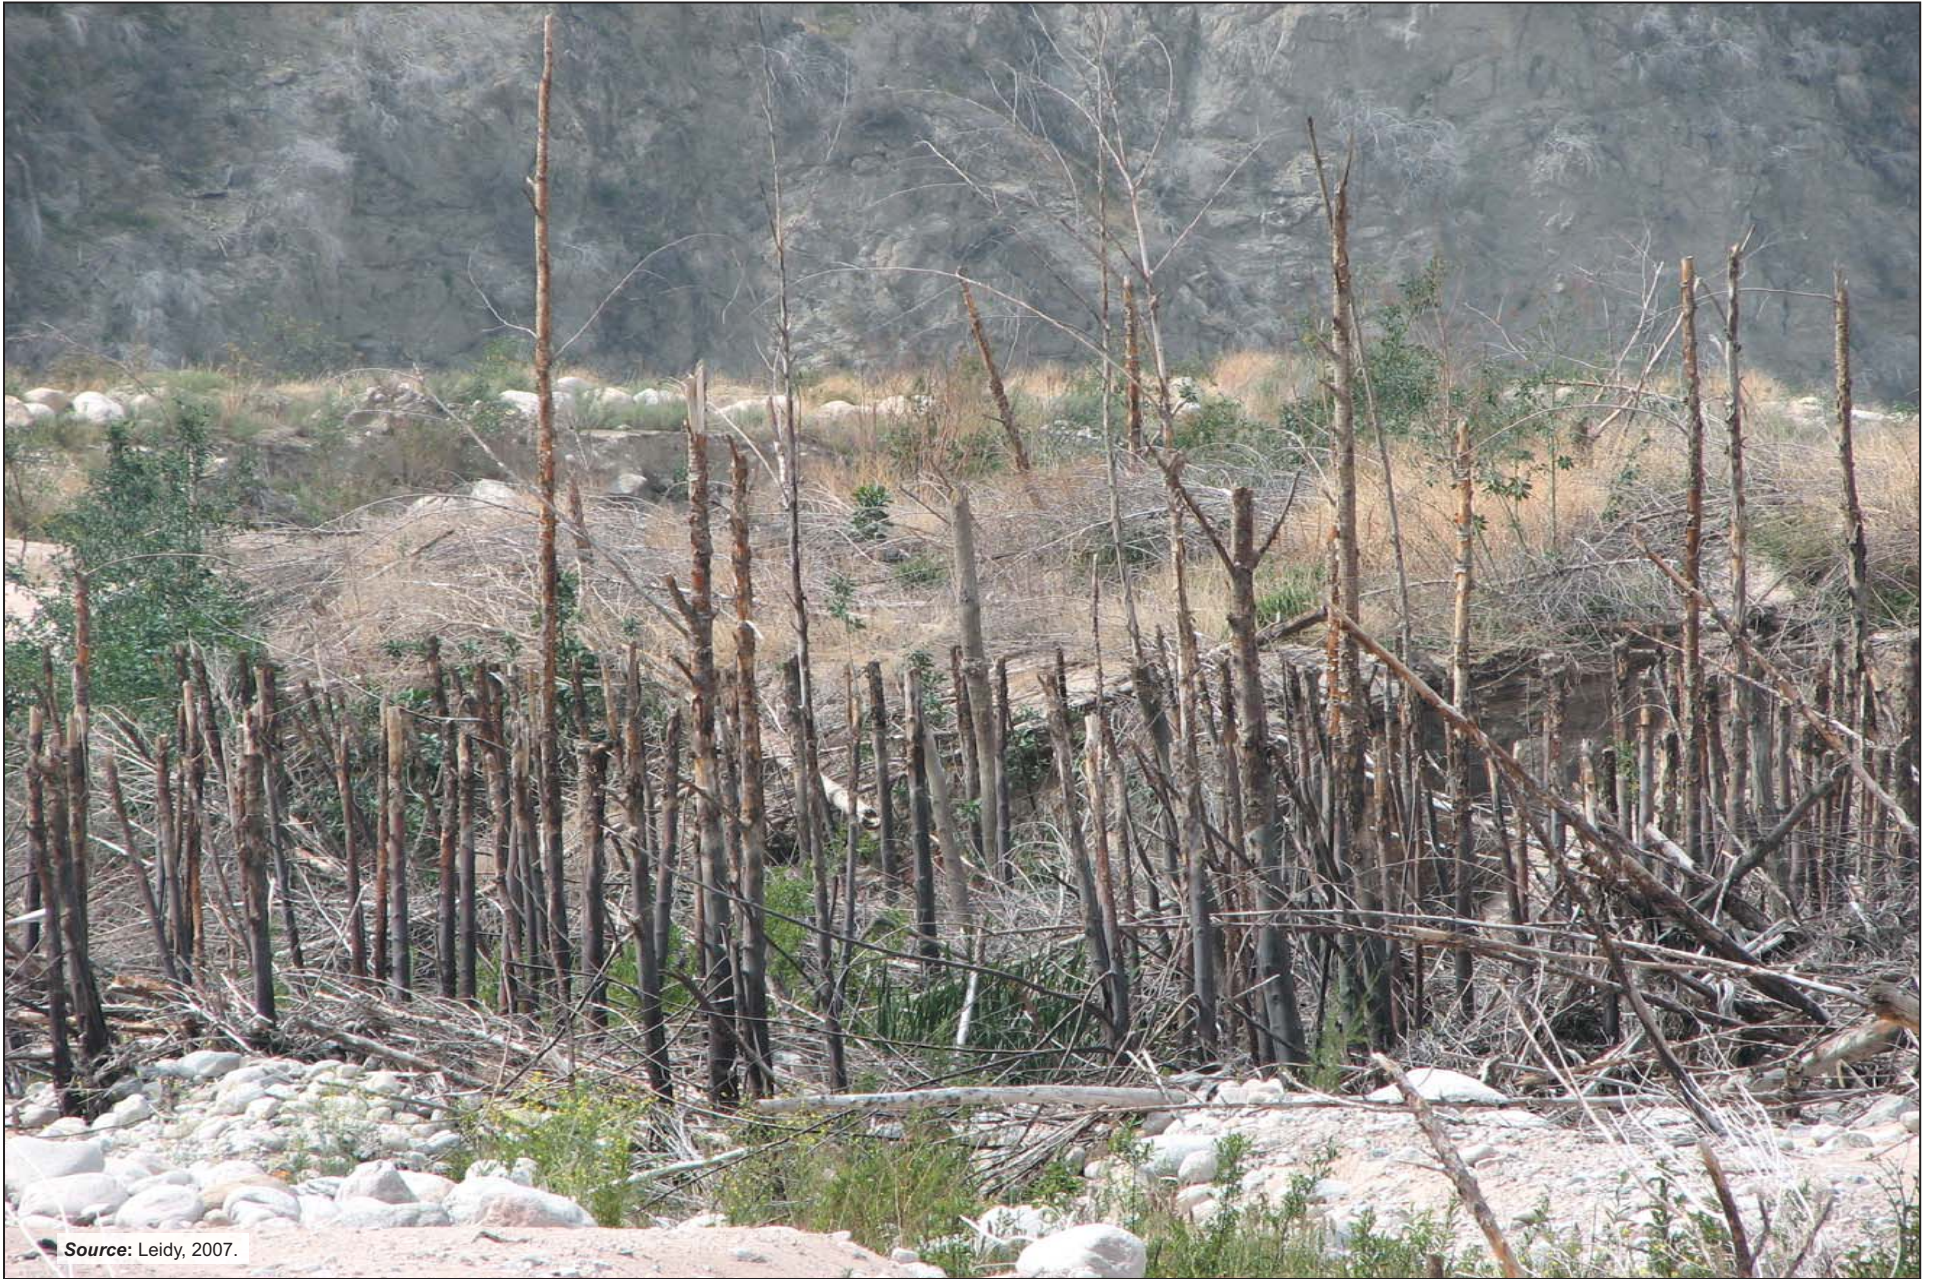
Muni/Western Ex. 9-24

Close-Up View of Damage to Warm Springs Cienega from 2005-2006 Flood Events, April 2007

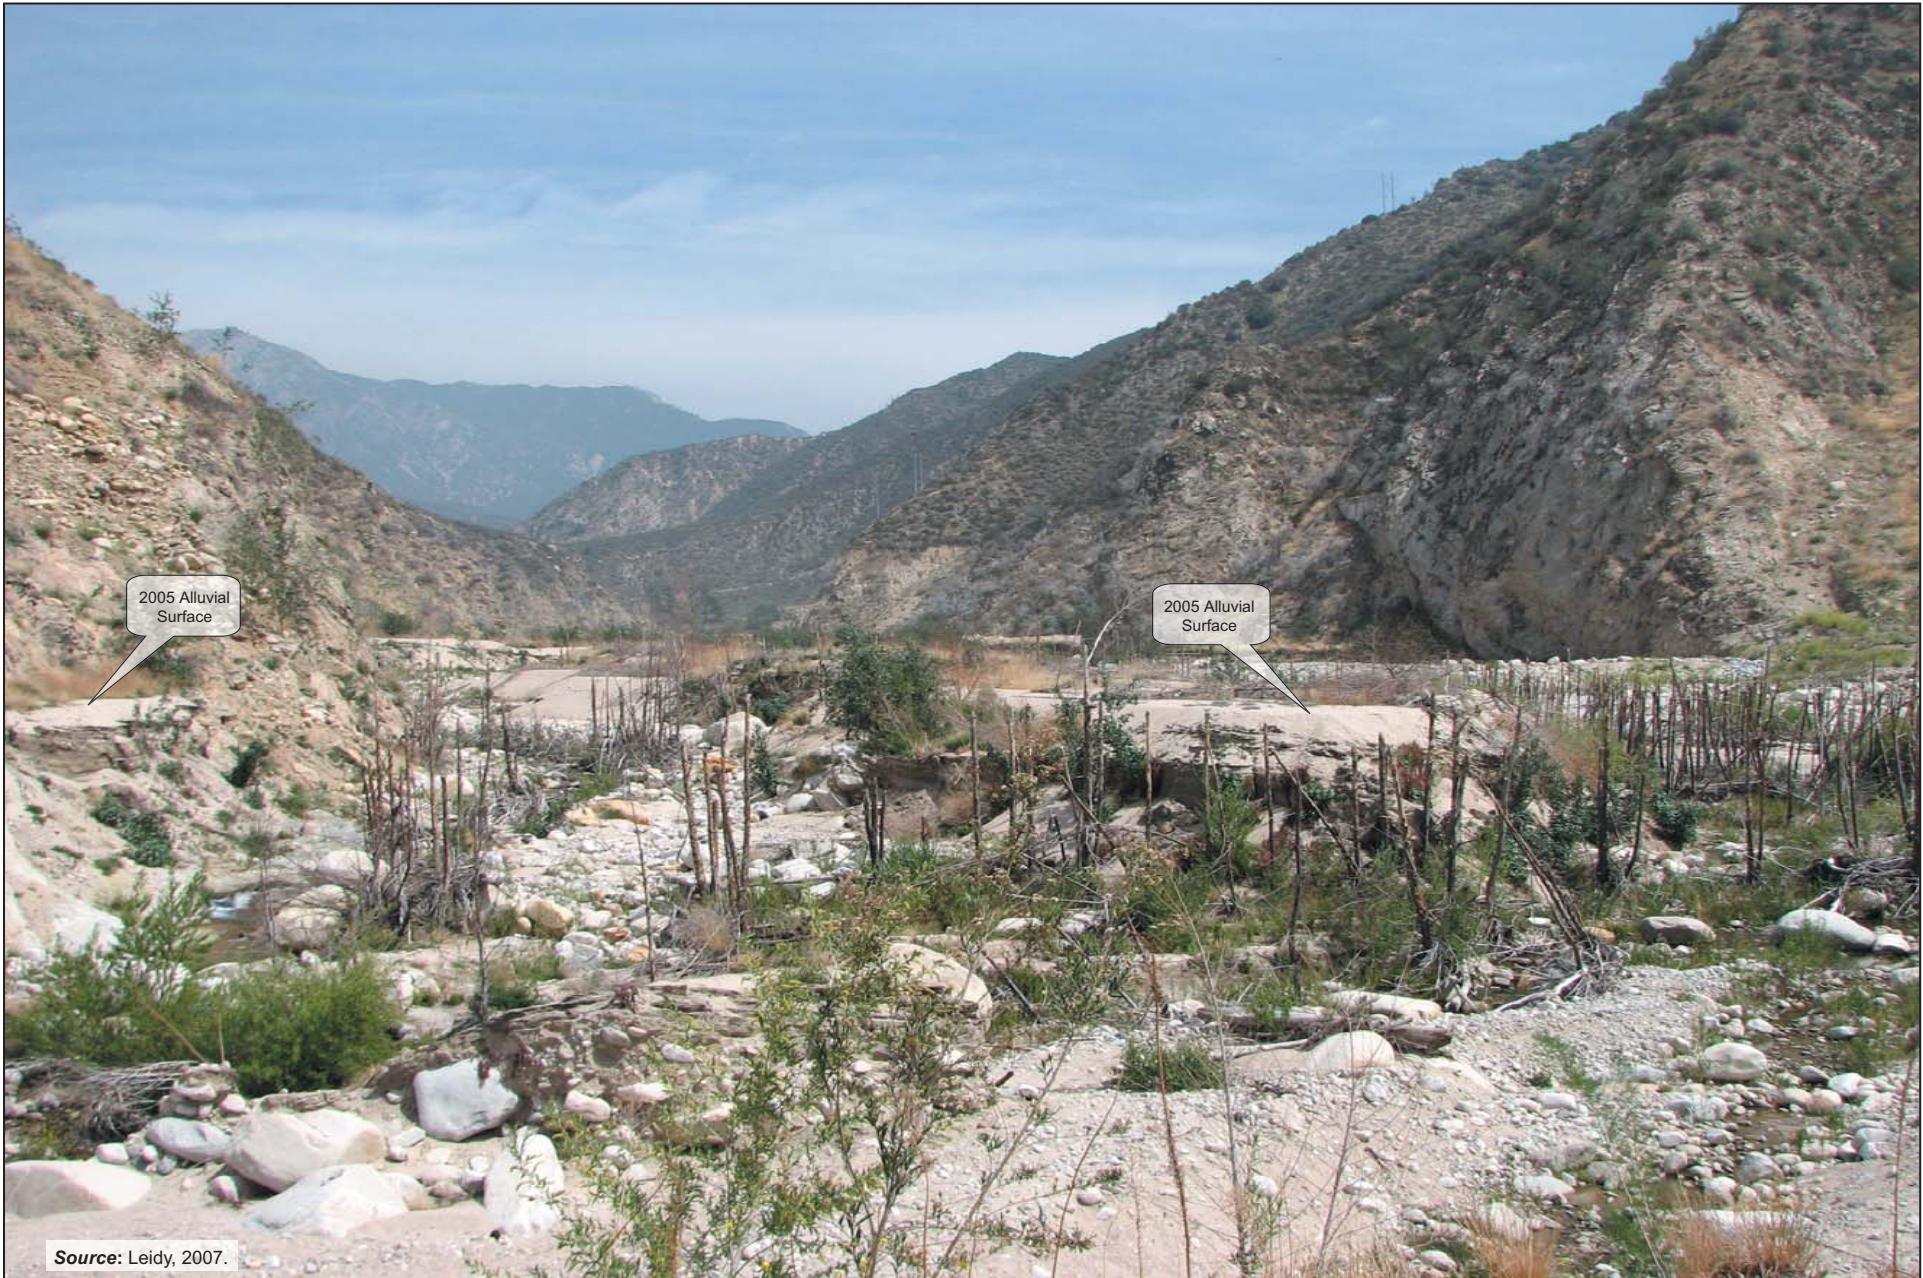
Muni/Western Ex. 9-25

Close-Up View of Warm Springs Cienega Looking Up the SAR Canyon Showing Substantial Erosion, April 2007

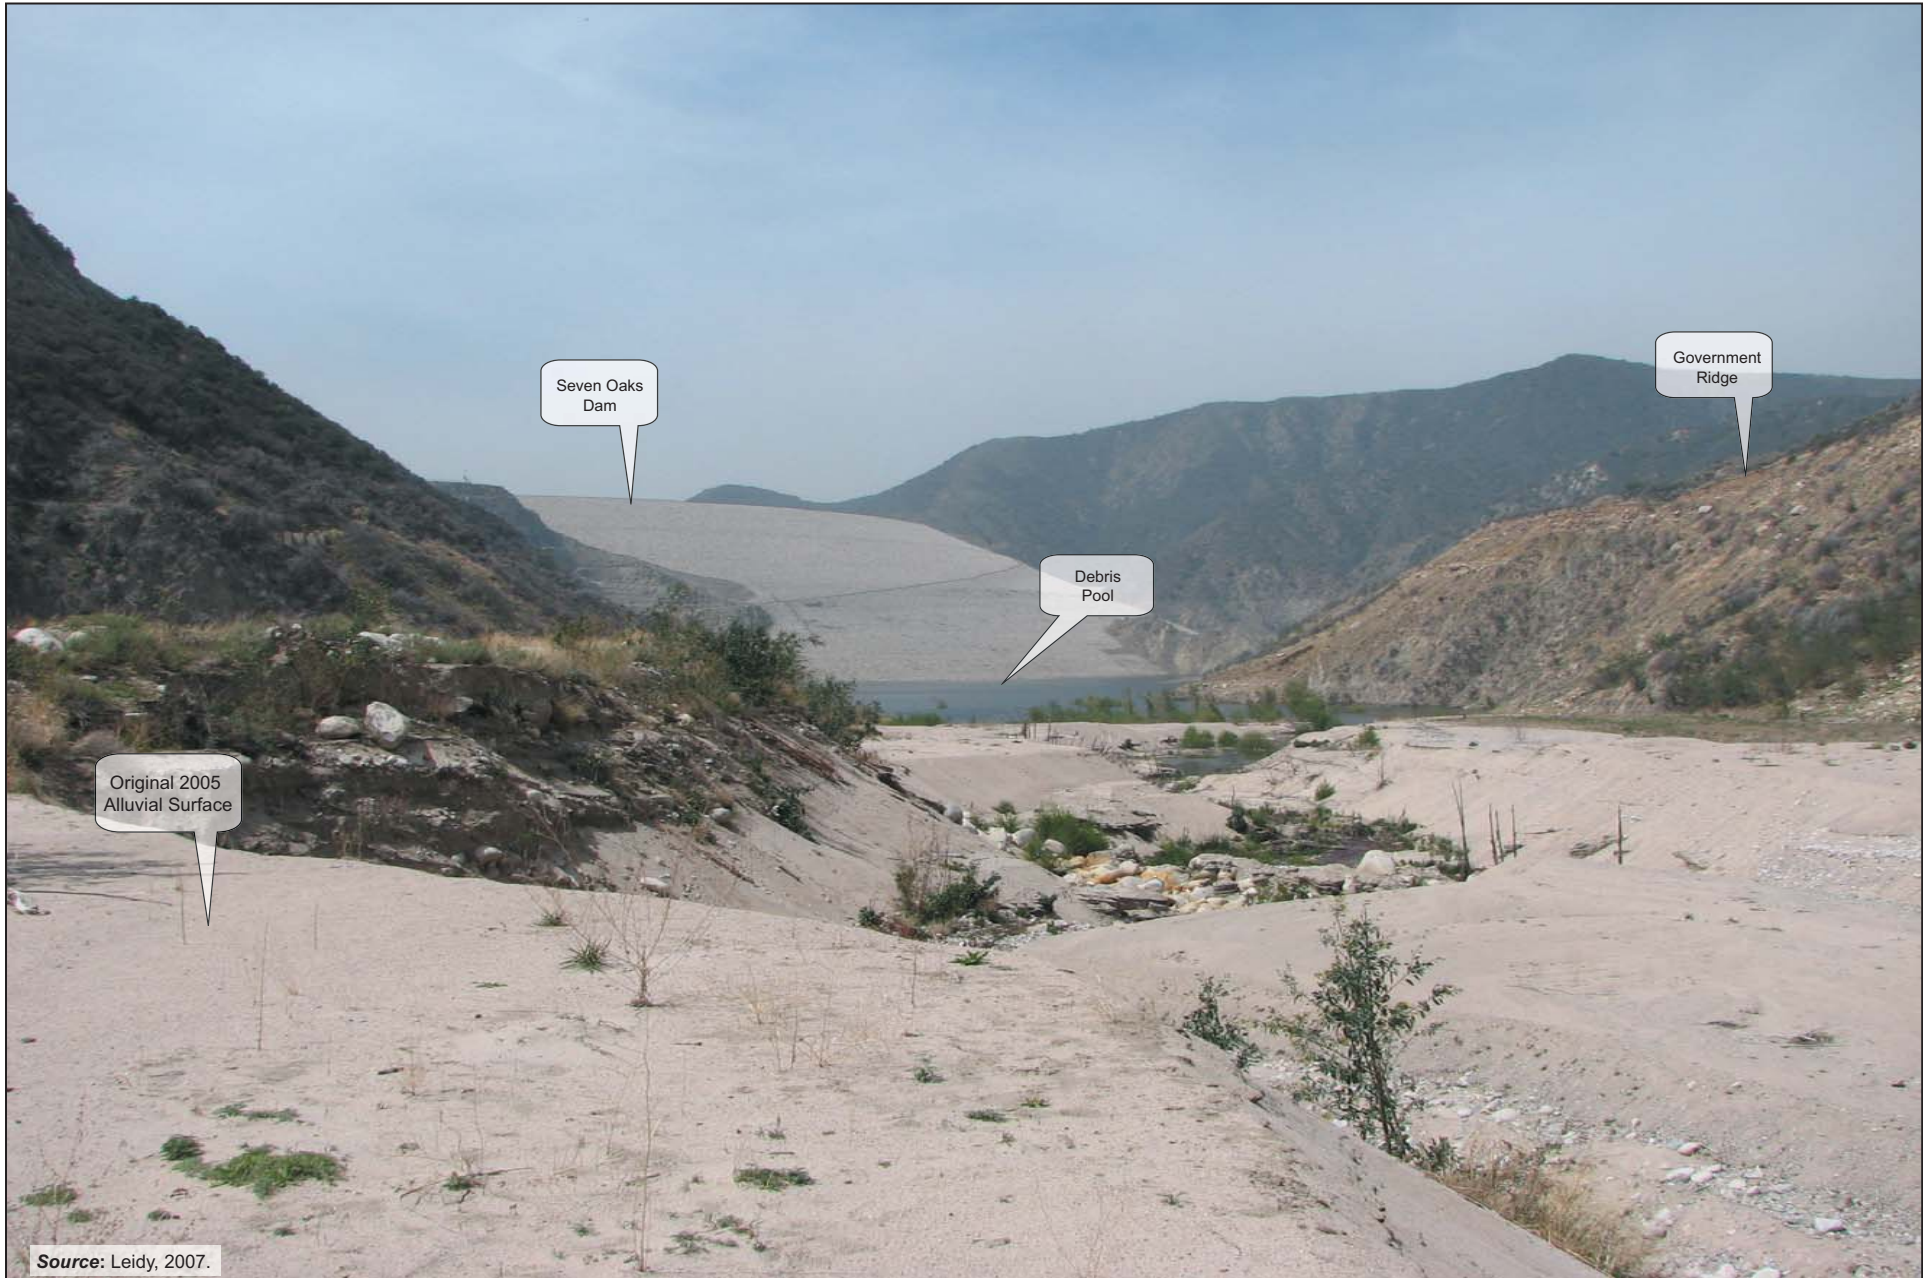
Muni/Western Ex. 9-27

View from Warm Springs Cienega Toward Seven Oaks Dam Showing Substantial Erosion of Sediments Deposited in 2004-2005, April 2007
