Muni/Western Ex. 9-2
Seven Oaks Dam

SEVEN OAKS DAM
SANTA ANA RIVER BASIN, CALIFORNIA
WATER CONTROL MANUAL

**SEVEN OAKS DAM
STORAGE ALLOCATION
DIAGRAM**

U.S. ARMY CORPS OF ENGINEERS
LOS ANGELES DISTRICT

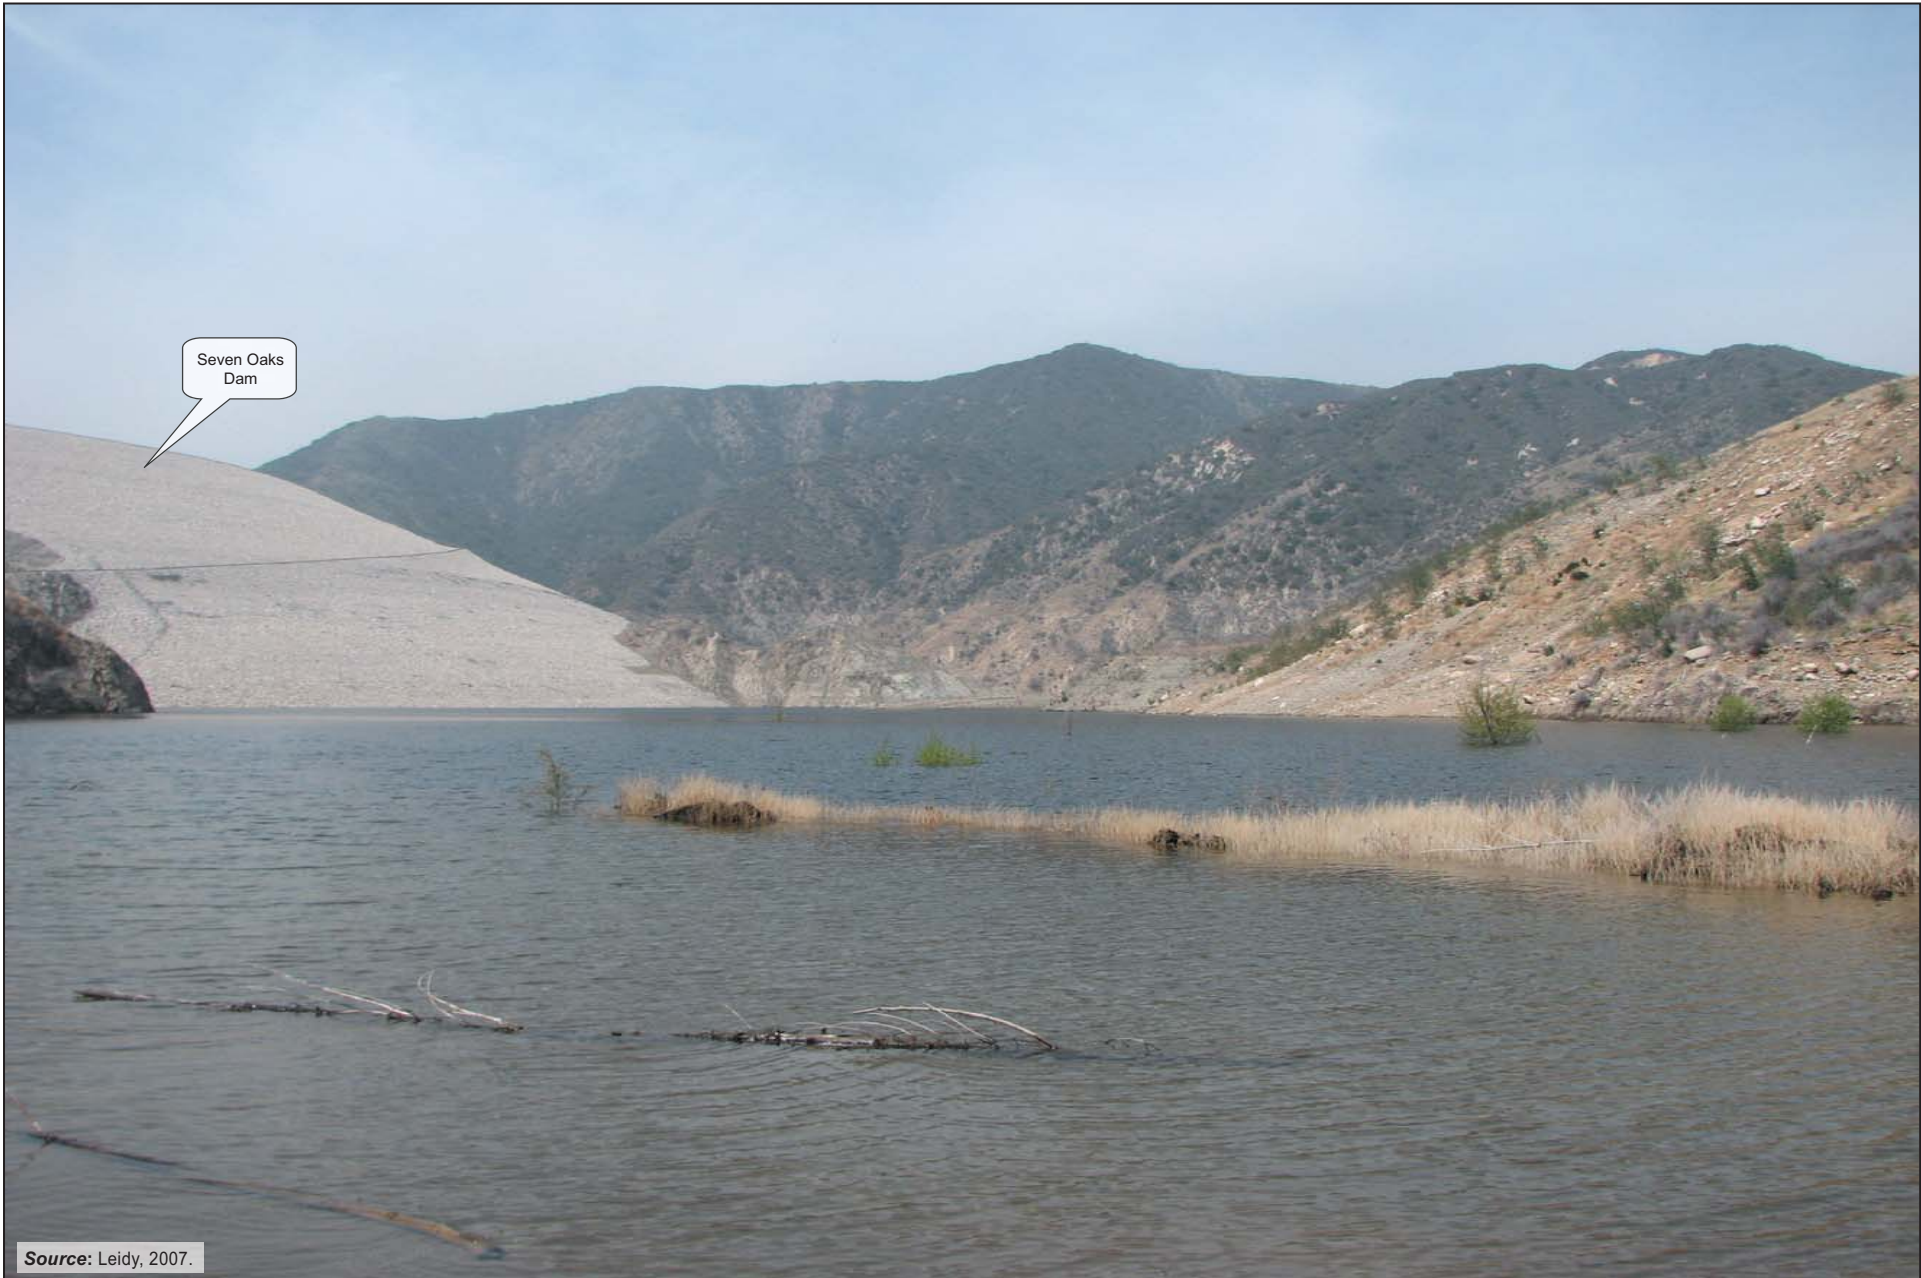
Muni/Western Ex. 9-28
Seven Oaks Dam Debris Pool at Approximately 1,500 af, April 2007

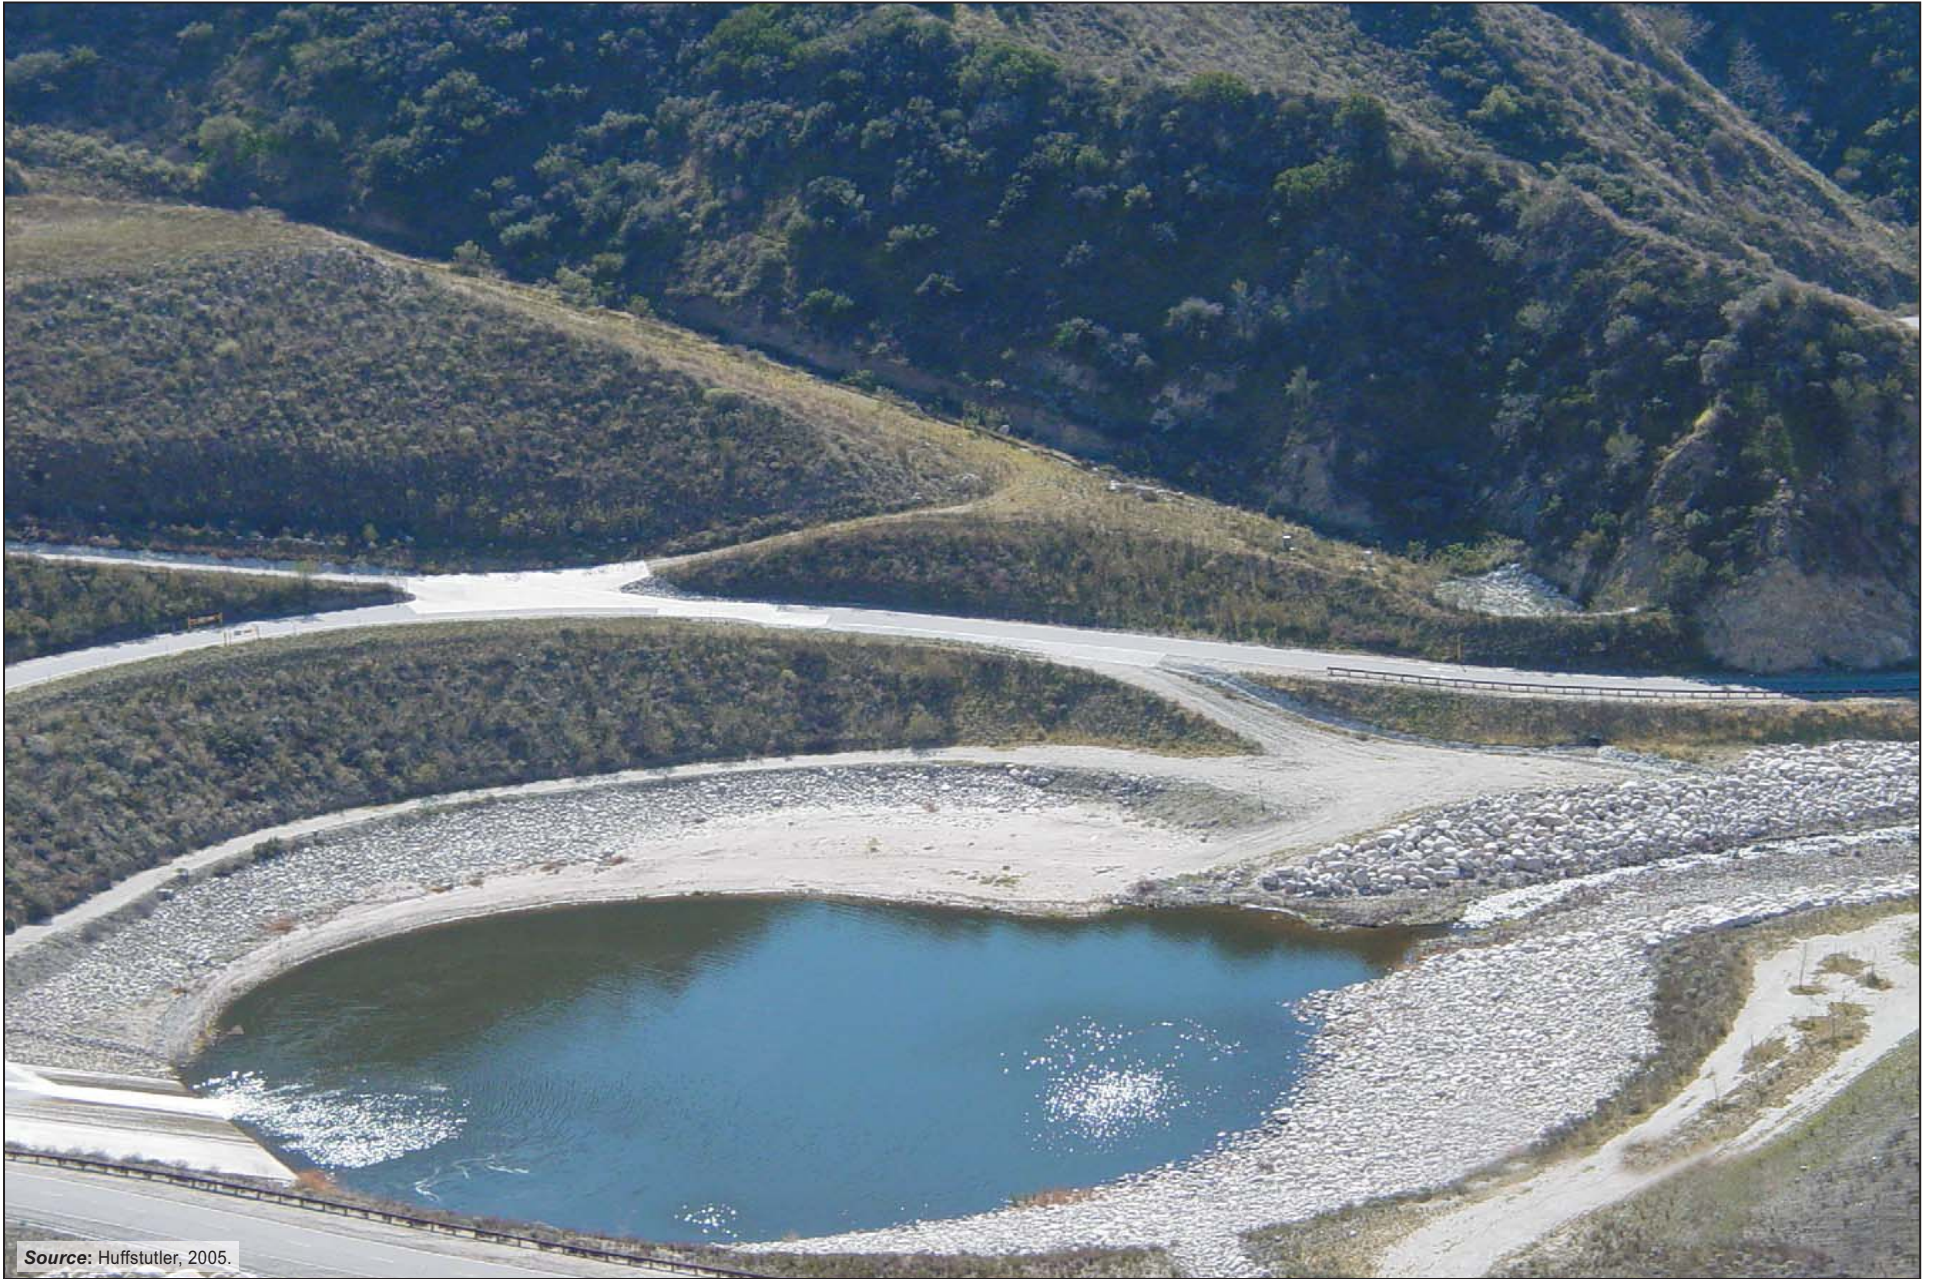
Muni/Western Ex. 9-36
Seven Oaks Dam Plunge Pool and Outlet Channel

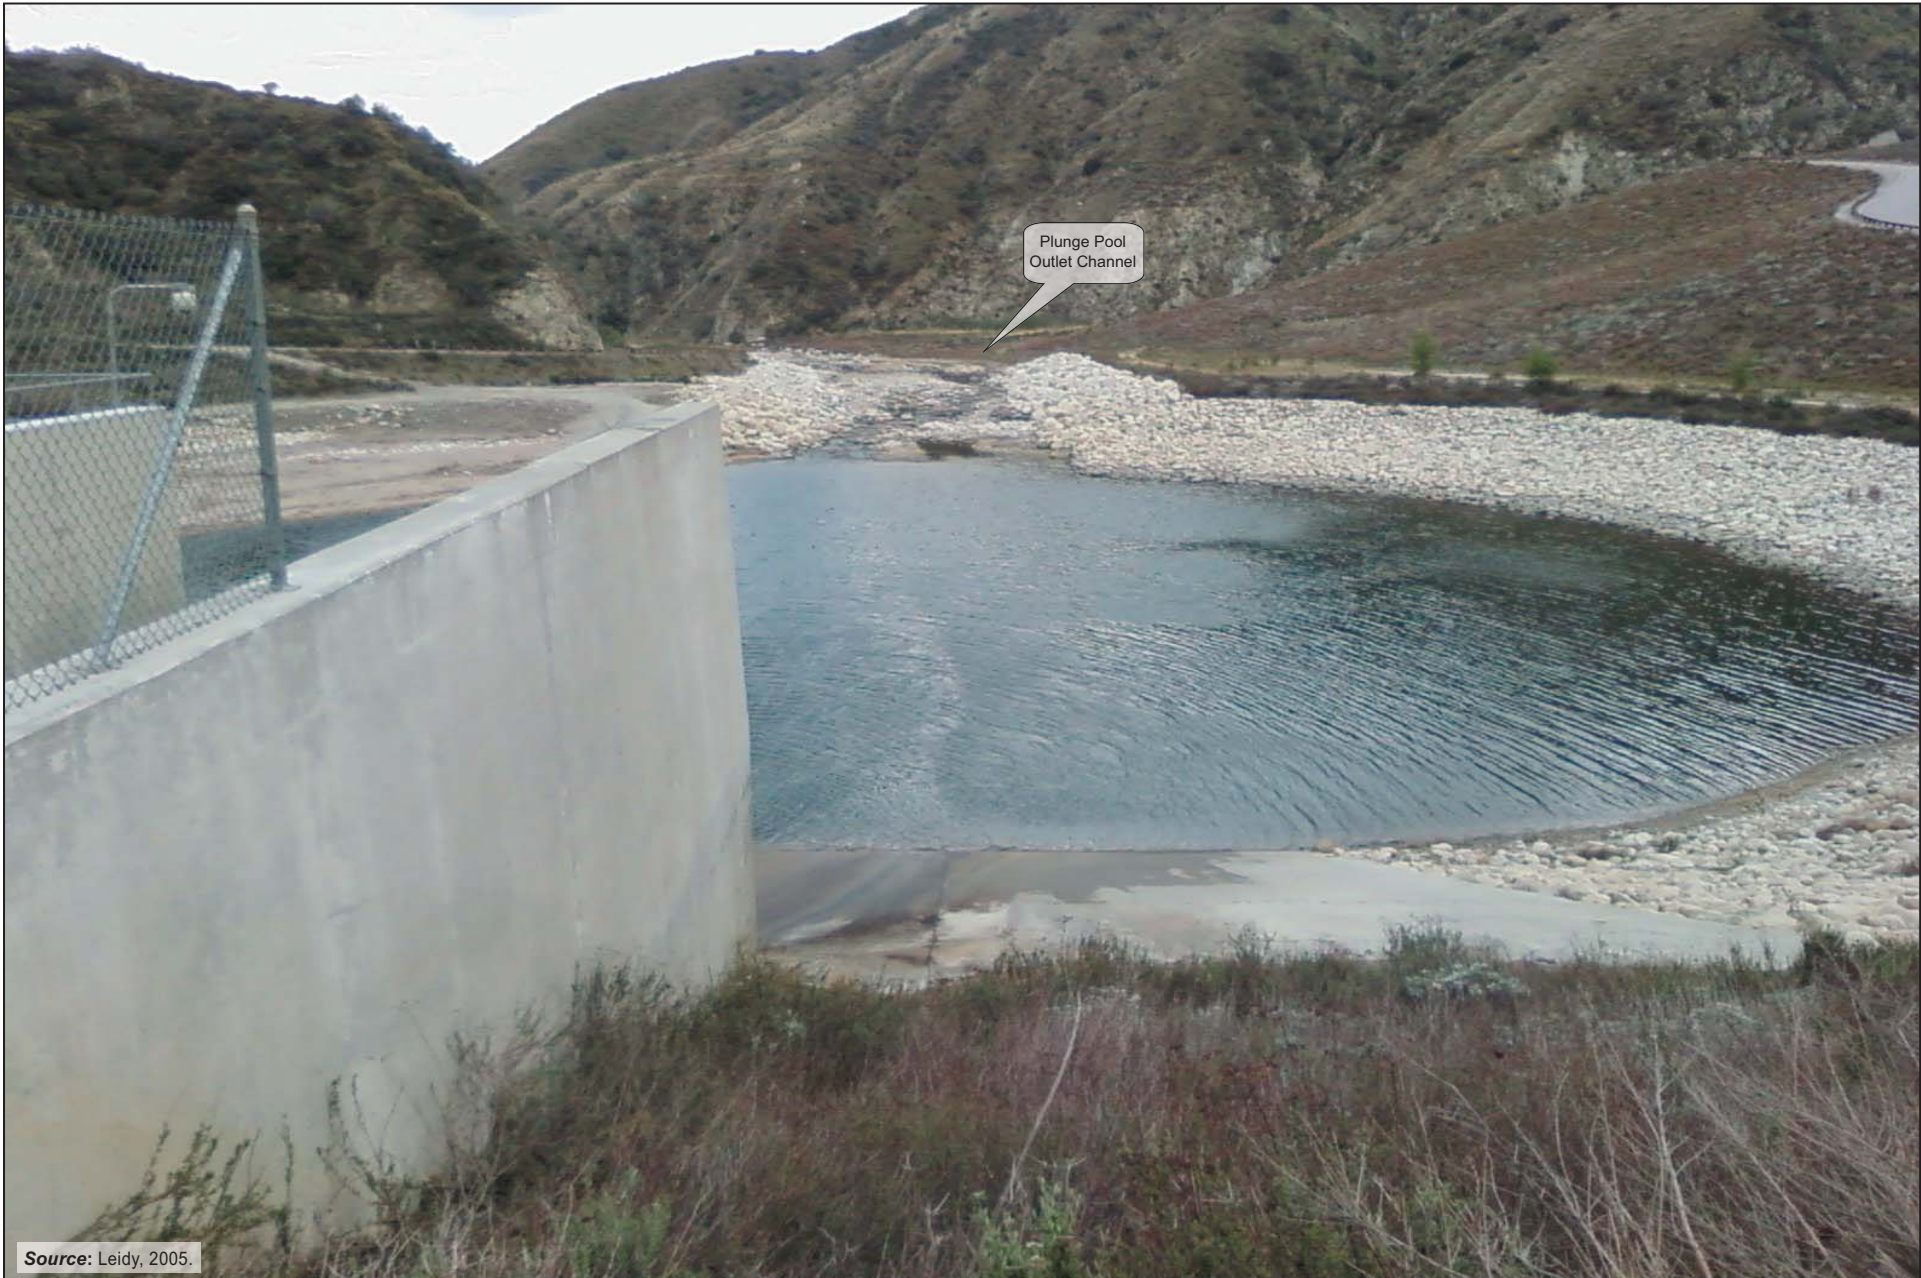
Muni/Western Ex. 9-43

Plunge Pool
Outlet Channel

Segment B Plunge Pool Showing Absence of Riparian Vegetation

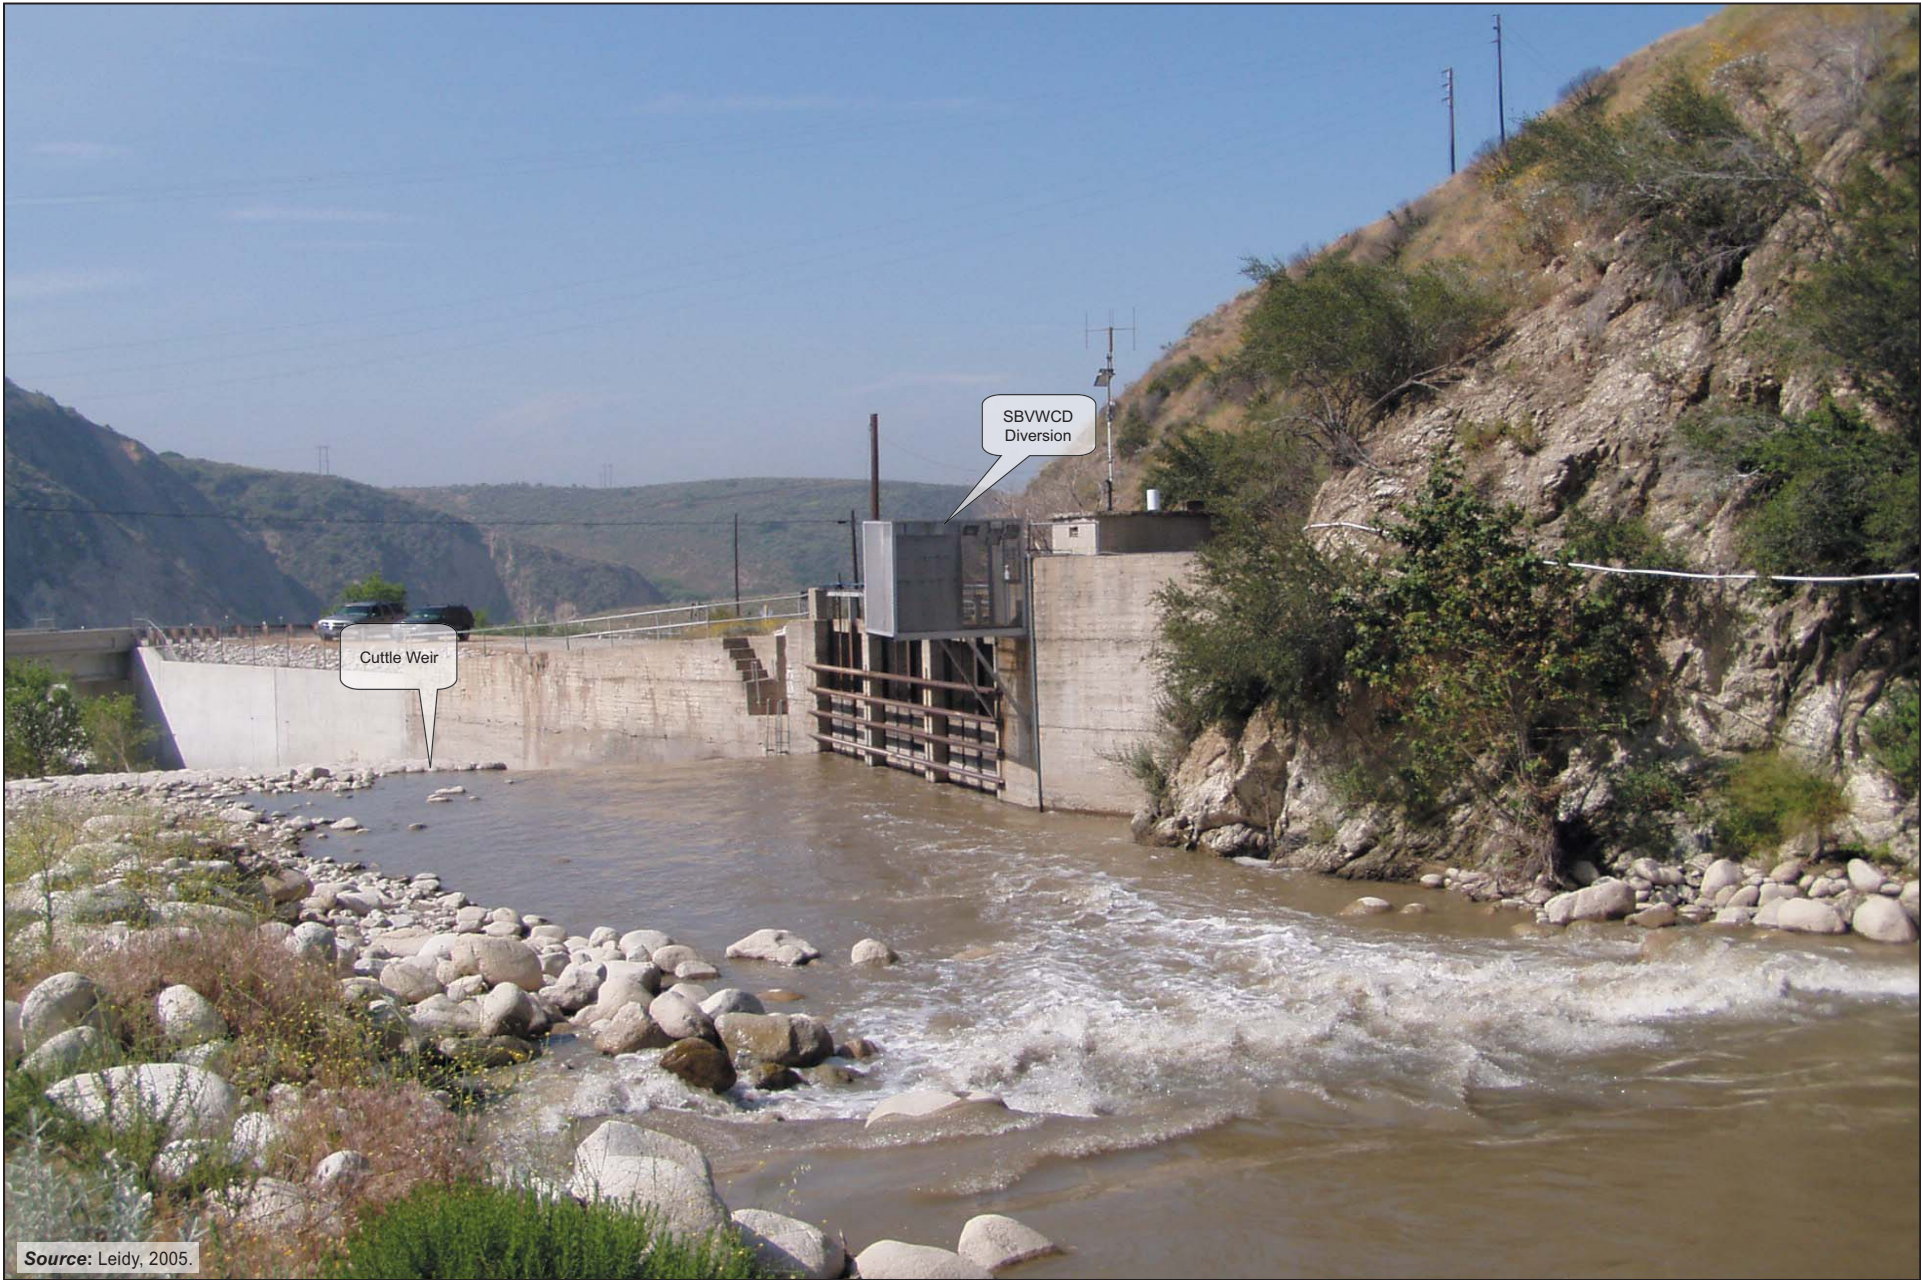
Muni/Western Ex. 9-45
Segment B Cuttle Weir and SBVWCD Diversion Looking Downstream at the SAR in a Wet Year

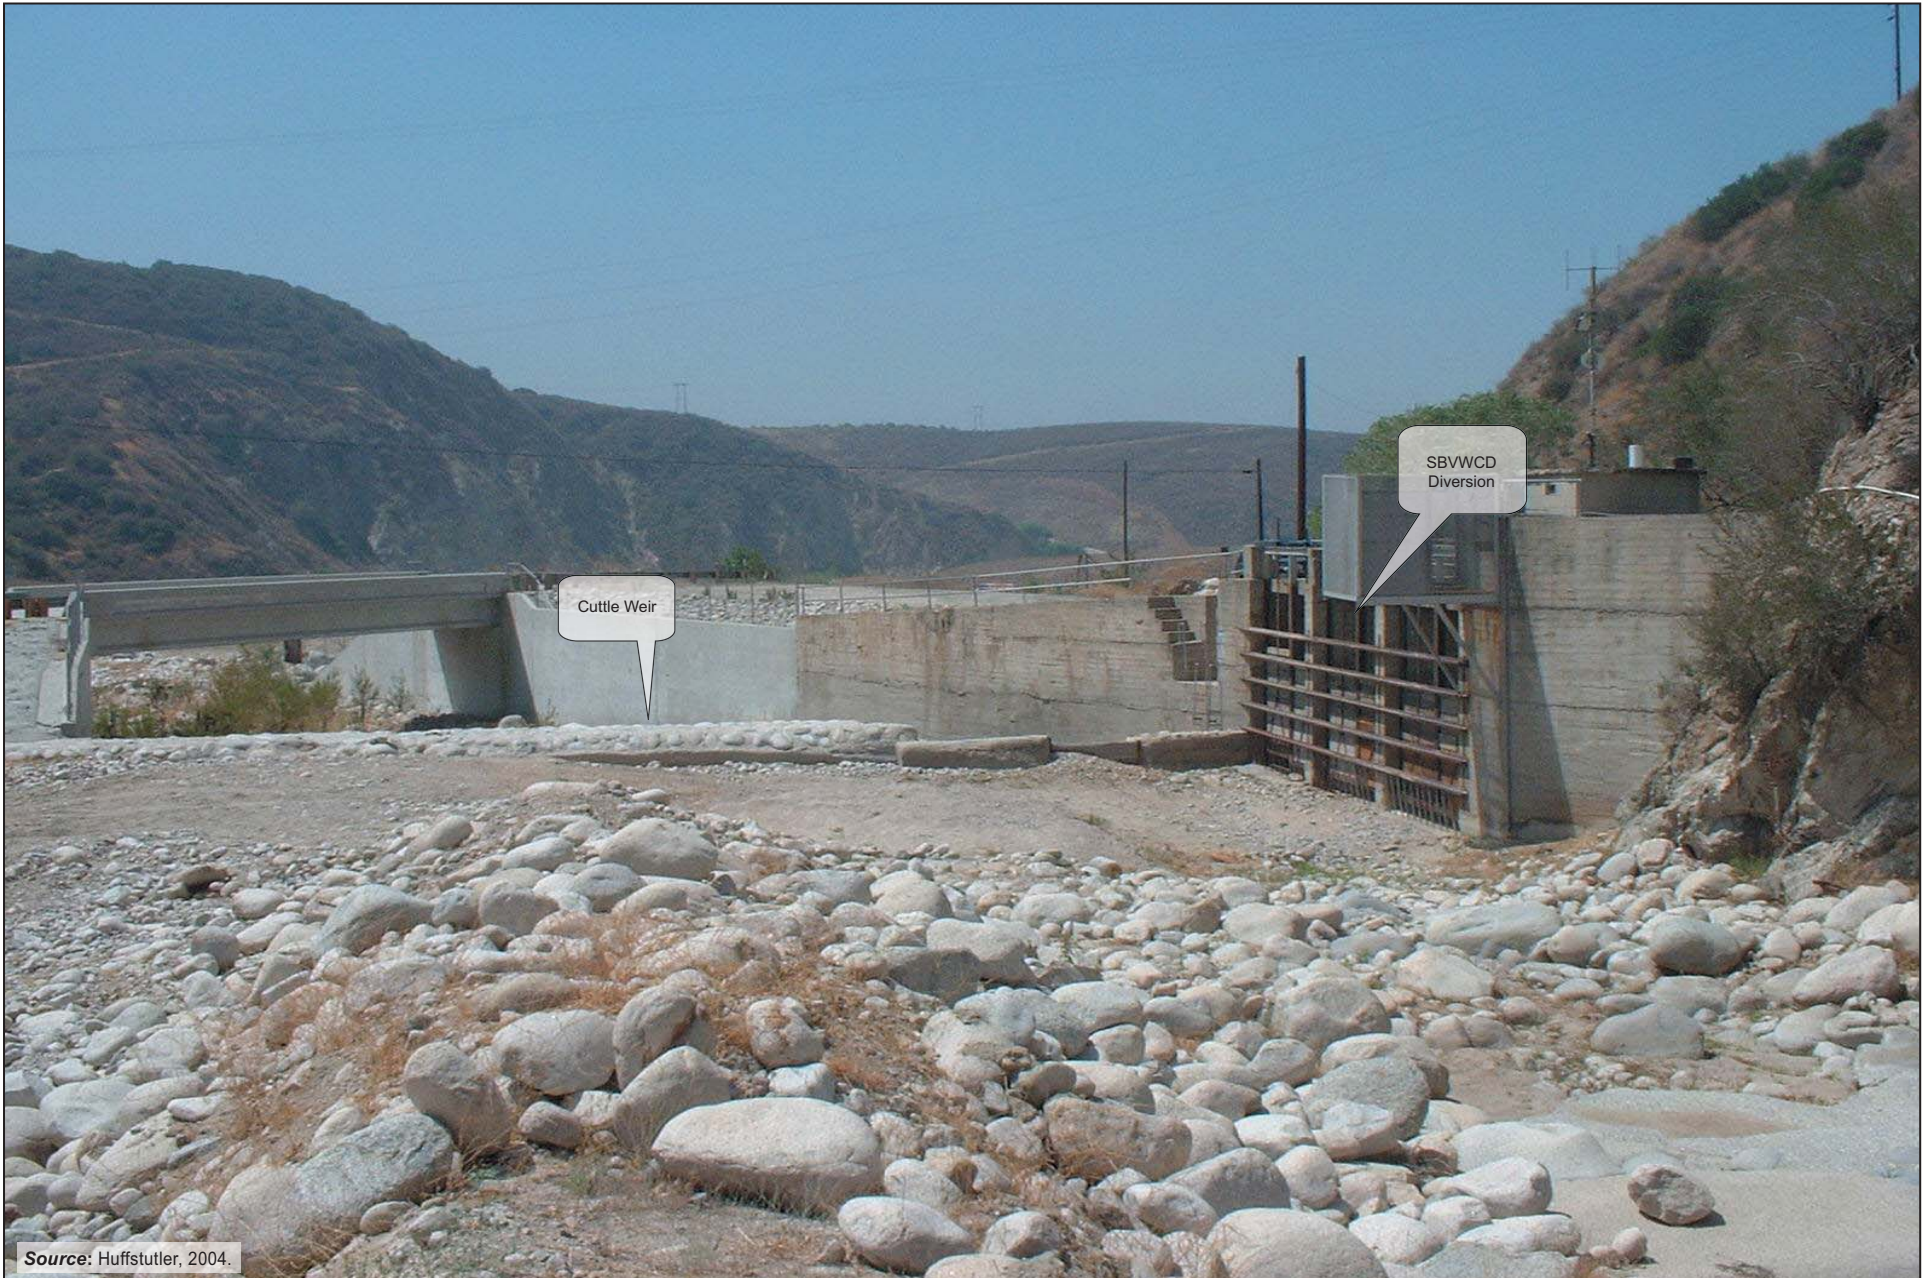
Muni/Western Ex. 9-46
Segment B Cuttle Weir and SBVWCD Diversion Looking Downstream at the SAR in a Dry Year

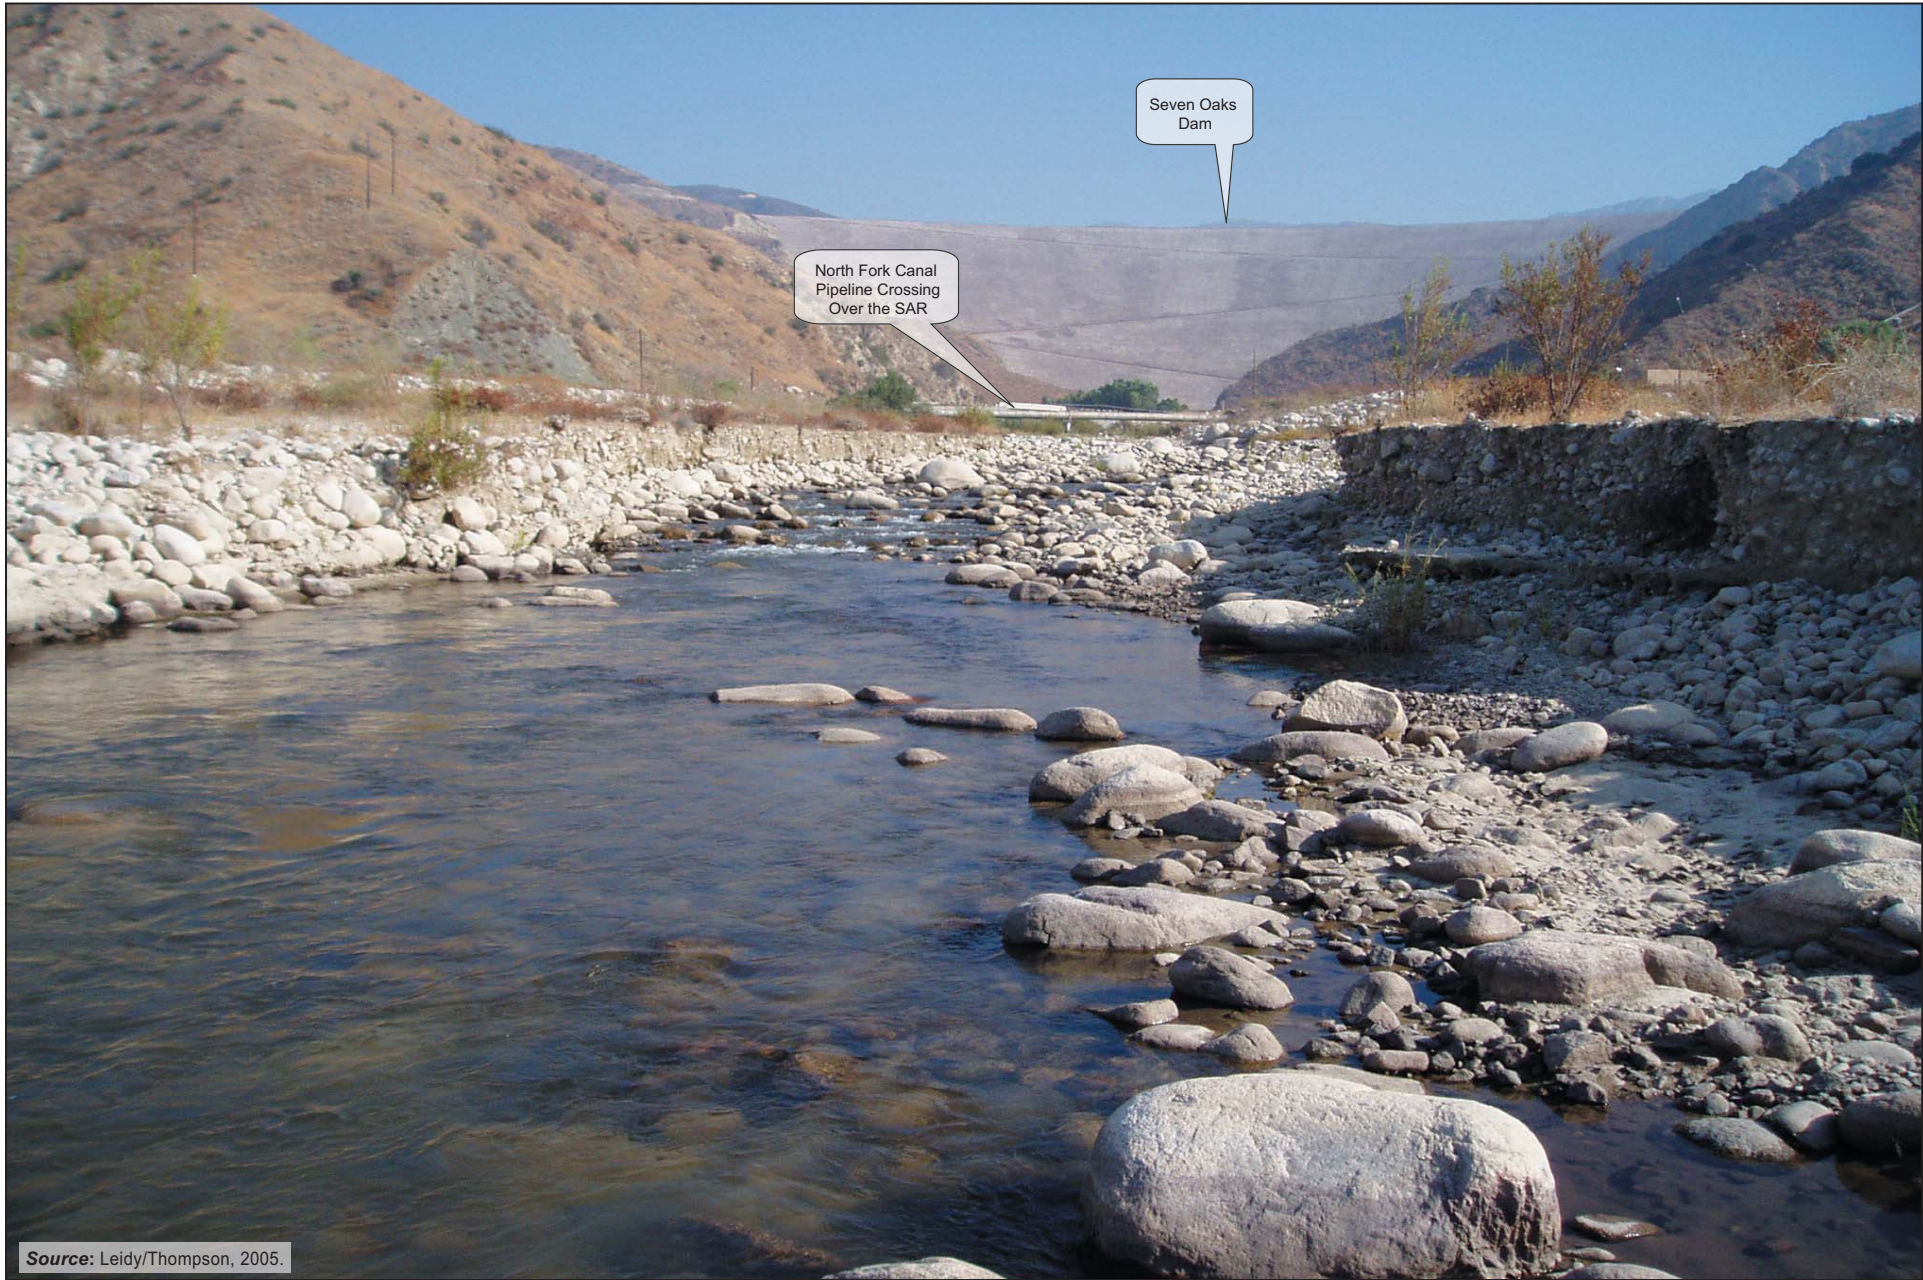
Muni/Western Ex. 9-48

Segment C View Upstream (North) Toward Seven Oaks Dam Showing SAR Channel Down-cutting and Substrate Coarsening Due to Flood Pool Releases in 2004-2005

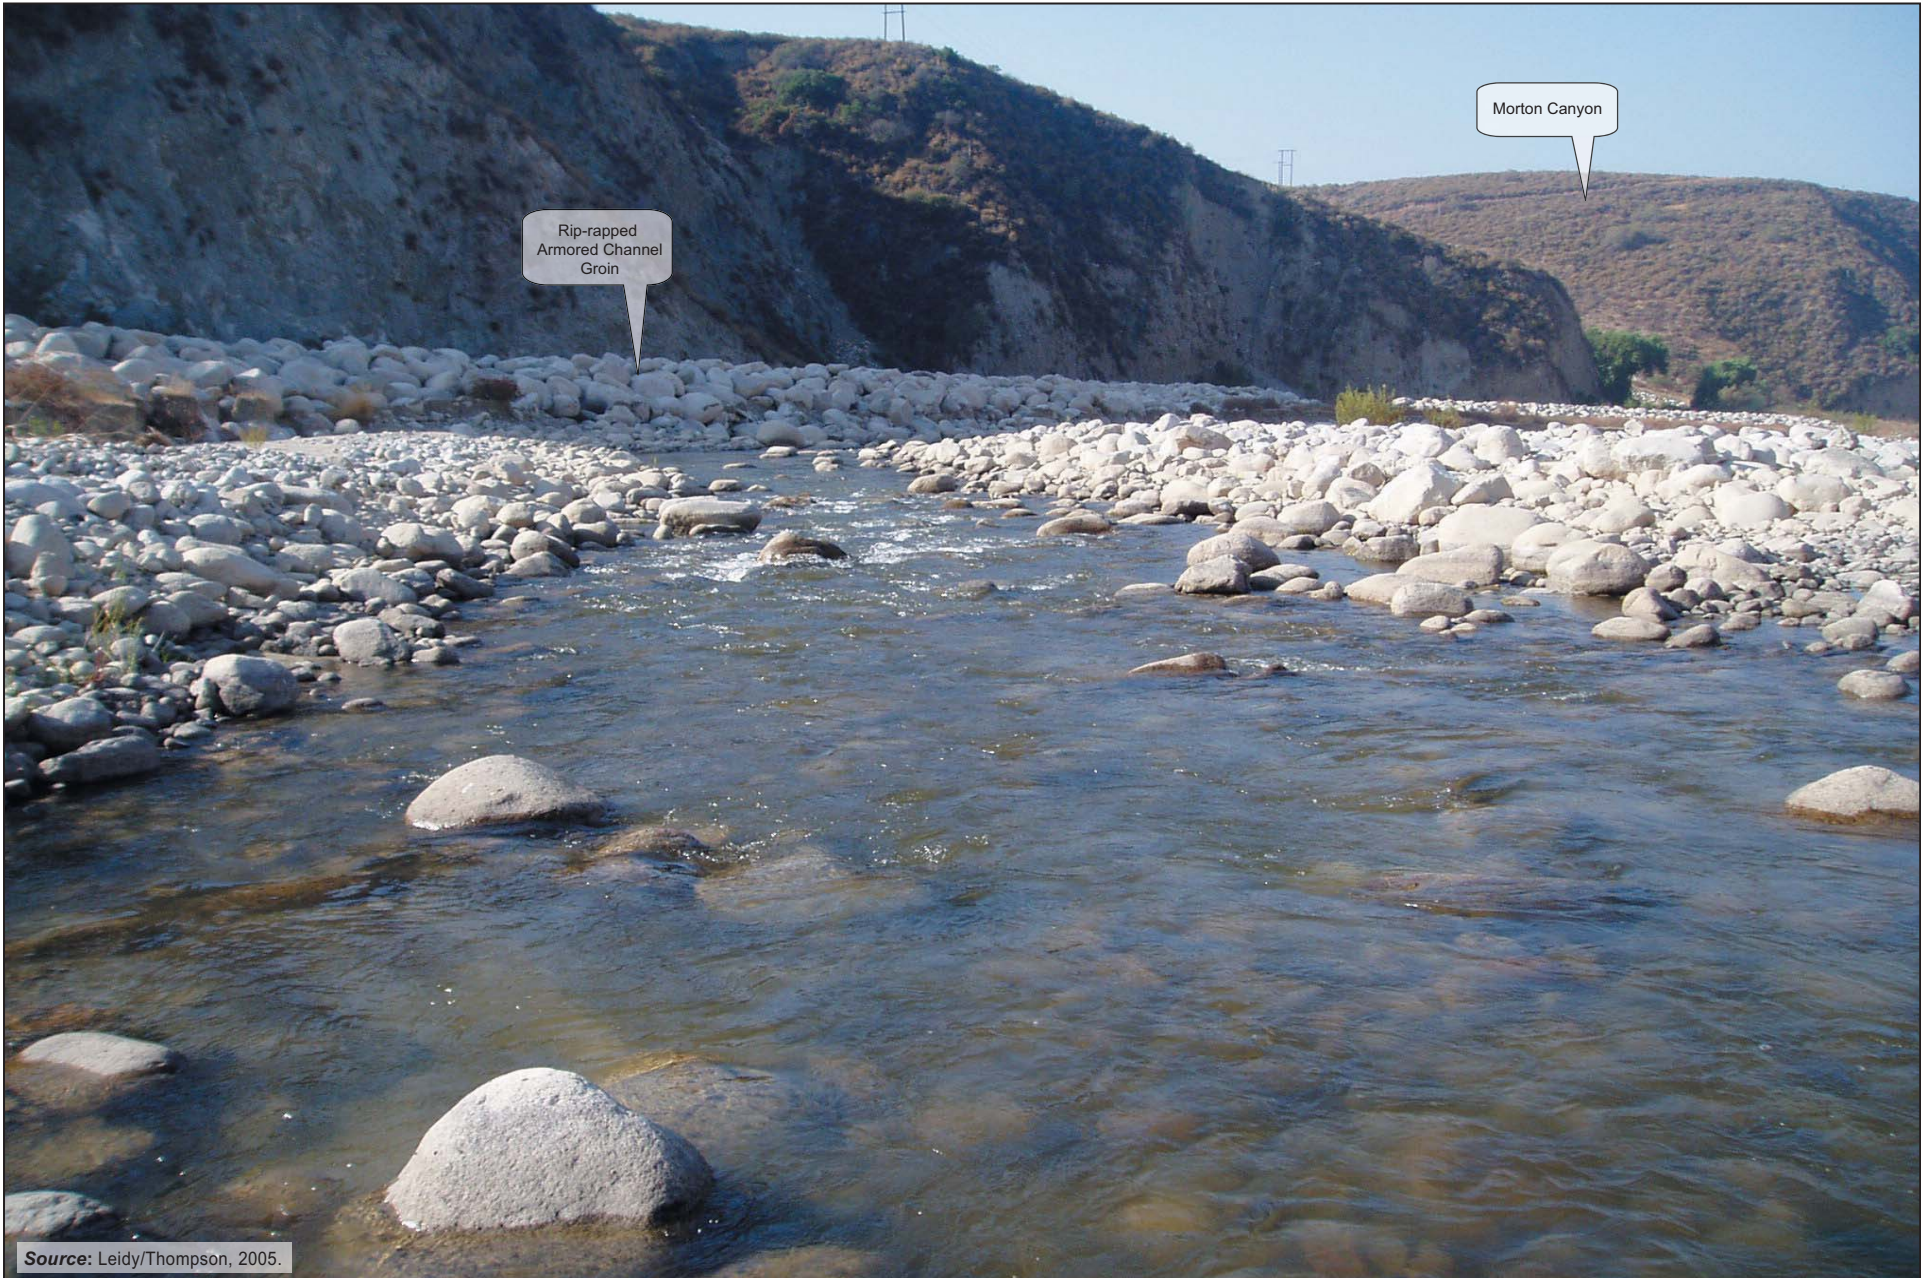
Muni/Western Ex. 9-50

Segment C Downstream View of SAR Channel Showing Armored Channel Bank

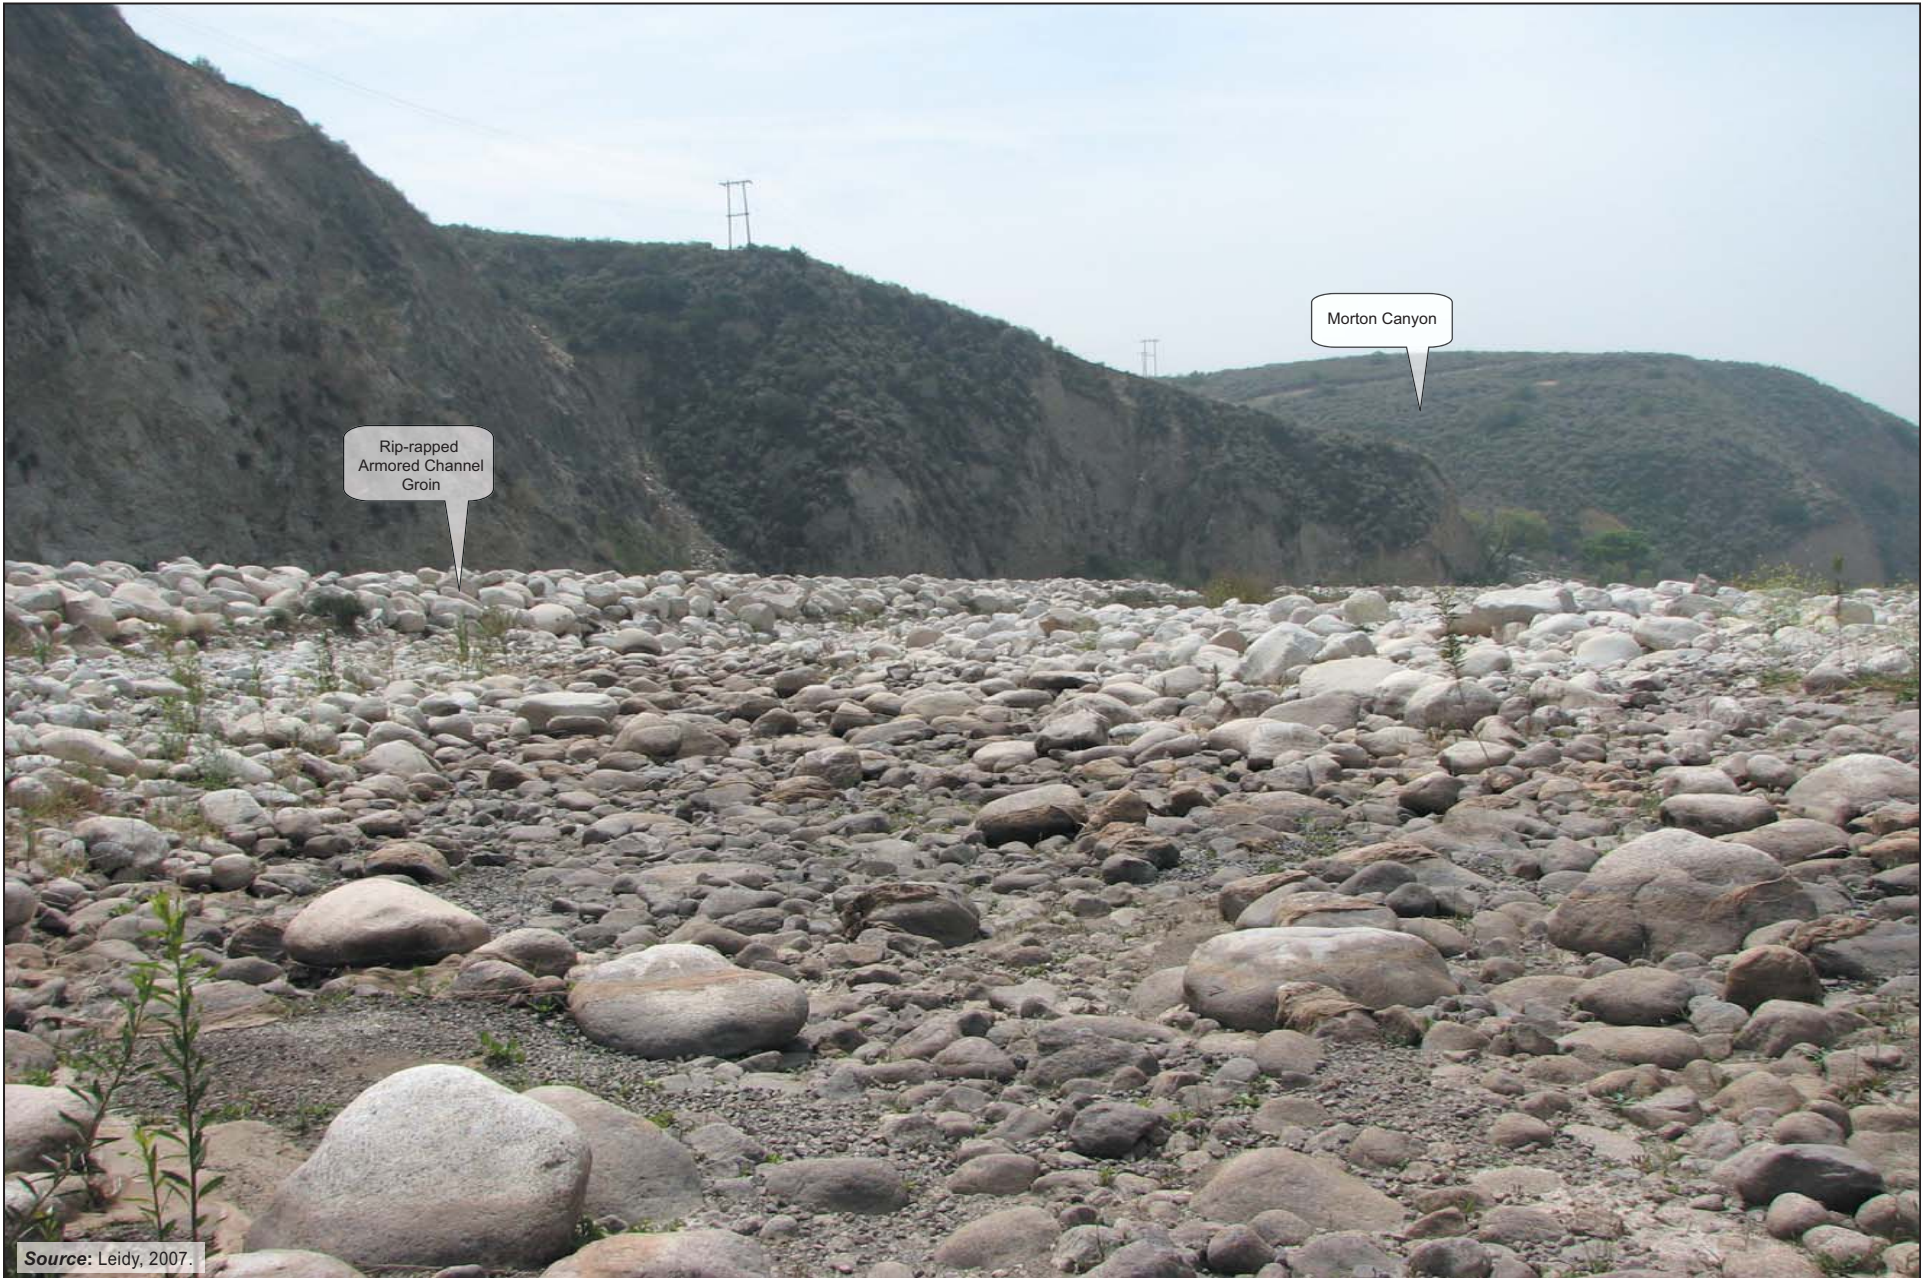
Rip-rapped
Armored Channel
Groin

Muni/Western Ex. 9-51
Segment C Downstream View of SAR Channel in Spring 2007

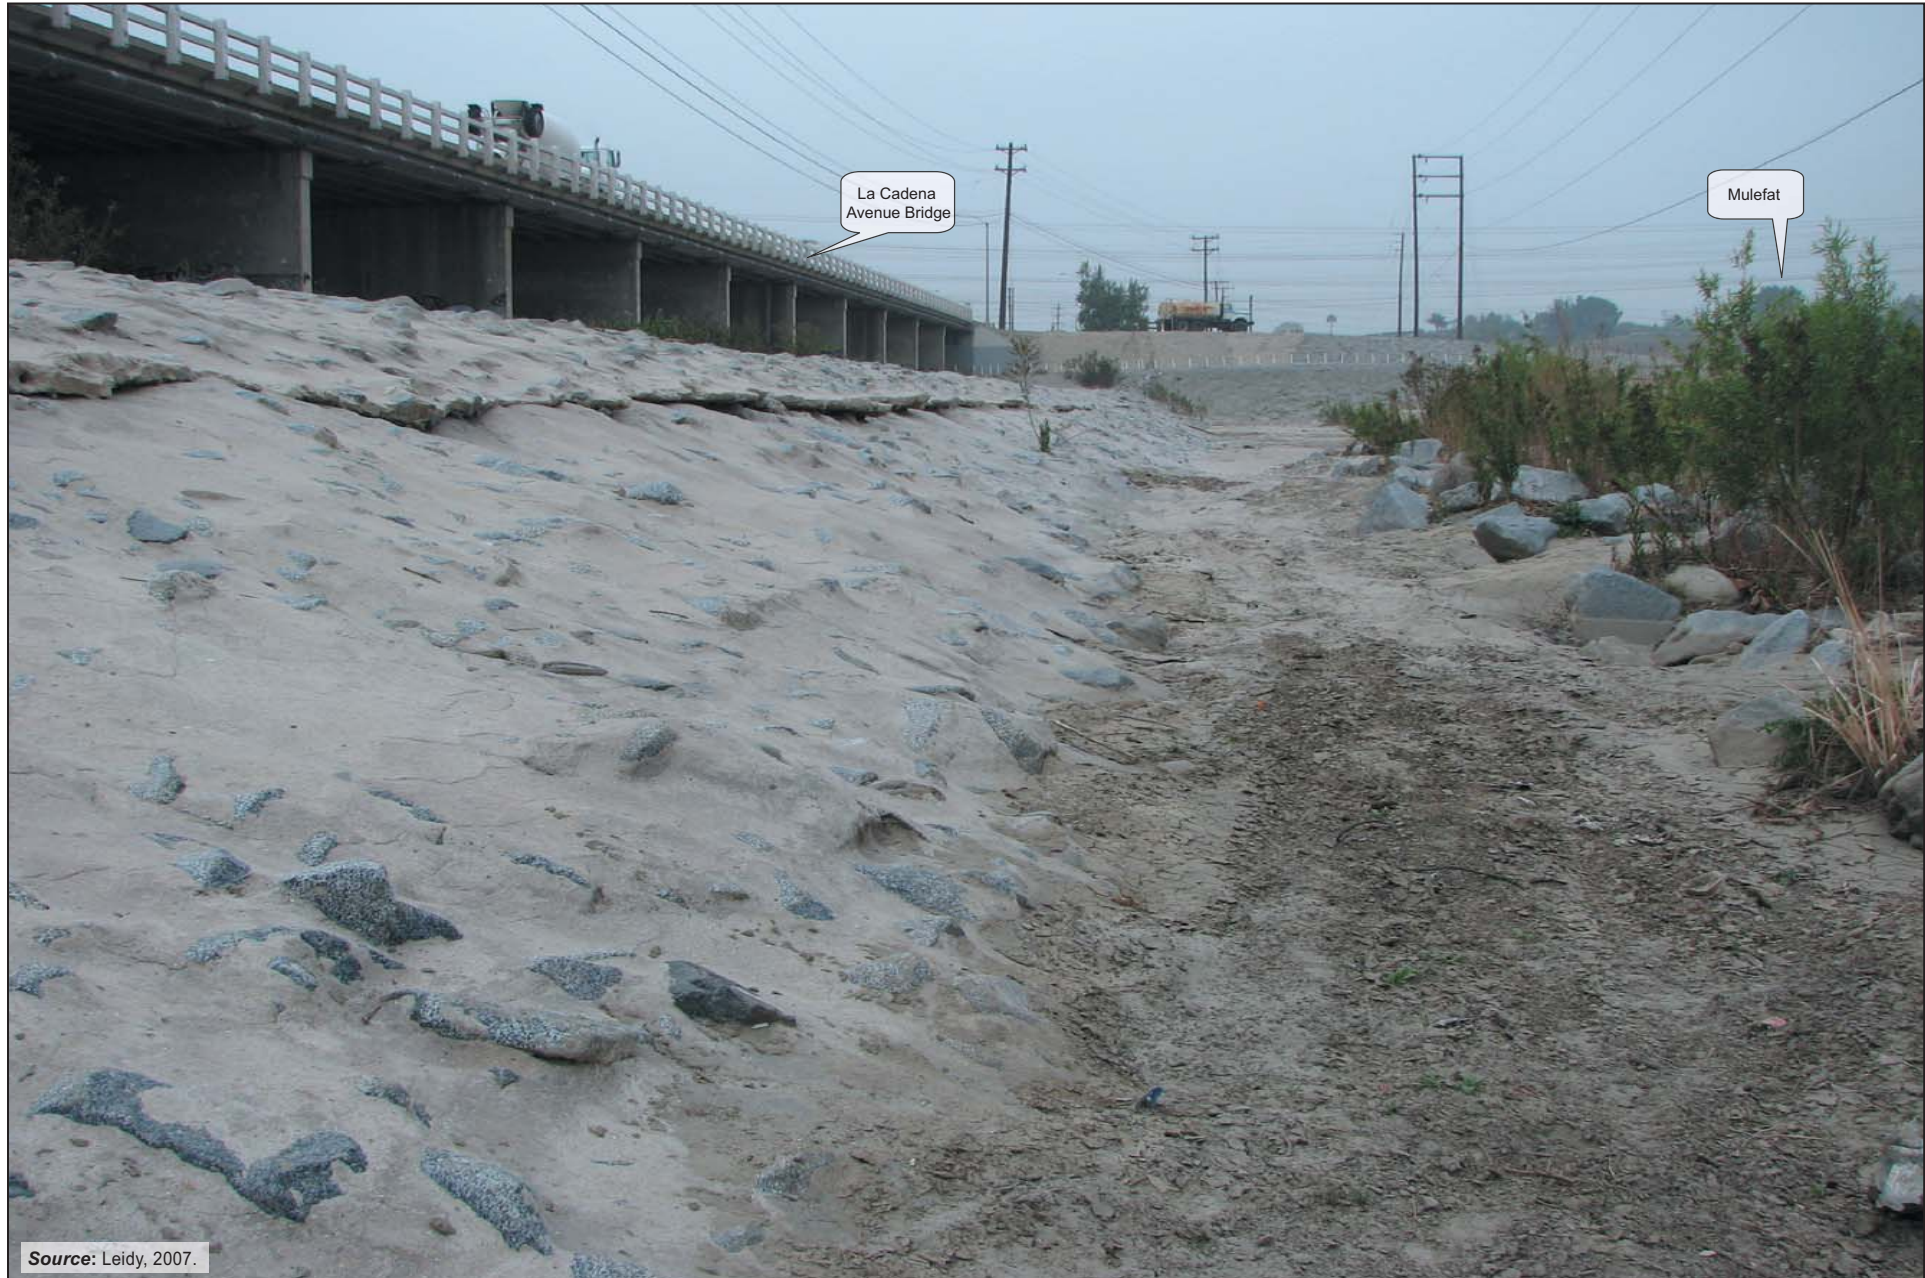
Muni/Western Ex. 9-73
Drop Structure Downstream of La Cadena Avenue Bridge
