Muni/Western Ex. 9-2
Seven Oaks Dam

SEVEN OAKS DAM
SANTA ANA RIVER BASIN, CALIFORNIA
WATER CONTROL MANUAL

**SEVEN OAKS DAM
STORAGE ALLOCATION
DIAGRAM**

U.S. ARMY CORPS OF ENGINEERS
LOS ANGELES DISTRICT

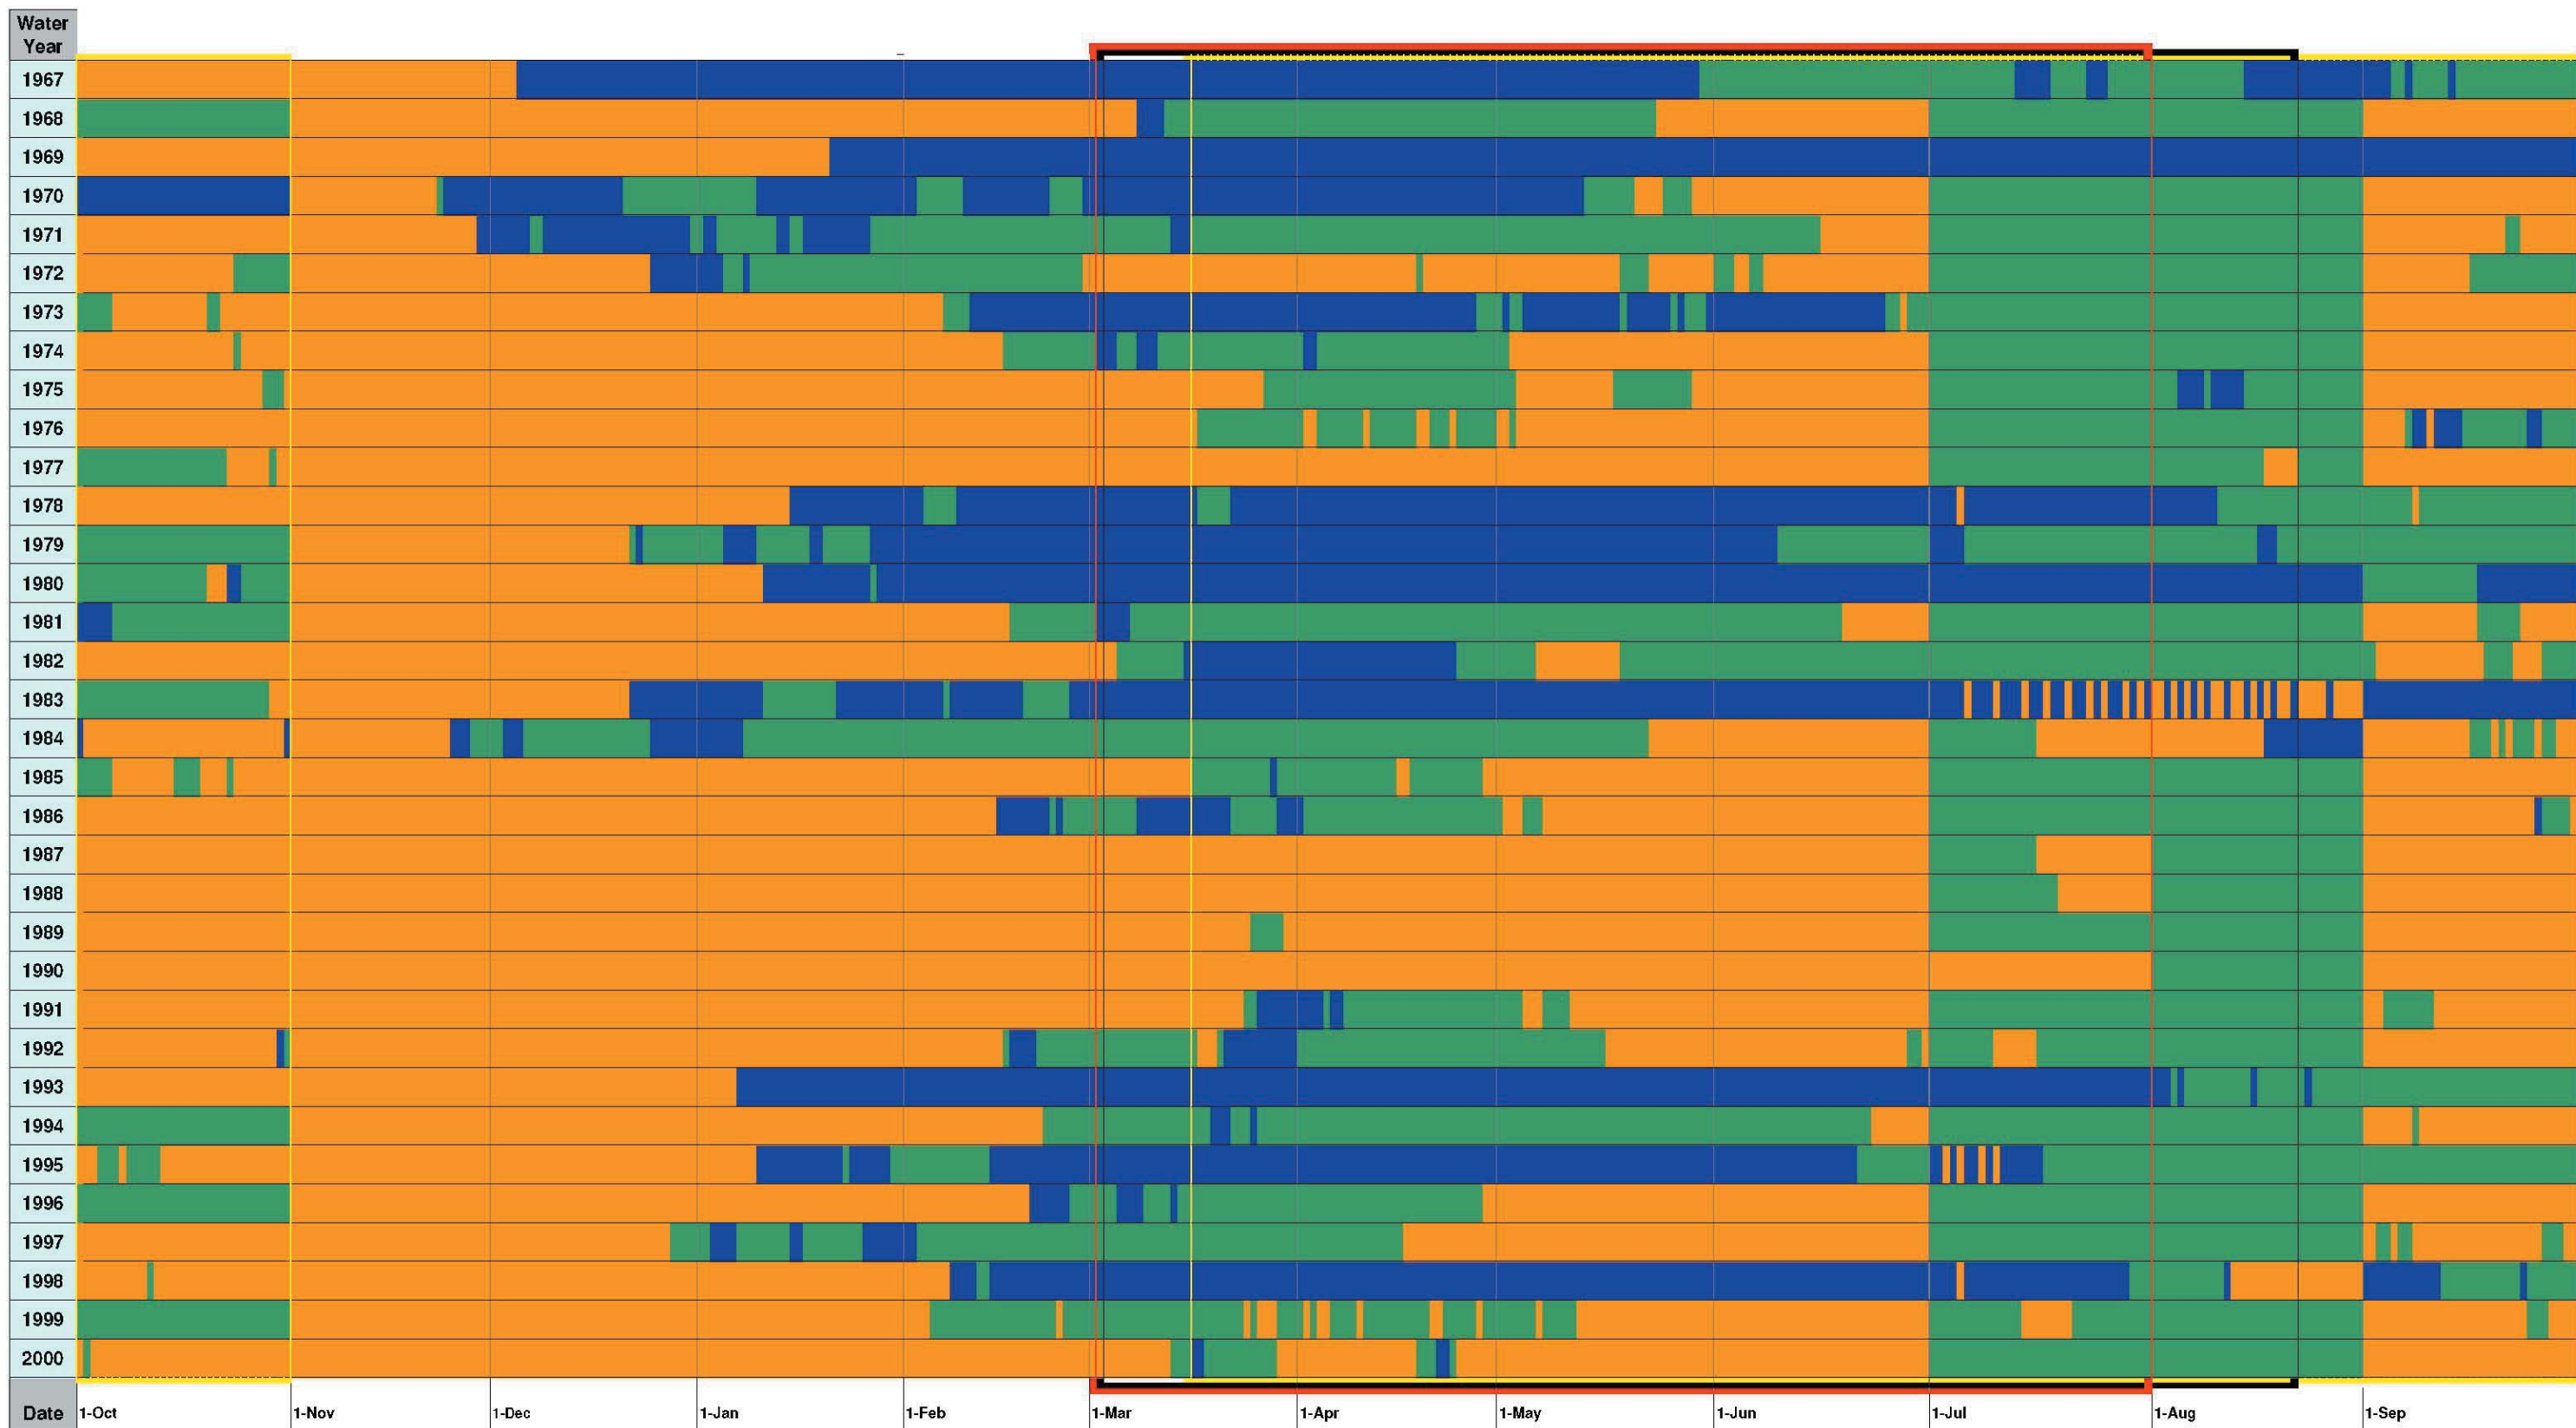
Muni/Western Ex. 9-95
Flow Ranges in Segment B Under "No Project"

Legend: = Flow <1 CFS = 1-5 CFS = 5-50 CFS = >50 CFS Canyon treefrog breeding Canyon treefrog egg incubation Canyon treefrog larval stage

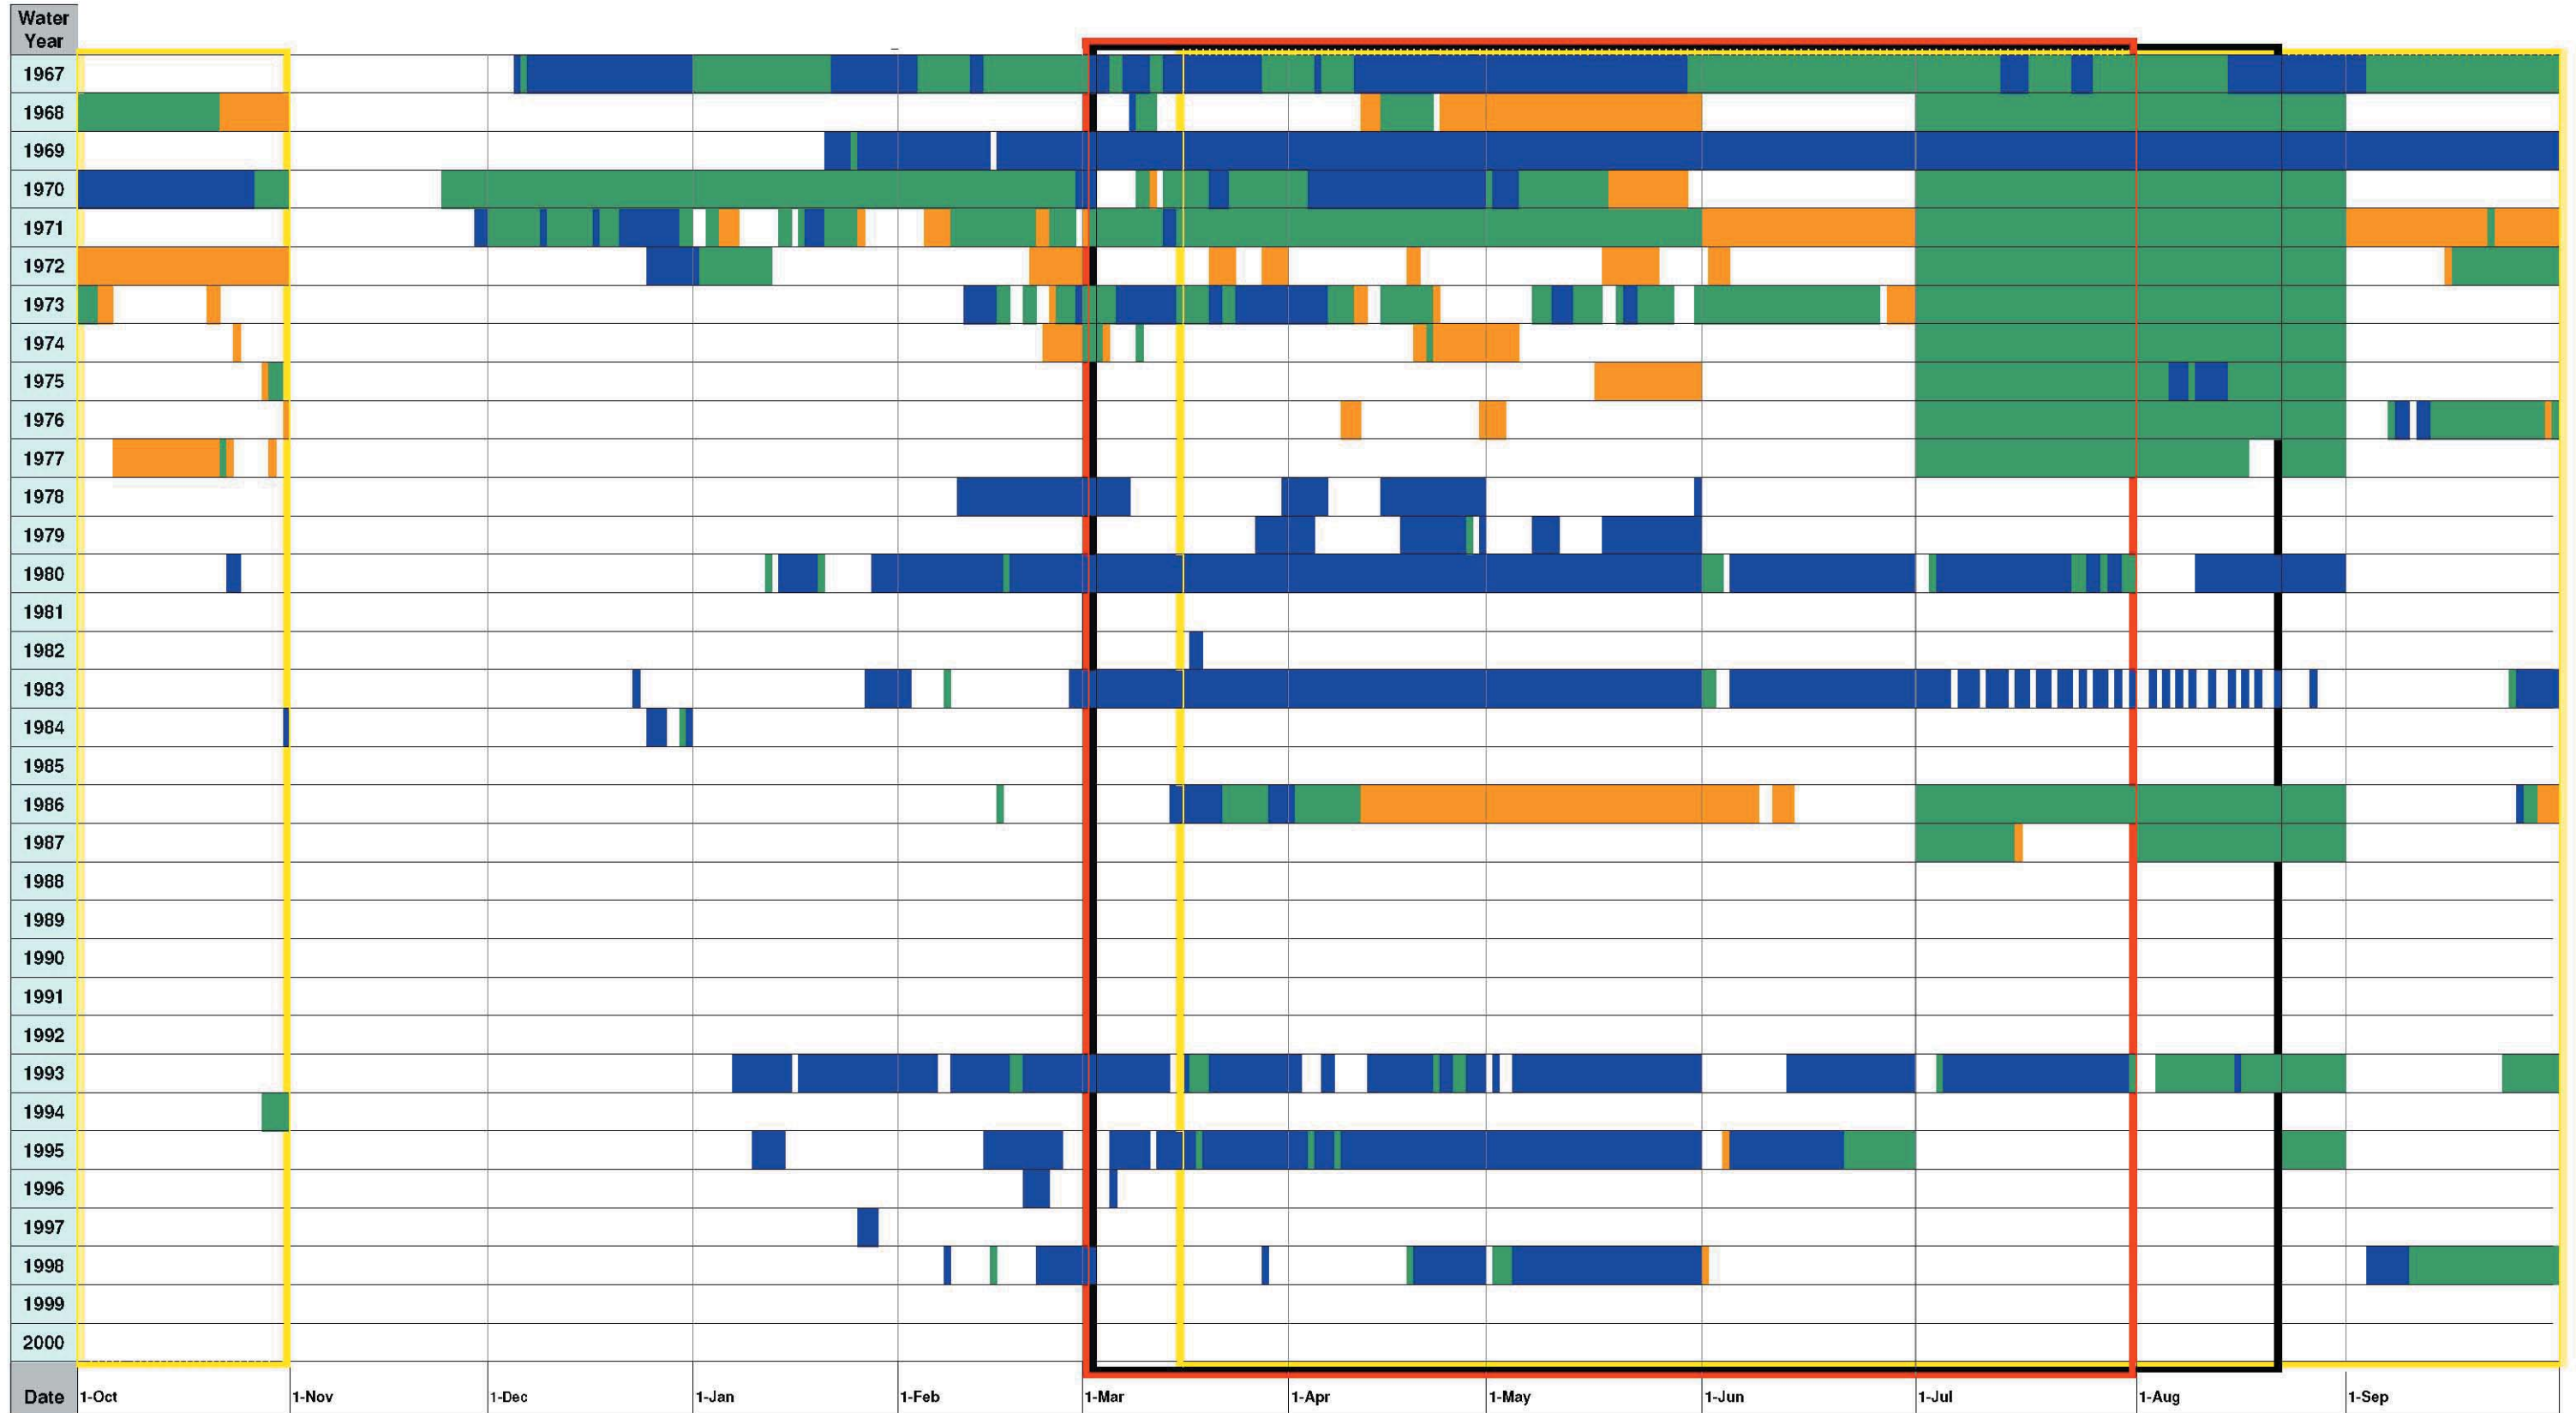
Muni/Western Ex. 9-103
Flow Ranges in Segment C Under "No Project"

Legend: = Flow <1 CFS = 1-5 CFS = 5-50 CFS = >50 CFS Canyon treefrog breeding Canyon treefrog egg incubation Canyon treefrog larval stage
