THIRD QUARTER 2012
QUARTERLY MONITORING REPORT

Berry Street Mall Landfill
901 Galleria Boulevard
Roseville, California

WDR No. 89-115

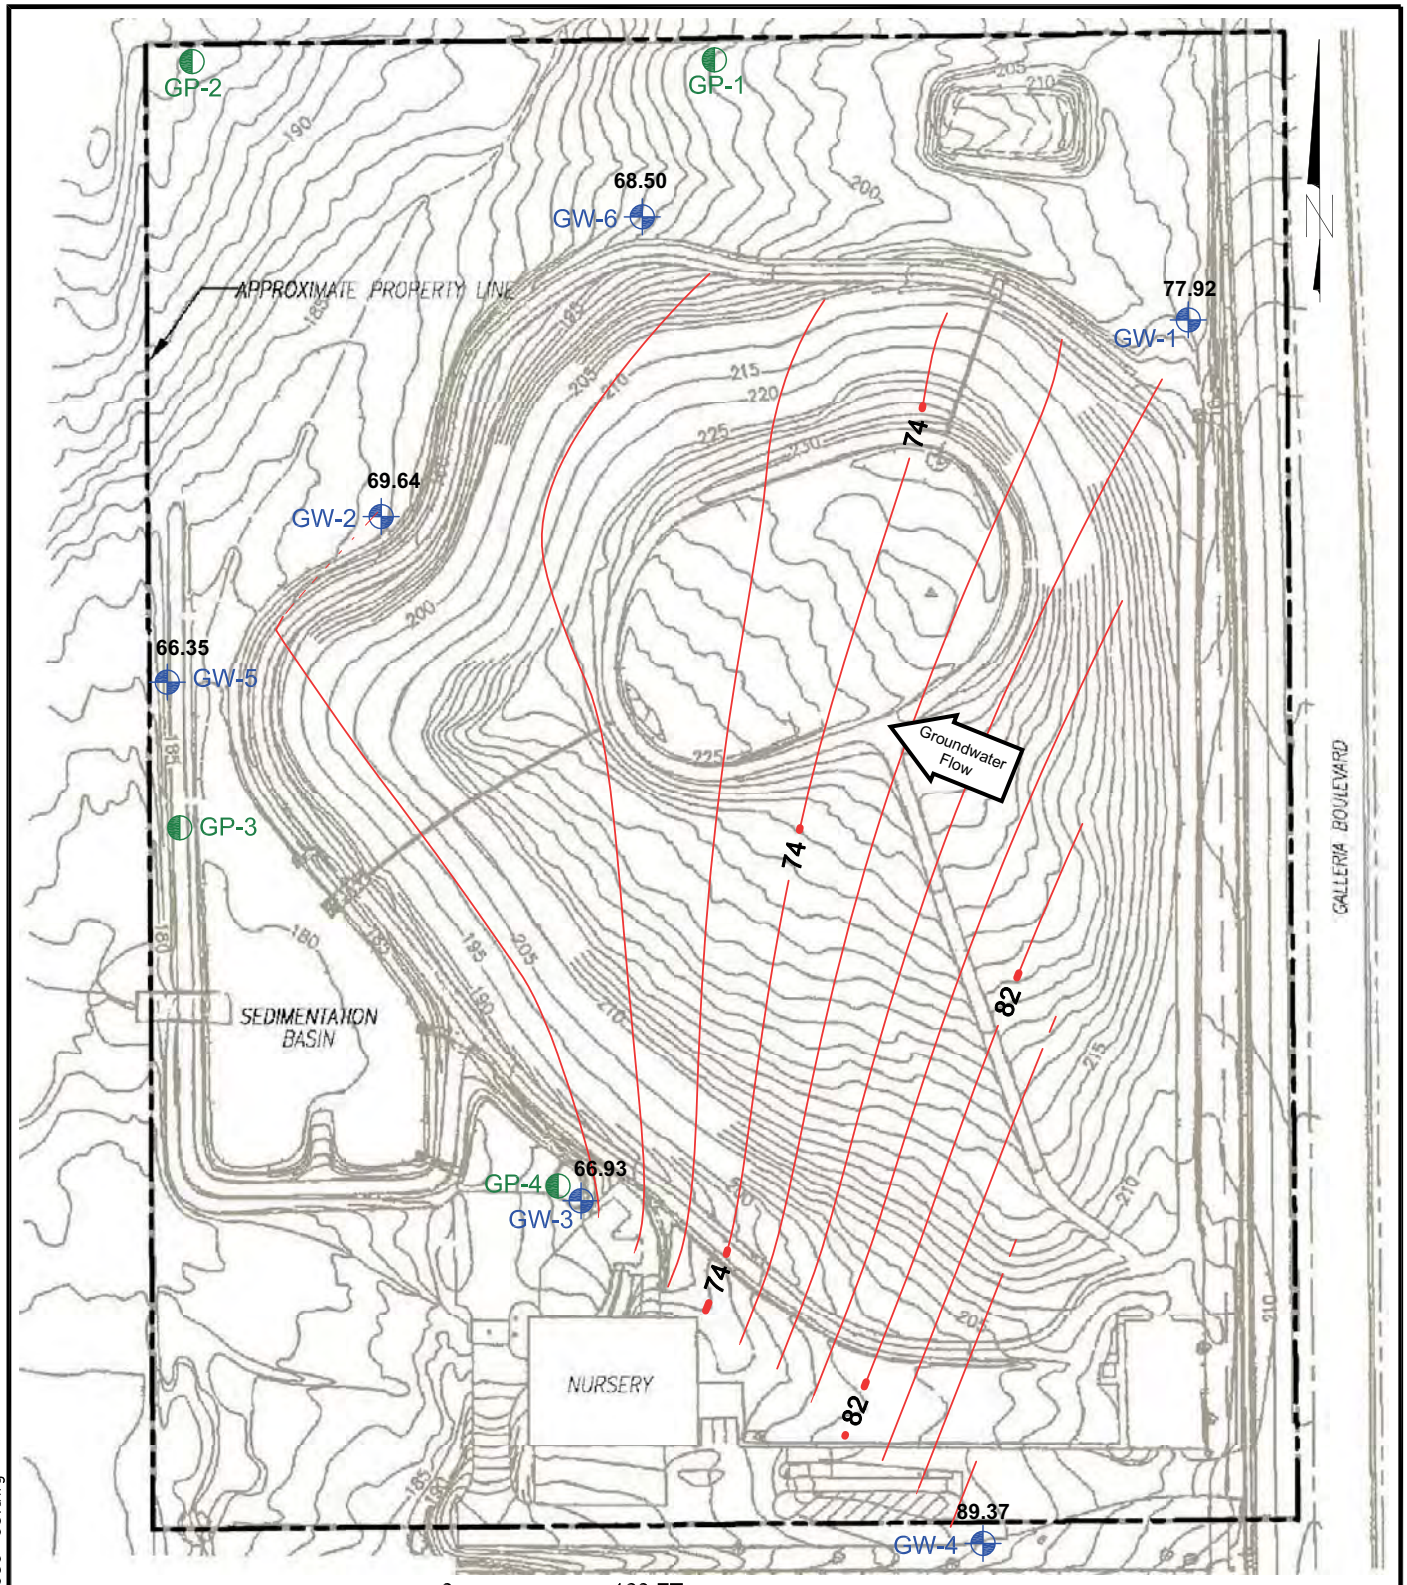
FIGURE 3

The results of groundwater potentiometric surface measurements conducted at the site on October 17, 2012 are summarized in Table 1. A potentiometric surface map illustrating the corresponding groundwater flow conditions is presented as Figure 3, “Groundwater Contour Map”. As shown in Figure 3, the southeast portion of the site is characterized by a northwesterly groundwater flow component, whereas a westerly groundwater flow component predominates beneath the central and western portions of the Landfill.

These flows conditions generally mimic the original site topography and orientation of a former ephemeral drainage that was present prior to landfill development.

The aforementioned variable groundwater flow component is also accompanied by variable hydraulic gradient conditions, with a fairly significant decrease in hydraulic gradient occurring from east to west across the site. As shown in Figure 3, the site exhibits a hydraulic gradient of approximately 0.027 foot per foot (ft/ft). Similar to the comparison noted above, the changes in hydraulic gradient generally mimic the former topographic features that characterized the site prior to landfill development.
