SECOND QUARTER 2012
QUARTERLY MONITORING REPORT

Berry Street Mall Landfill
901 Galleria Boulevard
Roseville, California

WDR No. 89-115

July 16, 2012

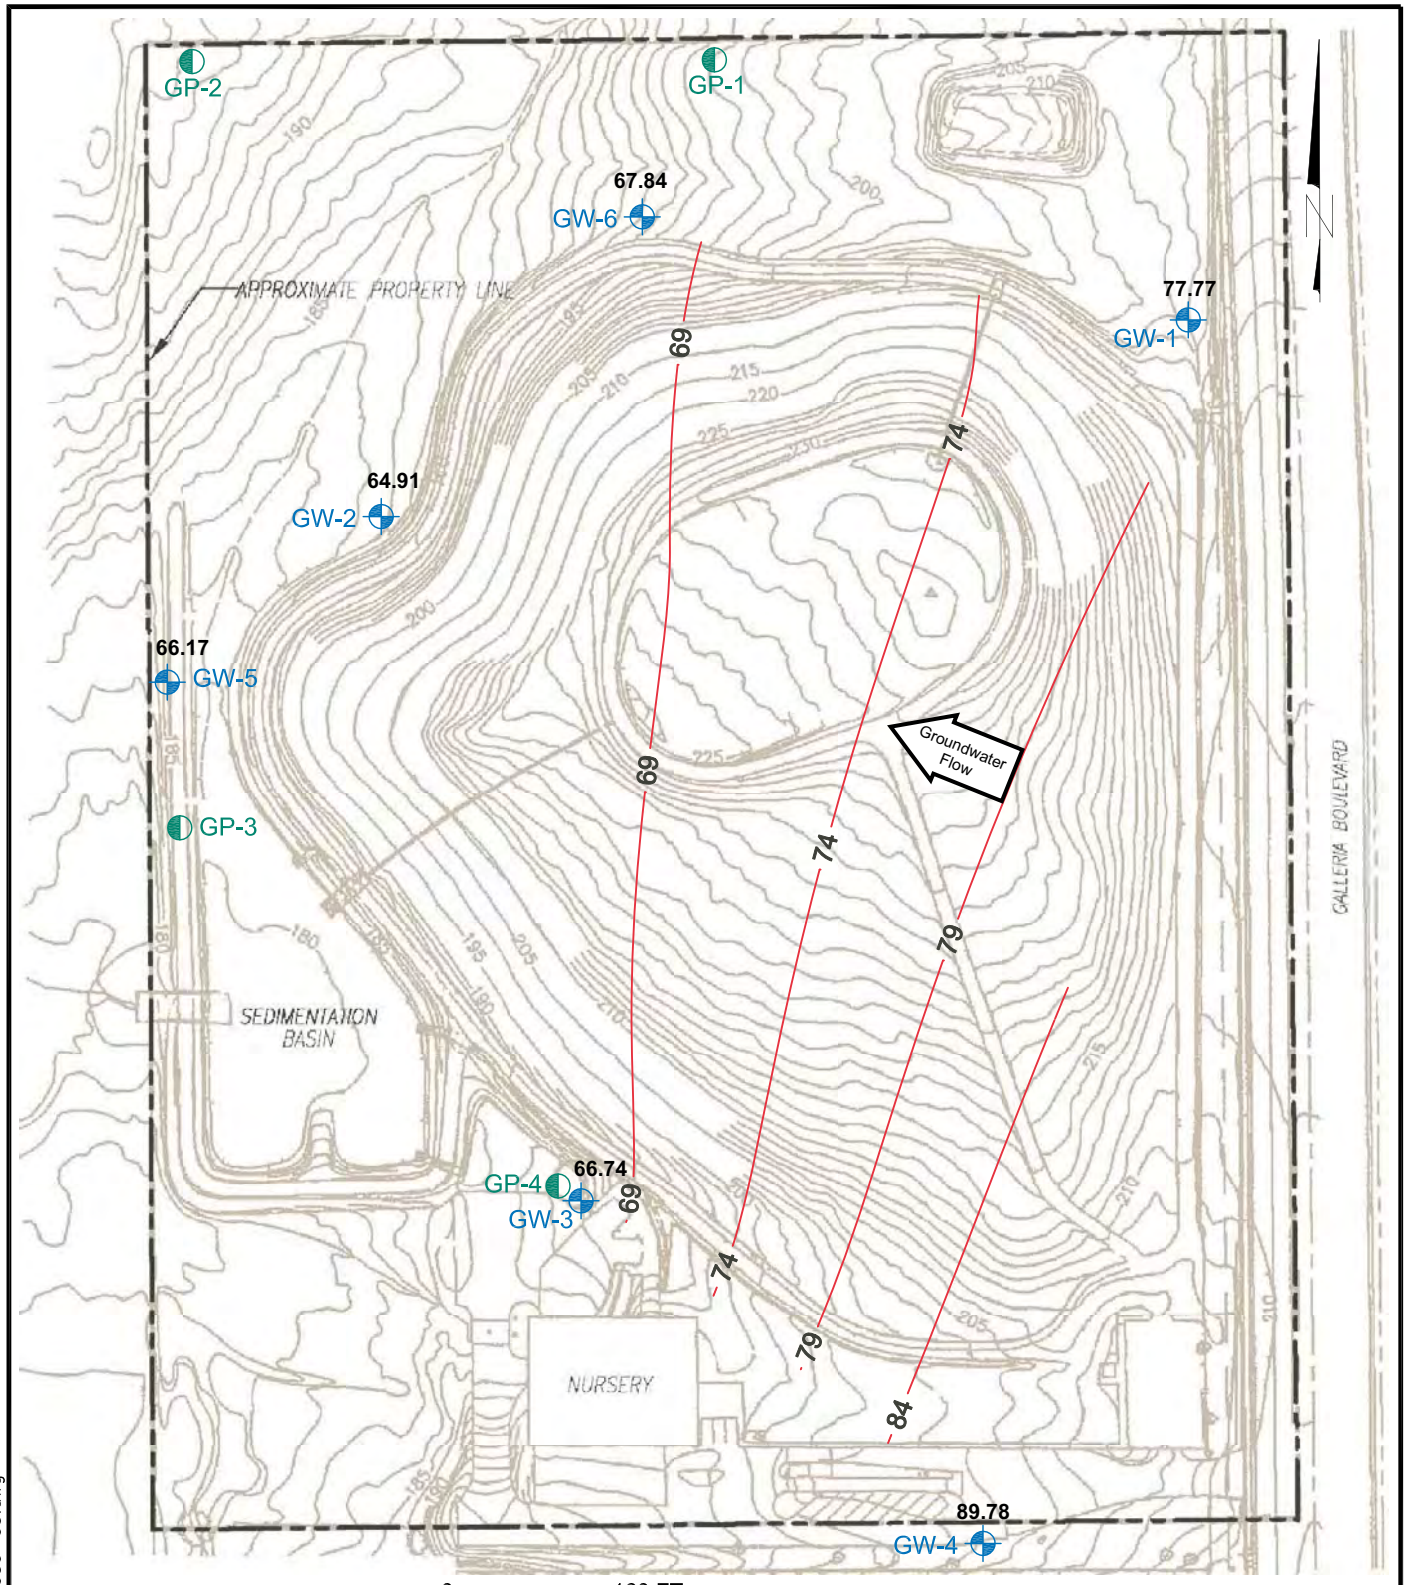
FIGURE 3

The results of groundwater potentiometric surface measurements conducted at the site on June 13, 2012 are summarized in Table 1. A potentiometric surface map illustrating the corresponding groundwater flow conditions is presented as Figure 3, “Groundwater Contour Map”. As shown in Figure 3, the southeast portion of the site is characterized by a northwesterly groundwater flow component, whereas a westerly groundwater flow component predominates beneath the central and western portions of the Landfill. These flows conditions generally mimic the original site topography and orientation of a former ephemeral drainage that was present prior to landfill development.

variable hydraulic gradient conditions, with a fairly significant decrease in hydraulic gradient occurring from east to west across the site. As shown in Figure 3, the site exhibits a hydraulic gradient of approximately 0.034 foot per foot (ft/ft). Similar to the comparison noted above, the changes in hydraulic gradient generally mimic the former topographic features that characterized the site prior to landfill development.
