1 May 2009

Subject: **Interim Removal Action Status**
Airport/Former TRA Site
2701 North Harbor Drive
San Diego, California

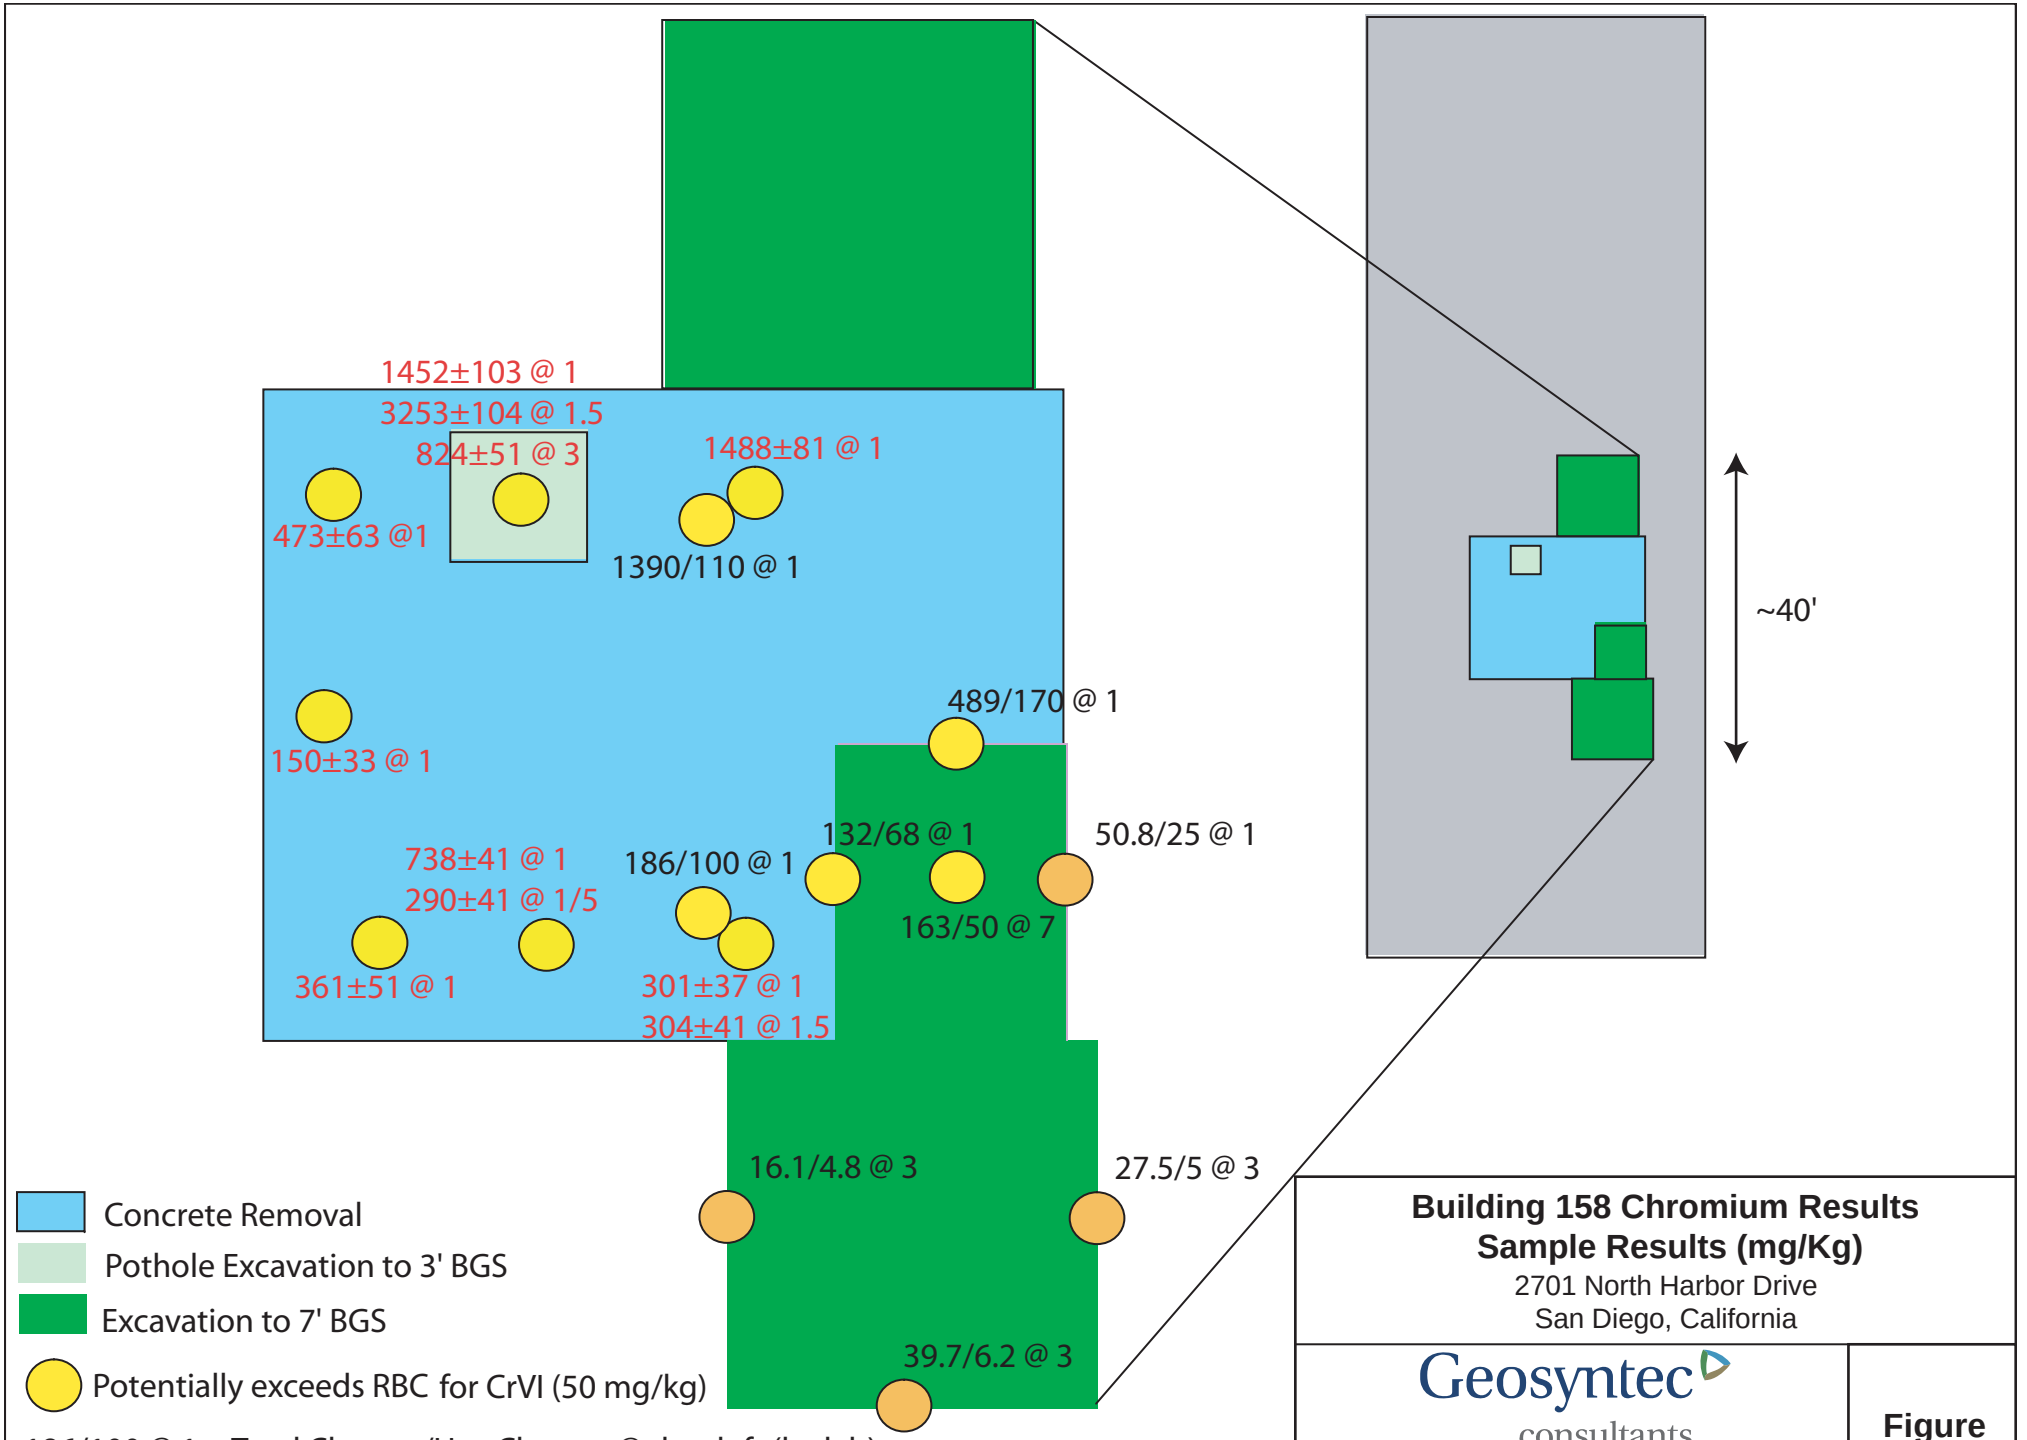
Building 158 Chromium Results
Sample Results (mg/Kg)
2701 North Harbor Drive
San Diego, California

Description: One 10-foot by 10-foot by 7 foot deep excavation was performed in Building 158 for removal of VOCs and TPH in soil (Figure 2) and $FeSO_4$ injections were performed to encourage in-situ reduction of hexavalent chromium (CrVI) in groundwater. During excavation activities, yellow soil staining was observed on the northern side wall of the planned excavation. Based on these observations total chromium (Cr) and CrVI analysis were added to the confirmation sampling. An RBC exceedance for CrVI was noted in this confirmation sample. The excavation was extended to the north with a 5-foot by 5-foot by 7-

foot deep excavation and a portion of the concrete slab was pulled back to the north and west. An x-ray fluorescence (XRF) analysis was performed to evaluate the potential extent of CrVI impacts in shallow soil.

Confirmation Sampling Results: The results from the VOC and TPH analysis were below RBCs; however, hexavalent chromium concentrations exceeded RBCs on the northern side wall. The excavation was extended to the north and the base and side walls of the excavation extension were sampled for Total Cr and CrVI. The north and west walls, and base of the excavation exceeded the RBCs for CrVI (Table 4). A 20-foot by 20-foot section of the floor slab was removed and the underlying soil was screened for total Cr using an XRF device. Confirmation samples were collected by hand auger and analyzed for total Cr and CrVI in the laboratory. The results indicated the potential extent of the hexavalent chromium in shallow soil was too large to address efficiently prior to building demolition. The excavation was backfilled and compacted with clean fill, covered with plastic, and sandbagged to reduce potential water infiltration.

To encourage hexavalent chromium reduction in groundwater, an $FeSO_4$ solution was injected into the groundwater through 17 direct push points. After injections were completed, groundwater monitoring was performed to evaluate the effectiveness of the $FeSO_4$ injections. The results indicate that while hexavalent chromium concentrations were initially reduced in groundwater, concentrations have since rebounded to pre-injection concentrations (Table 9).

Status: Further remedial measures are planned to address soil and groundwater impacts following building demolition.

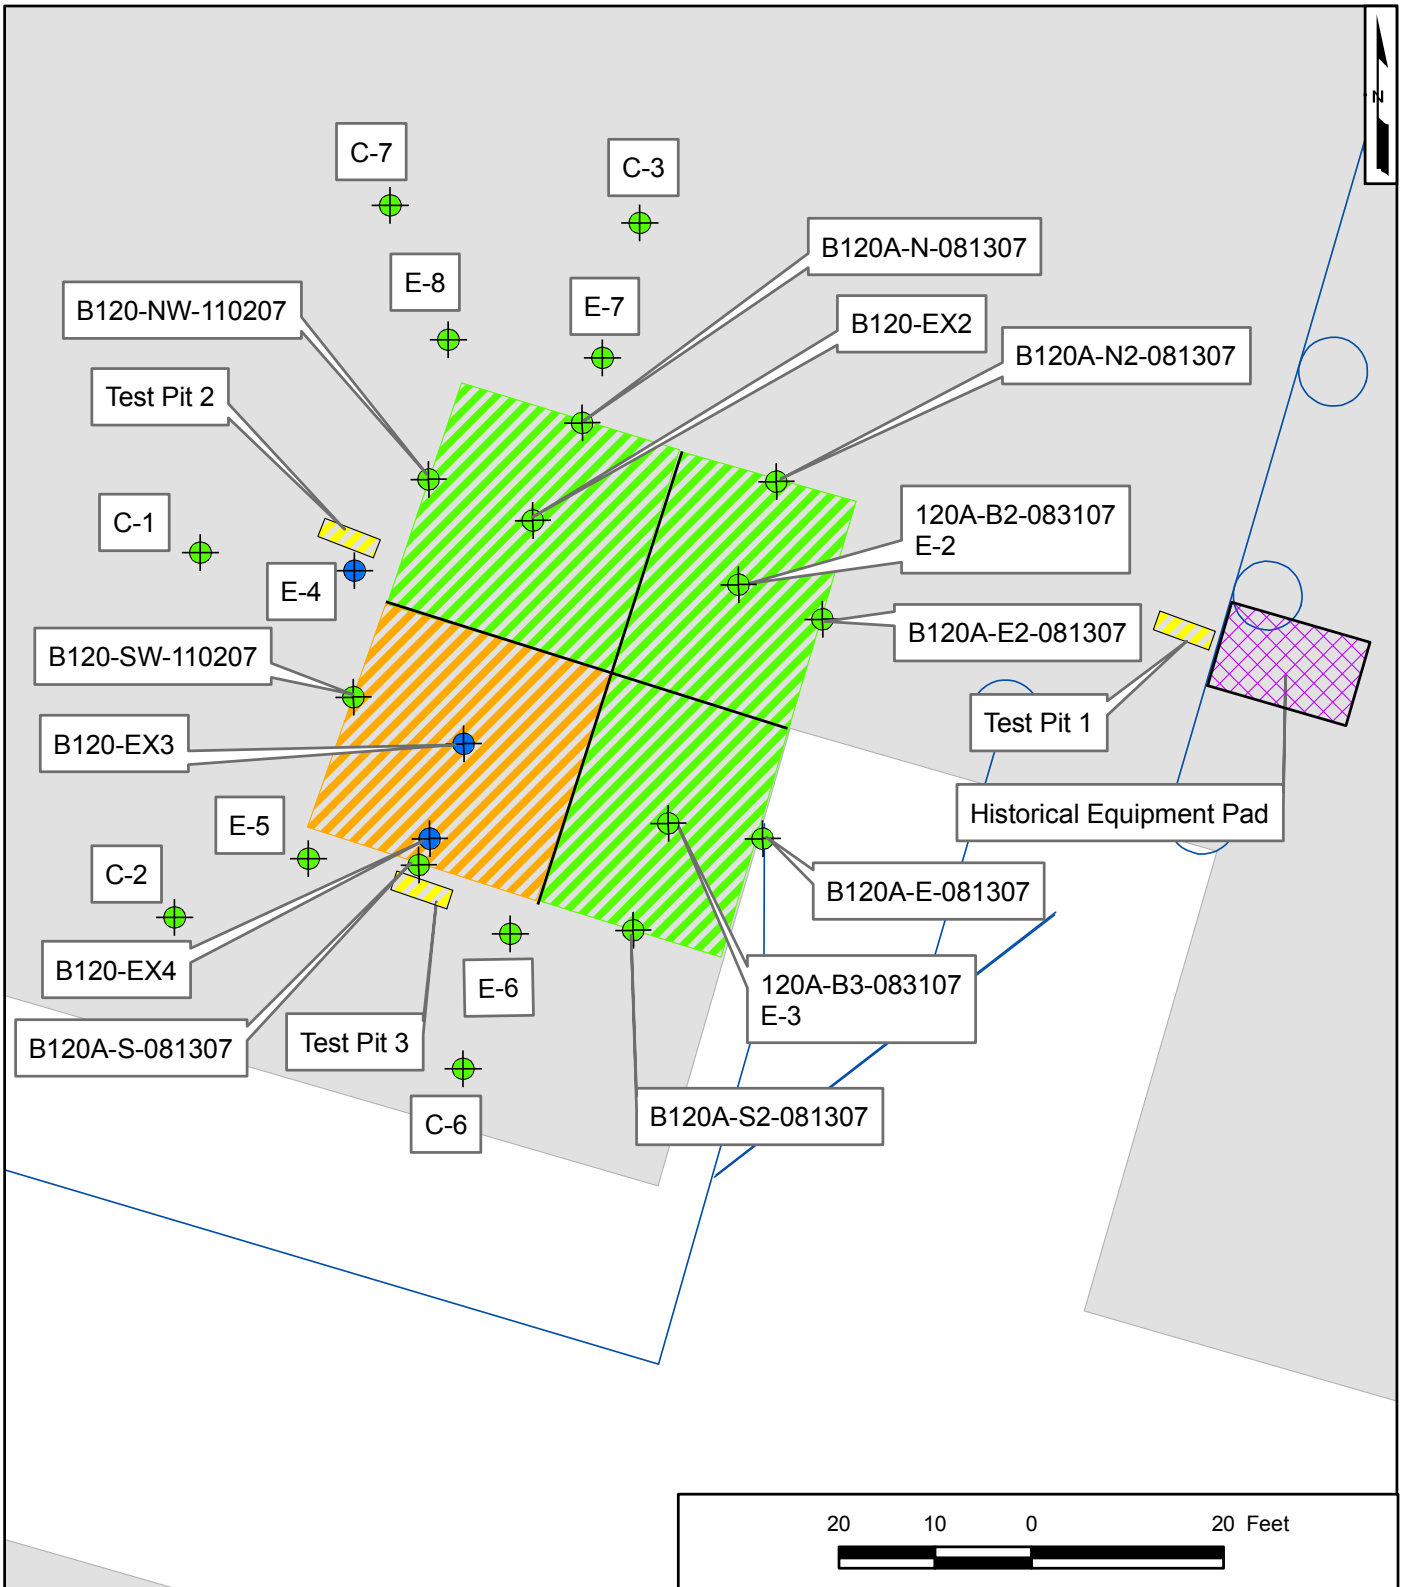
Building 120A Excavation and Test Pits

Description: Two excavations were conducted in Building 120. Excavation 120A was approximately 50-foot by 50-foot by 5 to 7 foot deep and located in the south central portion of Building 120 to address hydrocarbon impacted soil. Excavation 120B was a 10-foot by 10-foot by 7-foot excavation located in the north eastern section of Building 120, performed to remove VOC impacted soil.

The extent of the Building 120A excavation footprint increased from its original dimension of 34- by 27-feet, due to RBC exceedances in some of the initial side wall and bottom confirmation samples. To better delineate the potential extent of impacted soil, step out direct push borings were advanced around the excavation. Results from direct push investigation helped to define the potential extent of hydrocarbon impacted soil (Figure 3). The presence of LNAPL was also observed on the surface of the groundwater in the bottom of the southwestern quadrant of the excavation. Test pits were dug to the west and south of the excavation and also next to a former heavy machinery foundation east of the excavation (Figure 3). LNAPL was observed within each of the test pits. Soil and LNAPL samples were collected from each of the test pits. Building footings and obstructions hindered further step-out.

Confirmation Sampling Results: Confirmation samples were collected from the side wall and bottom of excavation 120A as well as from step out borings and test pits. All samples were analyzed for TPH by EPA Method 8015, and a subset of the samples were additionally analyzed for PCBs by EPA Method 8082. The confirmation results indicate that the bottom of the southwest quadrant of the excavation and areas to south and west have impacts of TPH that exceed the RBCs in the vicinity of the water table (Table 6). PCBs were detected in the free product up to a concentration of approximately 7 mg/kg. The excavation was backfilled pending building demolition which will allow for unobstructed access for further remediation.

Status: Additional remedial activities at excavation 120A are still pending once building demolition is completed. These activities will be focused on removing LNAPL and TPH impacted soil to the south and west of the existing excavation and further addressing TPH impacts with the south western quadrant of the Building 120A excavation. The 120B excavation is complete based on the confirmation sample results.
