Appendix N

EVALUATION OF TREATMENT PLANT OPERATION AND POTENTIAL CAUSES OF TREATMENT PLANT EFFLUENT LIMITATION VIOLATIONS (April to June 2004) FOR THE CITY OF ESCONDIDO HALE AVENUE RESOURCE RECOVERY FACILITY

Boris Trgovcich
Water Resources Control Engineer
Compliance Assurance and Enforcement Unit
State Water Resources Control Board

April 7, 2005

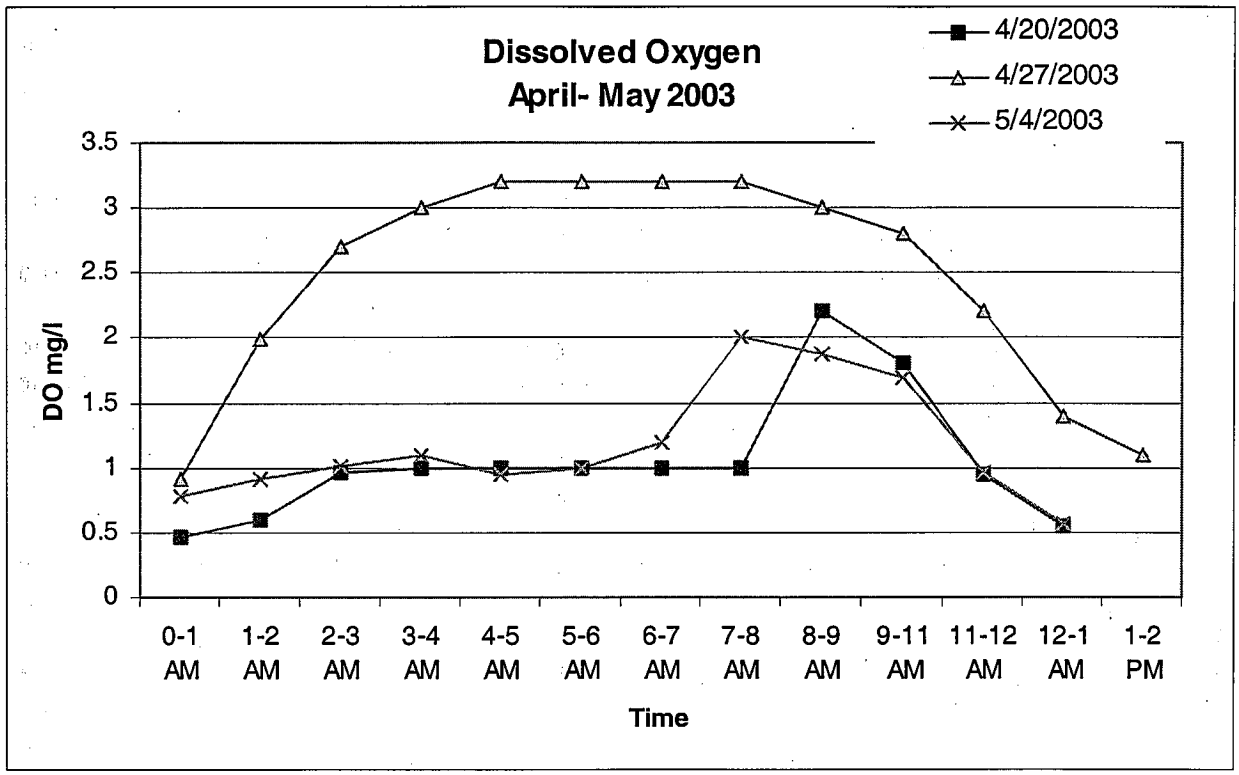
noticeable effect on the plant performance. For example, **Figure 1** shows DO "spikes" at this facility for selected days during three consecutive weeks, one year prior to the alleged April –June upset. During that three week period the plant experienced was no appreciable decrease in performance and no documented effluent limit violations.

Figure 1 – Example of DO "spikes" at HARRF during three days, one week apart in April-May 2003. The average DO concentration for the remainder of each day was approximately 1 mg/l.
