Central Valley Regional Water Quality Control Board

NOTICE OF VIOLATION, 3 SEPTEMBER 2014 INSPECTION REPORT, RECOLOGY HAY ROAD, SOLANO COUNTY

INSPECTION REPORT

DISCHARGER: Recology Hay Road
LOCATION & COUNTY: 6426 Hay Road, Vacaville, Solano County
CONTACT(S): Bryan Clarkson, Group Environmental Manager, Recology
INSPECTION DATE: 3 September 2014
INSPECTED BY: Andrew Altevogt, Howard Hold, Mary Boyd, and Marty Hartzell with the Central Valley Regional Water Quality Control Board (Water Board)
ACCOMPANIED BY: Paul Yamamoto (Group Vice President, Recology), Bryan Clarkson Group Environmental Manager, Recology), Chris Taylor (landfill manager, Recology Hay Road), and Tim Daleiden (Engineering and Operations Manager, Recology)

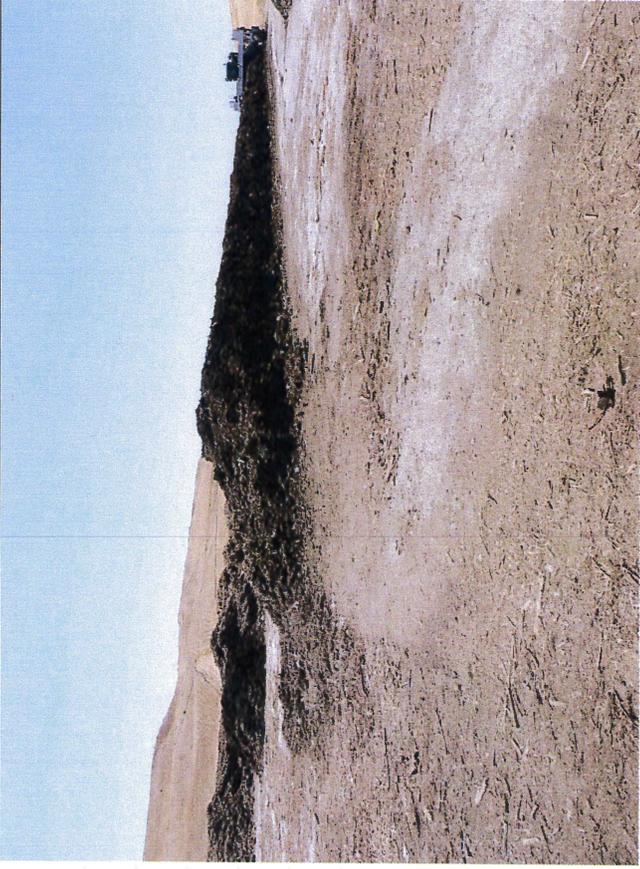
Photograph 20

Overview of the composting operations. This view shows the south side of the operations in the foreground. The "high-flow" pond is on the right side of the photo, and the green waste compost rows are shown on the left side.

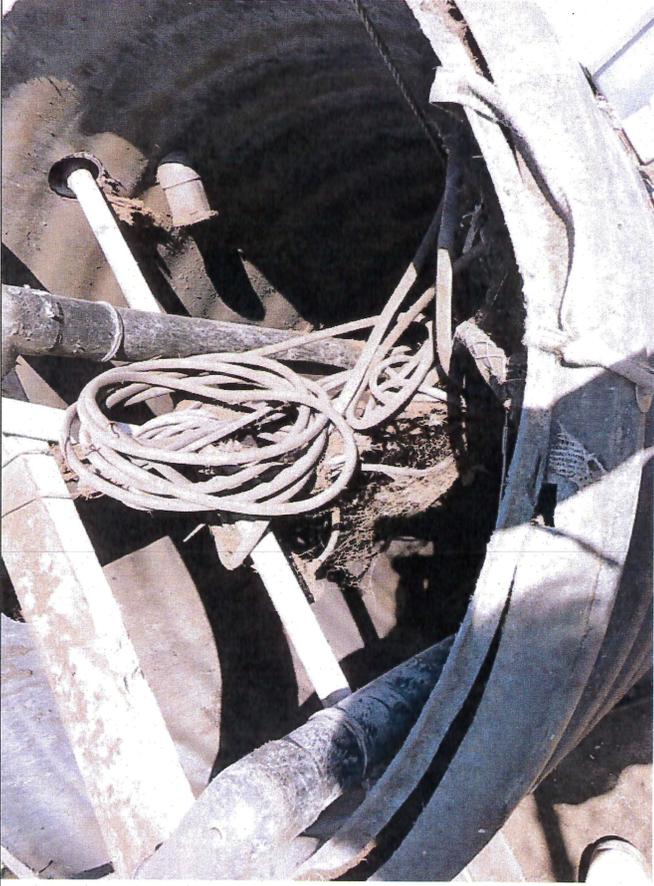
Photograph 25

View of the collection sump for the food waste composting area.
