CLEANUP AND ABATEMENT ORDER NO. R5-2015-0701

Attachment C – 28 October 2014 Baker Ridge Inspection Report

INSPECTION REPORT

28 OCTOBER 2014 BAKER RIDGE INSPECTION REPORT

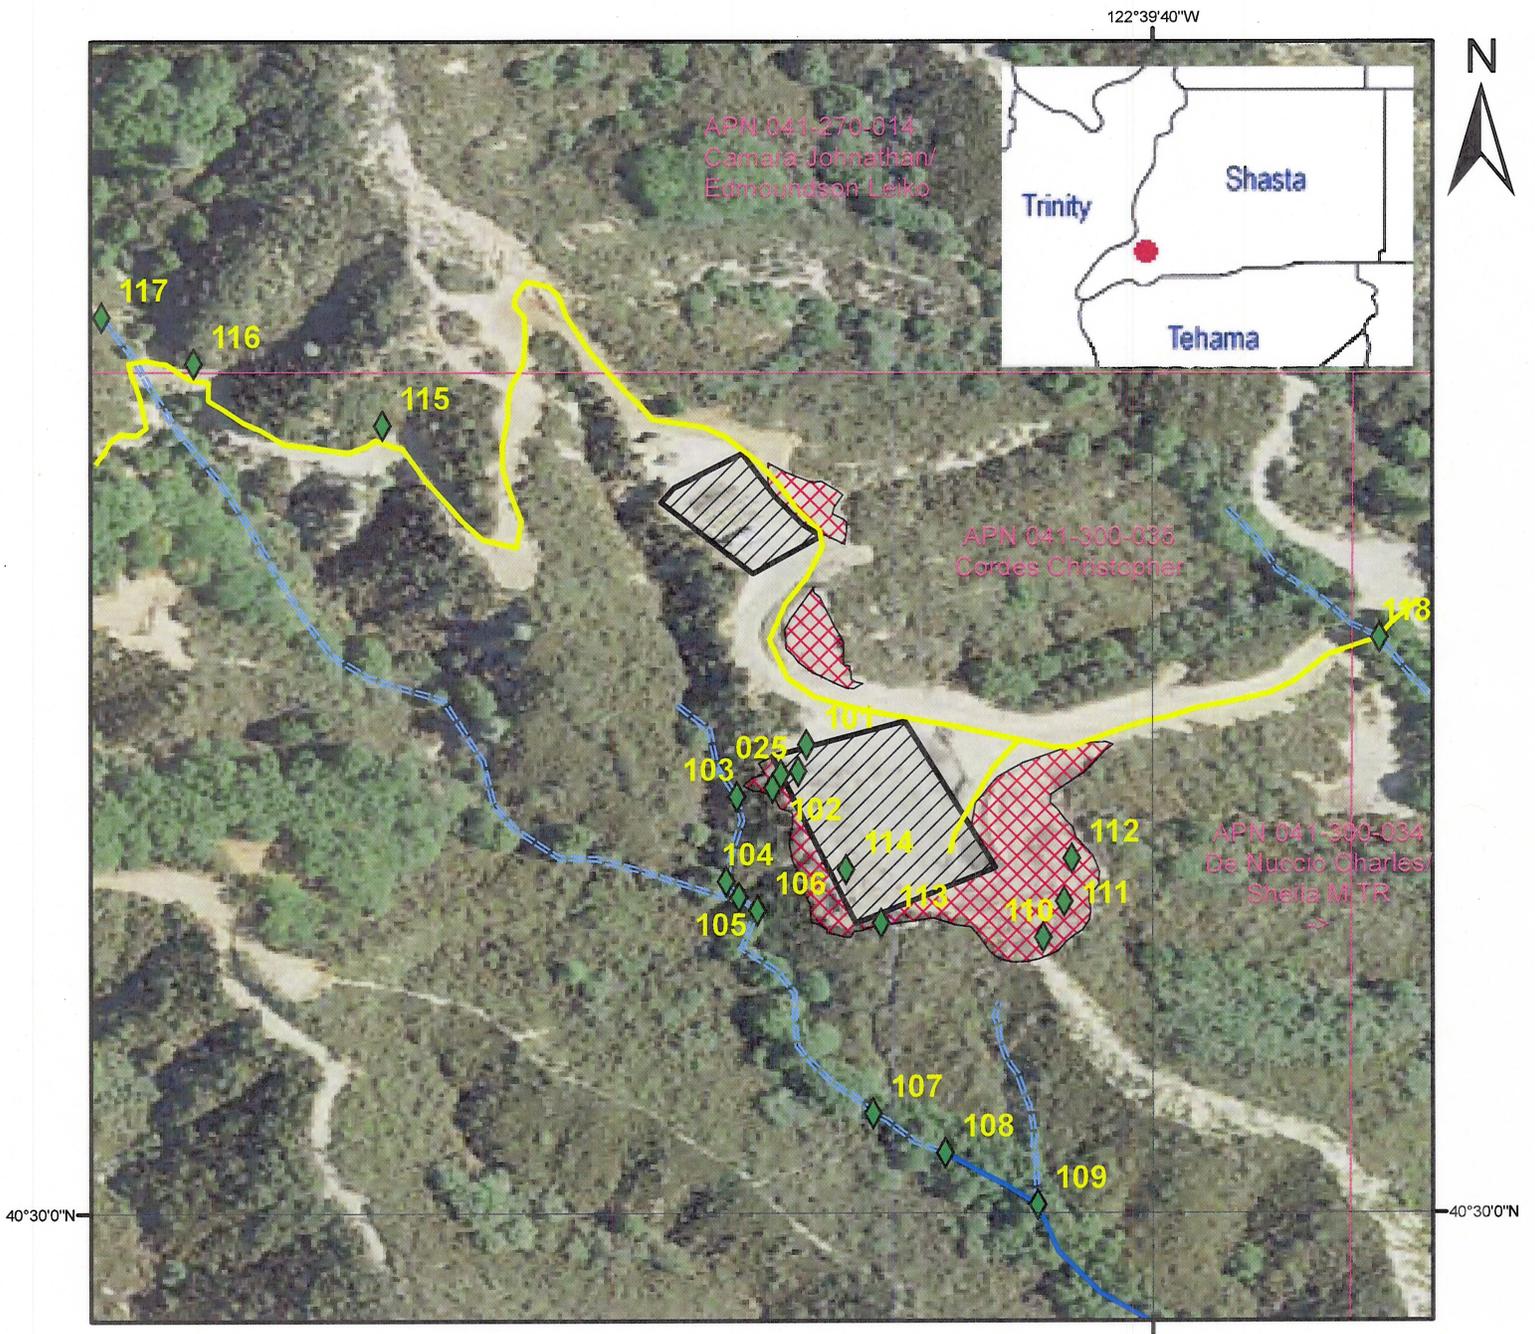
Baker Ridge Rd. Grow: 10-28-14 Inspection on NAIP 2014 Imagery

At approximately 0900 hours, Central Valley Water Board and CDFW staff arrived at the property and entered onto Parcel APN 041-300-035-000. They found the gate to the property open and staff from Eddie Axner Construction working on the Site. Several men (approximately 5) were installing straw erosion control blankets on berms along the road section connecting the upper terrace to the lower terrace, while two other men were operating heavy equipment (a Komatsu PC 200 LC & Caterpillar D4G) on the east fill slope of the lower terrace. The inspection team parked on the lower terrace then Lt. Little informed the working men that the Central Valley Water Board and CDFW were there to conduct an inspection. The Site is composed of two terraces with a native soil surfaced road connecting the upper and lower terraces to Baker Ridge Road. Recent road construction has continued this road from the north side and to the west of the upper terrace. Central Valley Water Board staff collected information at GPS Way Point locations 025 and 100-118 on this parcel (Figures 1 - 3).

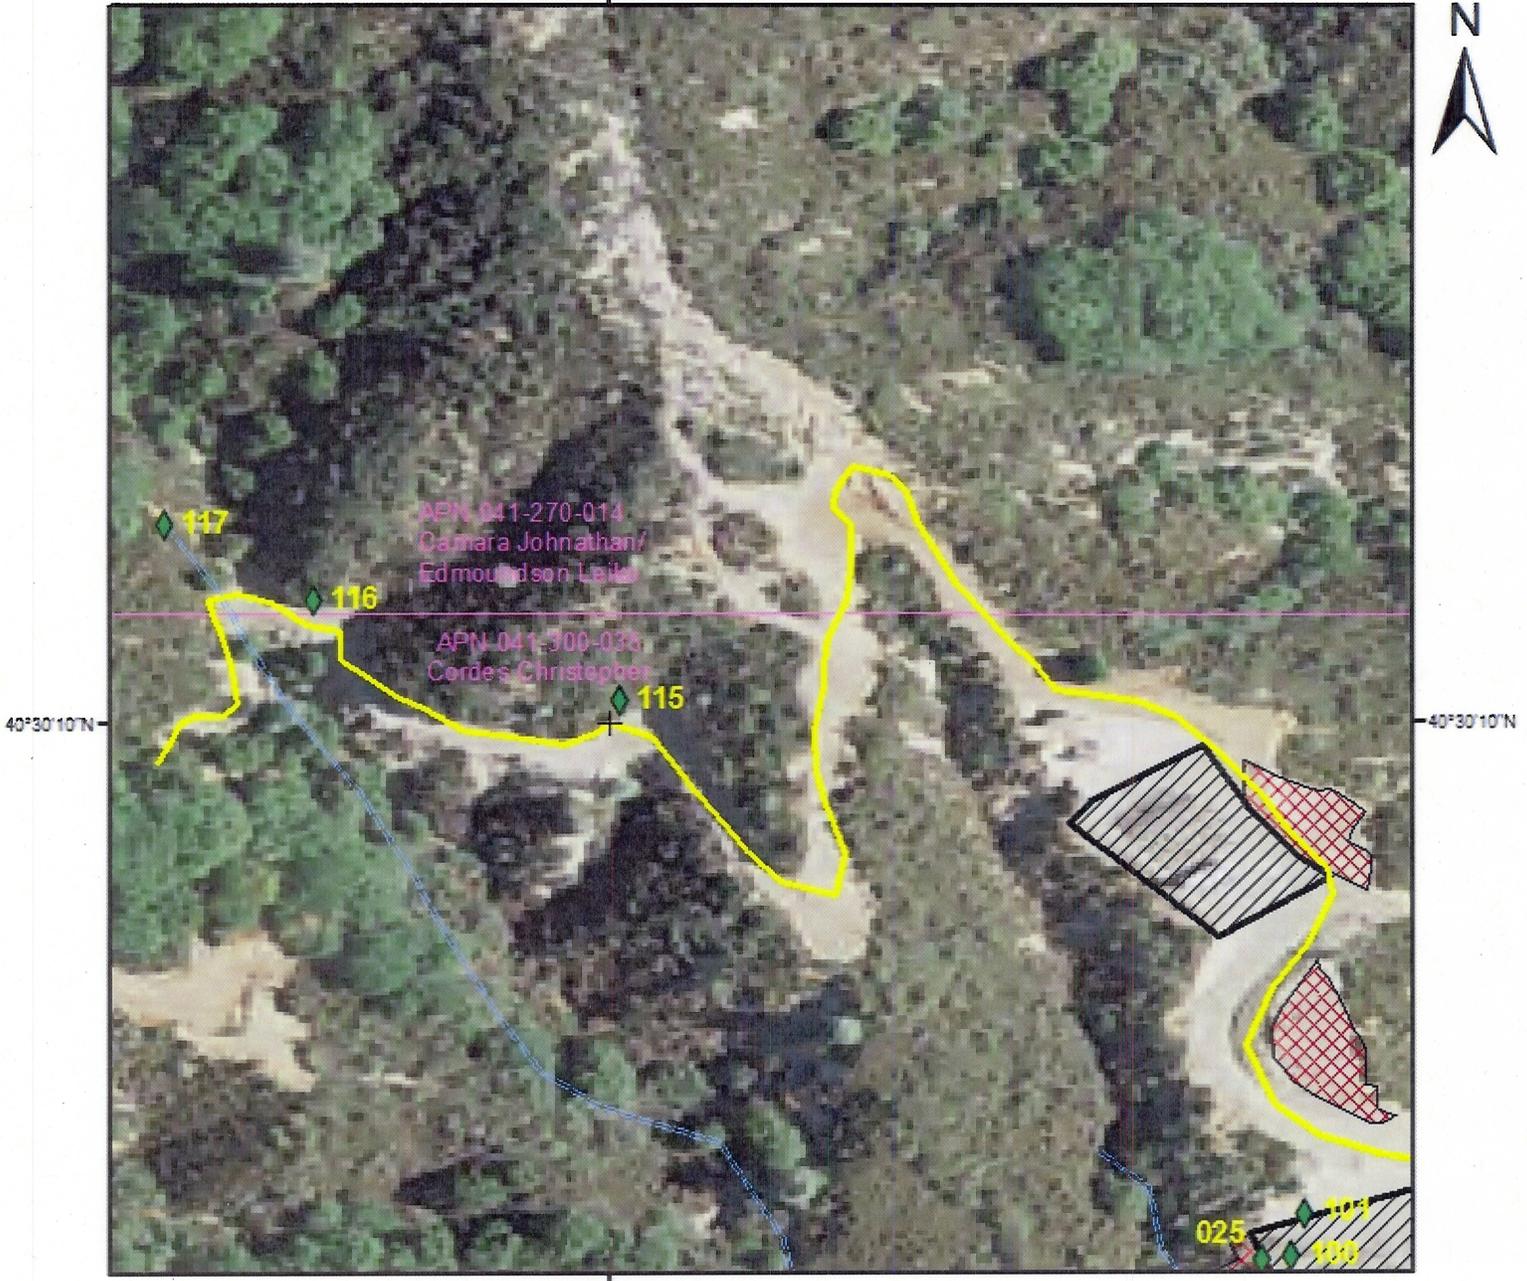
Baker Ridge Rd. Grow: 10-28-14 Inspection on NAIP 2014 Imagery Upper Pad and Roads

The upper terrace was constructed similar to the lower, by grading material to form a rectangular native soil surface with large berms around the perimeter. Using a GPS, Staff determined that this terrace surface is approximately 0.3 acres in size. Two 3000 gallon water tanks were located upslope and to the north northwest of the upper terrace surface (Photograph #11) and Staff found another area of dumped potting soil on the east fill/side slope of the upper terrace. At the time of the inspection the 1 water tank was full and the other approximately half full and there were no pipes connected to these tanks.

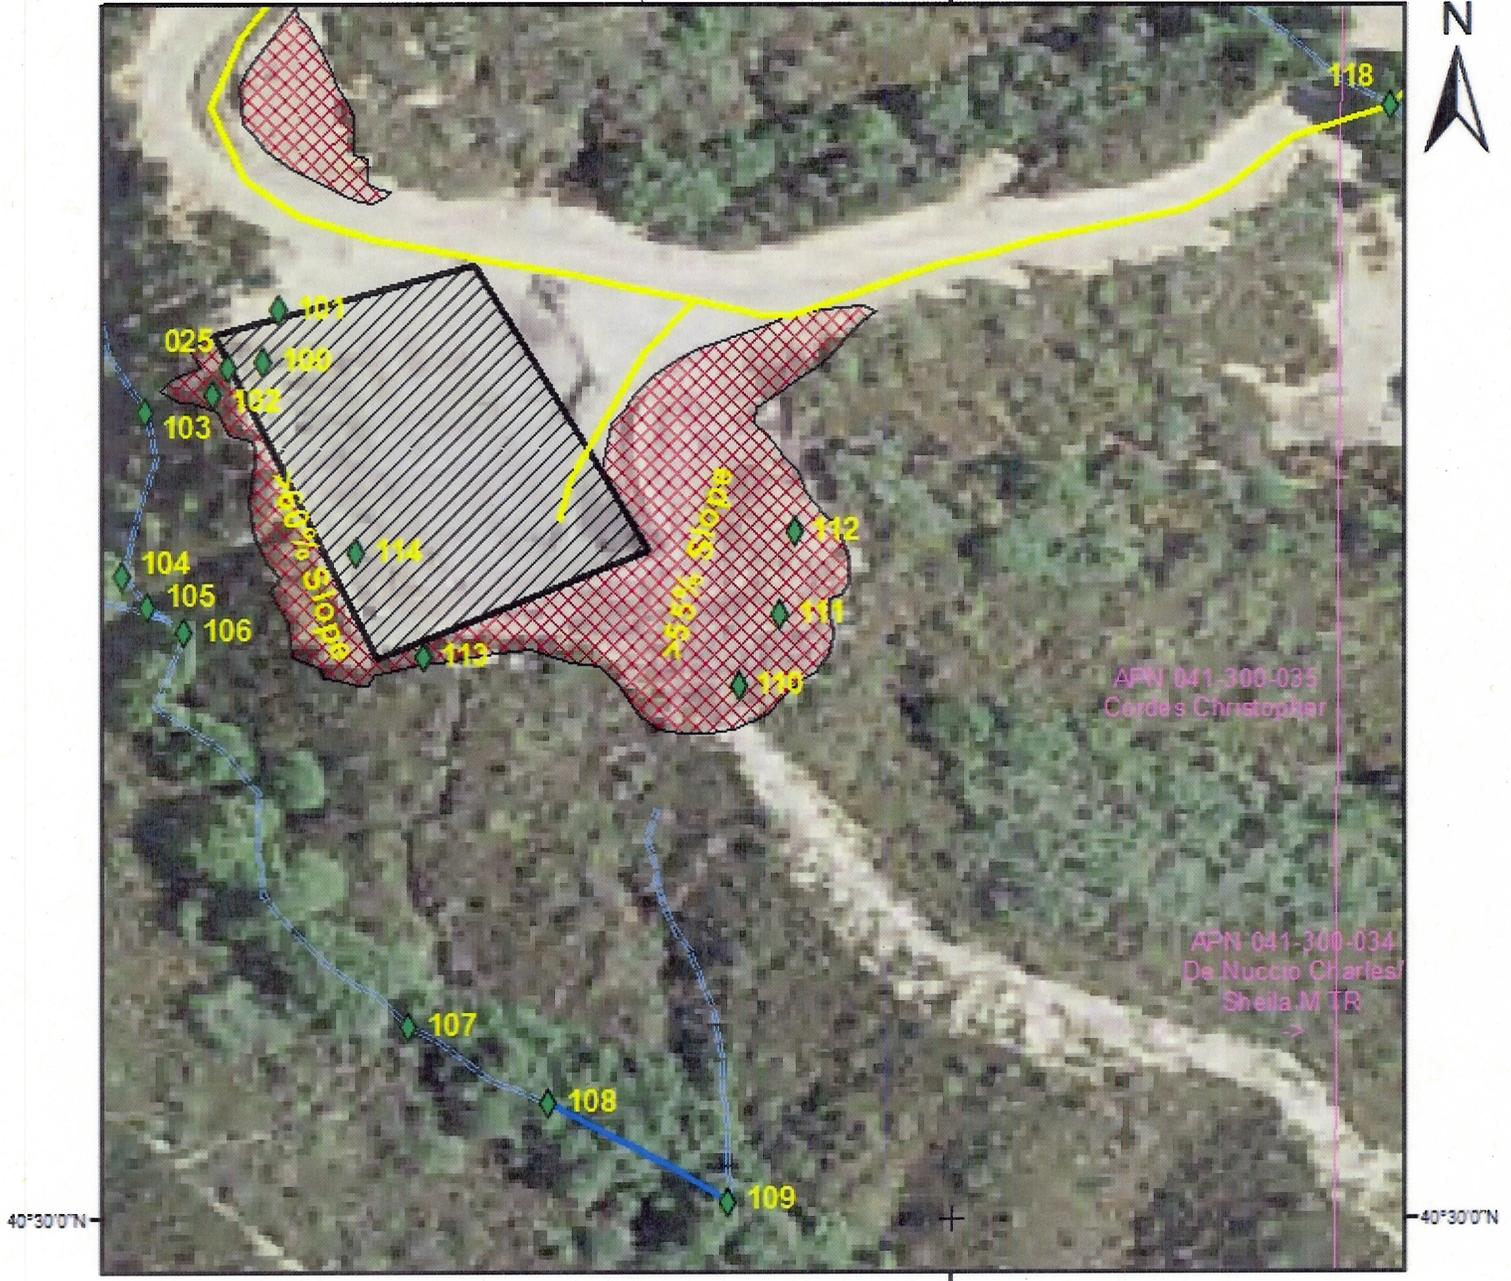
Baker Ridge Rd. Grow: 10-28-14 Inspection on NAIP 2014 Imagery Lower Pad

The lower terrace was constructed by grading down a ridge and pushing the graded material to the west and southeast piling it to form an approximately 0.9 acre rectangular terrace with approximately 5 feet tall berms around the perimeter. On the northwest corner of the lower terrace (Way Point 100) Central Valley Water Board staff (Staff) found a storm water drainage discharge for the lower terrace surface. Directly adjacent to and below this discharge site staff encountered a large amount of potting soil that had been dumped over the edge and down the side slopes of the lower terrace (Photograph #1) as well as tires, metal, and other debris that had been incorporated into the fill of the terrace. The debris had been exposed by erosion (Way Point 101, Photograph #2). The potting soil covered an area on the side slope of approximately 1900 ft² and had an average depth of more than 12 inches. There was evidence that some of the potting soil, through visible rills, had washed downhill prior to our inspection. A sample was taken from the center of the potting soil mass (Way Point 102).
