**Los Angeles Regional Water Quality Control Board**

**INSPECTION REPORT**

**DATE OF INSPECTION:** October 17, 2016

APNs 2821-002-023; 2821-009-030; 2821-002-024; 2821-002-025; 2821-009-029; 2821-009-031; 2821-009-023

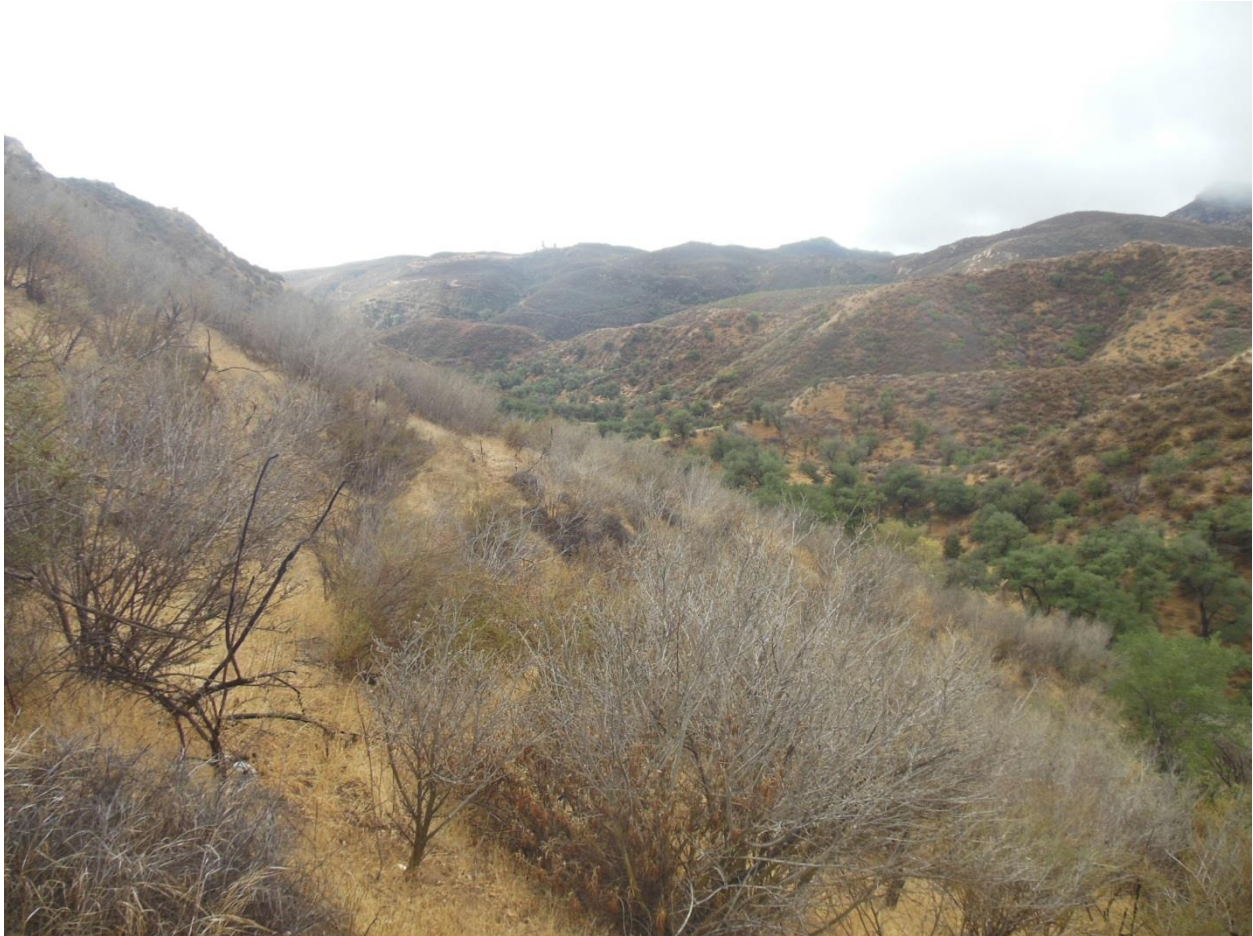
- **Partially completed corral** – A partially completed corral under construction was present in the parcel (Photo 15). A bobcat tractor was present near the partially completed corral (Photo 15).
- **Terrain** – The parcel is heavily covered with weeds, bushes, and trees. Several hillsides with valleys were discernable (Photo 16). Devil's Creek runs through the Parcel; there was no visible flow in the creek.

**Photo 16.** Showing undisturbed land found in parcel 2821-009-029.
