**Complaint Inspection Report  
Erik Windschitl Burnt Ranch Property**

Date: December 9, 2010

Subject: Complaint Inspection of Erik Windschitl Property

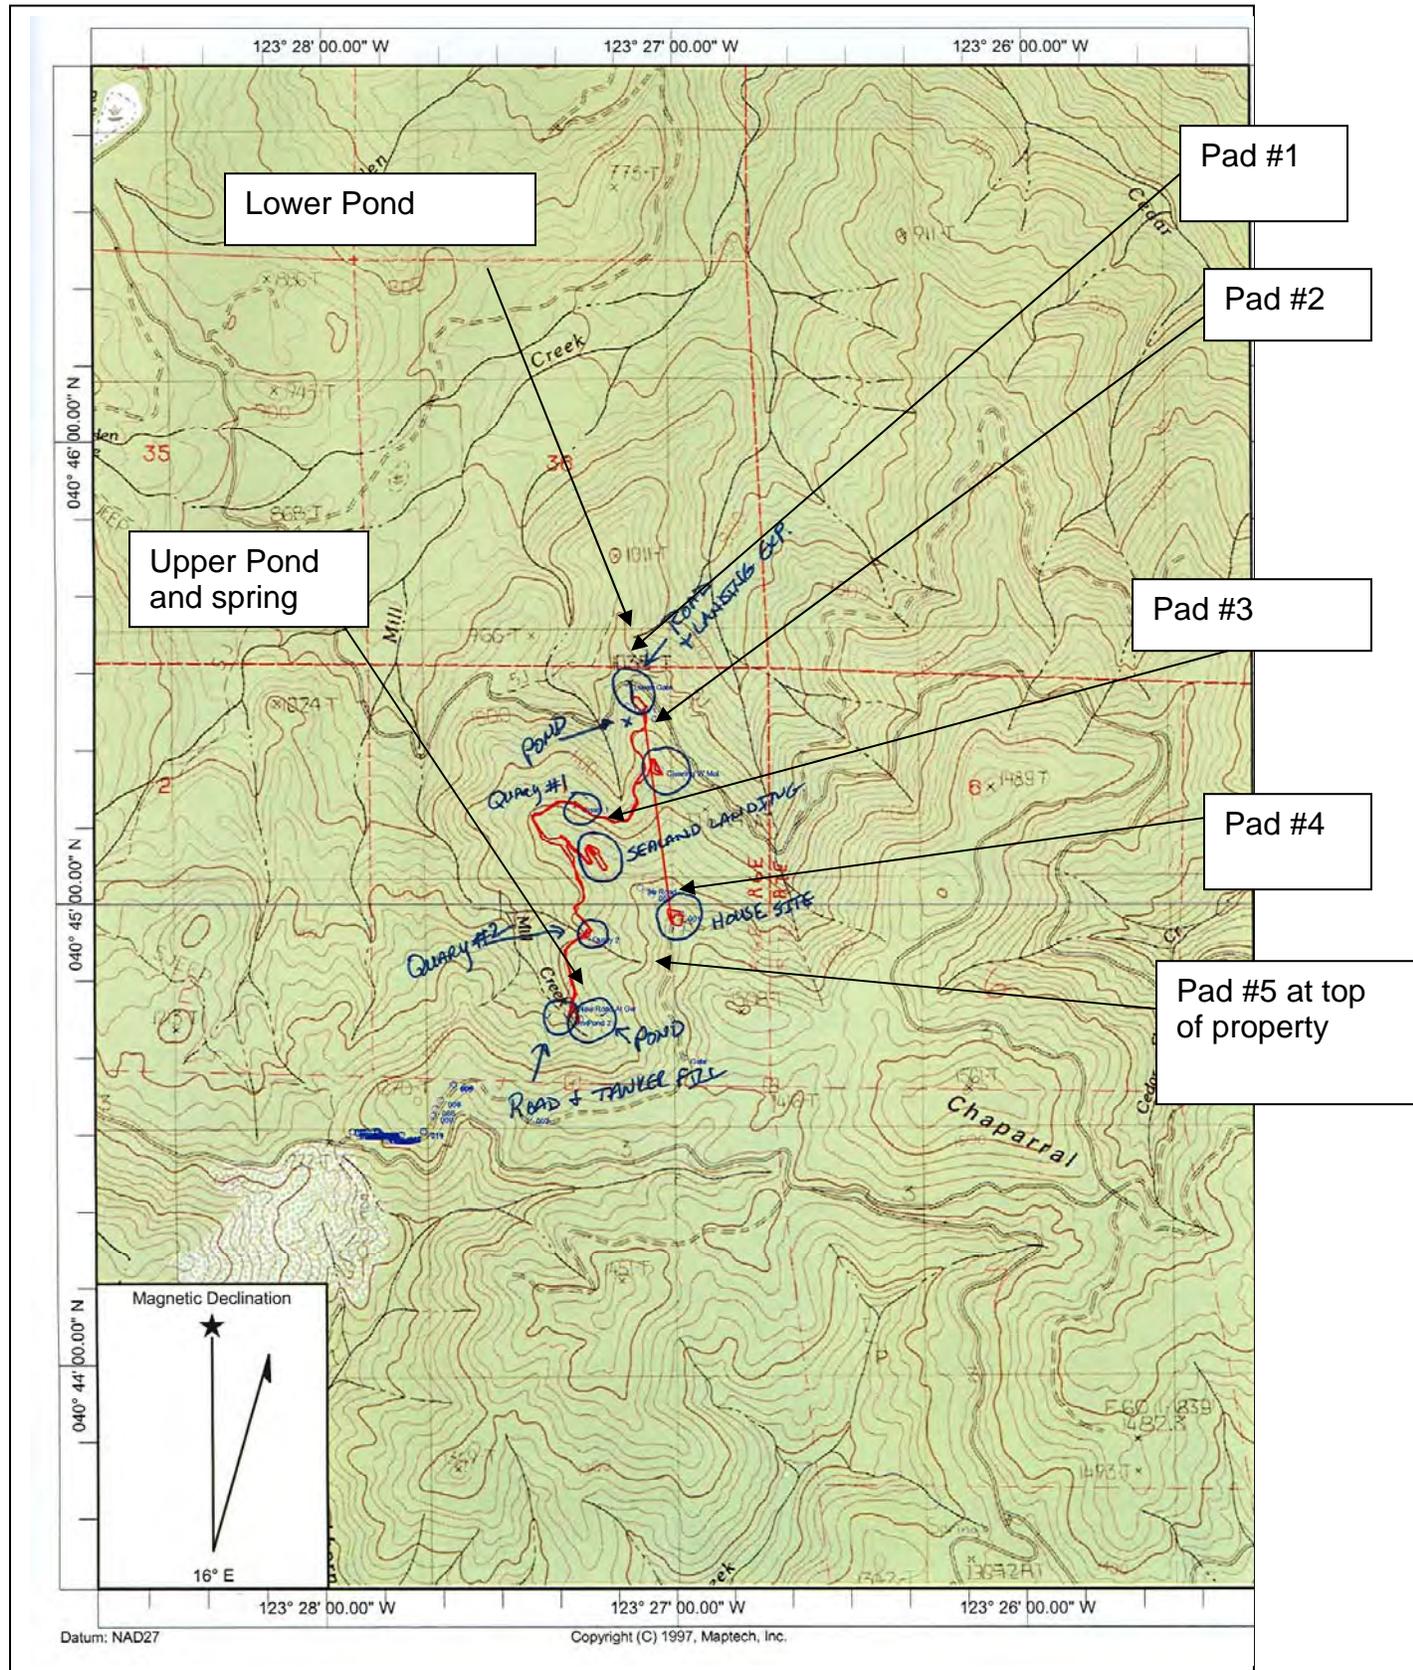
November 3, 2010 Upper pond fill failure down towards Class II stream.

Based on the observations described within this report, the dams should be removed to reduce the potential for sediment delivery and catastrophic failure of earthen fill materials. The areas of excavation should be restored by compacting earthen fill in engineered lifts assuring maximum compaction and shaped to mimic natural surface drainage patterns of dispersed flows. This work should be followed by a full re-planting of native vegetation to ensure soil stabilization and remediation success. It is likely that excess spoils will be generated. Excess spoils should be end hauled to a stable

location where there is no threat of delivery to surface waters, and then compacted and treated with standard erosion control management practices.
