Attachment A: Methodology

This technical analysis provides a summary of factual and analytical evidence that support the findings in Administrative Civil Liability Complaint No. R1-2020-0009 (Complaint) and the recommended assessment of administrative civil liability (ACL) in the amount of **\$6,425,680**. The Complaint alleges that Sonoma Luxury Resort LLC (Discharger) has failed to implement the requirements of State Water Resources Control Board (State Water Board) Order No. 2009-0009-DWQ, as amended by Order No. 2010-0014-DWQ and Order No. 2012-0006-DWQ, National Pollutant Discharge Elimination System (NPDES) General Permit for Storm Water Discharges Associated with Construction and Land Disturbance Activities (Construction General Permit or CGP) while conducting site development and construction work on the Saggio Hills Project, a 258-acre property located at 16840 Healdsburg Avenue, Healdsburg, in Sonoma County (Site). Additionally, the Complaint alleges that the Discharger has failed to meet the conditions of its December 5, 2008 (amended December 6, 2018), Clean Water Act section 401 Water Quality Certification (401 Certification) for work at the Site.

Figure 1. Saggio Hi

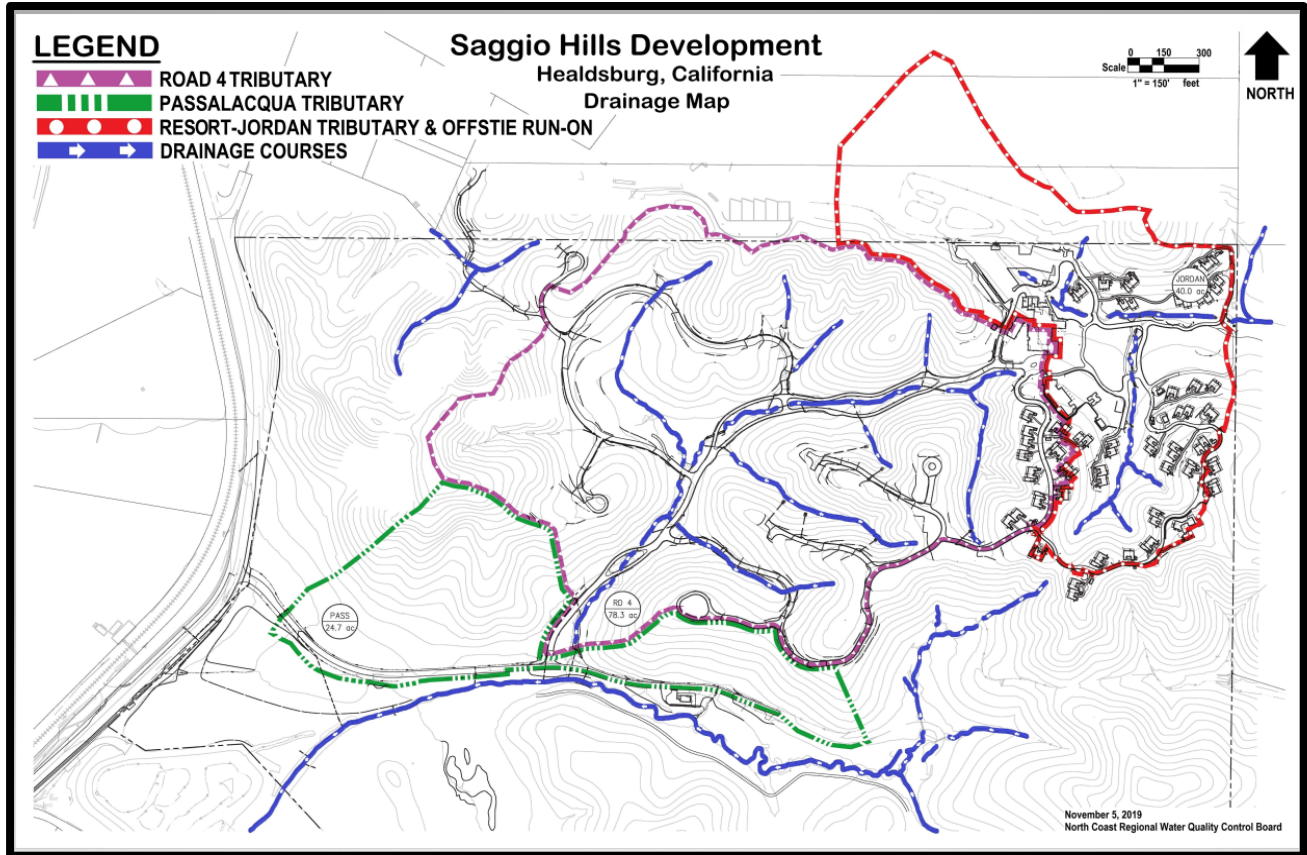
Drainage from the Site flows to Foss Creek, tributaries to Foss Creek, or tributaries to Jordan Pond and Lytton Creek. Both Foss and Lytton Creeks are tributary to the Russian River². Figure 1 shows the portions of the Site comprising each of the three drainage areas:

1. The lower project entrance including staging areas and slopes along Passalacqua Road (Foss Creek) – Portion enclosed in green line marked with intermittent sets of 4 parallel marks, and the portion of project along Healdsburg Avenue;
2. Roads 4, 5, and 8 (tributaries to Foss Creek) – Portion enclosed in purple line marked with triangles; and
3. The Resort Area (tributaries to Jordan Pond and Lytton Creek) – Portion enclosed in red line marked with circles.

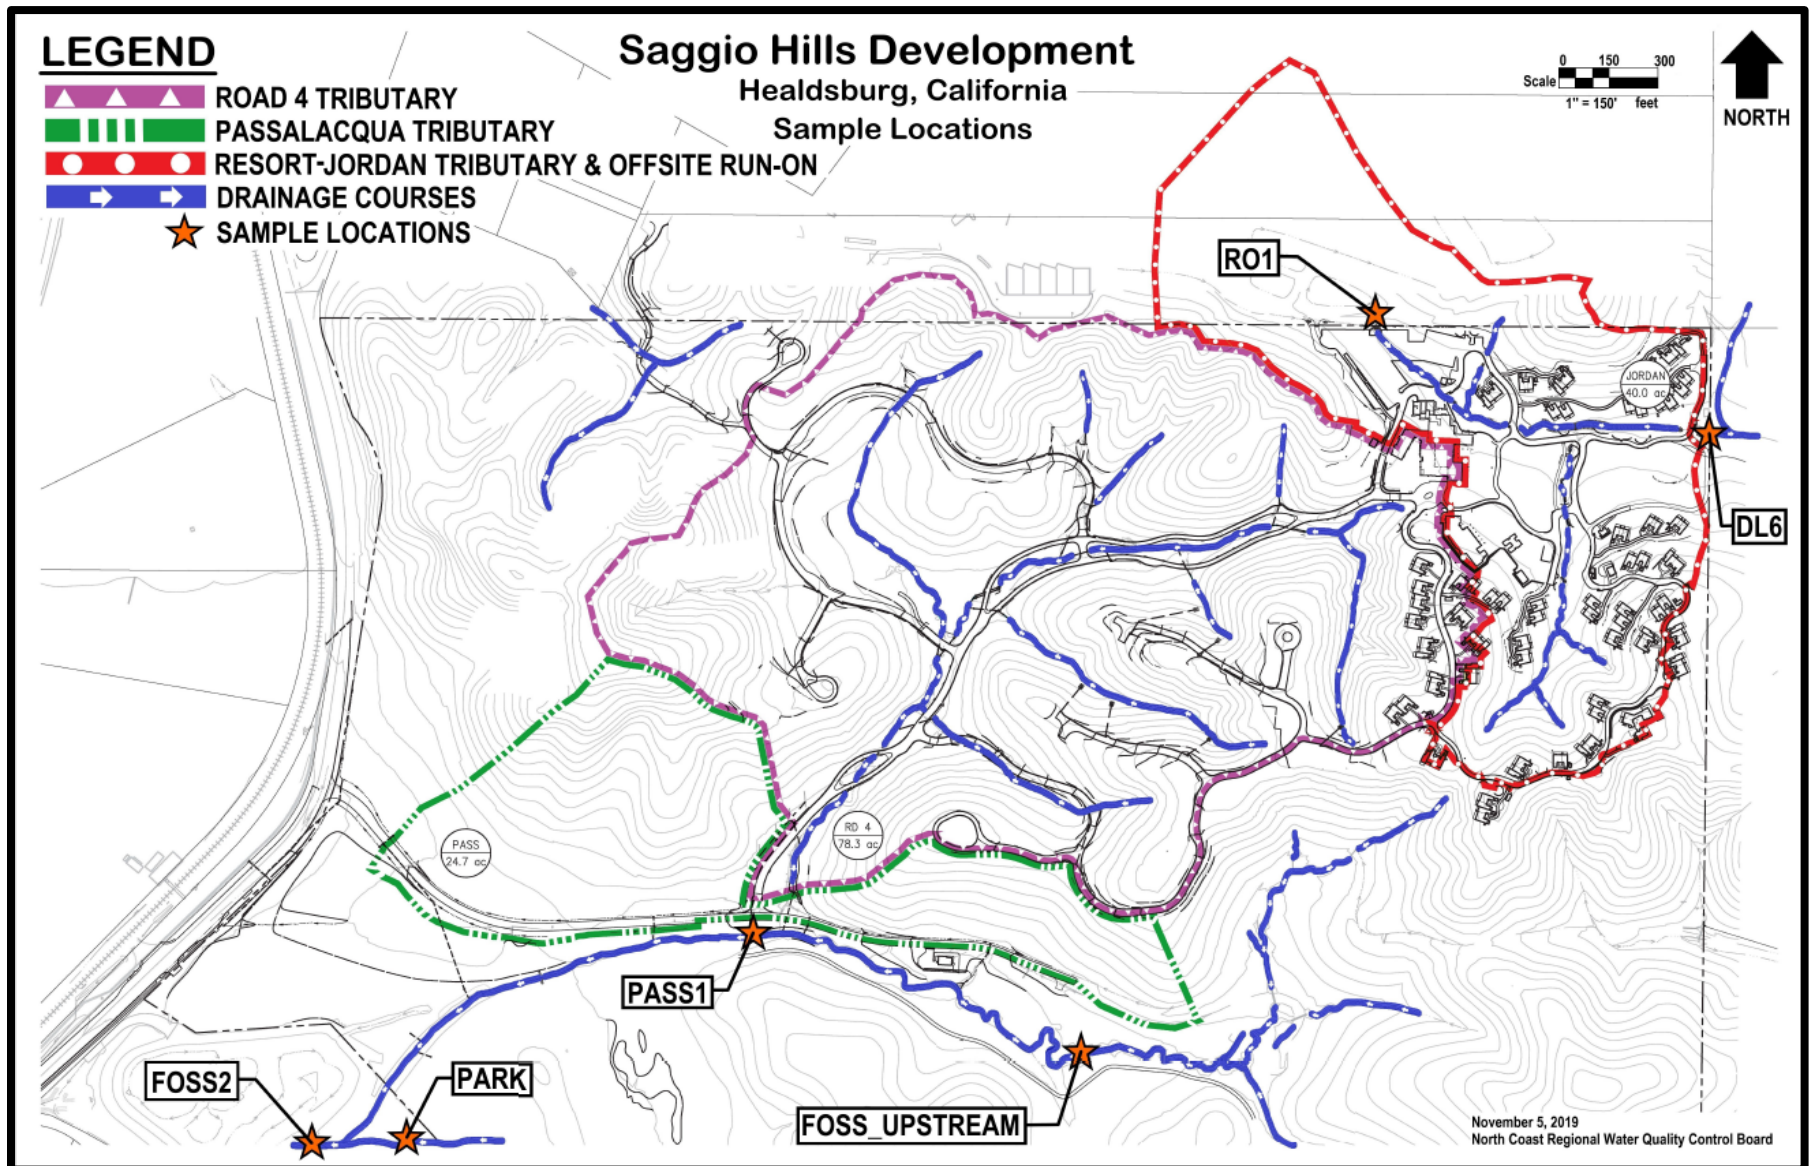
28, 2018. Table 1 and Figure 45-Figure 48 show sampling locations and turbidity results from the receiving water monitoring program. Table 1 presents sampling results that show exceedances of the turbidity objectives on 32 days. Staff collected the November 29, 2018, measurements from different sampling locations; therefore, the results are not included in Table 1 nor Figure 46-Figure 48.

- November 29, 2018: Regional Water Board staff collected downstream (896 NTU) turbidity samples with levels¹⁴ up to 118 percent higher than the upstream¹² (411 NTU) levels measured on this one (1) day.
- December 17, 2018: Exceedances ranging from 44 to 98 percent above the background measurement observed on this one (1) day.
- January 2019: Exceedances ranging from 24 to 2,197 percent above background observed at one or more locations on eight (8) days.
- February 2019: Exceedances ranging from 24 to 528 percent above background observed at one or more locations on ten (10) days.
- March 2019: Exceedances ranging from 20 to 436 percent above background observed at one or more locations on ten (10) days.
- May 2019: Exceedances ranging from 82 to 783 percent above background observed at one or more locations on three (3) days.

Figure 45. Saggio Hills receiving water monitoring program paired sample locations.
