Physical Setting Site SC#1: Soft and Intensively Deformed Franciscan Assemblage Mélange and Sheared Serpentinite terrain (Franciscan mélange); Deep-seated Landslides; 1995 vineyards and roads

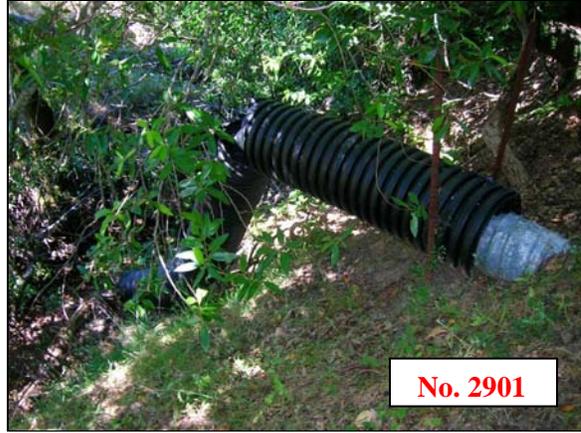
No. 2900

- 6) At another road-repair site, the creek was stabilized with the installment of new drainage pipes, which were built at the creek level, to prevent formation of scour pools (pics. nos. 2900, 2903);

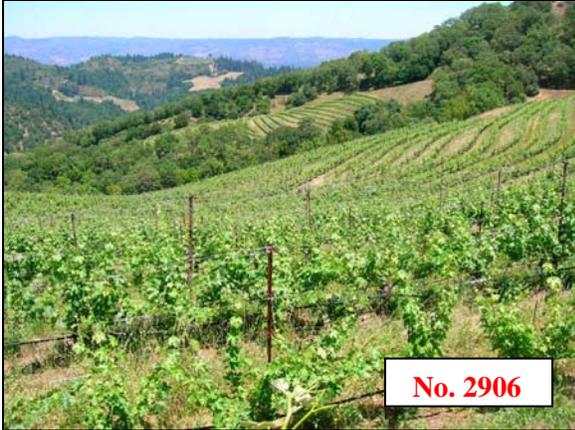
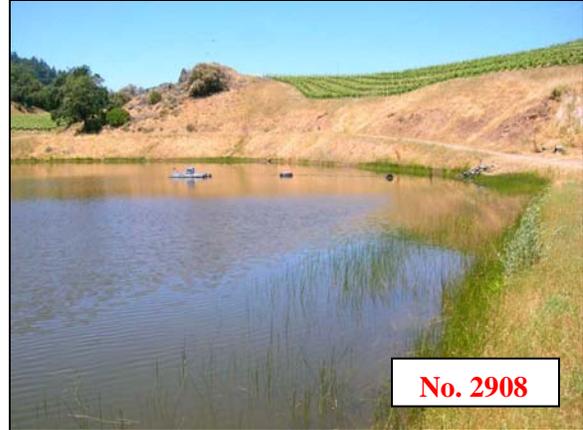
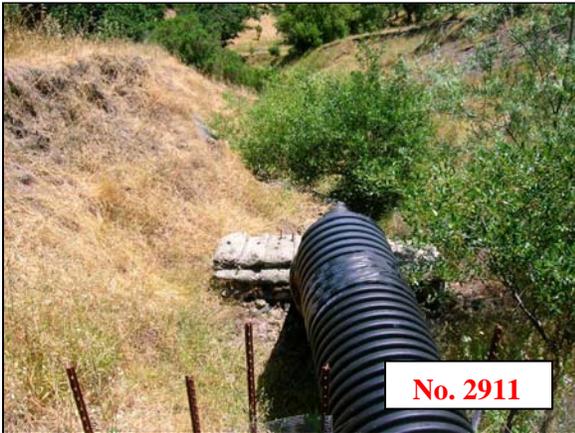
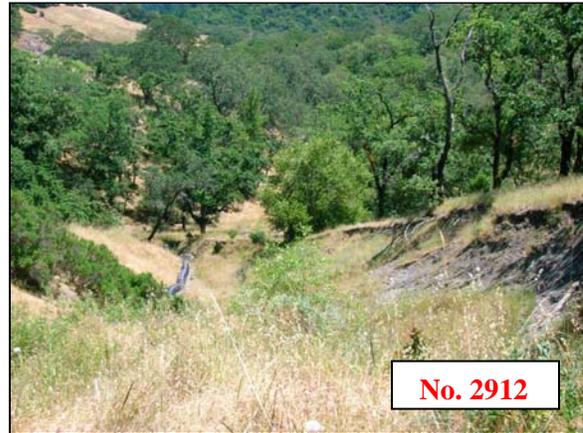
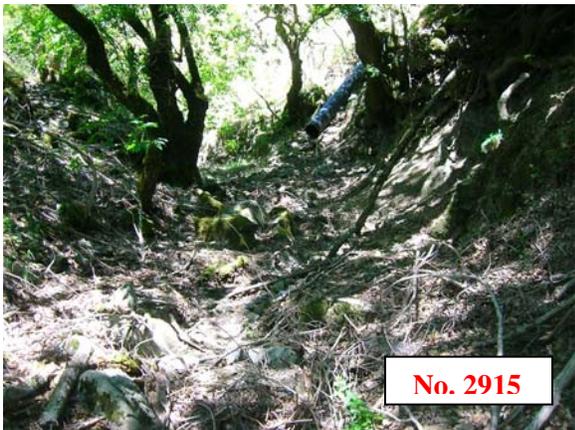
No. 2906

- 2) 95% of the vineyard is in a heavily engineered terrace;
- 3) Most of vineyard acreage (87ac) is replanted;
- 4) One of the blocks is located on a large and active rotational-translational landslide (pic. no. 2906). This landslide has been active since the late 1990s, when the vineyard was built, but it experienced an acceleration in March 2011. As a result, several slumps and cracks formed in the vineyard terraces on the upper slopes of the landslide (in the down-dropped hillside surface or in a fresh scarp) (pics. nos. 2897, 2904), and a large crack developed within the landslide toe (pic. no. 2896). A few trees were toppled due to the slumping of the toe. It is likely that the toe will collapse in less than 2 years, likely delivering 100-200m³ of sediment to the on-site creek. In the event of the re-activation of the entire landslide, an estimated 50,000m³ or more of sediment could be delivered, burying the creek at its toe;

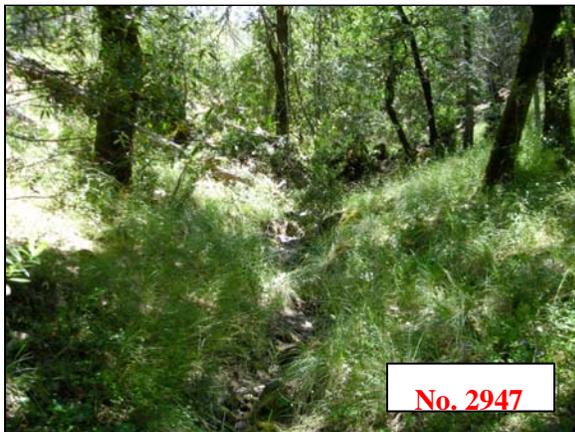
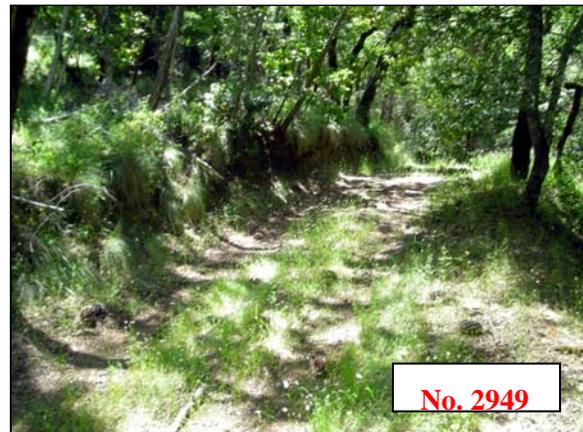
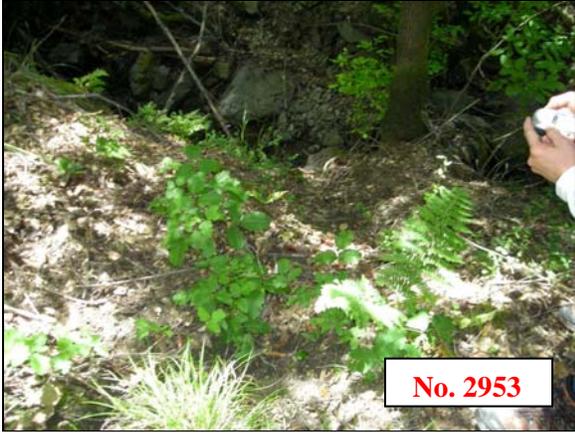
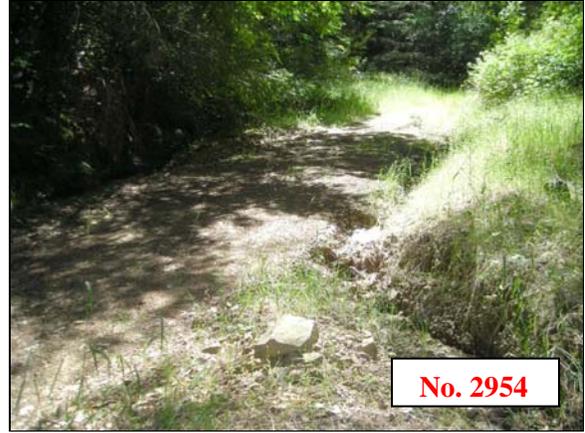
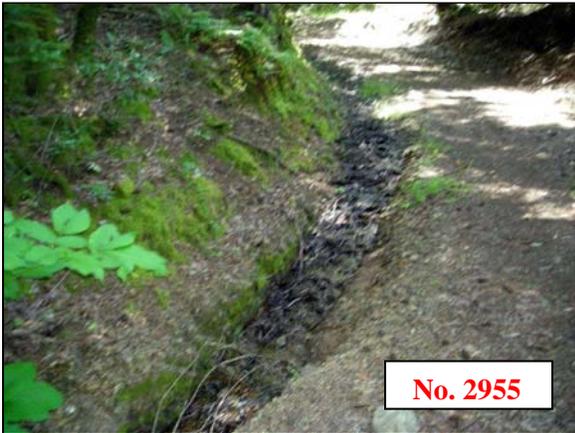
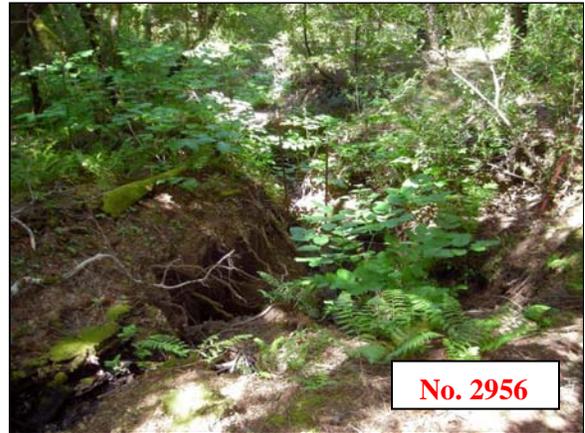
- 1) The property roads experience pervasive instability, namely involving: a) the formation of rills within the road tread (pics. nos. 2949, 2954), b) flow concentration in road ditches (pic. no. 2955), and c) flow concentration downslope of the road-watercourse crossings and formation of hillside gullies (pic. no. 2956);

- 2) The following hillside gullies have been observed downslope of the road-watercourse crossings on the main property road, with a 100% sediment delivery to the nearest watercourse:

- a) Length=50m, Width=0.4m, and Depth=0.2m;
 - b) Length=30m, Width=0.3m, and Depth=0.3m;
 - c) Length=7m, Width=0.7m, and Depth=0.4m;
 - d) Length=70m, Width=2.5m, and Depth=2m;

- and e) Length=500m, Width=1m, and Depth=0.5;
- 3) No evidence of accelerated bank scour was observed, due to the increased delivery of road-related runoff. This is due to the resistant nature of the channel bed (bedrock, boulder, and cobble substrate) (pic. no. 2953);

- 4) No evidence of channel incision was observed, in response to bedload cutoff below the on-site ponds. As above, this is likely due to the presence of coarse substrate in the channel bed (pic. no. 2947).

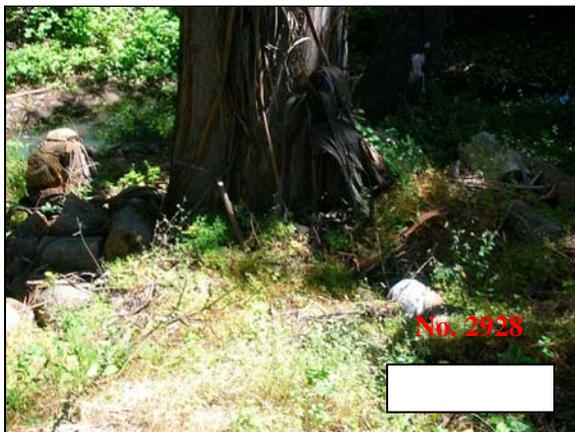
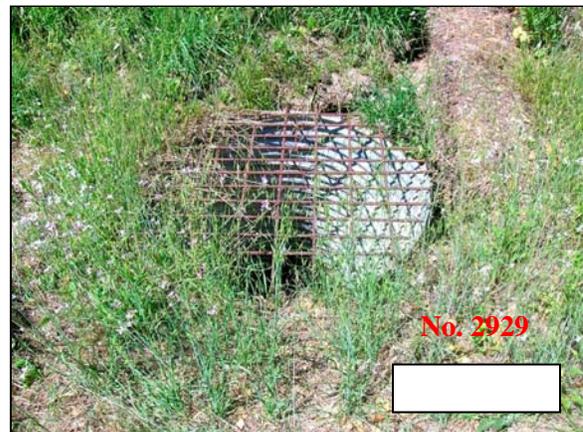
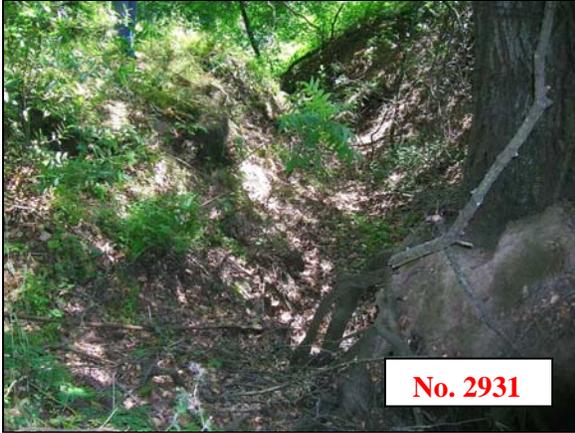
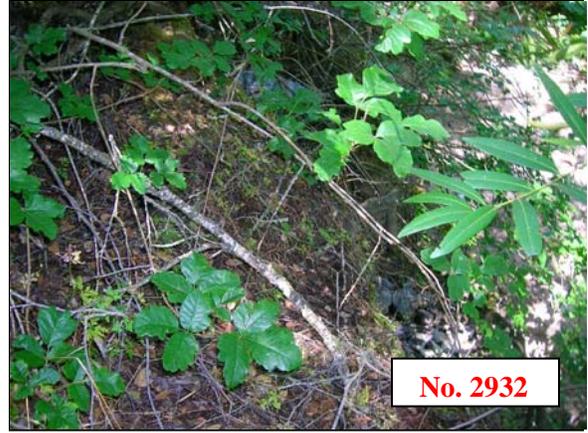
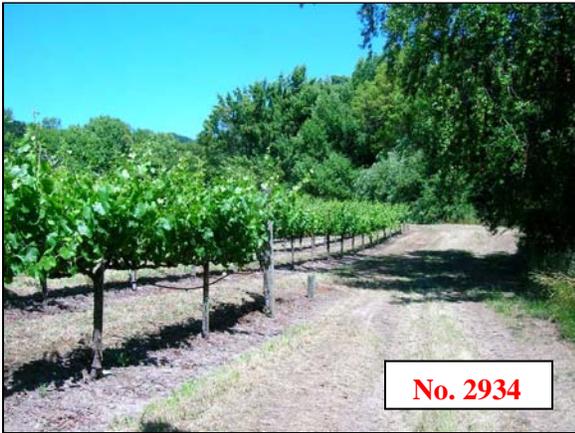
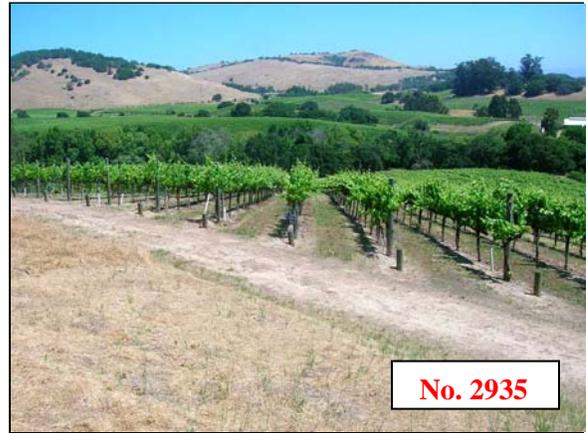
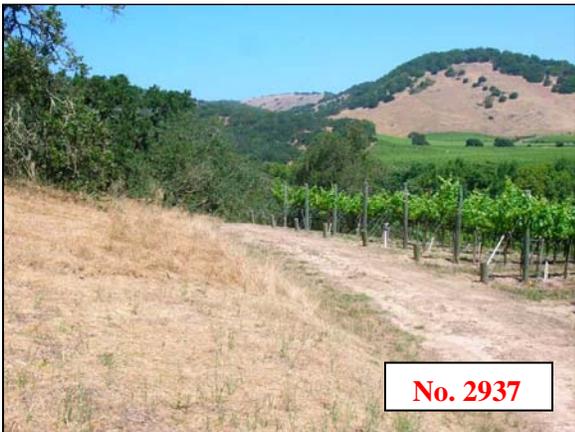
- 1) prior to vineyard development, the property had a long history of livestock grazing.
- 2) All vineyard blocks are drained by subsurface pipes that are routed all the way to the bank (even through the bank) of Huichica Creek (pic. no. 2932);

- 3) The drainage area of the hillside vineyards is about 10ac;
- 4) It appears that the creek has downcut about 0.5-to-1 m since 1990, leaving some of the subsurface drainage pipes ‘hanging.’ As a result, minor bank scour (2m3) has occurred at the base of each pipe location, due to flow scour;

- 5) The banks support recently constructed rock energy dissipators, at the base of the pipe outlets;
- 6) In one case, the drainage-pipe outlet is located by the base of a large tree to which the pipe runoff was designed to discharge (pic. no. 2928). This appears to be a good solution, preventing the scour of the bank;

- 7) In other cases, the drainage-pipe outlets were placed in 1990 within the pre-1990 grazing-related gullies (150m3) (pic. no. 2931). These gullies show no sign of fluvial action due to the pipe runoff under the current conditions, indicating that the hillside vineyard may no longer be producing runoff. It is likely that such cessation of excess hillside runoff is due to the presence of high-density permanent cover crop. Considering that bank scour may be forming locally due to eddy formation related to the pipes, it may be practical to remove the drainage pipes (at replant) which no longer function as originally designed;

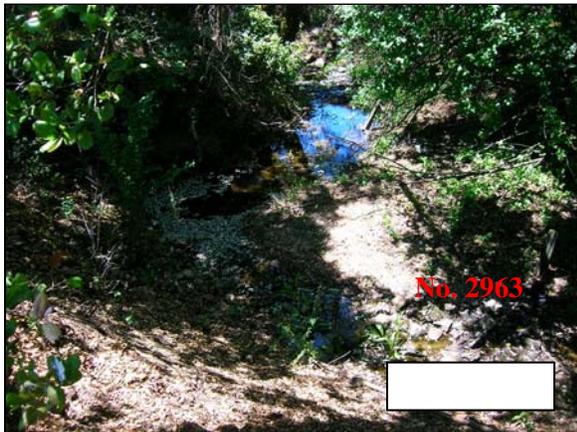
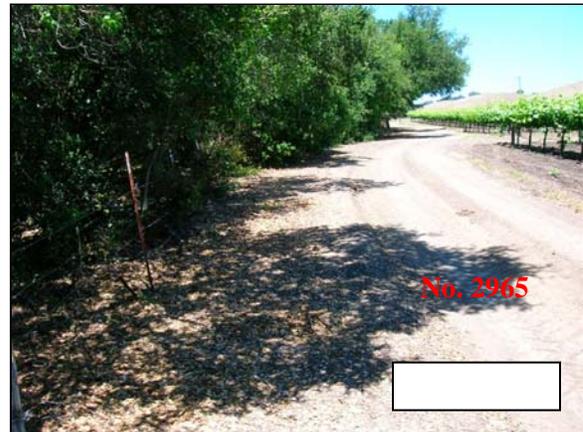
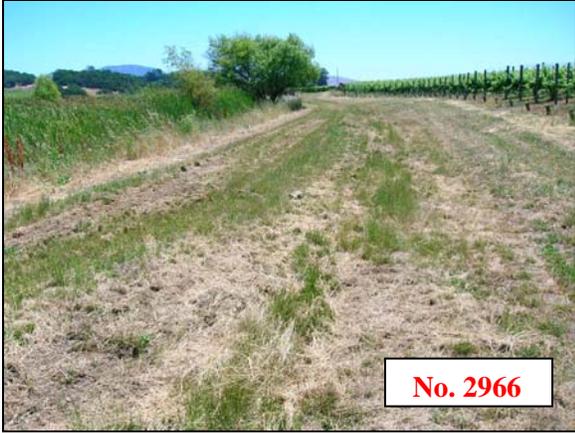
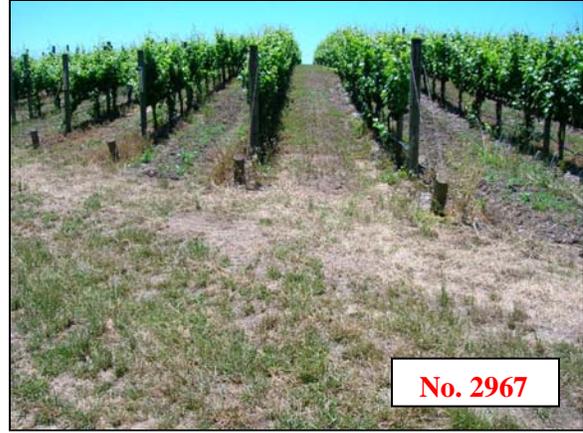
- 3) The drainage pipes are stable (bank scour has been noted at the base of the drainage pipes, but no corresponding hillside erosion);
- 4) The main access road parallels an unnamed creek. It is rock-surfaced, and shows minor signs of erosion (pic. no. 2965);

- 5) The seasonal BMPs (straw wattles, silt fences, etc.) appear to do little to prevent overland flow which forms along the riparian access road from discharging into the watercourse channel. This overland flow was observed to cause bank ravel and delivery (pic. no. 2963), which indicates that a filter strip should be built along the road;
