**AERIAL PHOTOGRAPHIC ANALYSIS
CASMALIA DISPOSAL SITE
CASMALIA, CALIFORNIA**

April 27, 2001

Prepared By: ERI

Contract No. 45791

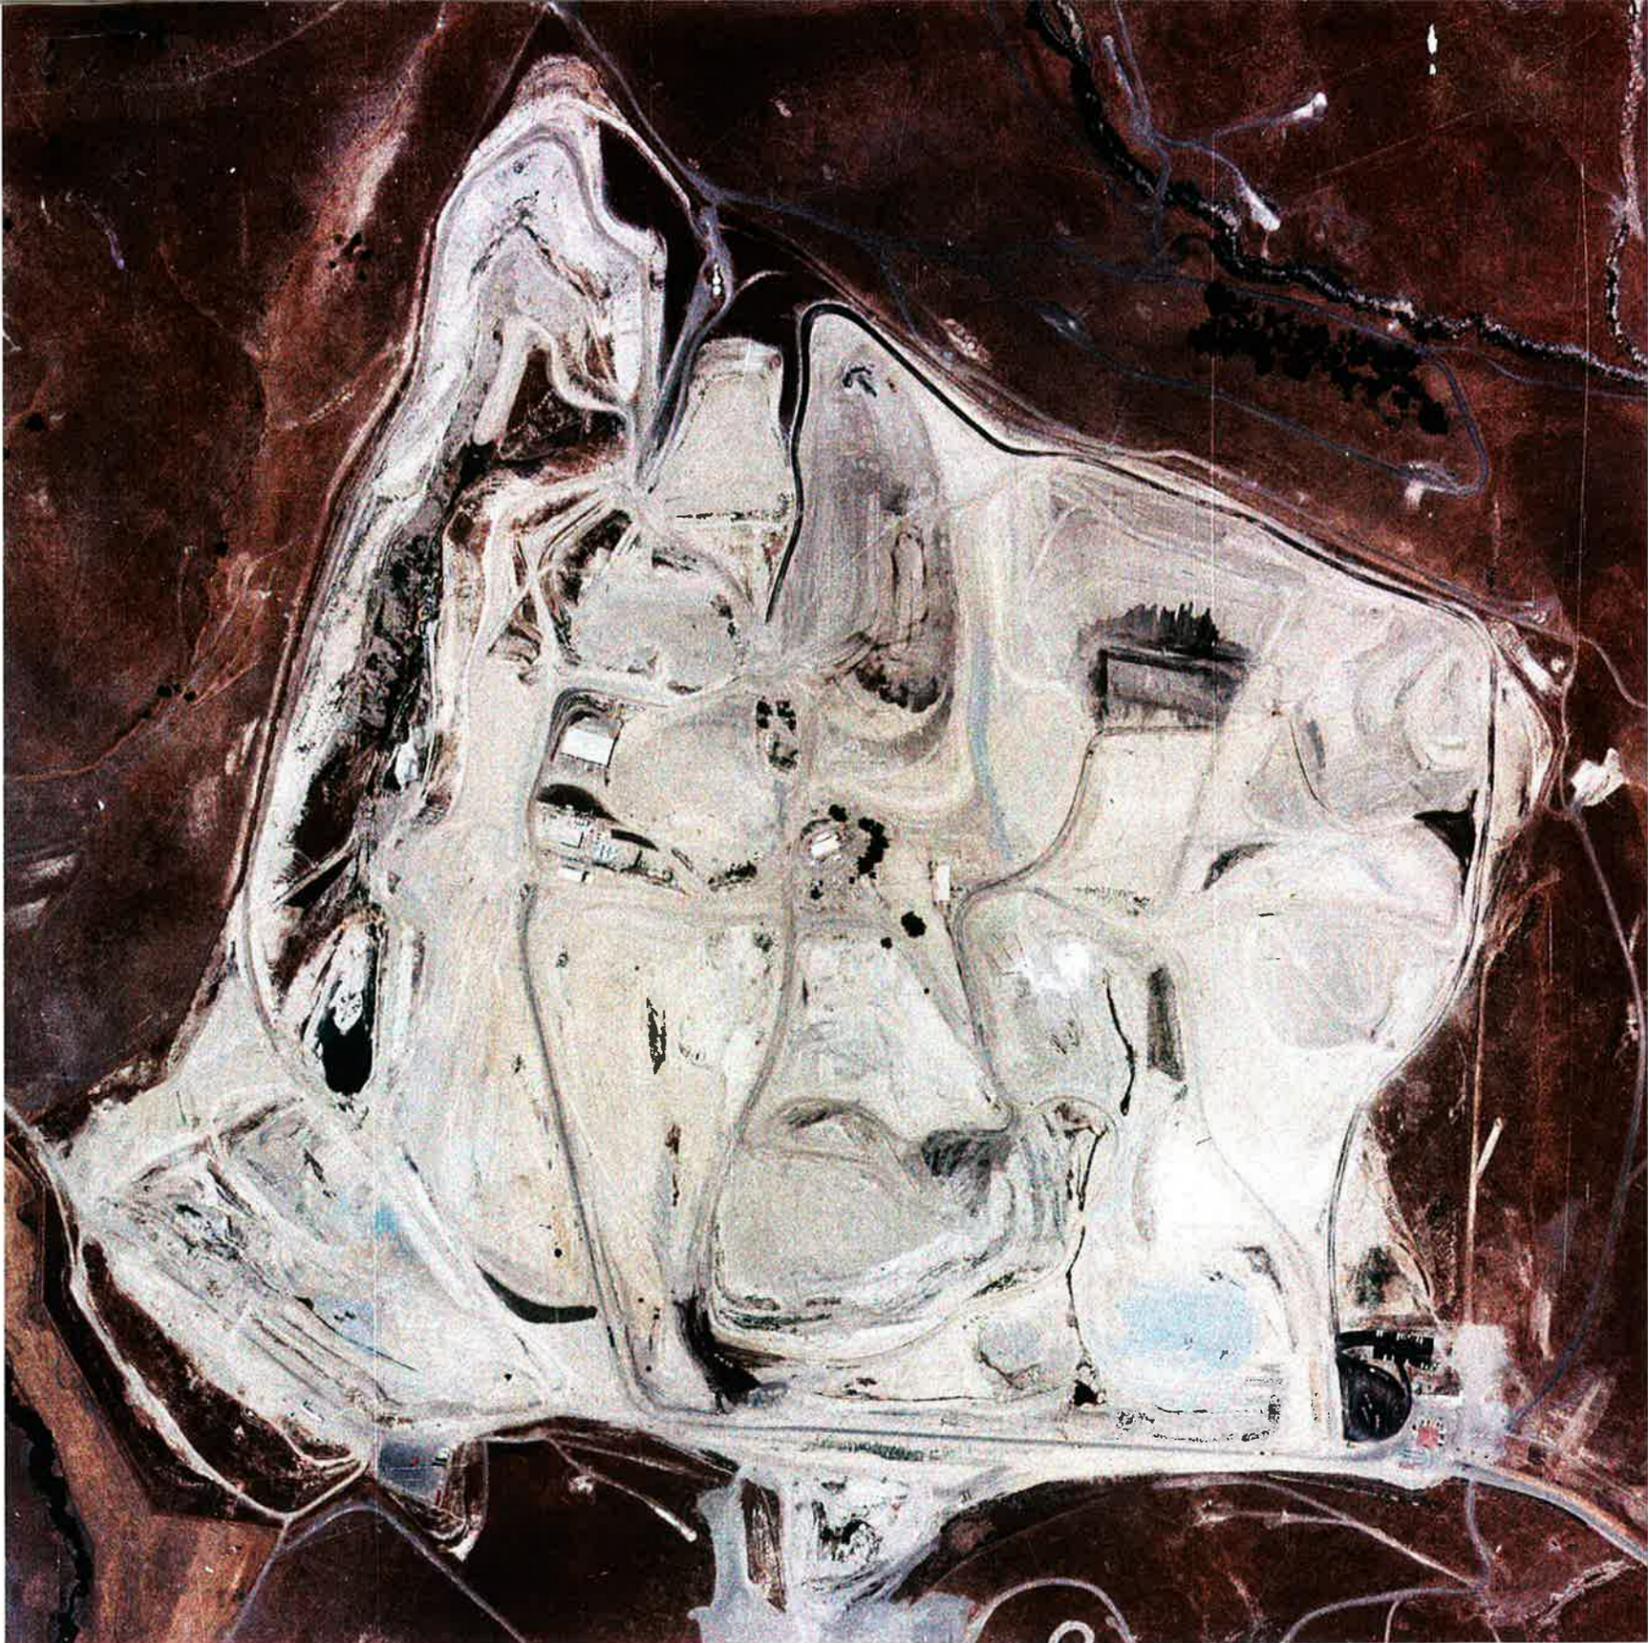
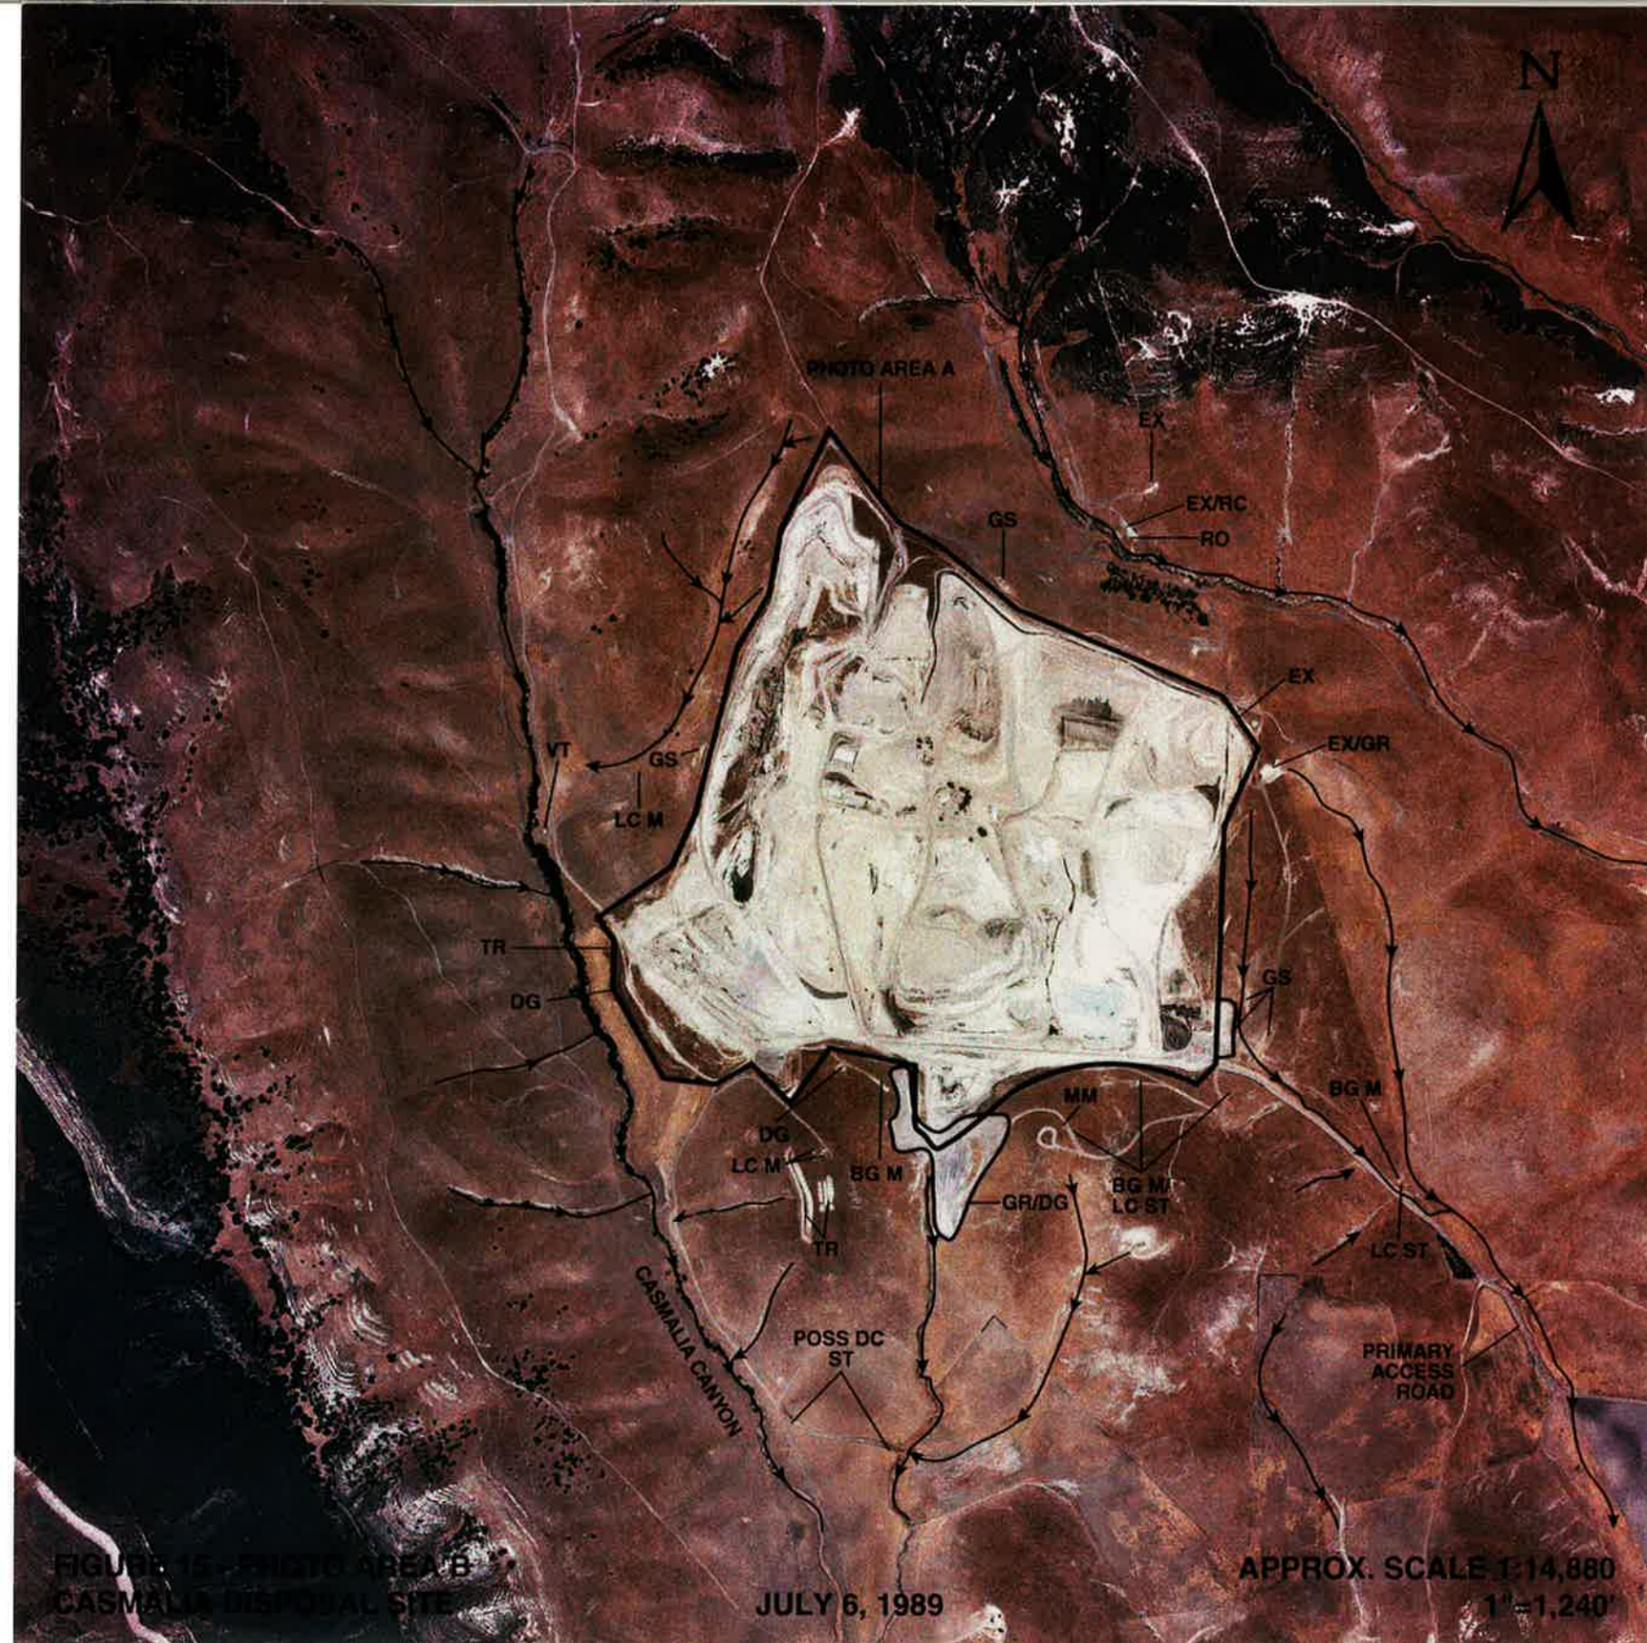
**FIGURE 14 - PHOTO AREA A
CASMALIA DISPOSAL SITE**

Remediation activity is observed throughout the disposal site on this date of photography. An empty trench is visible west of *Pad 1A*. An impoundment containing liquid remains visible east of the *RCRA Canyon*. Four vertical tanks remain visible north of the *PCB Landfill*. West and southwest of *P14*, one building remains visible. Two vertical tanks have been removed and seven have been added near the southernmost building. Six vertical tanks were visible in this location in 1987. A new building is visible east of *PP*, and a new building is visible east of *PR*. Staining is visible on an access road that connects to the primary access road near the southeastern entrance of the site. Staining is visible along most of the access road along the eastern and northern boundaries of the site. An empty excavation is seen north of *SL2*. A ground scar is visible east of the site near *SL1*. One new building has been constructed near *P12*, and two buildings remain.

Annotation	Description
<i>P11</i>	The contents and structure of the pond have been removed. Blue-gray material is visible in the graded material.
<i>P12</i>	<i>P12</i> has been filled. A heavily stained parking area containing three tank trucks and one trailer truck is visible in this location.
<i>P13</i>	The pond contains a small amount of liquid and/or staining.
<i>P14</i>	The contents and structure of the pond have been removed.
<i>P15</i>	The contents and structure of the pond have been removed.
<i>P16</i>	The contents and structure of the pond have been removed.
<i>P17</i>	The contents and structure of the pond have been removed.
<i>P18</i>	The contents and structure of the pond have been removed. A small amount of dark-colored mounded material is seen in the southern portion of the pond.
<i>P19</i>	The contents and structure of the pond have been removed.
<i>P20</i>	Vegetation is seen in the bottom of the pond.

Annotation	Description
<i>PAD 8B</i>	An access road is visible in this area.
<i>PAD 8C</i>	A heavily-stained parking lot is visible in this location.
<i>PAD 9A</i>	<i>Pad 9A</i> is graded.
<i>PAD 9B</i>	Three linear areas of light-colored mounded material are visible. These areas may cover pipes in this location. Light-colored material is visible surrounding the excavation. Objects covered with light-colored material are seen to the east of the excavated area.
<i>PAD 10A</i>	<i>Pad 10A</i> is graded.
<i>PAD 10B</i>	<i>Pad 10B</i> is graded.
<i>PAD 10C</i>	<i>Pad 10C</i> is graded. A small amount of blue-gray material is visible in the graded material. East of <i>Pad 10C</i> , graded dark-colored material is visible on a berm. An earth-moving (EM) vehicle is visible in this location.
<i>PAD 10E</i>	<i>Pad 10E</i> is graded.
<i>PAD 10F</i>	<i>Pad 10F</i> is graded. A small amount of blue-gray material is visible in the graded area.

Annotation	Description
<i>PESTICIDES/ SOLVENTS LF</i>	Probable drums are visible in the central portion of the landfill. An excavation is visible in the northern portion of the landfill. Two trailer trucks and two other vehicles are seen in this location. Liquid or staining is visible at the rear of one of the trucks and extends into the excavation. Multi-colored mounded material is visible in the southern portion of the fill area.
<i>HEAVY METALS LF</i>	The landfill has been graded with dark-colored material. Two graders, currently in operation, and a vehicle are visible on the surface of the landfill.
<i>CAUSTIC/ CYANIDE LF</i>	The surface of the landfill is graded.
<i>ACIDS LF</i>	The surface of the landfill is graded.

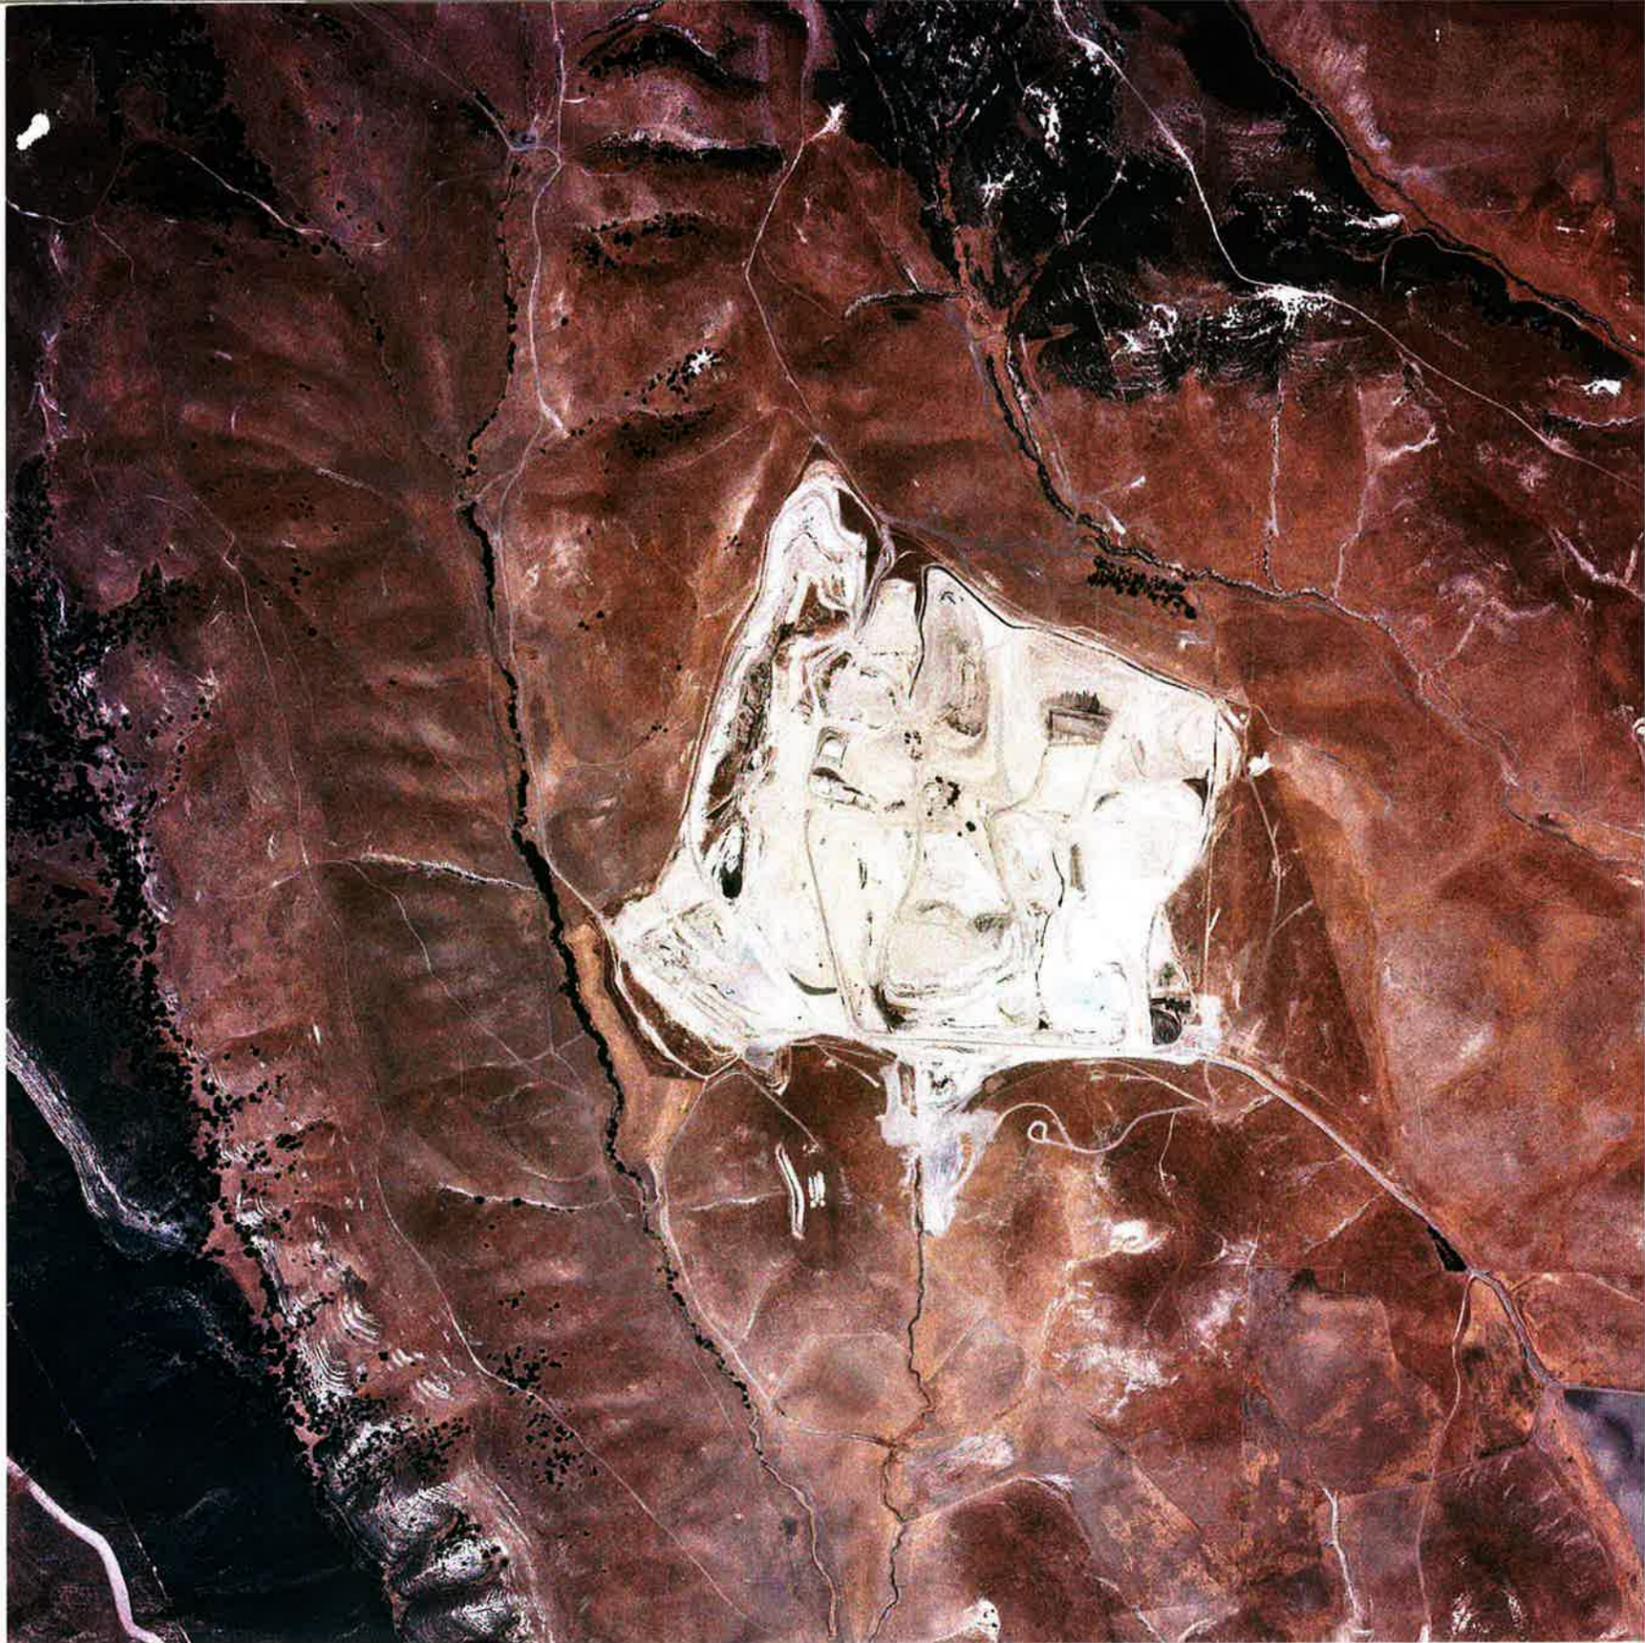
**FIGURE 15 - PHOTO AREA B
CASMALIA DISPOSAL SITE**

West of the disposal site, a trench, disturbed ground, light-colored material, and a ground scar are visible. Northeast of the disposal site, a ground scar, an excavation, and an excavation or road cut (RC) are visible. An erosion scar from liquid runoff (RO) extends south from the road cut. East of the disposal site, an excavation and an excavation and graded area are seen. Continued activity in the vicinity of the ground scars, seen east of the disposal site on the 1987 photography, has resulted in additional ground scars. Blue-gray (BG) material and light-colored staining are visible southeast of the disposal site. A graded area with disturbed ground extends from the southern portion of the disposal site into Photo Area B. Blue-gray material, light-colored staining, mounded material, disturbed ground, light-colored material, and two trenches are visible south of the disposal site. Possible dark-colored staining is visible on a road south of the disposal site.
