CLEANUP AND ABATEMENT ORDER R5-2013-0703, TRINITAS ALMOND PARTNERS II, L.P., STANISLAUS COUNTY

CLEANUP AND ABATEMENT ORDER NO.R5-2013-0703

FOR
TRINITAS ALMOND PARTNERS II, L.P.
STANISLAUS COUNTY

INSPECTION REPORT

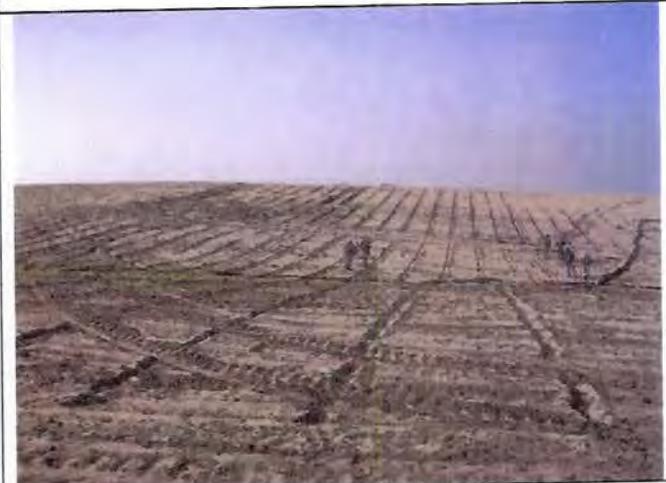
Photo 4: Plateau area in location B in Figure B.

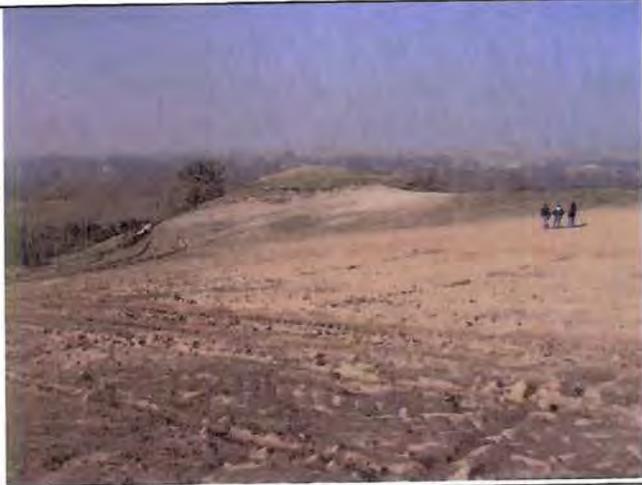
Photo 9: Looking north, the plateau area at location C in Figure B.

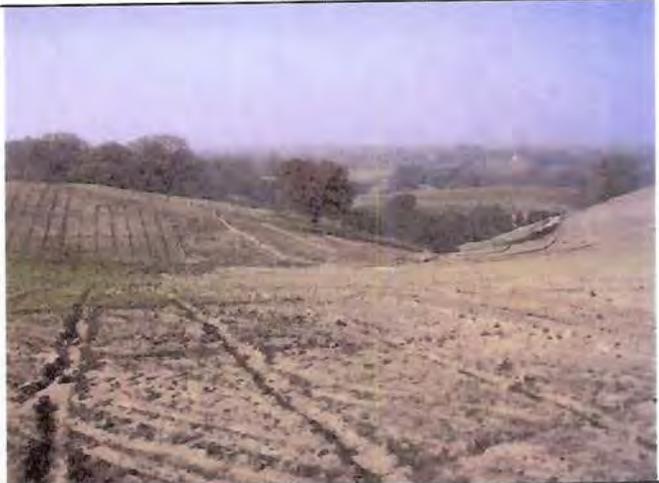
Photo 10: The plateau area funnels to the drainage course.

Location C – There was extensive modification compared to the December 11th inspection. As with the other site (Location A), channels have been installed across the flow gradient to help catch sediments and slow the surface runoff velocity. There were numerous signs of erosion, although not as extensive as in Location B. Some erosion of the channel berms was observed (See Photo 10).

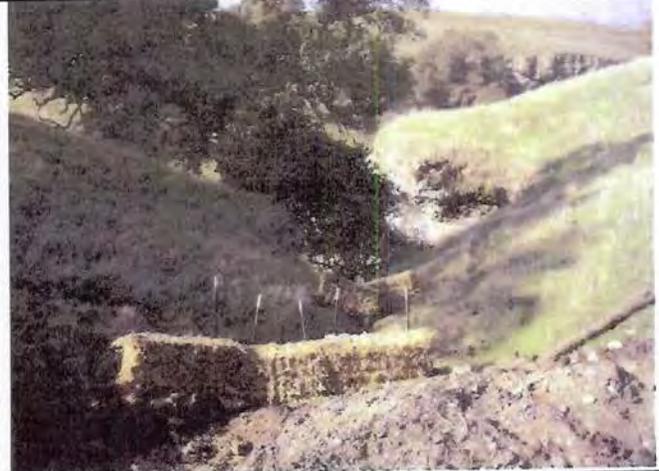
Photo 12: Close-up of some of the straw bales.

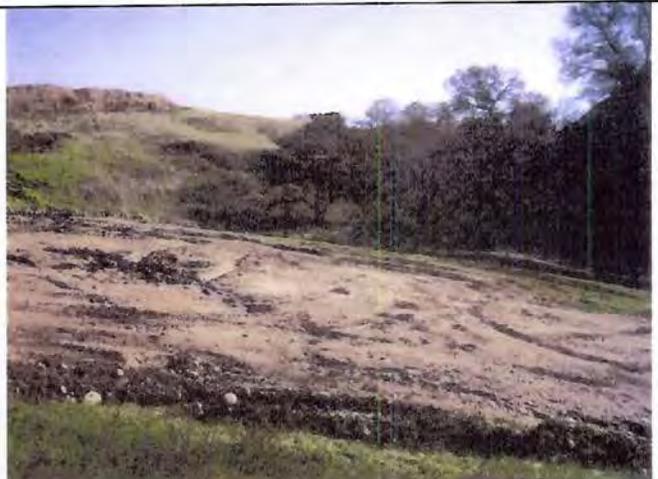
Photo 14: Looking south from the bottom of the west side drainage just prior to the site shown in Photo 16.

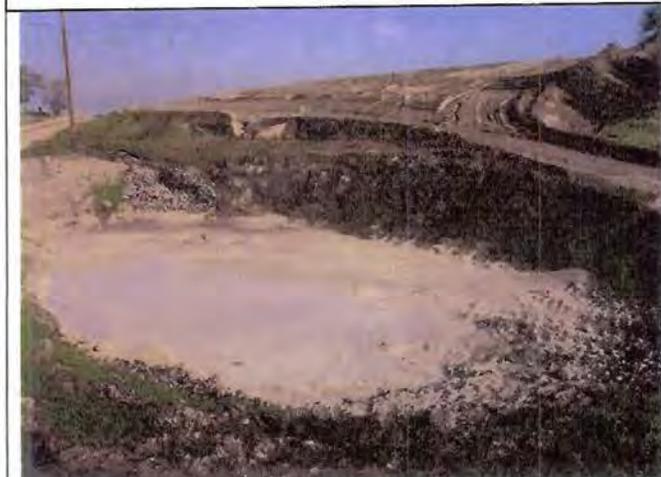
Photo 15: Sediment pond on the northwest corner of the project area. The pond collects runoff from a small portion of graded land some of which is seen in the upper right of the photo.

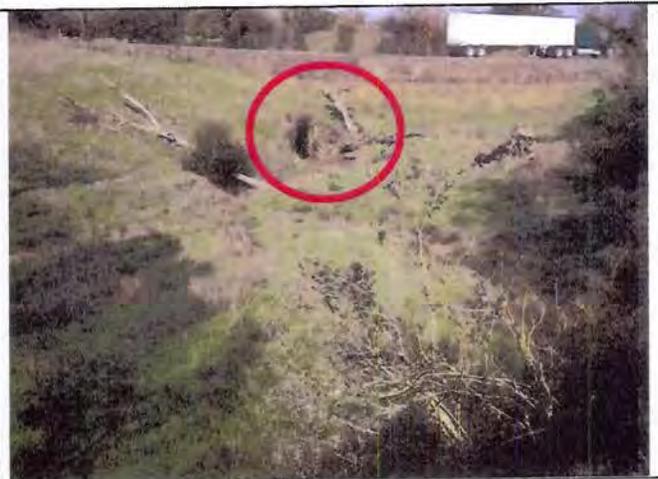
Photo 16: Looking north at the location where the western drainage flows under Hwy 108/120 via the "tunnel" highlighted by the circle.

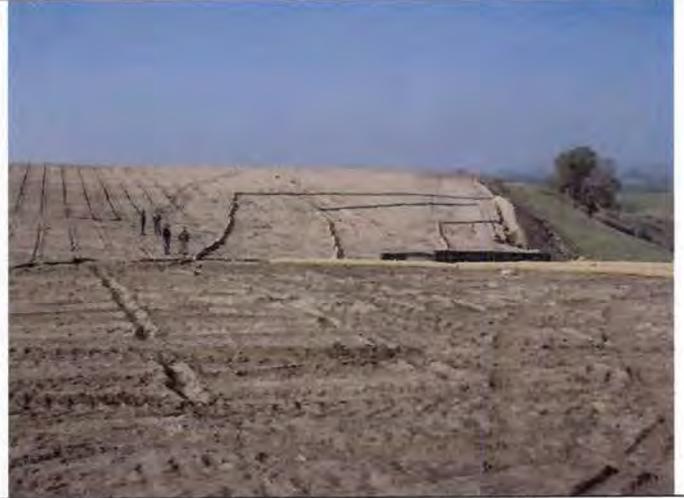
Photo 2: December 11, 2012 – Location B, Figure A
Looking north at the location of Photo 1.

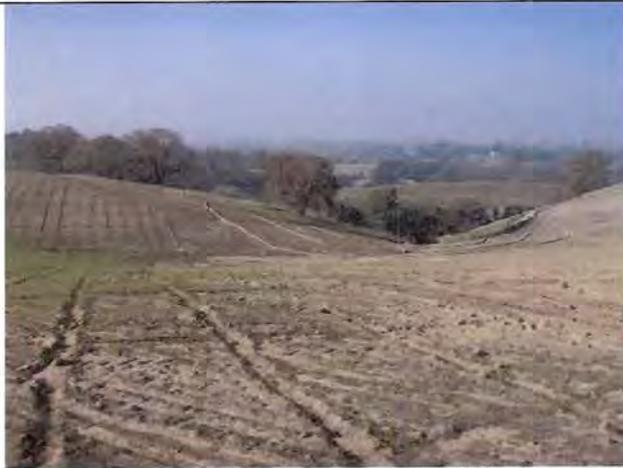
Photo 8: December 11, 2012 – Location C, Figure A
Looking north. A series of straw waddles can be seen mid-right in the photo.

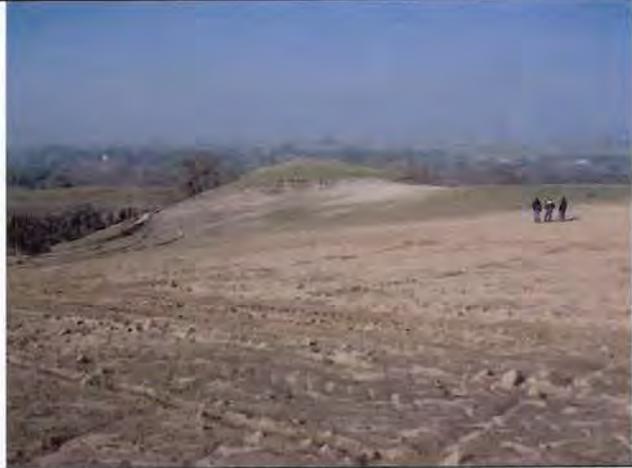
Photo 9: December 11, 2012 – Location C, Figure A
Looking northwest at the same location as Photo 8.

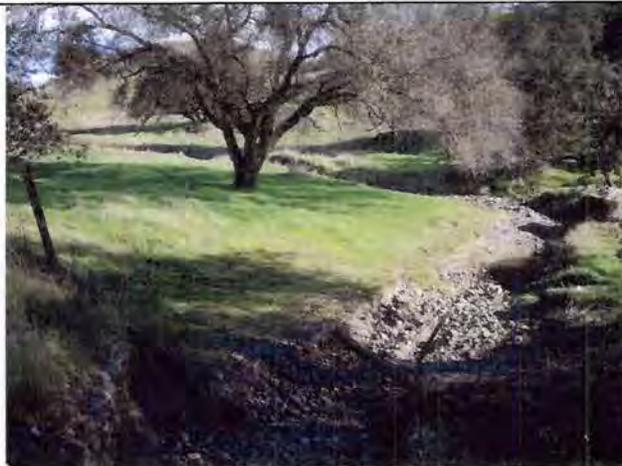
Photo 13: January 10, 2013 – Location A, Figure A
Looking upstream Blitz Creek from Hwy 108.

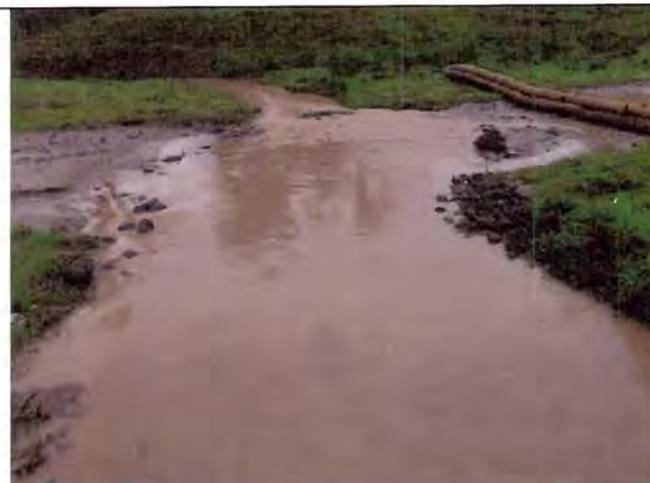
Photo 18: Photo submitted by DFG of the Jan 6, 2013 discharge.
 Looking at the drainage on the west side of the project area.

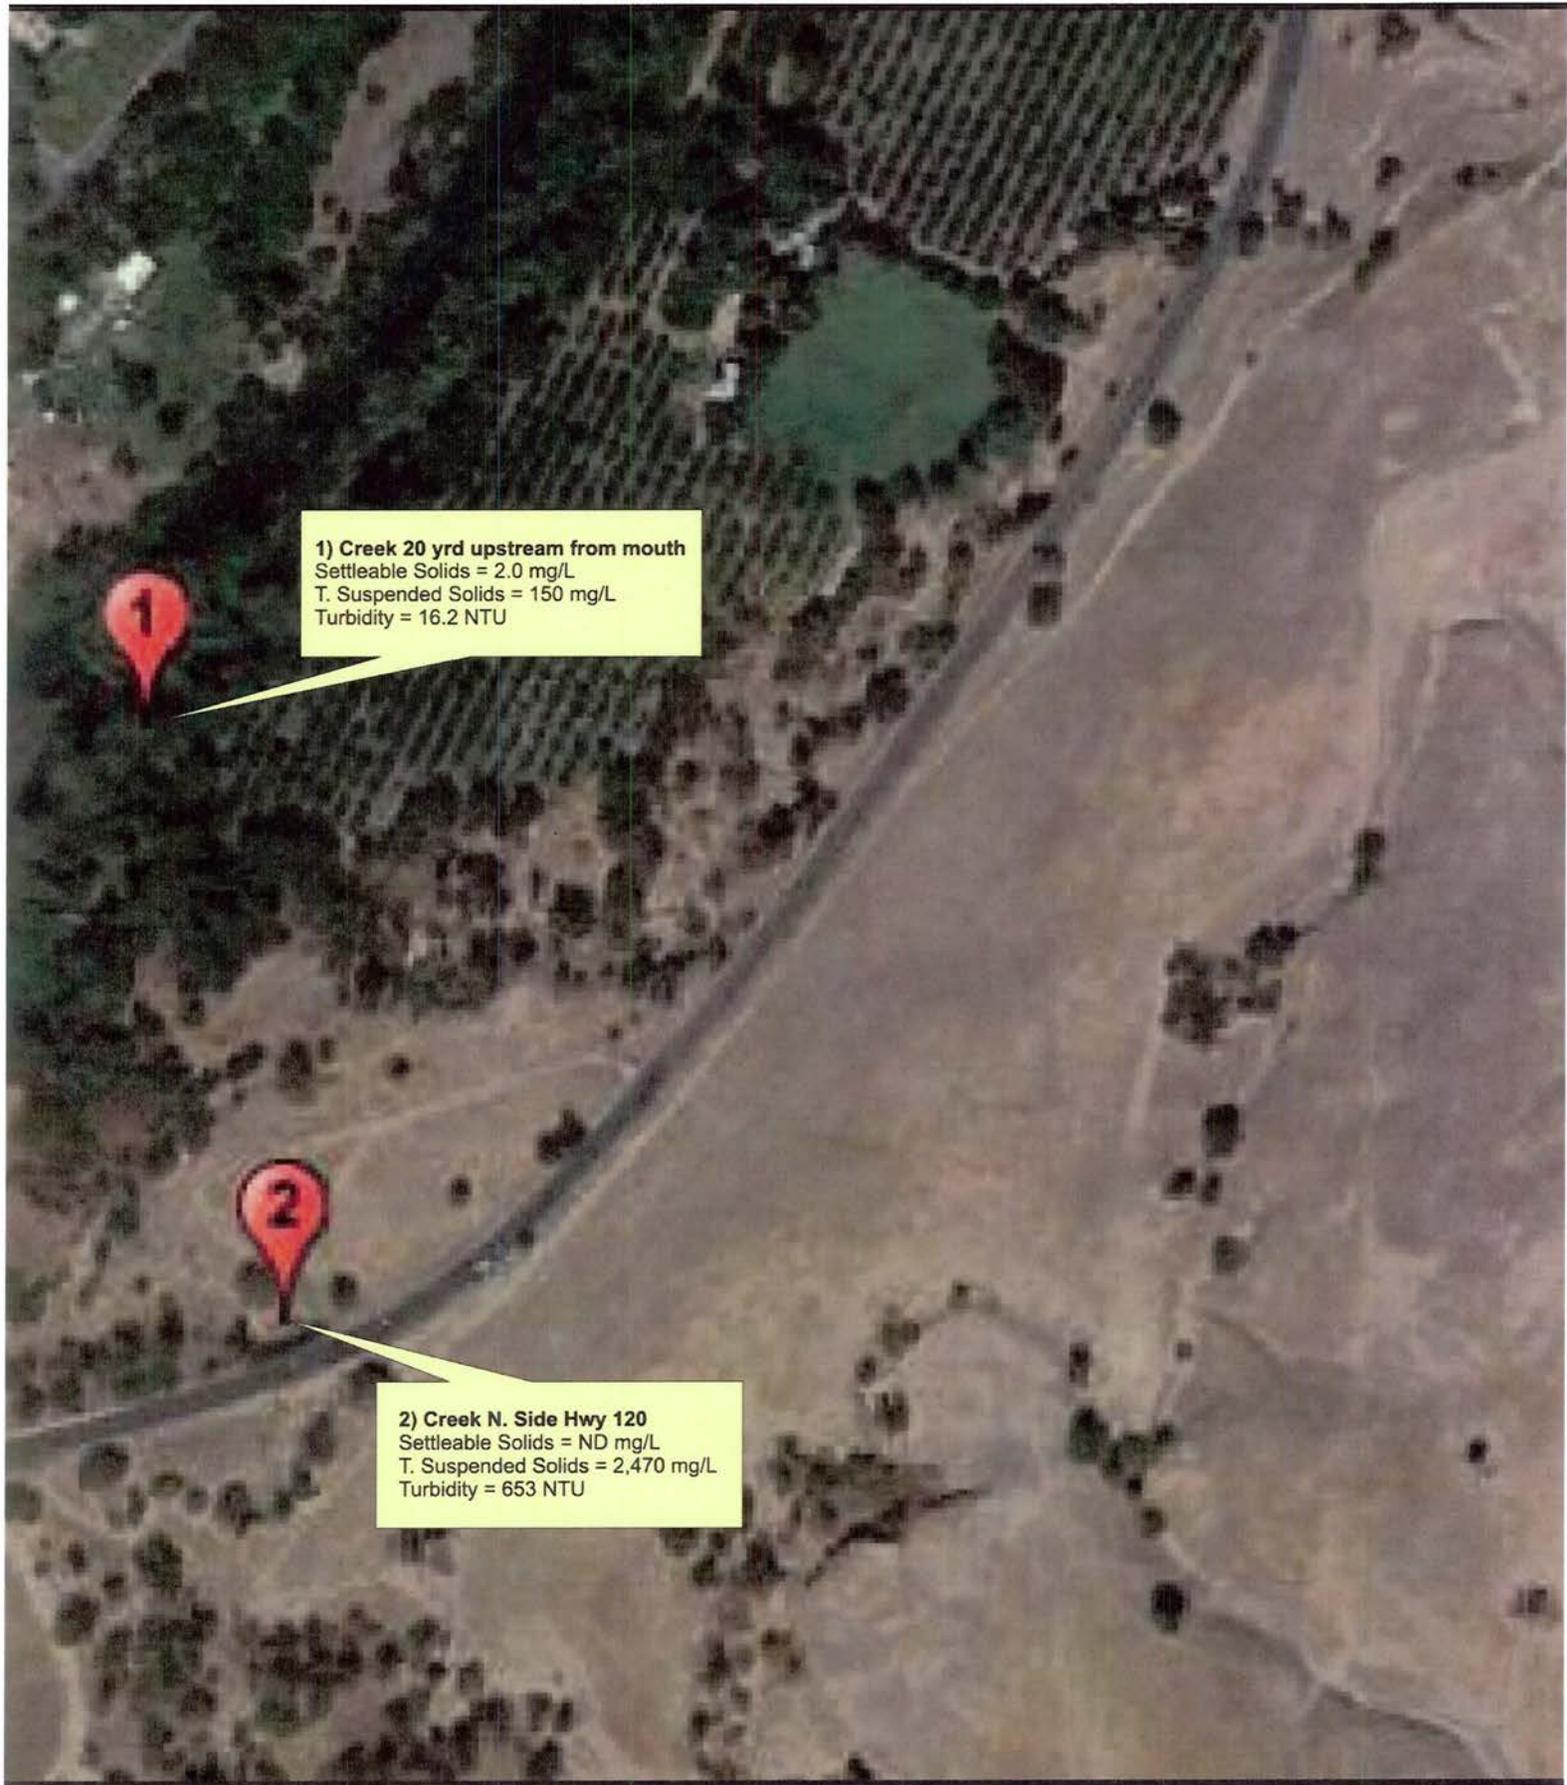
December 2, 2012
DFG Discharge Investigation
Water Sample Map

1) Creek 20 yrd upstream from mouth
Settleable Solids = 2.0 mg/L
T. Suspended Solids = 150 mg/L
Turbidity = 16.2 NTU

2) Creek N. Side Hwy 120
Settleable Solids = ND mg/L
T. Suspended Solids = 2,470 mg/L
Turbidity = 653 NTU

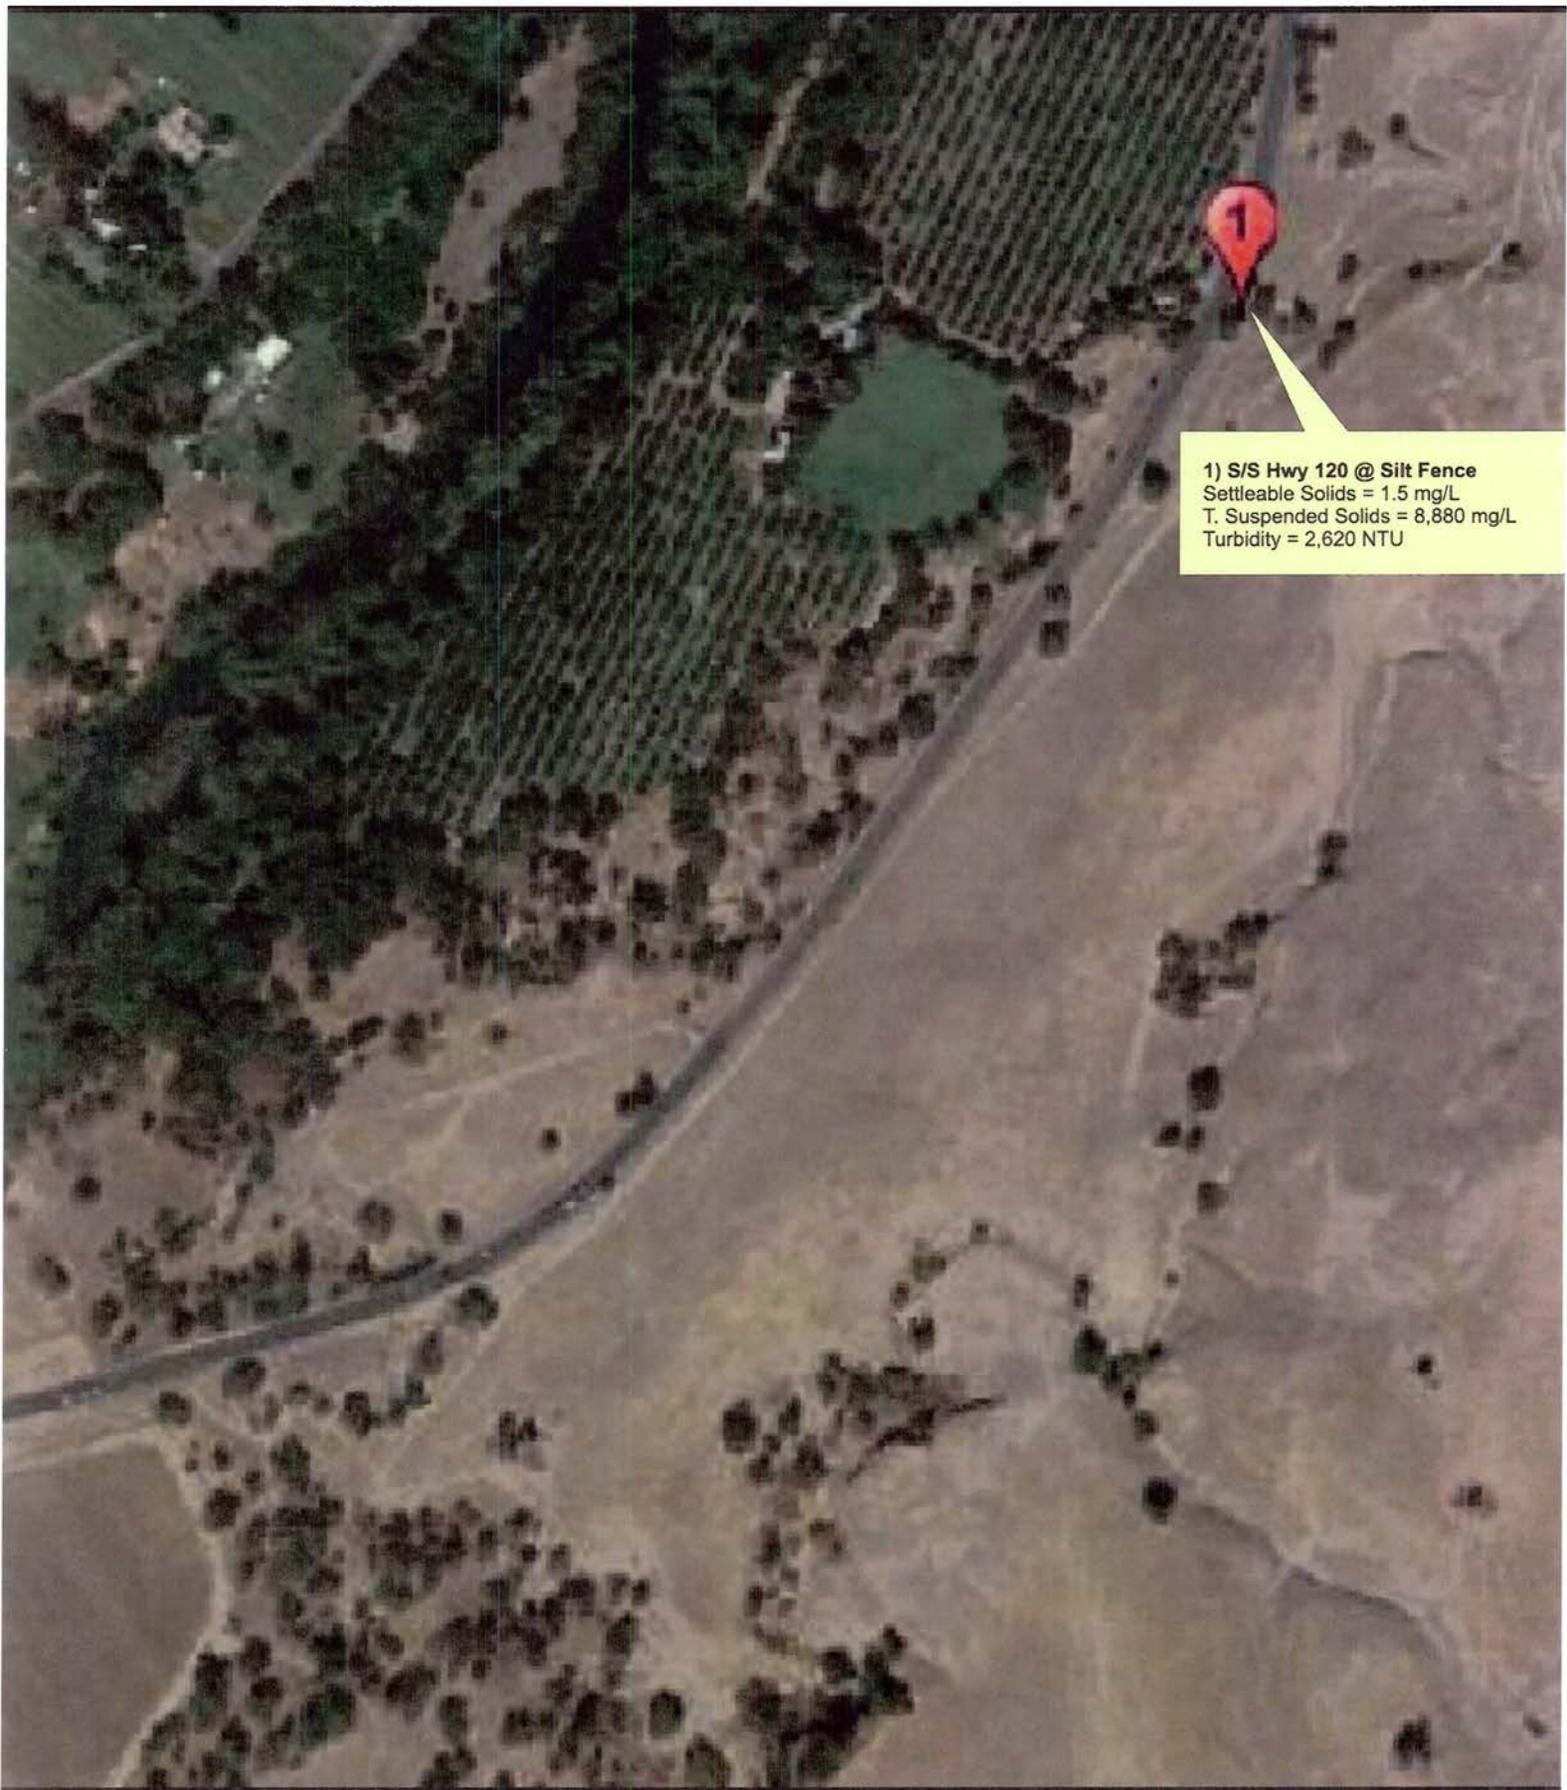
December 5, 2012
DFG Discharge Invest
Water Sample Map

1) S/S Hwy 120 @ Silt Fence
Settleable Solids = 1.5 mg/L
T. Suspended Solids = 8,880 mg/L
Turbidity = 2,620 NTU

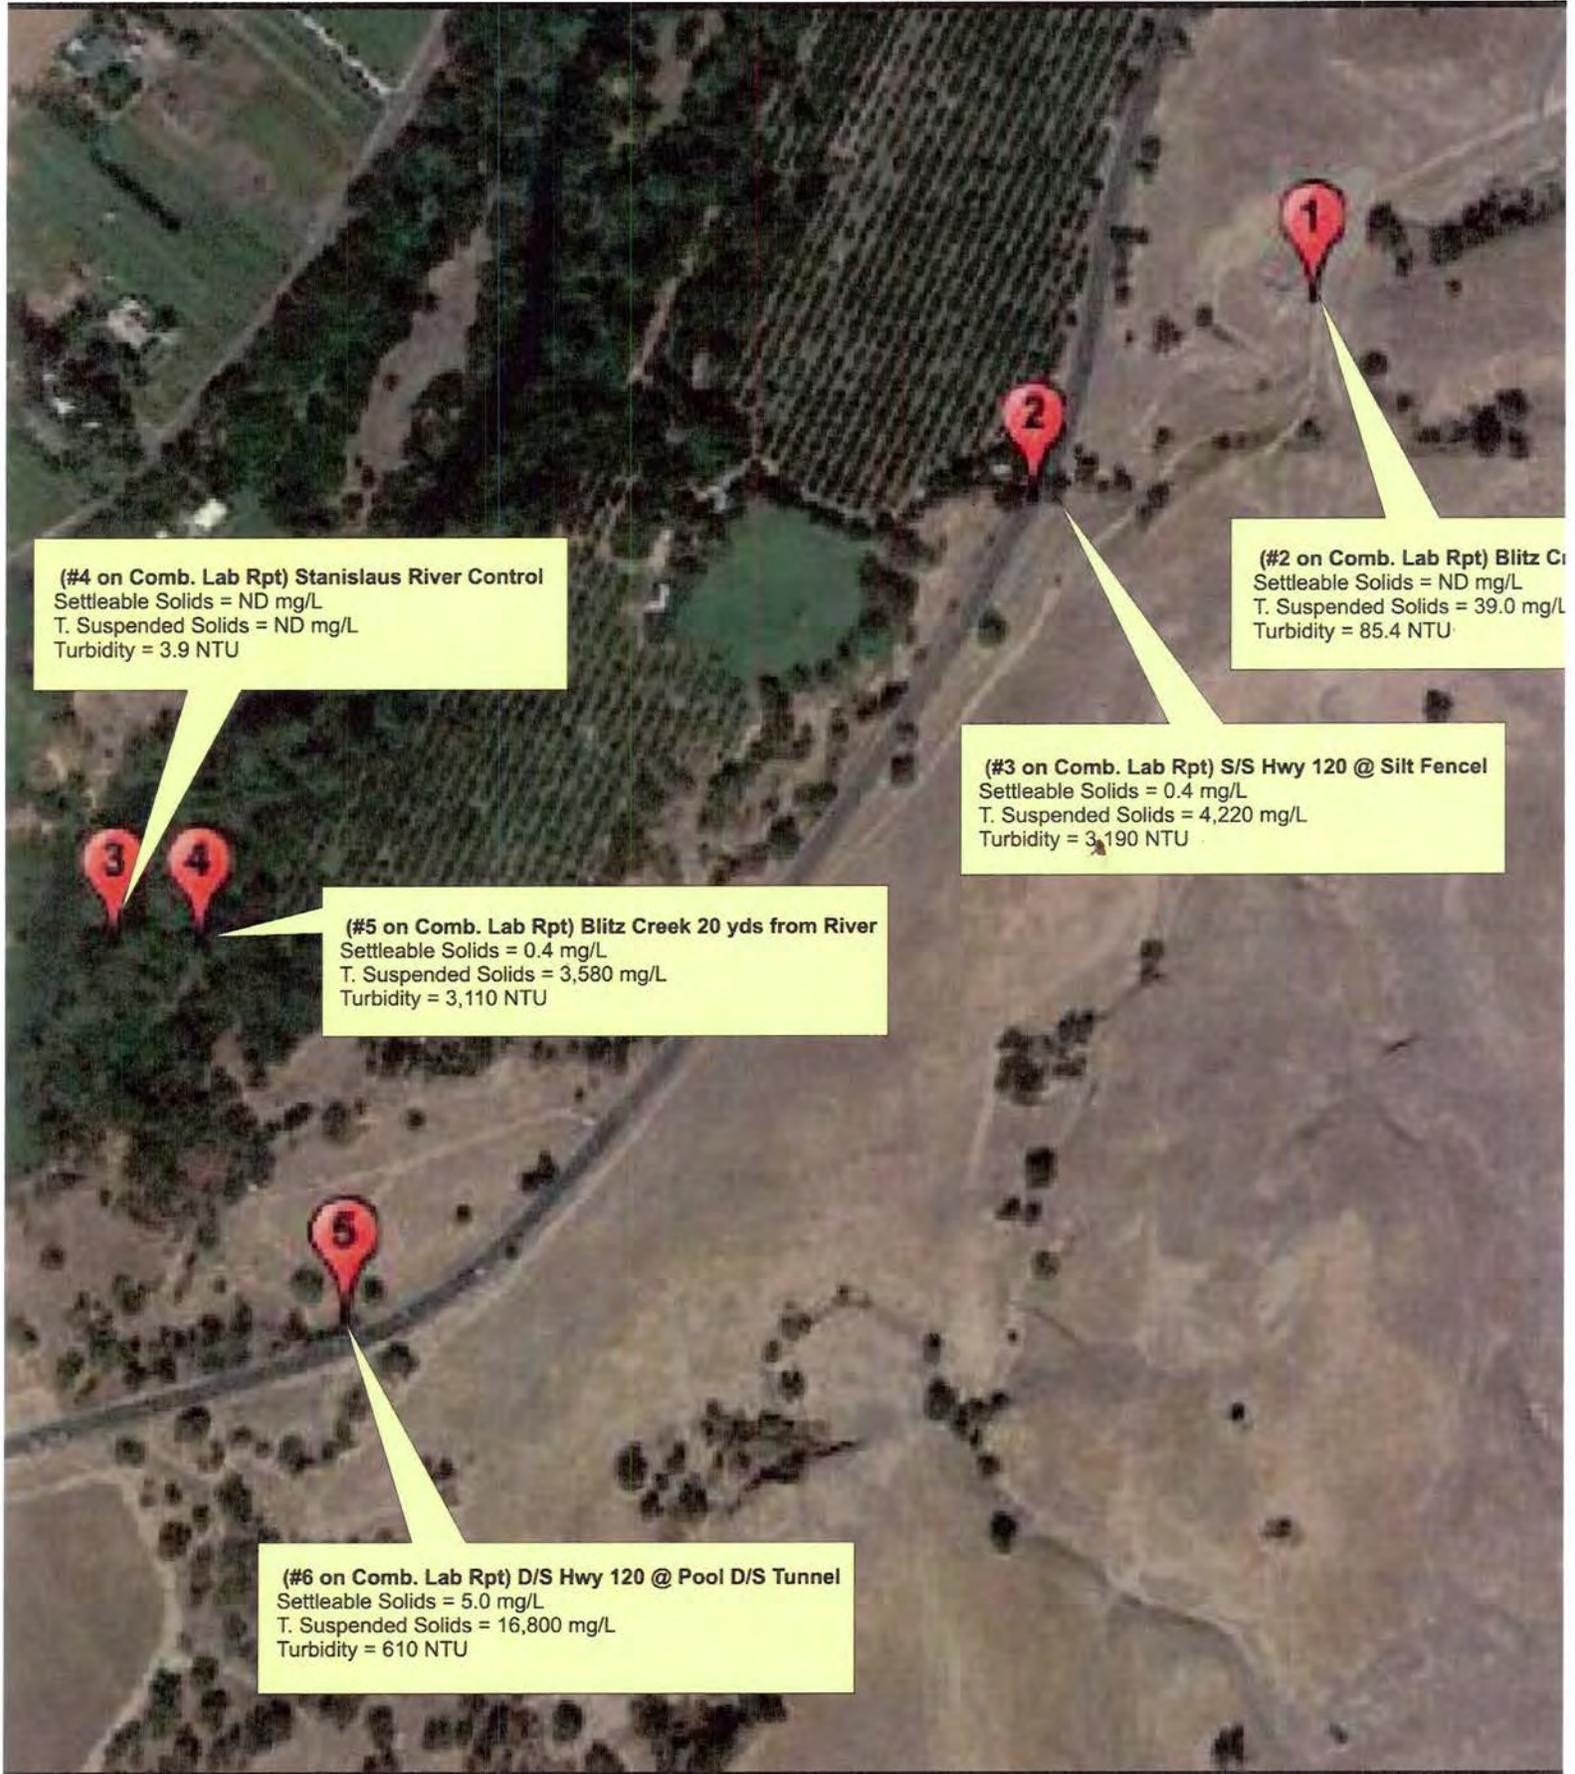
December 22, 2012
DFG Discharge Investigation
Water Sample Map

(#4 on Comb. Lab Rpt) Stanislaus River Control
Settleable Solids = ND mg/L
T. Suspended Solids = ND mg/L
Turbidity = 3.9 NTU

(#2 on Comb. Lab Rpt) Blitz C
Settleable Solids = ND mg/L
T. Suspended Solids = 39.0 mg/L
Turbidity = 85.4 NTU
