**THREE INDEPENDENT ASSESSMENTS REPORTS HAVE
BEEN COMPLETED ON THE DRAINAGE, EROSION AND
DAMAGE OCCURING FROM I-80 TO THE GREEN POINT
SUBDIVISION**

**2. AN ASSESSMENT OF SURFACE WATER RUNOFF AND
EROSION ABOVE AND BELOW WEST REED AVENUE,
TRUCKEE, CA. BY INLAND ECOSYSTEMS, JULY 2006**

**3. TRUCKEE RIVER WATER SHED COUNCIL EROSION AND
WATER QUALITY REPORT & ASSESSMENT SUMMARY,
SEPTEMBER 16, 2016**

Proposed Montano Property Wetland Restoration Plan

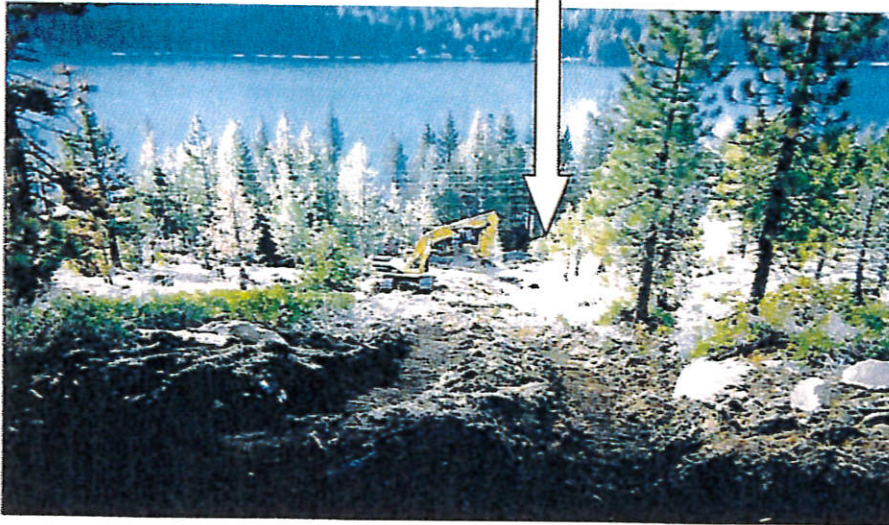
The TDPUD also installed a pipeline downslope from the Cedar Point alignment to West Reed Avenue in 2004 (See Photo 23). After pipeline installation this alignment was mulched with pine needles, and hay bales were placed at key locations to reduce runoff velocity (See Photo 24). A photograph of the site taken on June 21, 2006 demonstrates that restoration of the former construction area is occurring (See Photo 25). No evidence of substantial erosion is evident at the site.

Photo 23.
The TDPUD installed a water pipeline from the Cedar Point alignment downslope to West Reed Avenue in 2004. Photo taken August 2004.

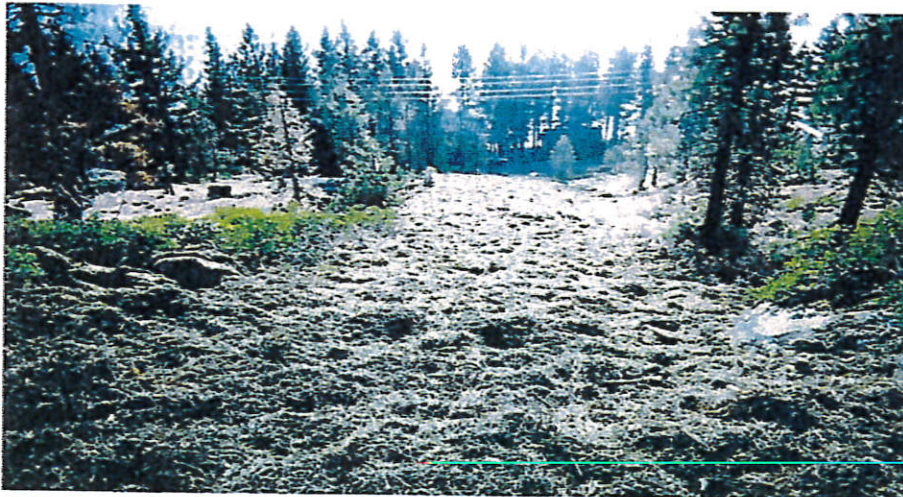
Photo 24.
Erosion control measures were implemented on the site in September 2004 after the completion of construction. Photo taken October 2004.

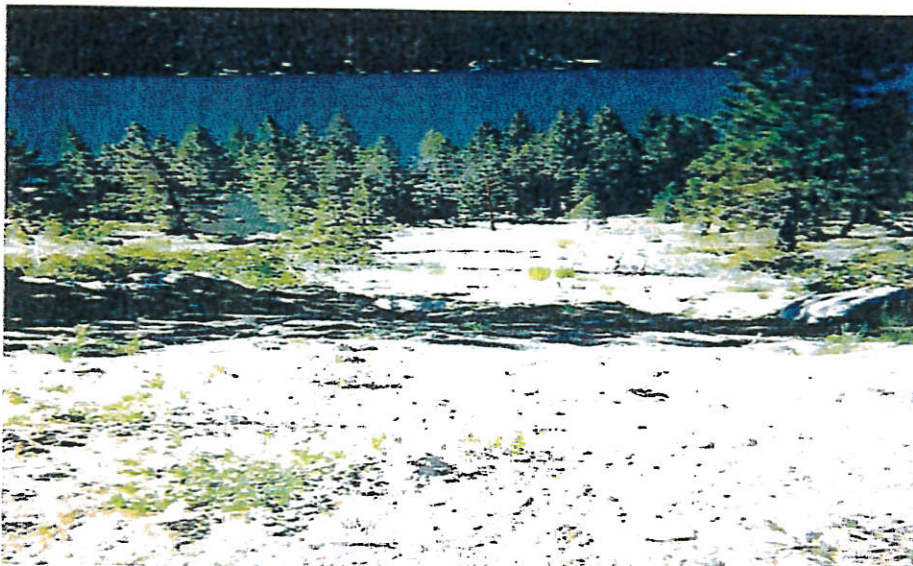
Photo 25.
A photo of the construction area taken on June 21, 2006. No substantial erosion has occurred in this area of the hillside.

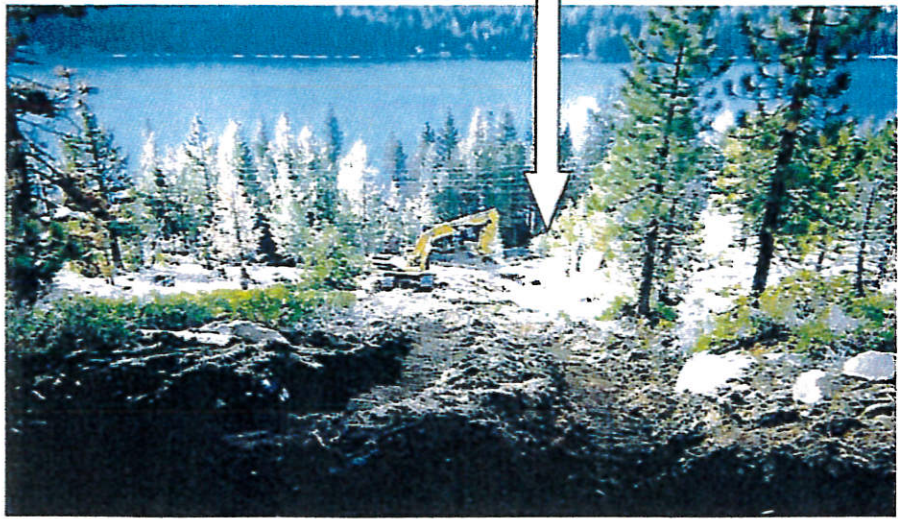
Photo 23.
The TDPUD installed a water pipeline from the Cedar Point alignment downslope to West Reed Avenue in 2004. Photo taken August 2004.

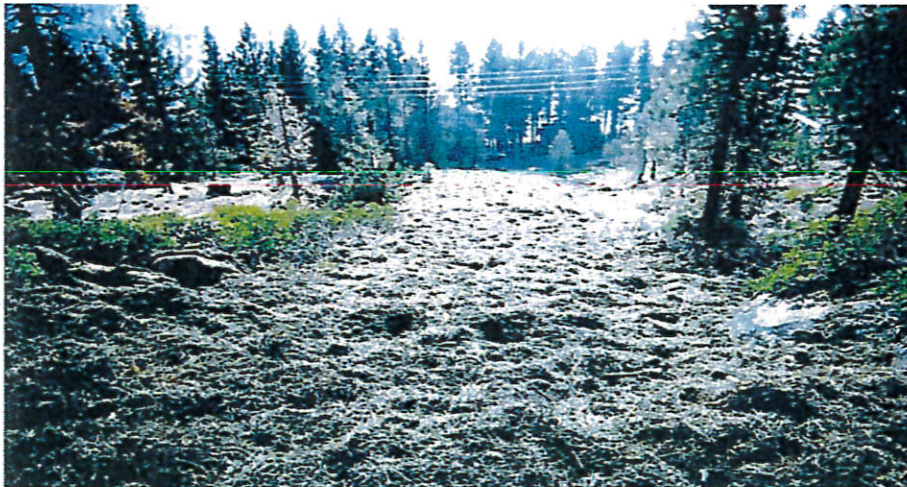
Photo 24.
Erosion control measures were implemented on the site in September 2004 after the completion of construction. Photo taken October 2004.

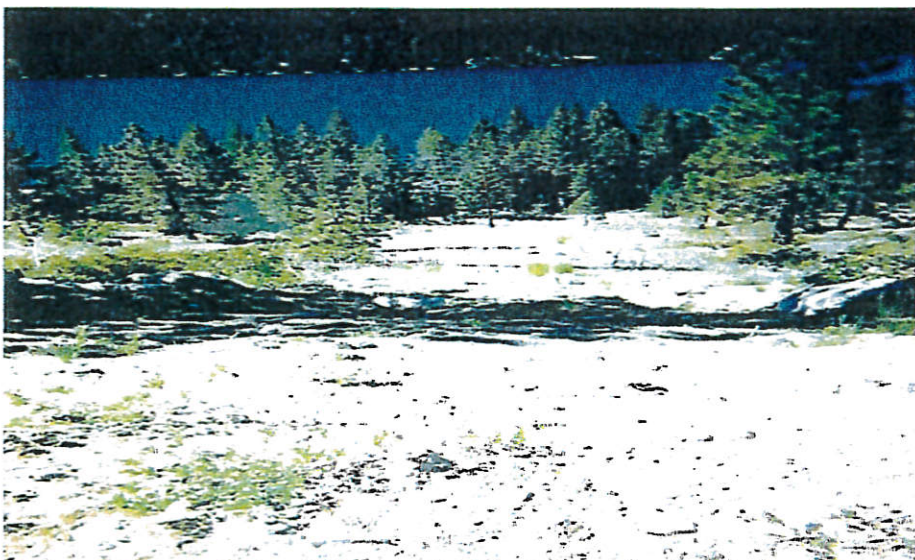
Photo 25.
A photo of the construction area taken on June 21, 2006. No substantial erosion has occurred in this area of the hillside.
