**Subject: Notice of Violation No. R9-2010-0135 and Water Code Section 13267
Technical Report, City of San Diego**

NOTICE OF VIOLATION No. R9-2010-0135

FACILITY INSPECTION REPORT

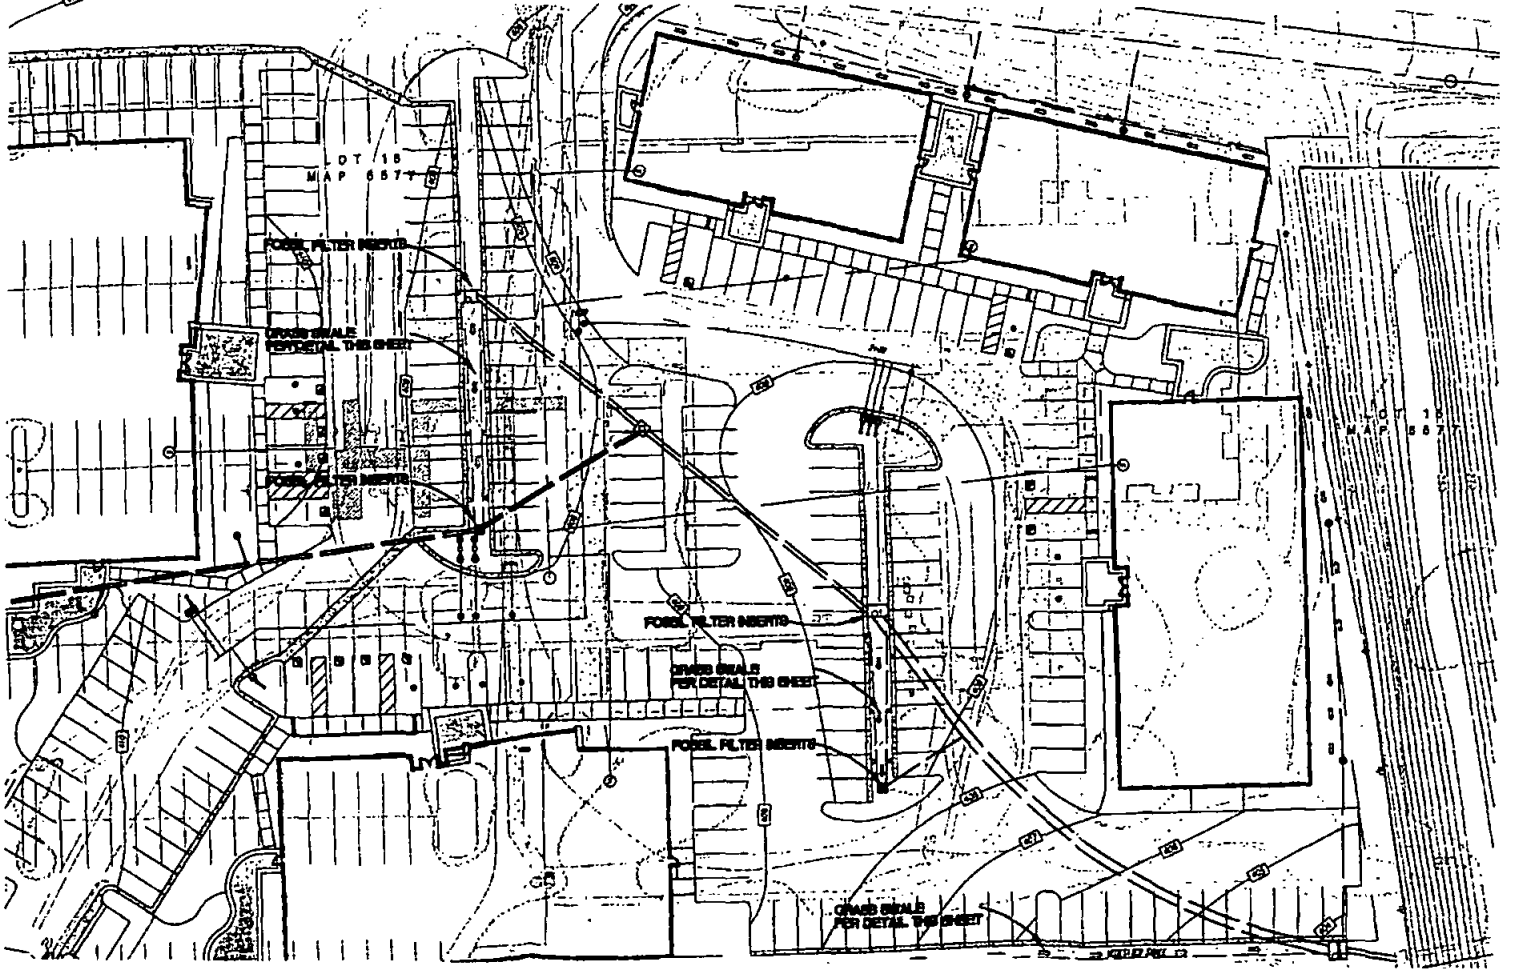
Figure 14. Engineering Specifications for Highland Skypark

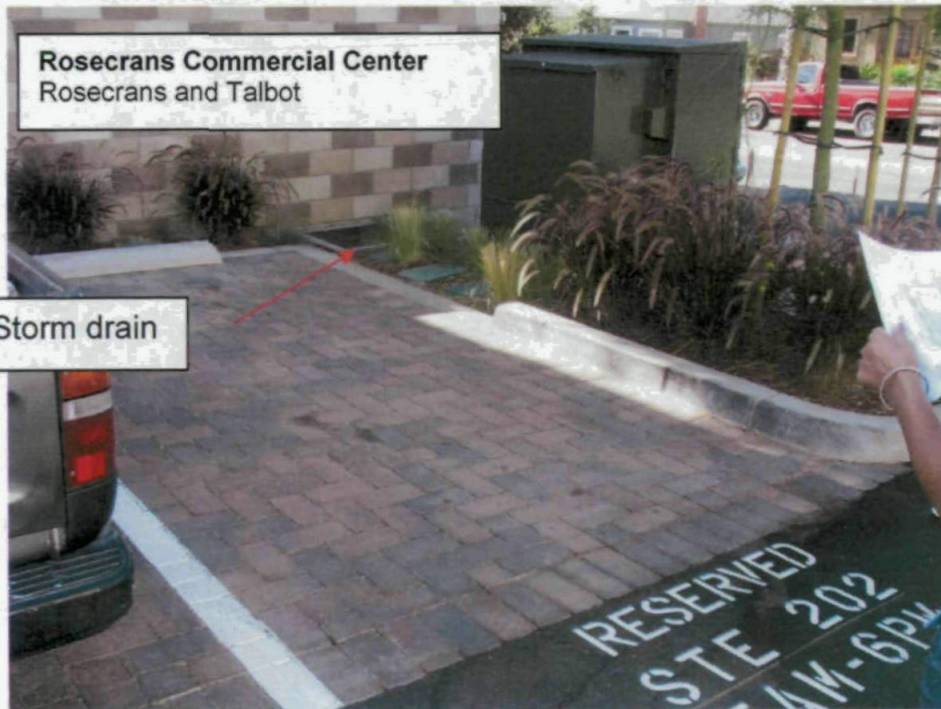
Figure 8. Pervious pavers at Rosecrans Commercial Center

Rosecrans Commercial Center is in the Point Loma area of the City of San Diego and received final approval from the City in July 2009. Figures 8-13 show permanent BMPs installed in the parking lot. BMPs include porous pavers, a vegetated swale, and a trench drain with filter inserts (the swale is described as a bioswale in the engineering specifications and a grass swale on the BMP sheet). The storm drain shown in Figure 8 does not have an inlet filter. One roof drain discharges into a planter box; 3 roof drains discharge onto impervious asphalt.
