**Subject: Notice of Violation No. R9-2015-0032, Laurel Pointe Construction Project, Order No. 2009-0009-DWQ, NPDES Permit No. CAS000002, Construction General Permit**

NOTICE OF VIOLATION
No. R9-2015-0032

**FACILITY INSPECTION REPORT**

**FACILITY:** Laurel Pointe

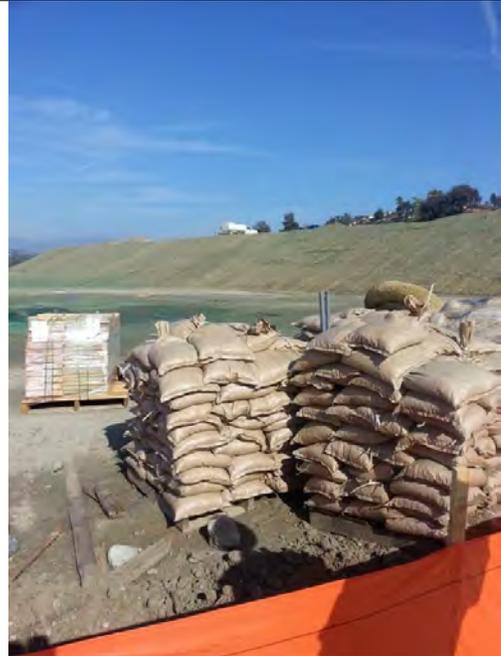
As seen in Figures 2-5, erosion control BMPs were not installed on the slope nearest the street prior to the rain event that began on February 28, 2014. Erosion control and sediment control BMP materials were present on Site as seen in Figures 6, 7, and 11, however the slope in Figure's 2 and 3 did not have erosion control along with sediment control BMPs in place prior to the rain event. The gravel bags used for sediment control BMPs (see Figures 2-4) were inundated due to lack of adequate erosion control BMPs and caused a discharge of sediment from the Site to the MS4.

Figure 7: Silt fence as sediment control present around curbs and erosion control present on interior slopes. Stacked gravel bags present on site for deployment as erosion/sediment control measures.

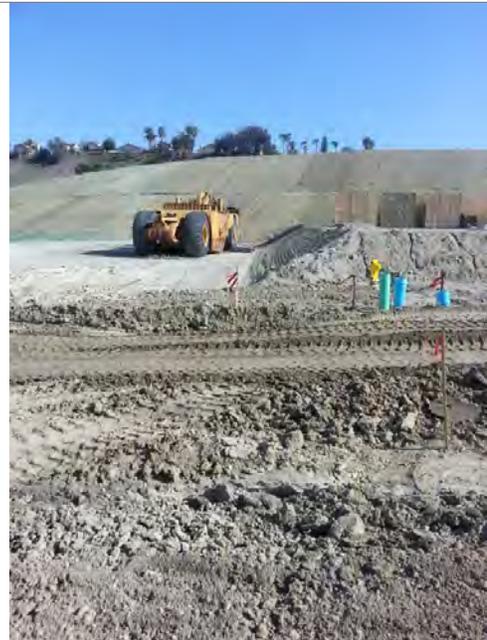
Figure 9: Erosion control BMP present on the interior slopes of project.

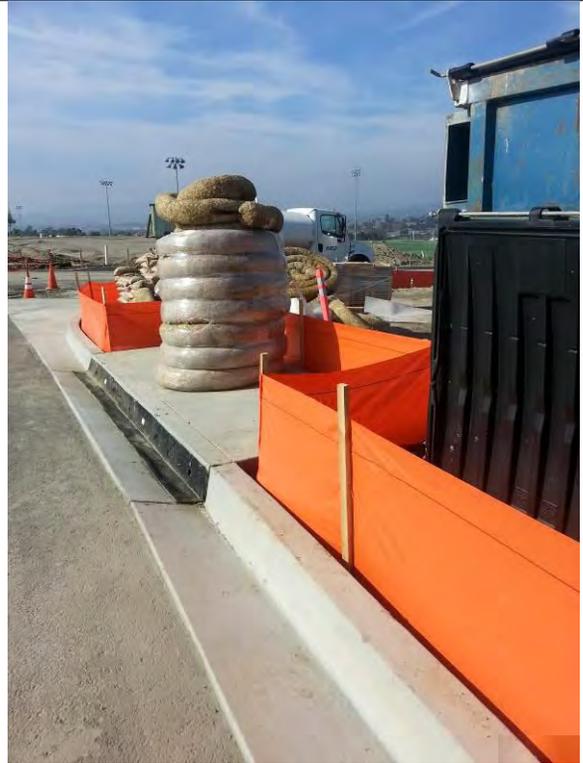
Figure 11: Silt fence installed to provide sediment control on interior portions of site. Stacked BMPs material present for deployment, if needed.
