City of Vista

April 23, 2007

**DISCHARGER RESPONSE TO INVESTIGATIVE ORDER NO. R9-2007-0060, DISCHARGE OF
UNTREATED SEWAGE INTO THE BUENA VISTA LAGOON WITHIN THE CITY OF
CARLSBAD SAN DIEGO COUNTY
(Reference: NCRU:01-0743.02 & 01-0764.02:ebecker)**

City of Carlsbad

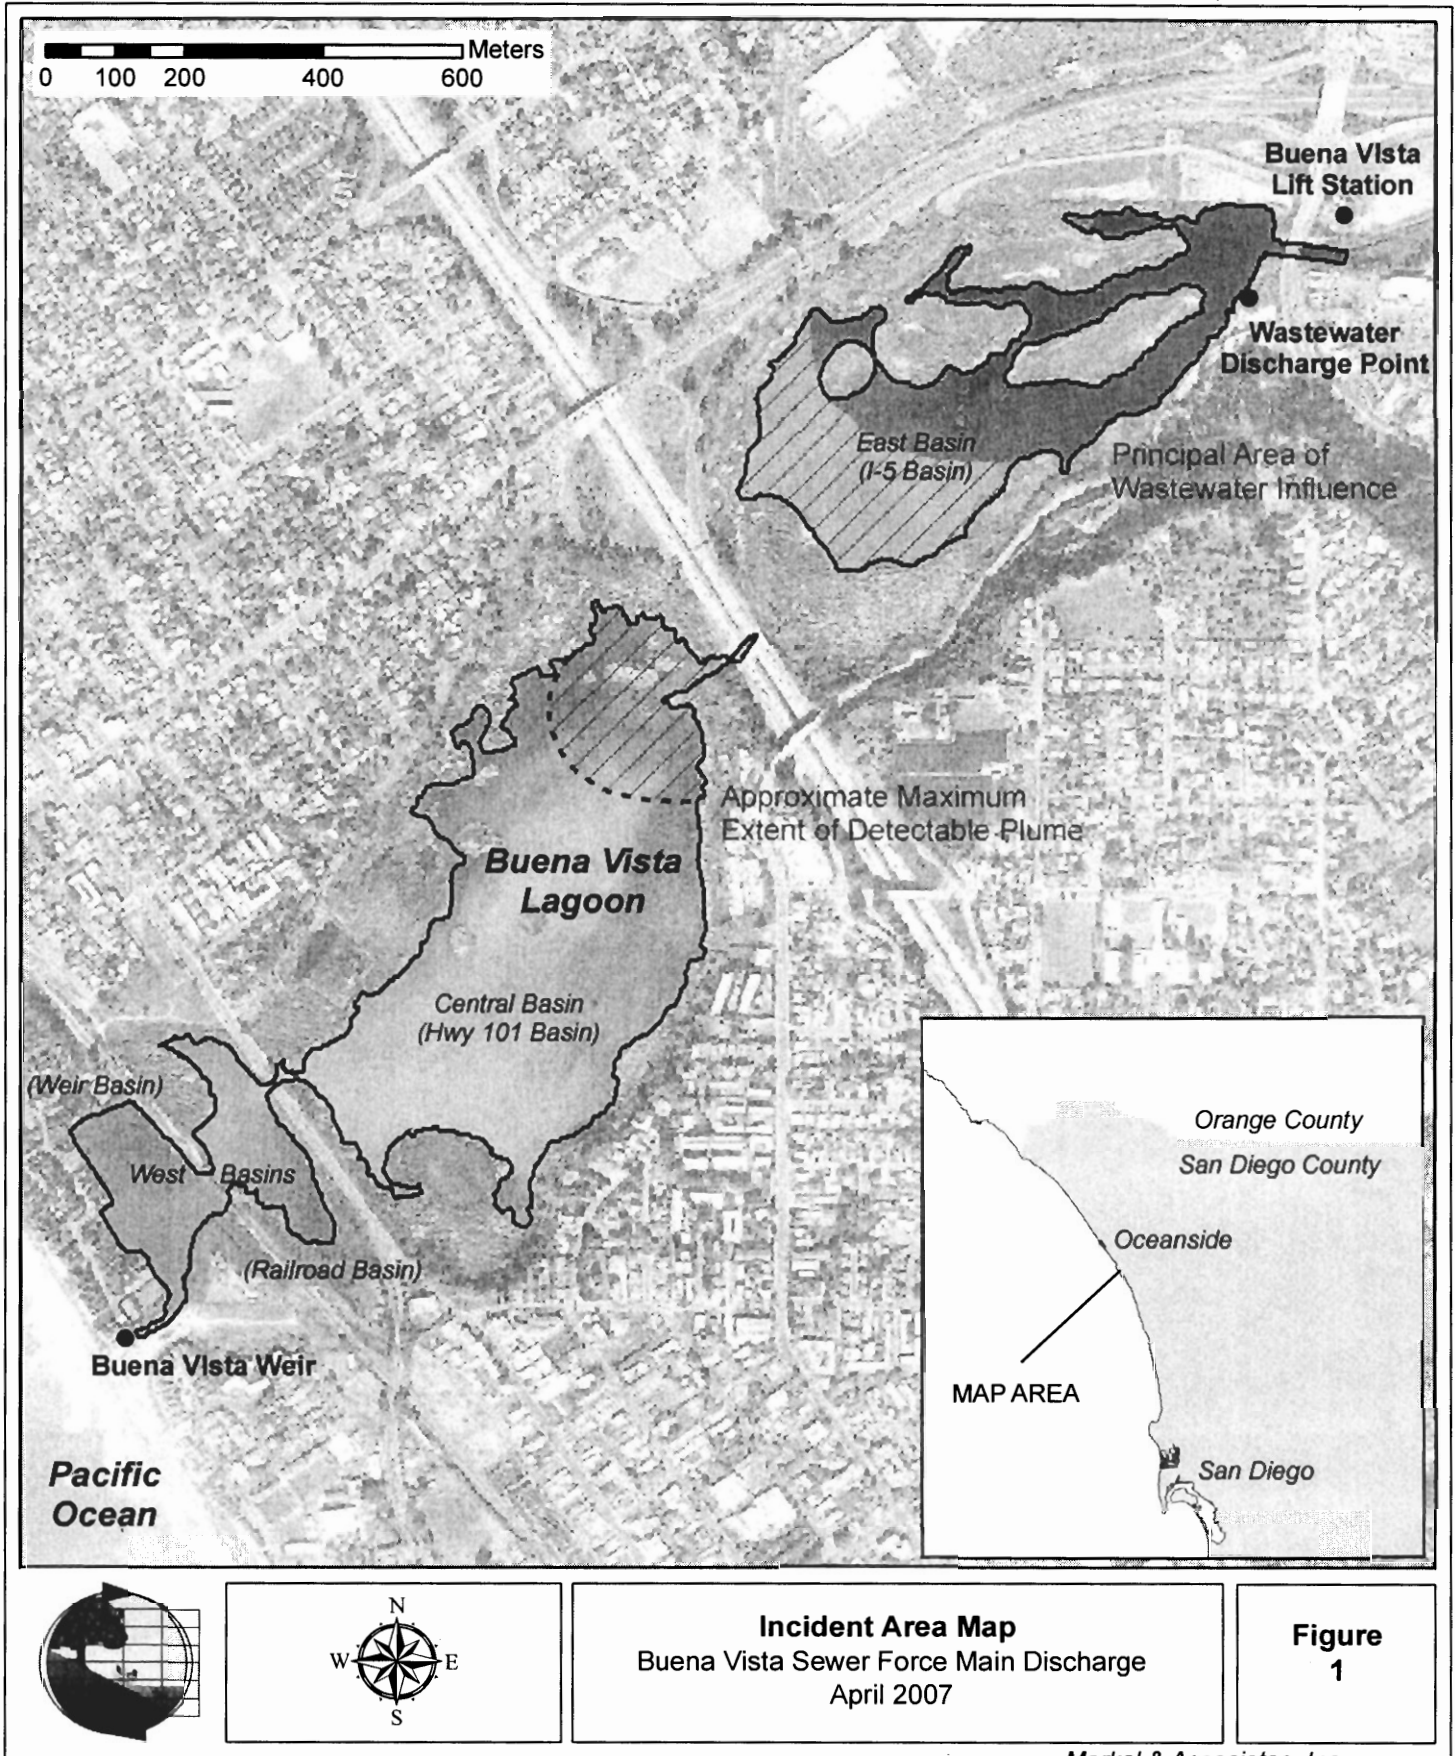
Figure
1

From March 31, 2007 through April 3, 2007, the Dischargers spilled an estimated 7.329 million gallons of untreated sewage from a rupture of the sewer main and as a result of repair period overflow from the containment berm at the adjacent Buena Vista Sewer Lift Station into Buena Vista Lagoon (Figure 1). As a result of the spill into Buena Vista Lagoon, the Regional Board requested information to evaluate the actions taken to prevent the sewage discharge, to repair the failed pipeline, and to investigate the impacts to water quality (WQ) from the sewage discharges. This request was tendered to the Dischargers on April 6, 2007 in the form of Investigative Order (IO) No. R9-2007-0060. The IO requires technical investigations and submittal of a technical report to the Regional Board no later than April 23, 2007. This document, and attachments hereto, constitutes the Dischargers’ response to Investigative Order No. R9-2007-0060.

Incident Area Map
Buena Vista Sewer Force Main Discharge
April 2007

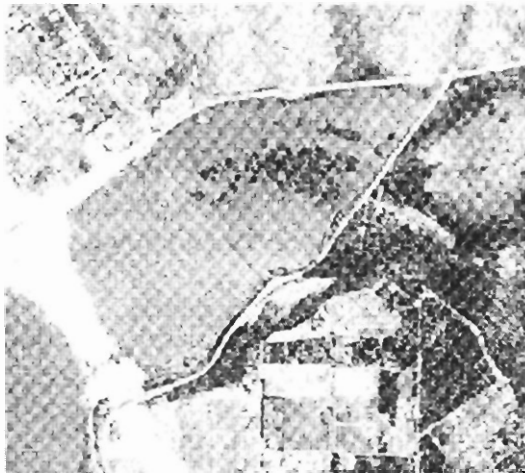
Upper Buena Vista Lagoon illustrating the original alignment of Jefferson Street on lagoon shoreline.

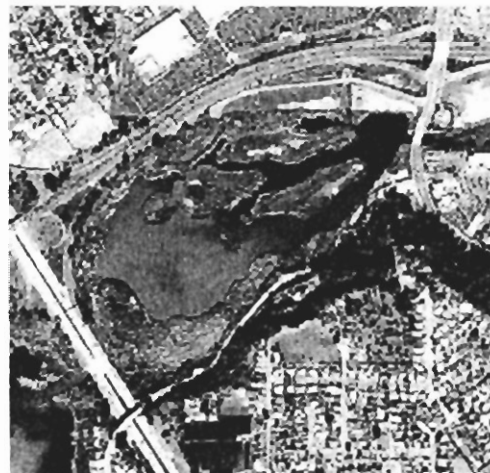
Buena Vista Lagoon with current Jefferson Street Alignment

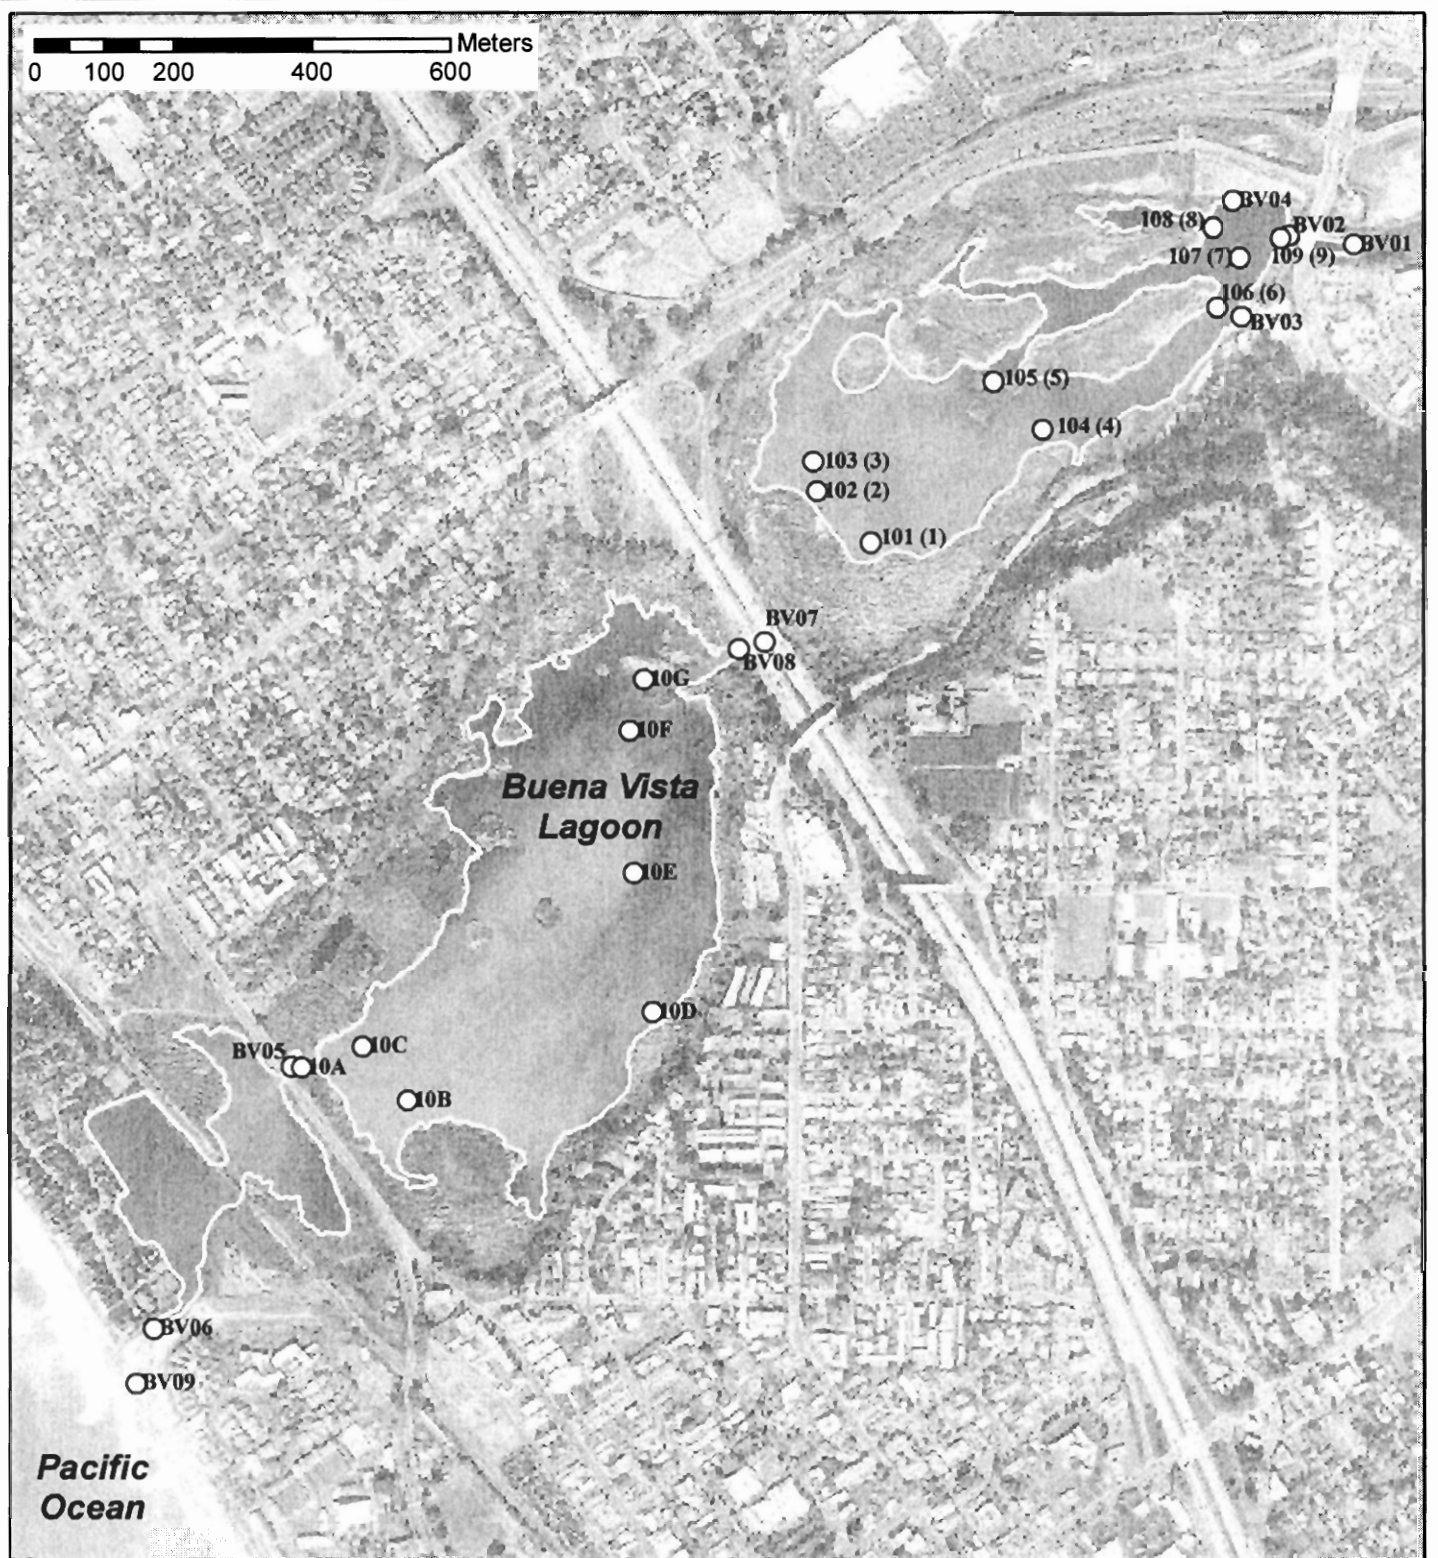
Figure 3 illustrates all WQ sampling stations employed during the post spill monitoring. Shoreline WQ monitoring commenced on April 2nd, at 8:30 AM, with bacteriological sampling conducted by EWA. Dissolved oxygen monitoring also commenced on April 2nd through the actions of Carlsbad Environmental Programs staff. This monitoring program was supplemented on April 3rd by Weston Solutions, Inc. performing on-water monitoring in accordance with the EWA SSORP and 1997 spill monitoring method. On April 7th, Merkel & Associates took over field monitoring for shoreline DO, and on April 12th, Merkel & Associates took over field monitoring on the water. Summary data tables for bacteriological and dissolved oxygen data are incorporated in Appendix 10a. Bacteriological laboratory reports from the Encina Wastewater Laboratory are provided as Appendix 10b. Appendix 10c includes field data sheets for dissolved oxygen monitoring. Early spill period dissolved oxygen monitoring results were recorded in field notebooks and are not included in this appendix. However, all monitoring results are provided on the data summary sheets (Appendix 10a).

Water Quality Monitoring Stations
Buena Vista Sewer Force Main Discharge
April 2007

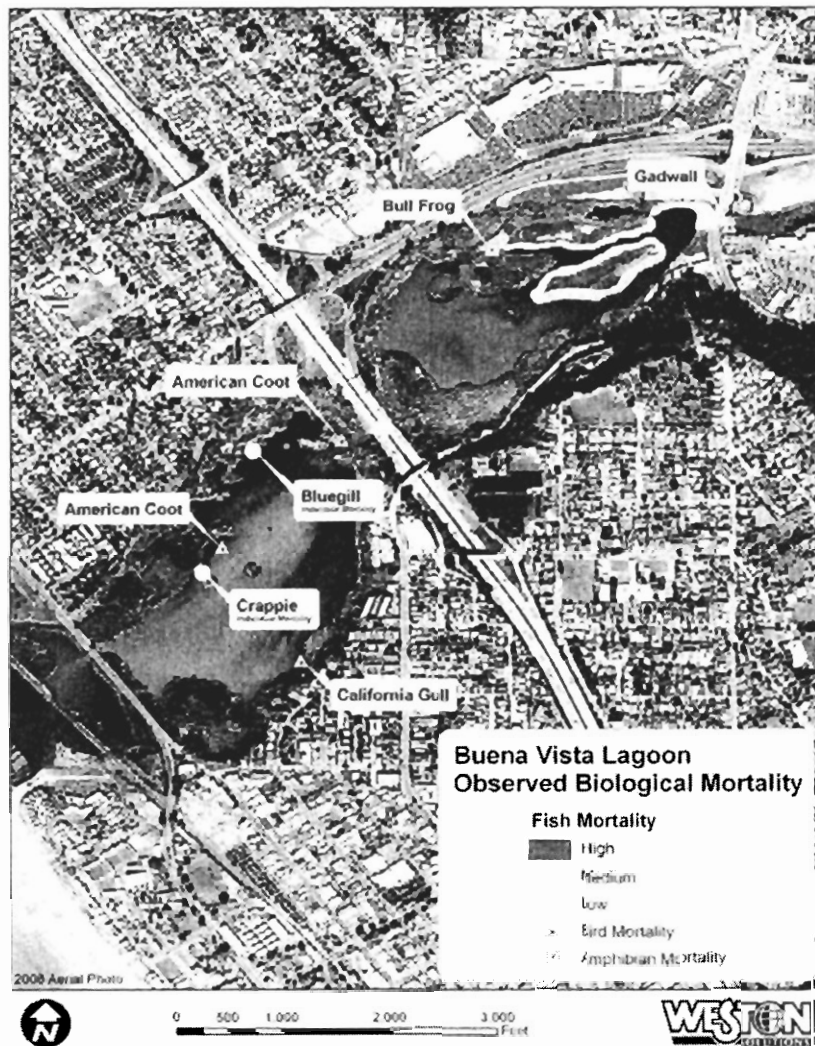
DO values below 3.0 mg/l may result in fish kills although most of the species of warm water fish found in Buena Vista Lagoon have tolerances below this level (Table 1). Fish mortality appears to have occurred primarily in the eastern portions of the east basin as indicated in a map of the fish collection concentrations prepared by Weston (Figure 4). No dead fish were recovered on the south shoreline of the east basin but rather were recorded primarily on the northern shoreline and around the island in the center of the basin. Fish likely expired around the center of the spill location and were moved northward by the wind. Only two dead fish were found on the northern shoreline of the central basin. This would suggest that low DO might have encroached into the central basin enough to have a minor impact on fish there. However, given the location of these fish and the fact that they were both of reasonably large size, it is possible that these two fish losses are the result of injuries sustained from fishing, or other causes of mortality. The remainder of the 1,694 fish lost (99.9%) were recovered in the east basin.

A total of four dead birds were found during surveys for impacts to avian species. These included one California gull, two American coots, and one gadwall. The distribution of these birds is illustrated in Figure 4. No sick birds were detected.

One bullfrog was found dead in the east basin (Figure 4).

Figure 4. Distribution of fish and bird collections during April 2007 spill.
